National Capital Commission  
601, chemin du Lac Meech Rd, Chelsea  
Appendix B - Photos

Asa Meech – 601, chemin du Lac Meech, Chelsea

## Asa Meech House – Heritage Summary

**Phase I Environmental Site Assessment  
NCC Property Asset Number 727  
601 Meech Lake Road, Chelsea, Québec**

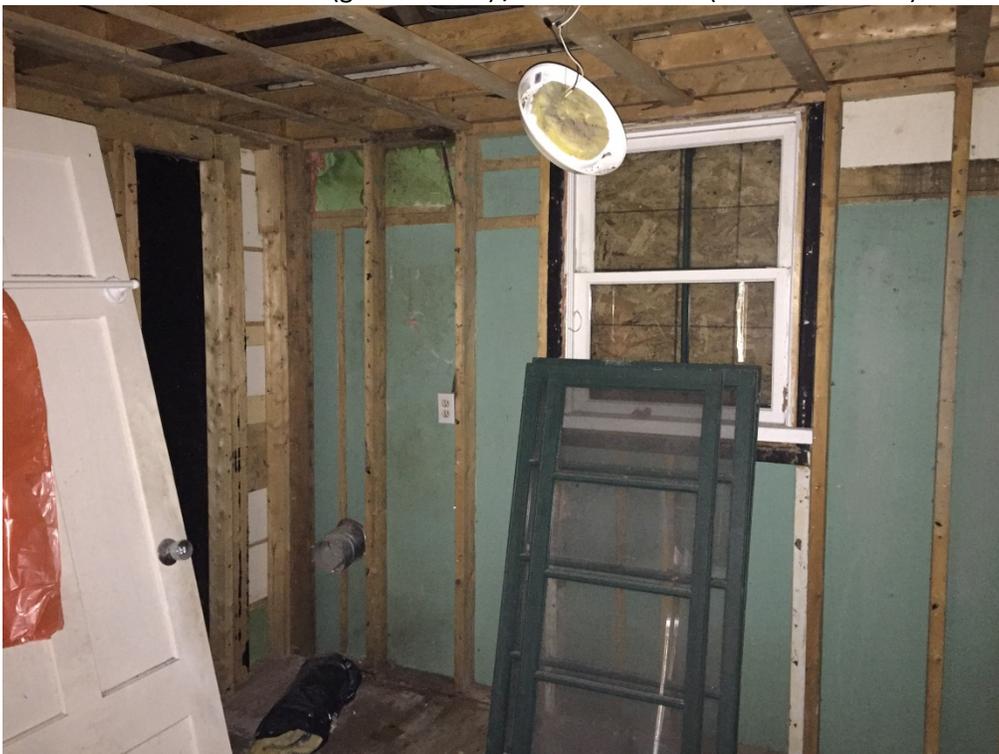
19. – Cracked beam (ground floor) / Poutre fissurée (rez-de-chaussée)

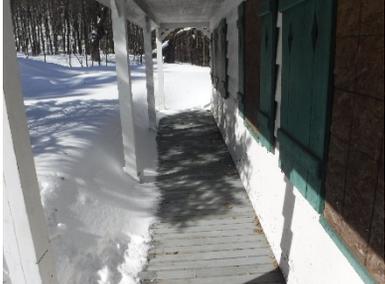
Location	Description	Condition	Concentration of Lead (ppm)	Sample Number	Lead-Containing Paint (Yes/No)	Image
Exterior	Grey paint on porch	Poor	<89	LP-001	No

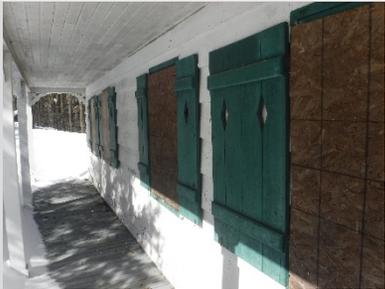
Exterior	Green paint on shutters/windows	Poor	42,000	LP-003	Yes

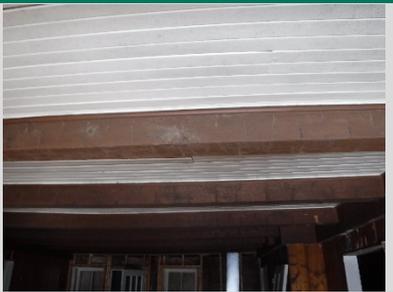
Location	Description	Condition	Concentration of Lead (ppm)	Sample Number	Lead-Containing Paint (Yes/No)	Image
First floor – Main entrance	Brown paint/stain on 4 x 4 beams along the ceiling	Fair	680	LP-004	Yes

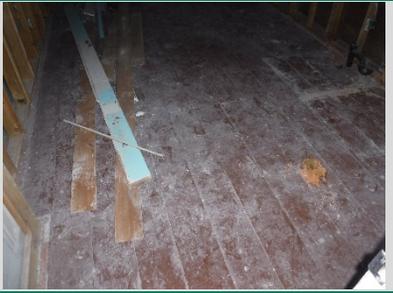
First Floor – Kitchen	Medium brown/orange paint on floor	Poor	23,000	LP-006	Yes

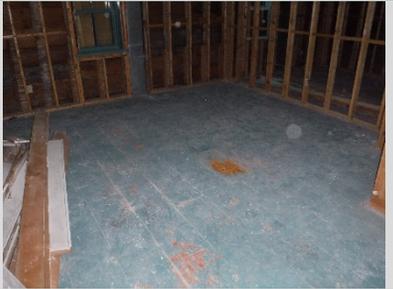
Location	Description	Condition	Concentration of Lead (ppm)	Sample Number	Lead-Containing Paint (Yes/No)	Image
First floor – Family room	Green/orange paint on floor	Poor	92,000	LP-007	Yes

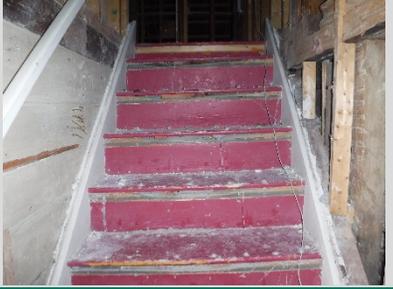
Stairwell between first and second floors	Red paint on stairs	Poor	47,000	LP-009	Yes

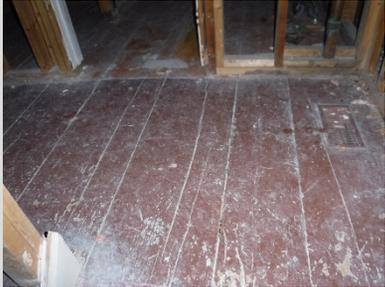
Second floor – Common Area	Dark brown/orange paint on floor	Poor	110,000	LP-012	Yes

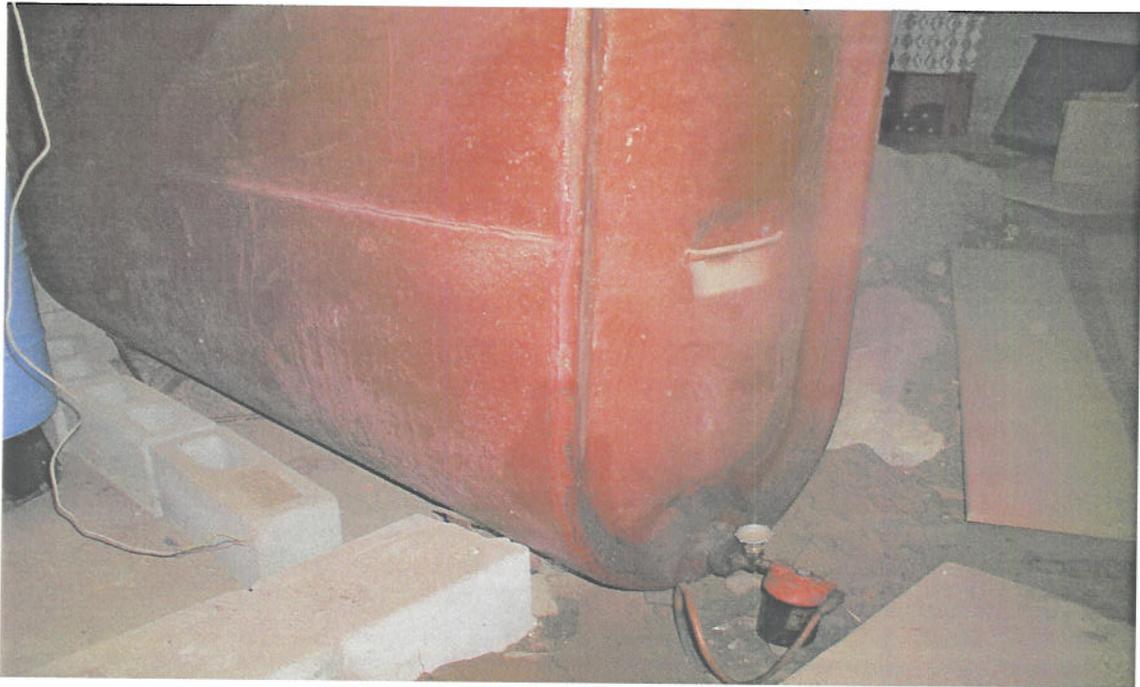
Photo 3: AST located in crawlspace of basement.

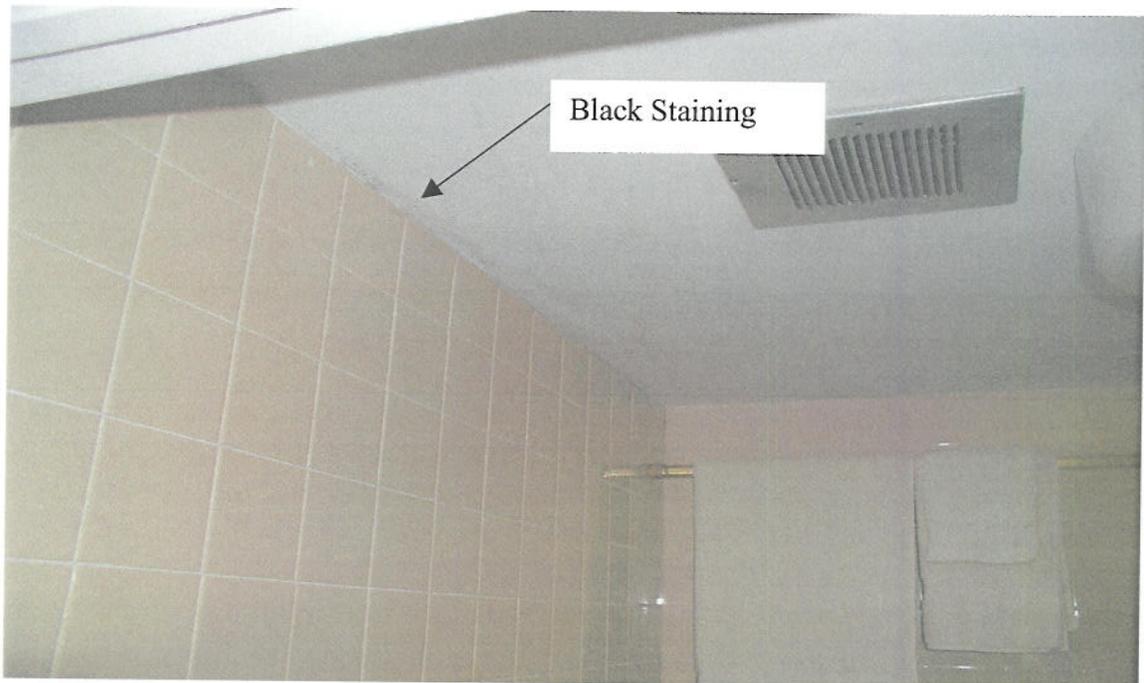
Photo 4: Minor black staining indicating potential mould along ceiling in bathroom.

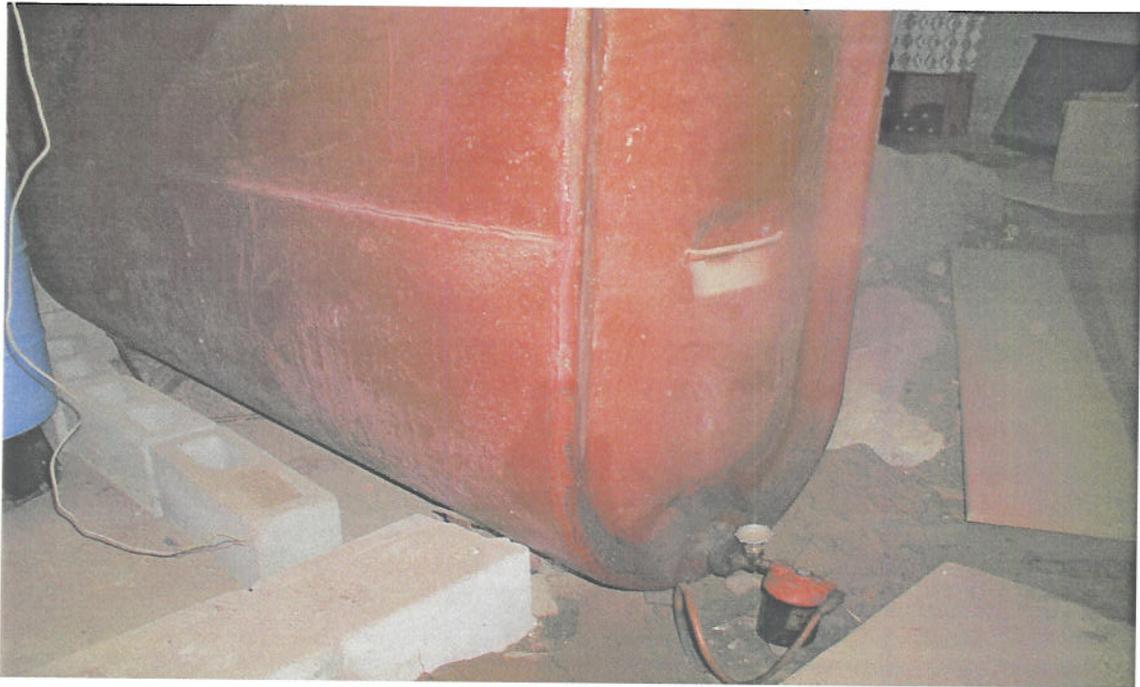
Photo 3: AST located in crawlspace of basement.

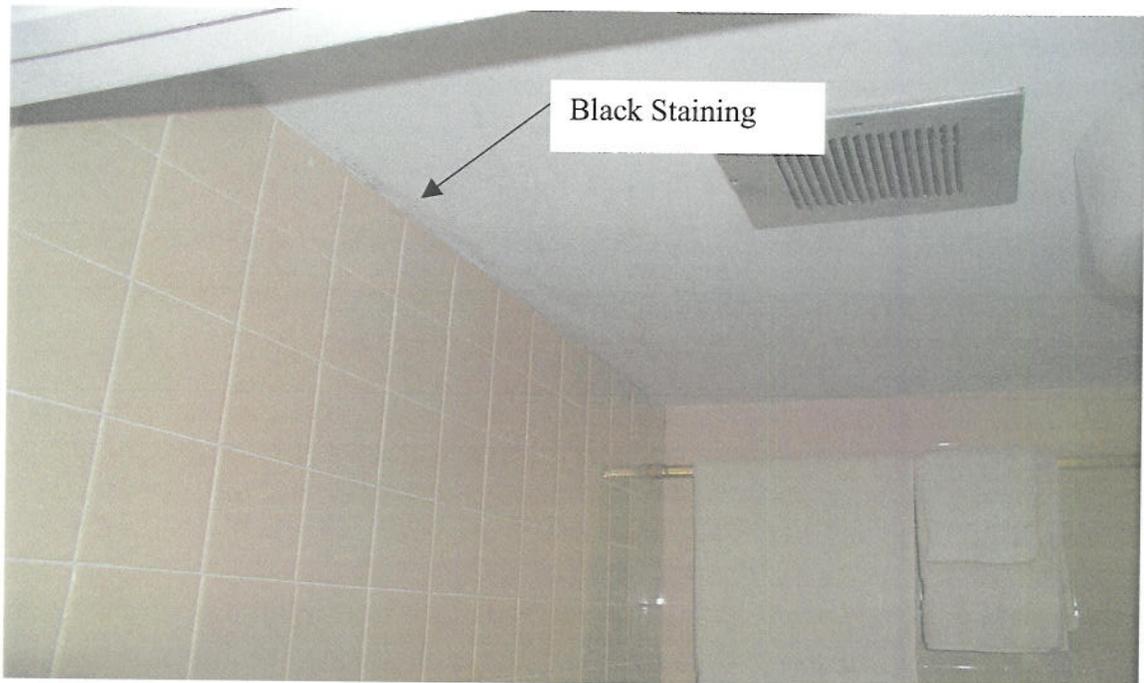
Photo 4: Minor black staining indicating potential mould along ceiling in bathroom.

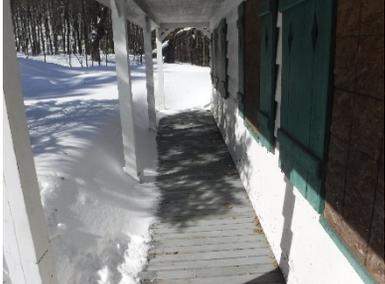
Location	Description	Condition	Concentration of Lead (ppm)	Sample Number	Lead-Containing Paint (Yes/No)	Image
Exterior	Grey paint on porch	Poor	<89	LP-001	No

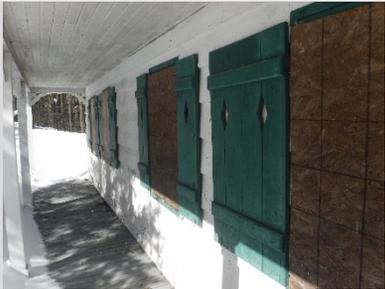
Exterior	Green paint on shutters/windows	Poor	42,000	LP-003	Yes

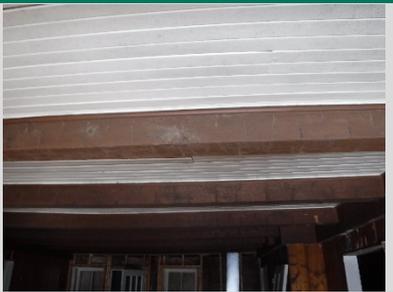
Location	Description	Condition	Concentration of Lead (ppm)	Sample Number	Lead-Containing Paint (Yes/No)	Image
First floor – Main entrance	Brown paint/stain on 4 x 4 beams along the ceiling	Fair	680	LP-004	Yes

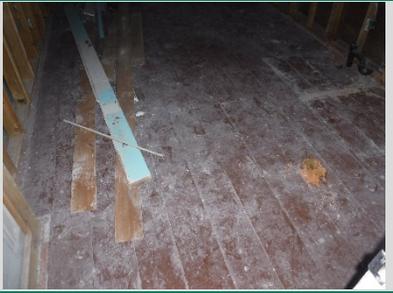
First Floor – Kitchen	Medium brown/orange paint on floor	Poor	23,000	LP-006	Yes

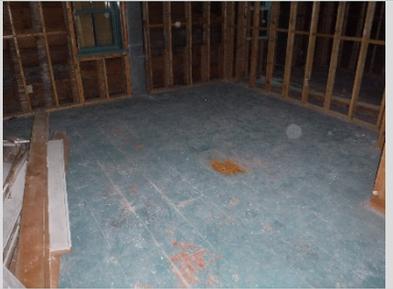
Location	Description	Condition	Concentration of Lead (ppm)	Sample Number	Lead-Containing Paint (Yes/No)	Image
First floor – Family room	Green/orange paint on floor	Poor	92,000	LP-007	Yes

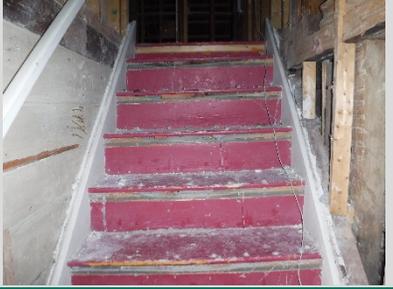
Stairwell between first and second floors	Red paint on stairs	Poor	47,000	LP-009	Yes

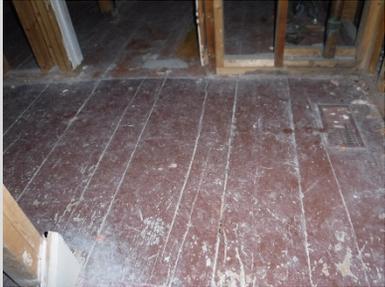
Second floor – Common Area	Dark brown/orange paint on floor	Poor	110,000	LP-012	Yes
