**Designated Substances and
Hazardous Building Materials
Assessment – Newboro Lock
36 Rehabilitation on the
Rideau Canal**

Newboro Lock 36
10 Blockhouse Lane
Newboro ON

July 13, 2018

Prepared by:
Stantec Consulting Ltd.
300W – 675 Cochrane Drive
Markham ON L3R 0B8

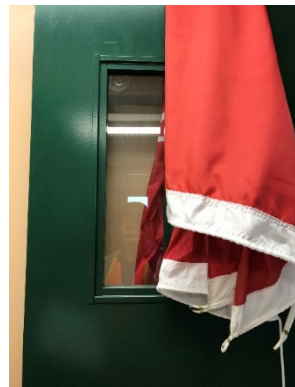
LOCATION	DESCRIPTION	PHOTO
Control Building, Corridor	Asbestos-containing interior window (on door) glazing compound – black on the corridor door Sample Ref:BS-08A 0.95% chrysotile

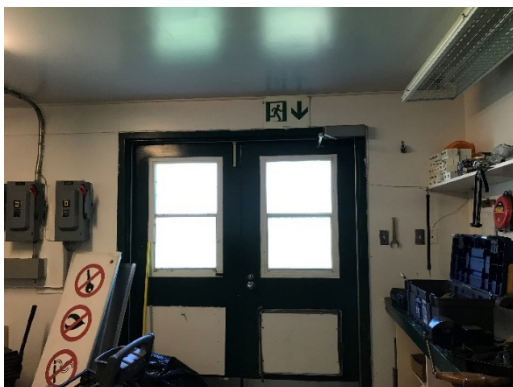
Control Building, Mechanical Room 2	Presumed asbestos-containing fire rated doors, not expected to be impacted by renovations

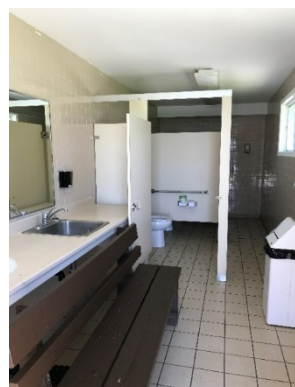
Control Building, Women's Washroom	Presumed asbestos-containing ceramic tile grout and mortar/adhesive, not expected to be impacted by renovations

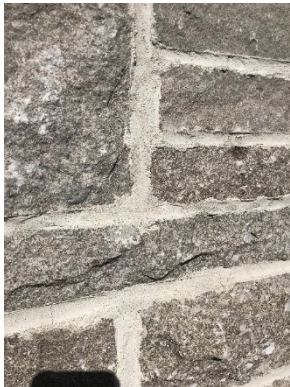
LOCATION	DESCRIPTION	PHOTO
Control Building, Exterior	Non-asbestos-containing exterior brick mortar – grey Sample BS-01A

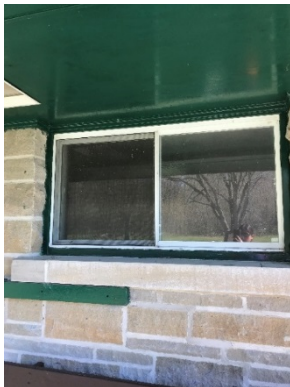
Control Building, Exterior	Non-asbestos-containing exterior window caulking – grey Sample BS-02B

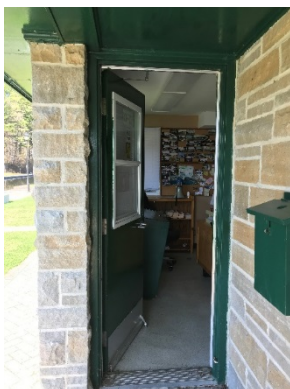
Control Building, Exterior	Non-asbestos-containing exterior door caulking – grey Sample BS-03C

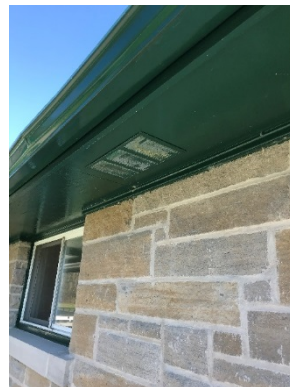
LOCATION	DESCRIPTION	PHOTO
Control Building, Exterior	Non-asbestos-containing exterior wall/ceiling caulking – grey Sample BS-04A

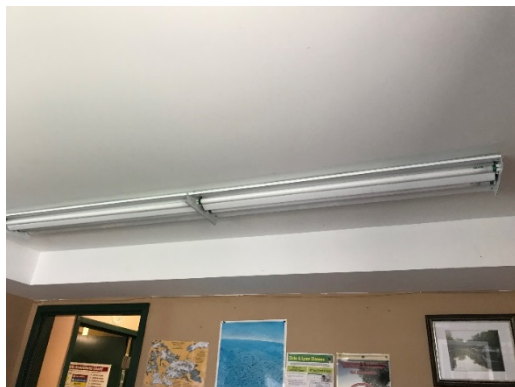
Control Building, Office	Non-asbestos-containing drywall joint-fill compound Sample BS-05A

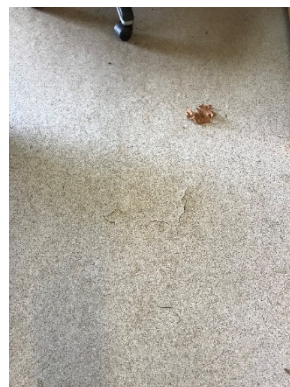
Control Building, Office	Non-asbestos-containing vinyl sheet flooring – beige grey with specks and associated paper backing Sample BS-06A

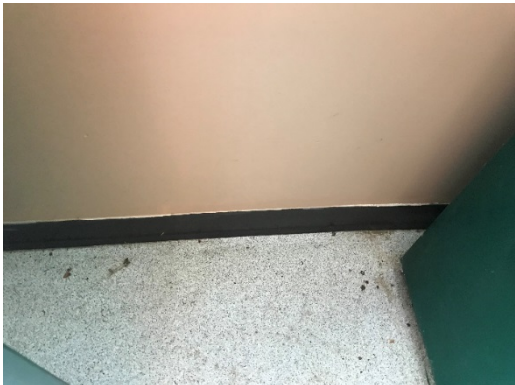
LOCATION	DESCRIPTION	PHOTO
Control Building, Corridor	Non-asbestos-containing cove base mastic Sample BS-07B

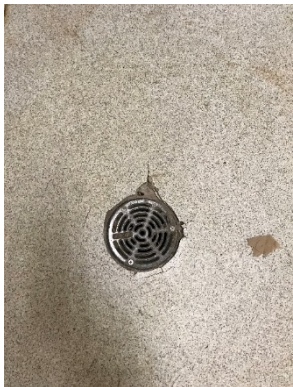
Control Building, Washroom	Non-asbestos-containing floor drain caulking – clear Sample BS-09A

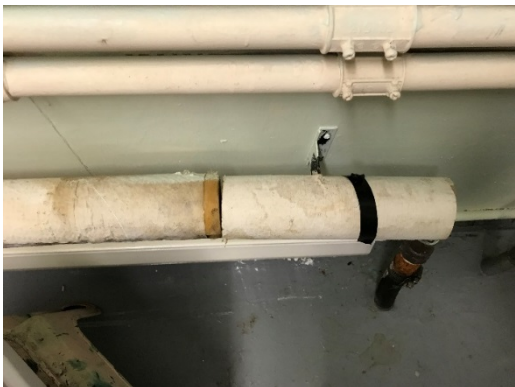
Control Building, Mechanical Room 1	Non-asbestos-containing floor leveling compound and fibreglass pipe insulation Samples BS-10A

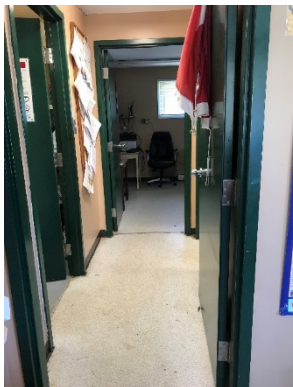
LOCATION	DESCRIPTION	PHOTO
Control Building, Corridor	Non-asbestos-containing interior door caulking – white. Sample Ref: BS-11A

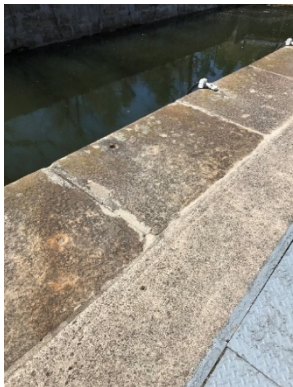
Exterior	Non-asbestos-containing walkway mortar Sample BS-12A

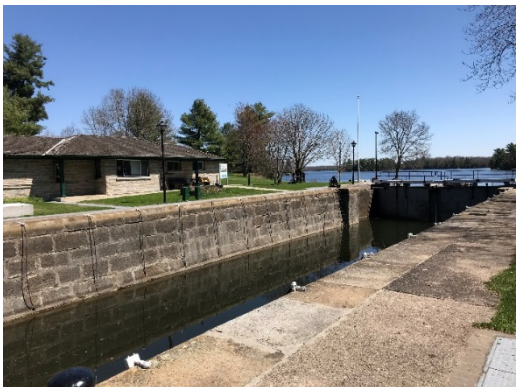
Exterior	Non-asbestos-containing retaining wall mortar Sample BS-13A

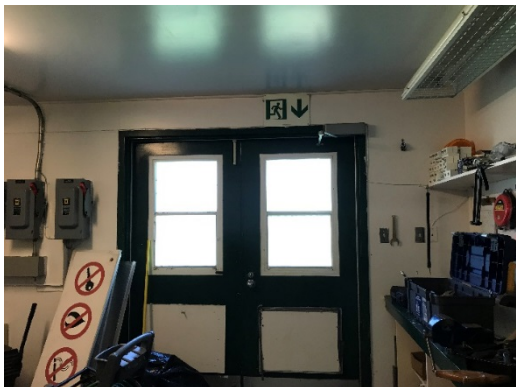
LOCATION	DESCRIPTION	PHOTO
Control Building, Mechanical Room 2	Lead-based dark green coloured paint observed on the door frames Sample PS-03 25,000 ppm

Work that may disturb any lead-containing paints should follow the recommendations provided in the document entitled:

- Ministry of Labour *Guideline: Lead on Construction Projects*
- *EACO Lead Guideline for Construction, Maintenance or Repair*, dated October 2014

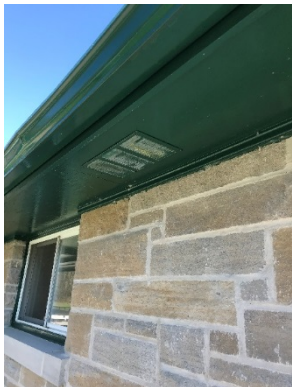
Control Building, Exterior	Lead-based dark green coloured paint observed on the exterior soffit, window frames and door frames on the Control Building Sample PS-01 26,000 ppm

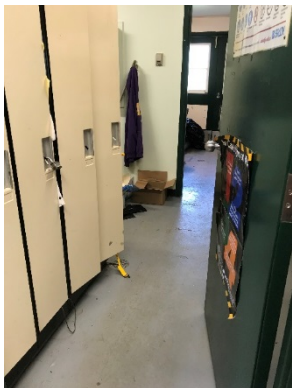
Control Building, Mechanical Room 1	Lead-based grey coloured paint observed on the floor Sample PS-04 17,000 ppm

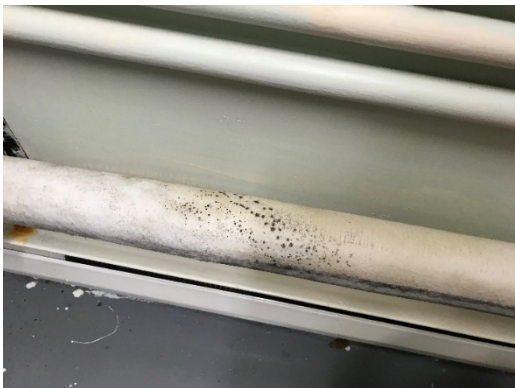
It is anticipated that the pipe insulation may be disturbed during the project. The mould observed was less than one (1) square meter and should be remediated in accordance with procedures for small scale (Level 1) mould growth in accordance with the documents entitled:

LOCATION	DESCRIPTION	PHOTO
Control Building, Mechanical Room 1	Identified mould on the pipe insulation Sample MS-01

Remediation should be done by a competent person, who is knowledgeable of potential hazards of mould exposure, following remediation precautions.
