**DESIGNATED SUBSTANCE AND HAZARDOUS MATERIALS  
SURVEY  
HMCS HAIDA  
658 CATHARINE STREET NORTH  
HAMILTON, ONTARIO**

**Parks Canada**

**31 January 2017**

**Project No.: 16.291**

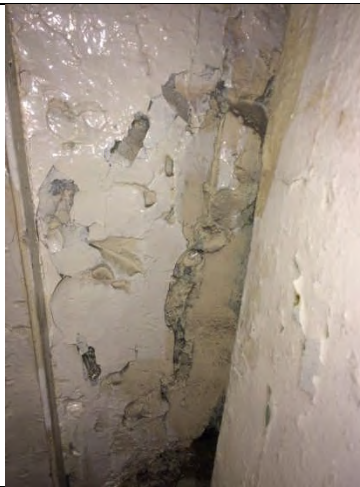
<p><b><u>Photo 1.0</u></b></p> <p>Description: Damaged asbestos containing Fireproofing insulation on walls within vessel</p> <p>Common White Paint Containing high lead concentrations throughout vessel.</p>

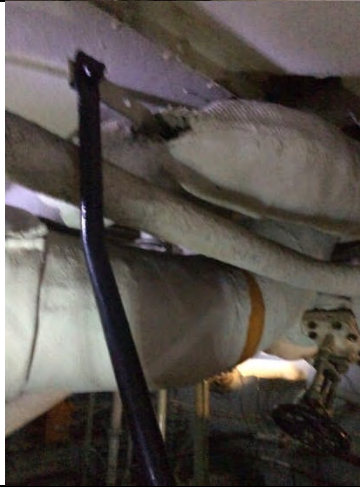
<p><b><u>Photo 2.0</u></b></p> <p>Description: Asbestos containing Piping and cloth wrap insulation on mechanical systems of the engine room.</p>

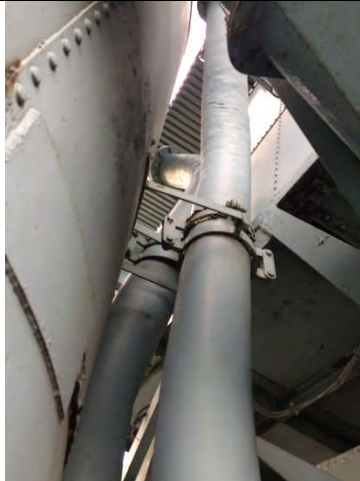
<p><b><u>Photo 3.0</u></b></p> <p>Description: Asbestos containing Piping and exhaust lines on exterior of vessel. Material is in fair to good condition</p>

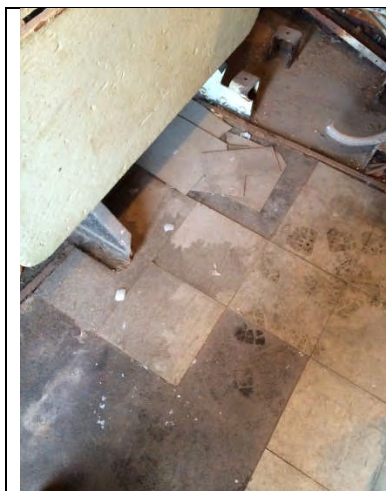
**Photo 4.0****Description:**

Asbestos containing Floor tile identified in vessel. Material is in poor condition in former radio room Signal deck

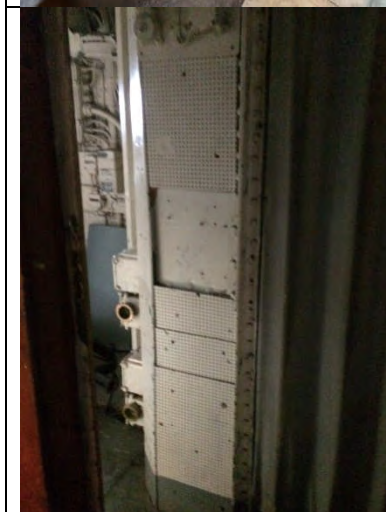
**Photo 5.0****Description:**

Asbestos containing White Dot transite Panel in Operations room on signal deck. Material is in fair condition and requires minor repair to damaged and exposed edges

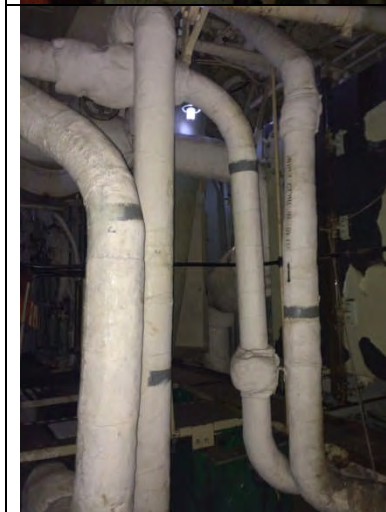
**Photo 6.0****Description:**

Asbestos containing Pipe Insulation with various pipe diameters and systems within engine room. Material is in fair to good condition within this space

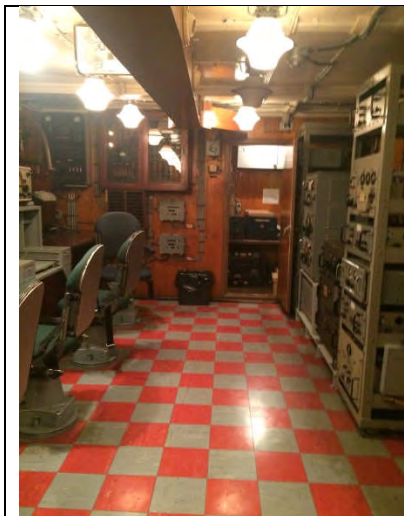
**Photo 7.0****Description:**

Asbestos containing Floor tile identified in vessel. Material is in good condition in radio room on Upper Deck Fwd.

In addition equipment in space may contain lead and mercury within the electrical components

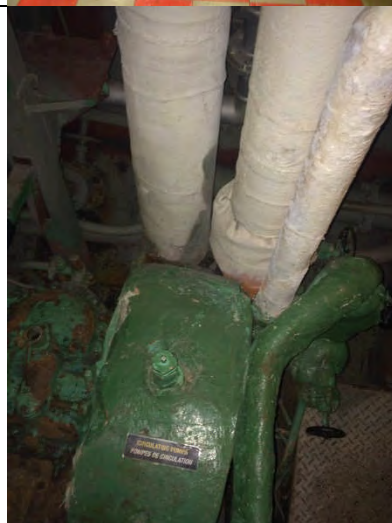
**Photo 8.0****Description:**

Asbestos containing circulating pump in engine room requiring repair in lower level. Material is in fair condition

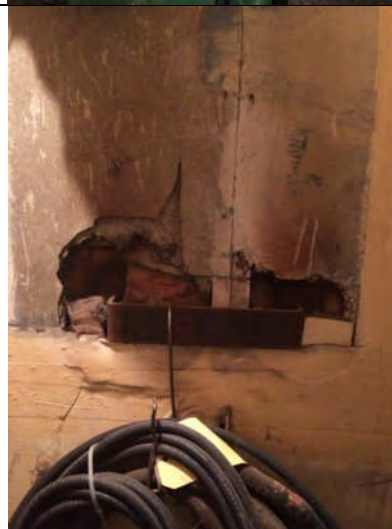
**Photo 9.0****Description:**

Asbestos containing transite panel damaged and exposed fireproofing insulation behind in Lower deck level at lobby area.
