2015 HARBOUR WALL INSPECTION

Small Craft Harbours,  
Fisheries and Oceans Canada

## **Port Dalhousie, ON – Harbour Wall Engineering Inspection Report**

December, 2015

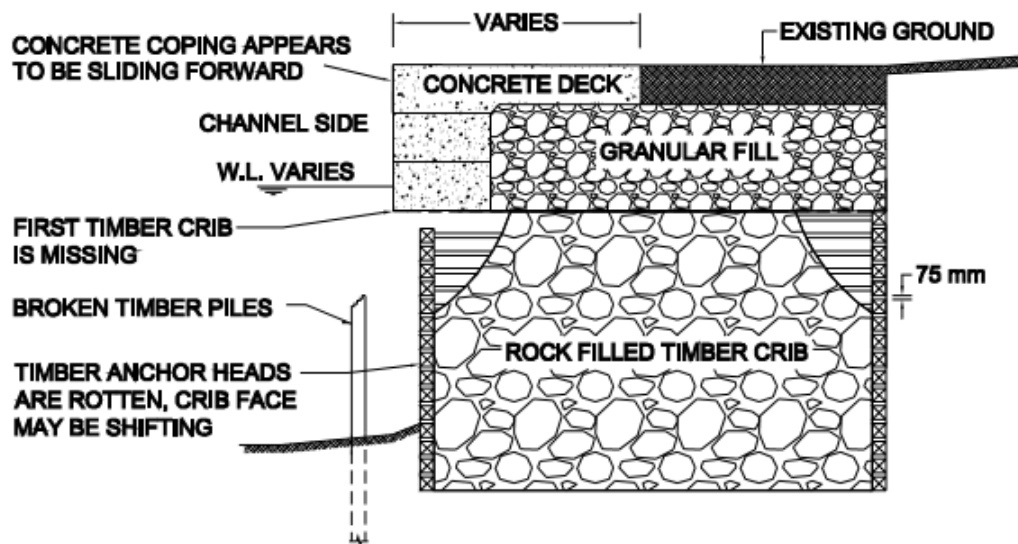
Figure 10: Typical Current Condition of the East Concrete Wall

The deck over the East Concrete Wall appears to be in fair condition. Medium transverse cracks were noted at Station 408+002, Station 408+004, and Station 408+036 (See Photos 8-10 in Appendix B).

The exposed surfaces of the concrete coping blocks appear to be in poor condition with several medium concrete spalls and wide cracks. During the underwater inspection, the front face of the concrete coping was observed to be offset from the front face of the timber cribs by approximately 450 mm. The coping appears to be sliding towards the Basin. Lateral earth pressure, over time, appears to have pushed the concrete coping wall and the concrete deck towards the Basin (see Figure 11 for an illustrative example). The manager for the Dalhousie Yacht Club claims that the grassy area behind the deck slab has settled over the last 3 years; however, no measurements exist to quantify the settlement.

The movement of the concrete coping blocks is of particular concern because there is an existing fuel line buried behind this wall and a fueling station mounted on the concrete deck. The fuel storage tanks are located in the grassy area behind the office building operated by the Dalhousie Yacht Club. Excessive soil movement could rupture the fuel line and pose an environmental hazard. There is also the risk that the movement of the concrete coping blocks will destabilize the coping units and cause both the coping units and the deck to fail.

In many locations, the top timber headers are missing from the crib. With the exception of the top timbers on the front face of the wall, the headers are relatively plumb and the connections appear to be sound. No sign of rot or deterioration was observed in the timber headers; however, many of the timber anchor heads near the bottom of the cribs were found to be rotten. Because the anchor heads are rotten, they may no longer be capable of restraining the timber headers. Movement of the timber headers would account for the settlement of the grassy area behind the deck slab. No signs of undermining of the timber cribs were observed.

Based on our inspection, we have given the concrete deck and concrete coping units a Condition Rating of 1 and the timber cribs a Condition Rating of 2. The crib facing appears to be in good condition, but this is misleading as the timber anchors that secure the facing are rotten. The East Concrete Wall is performing poorly. There is a risk that the coping will fail or that excessive soil movements will rupture the buried fuel lines. Immediate action is warranted.

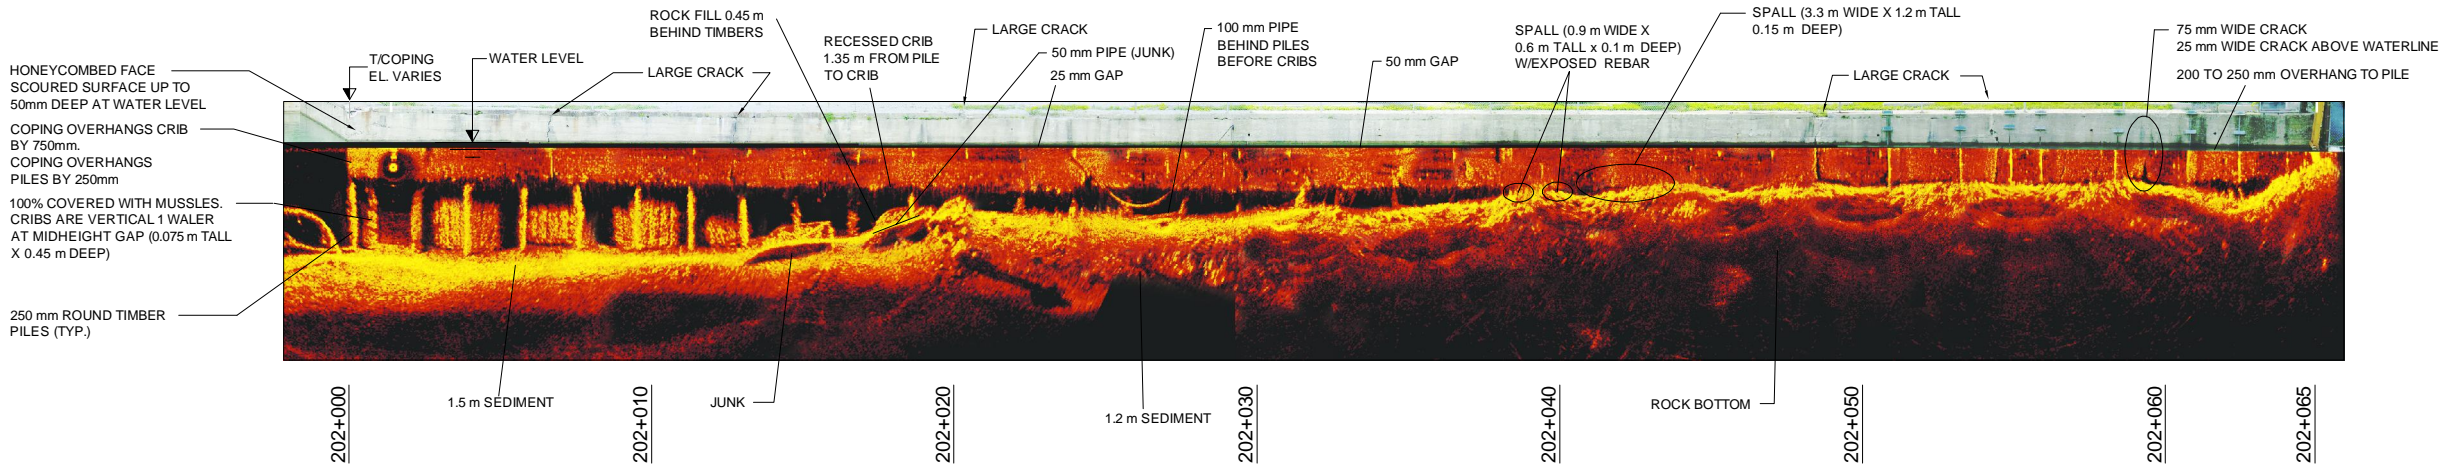
PLAN - SNUG HARBOUR BASIN STA. 202+000 TO 202+065

LARGE SPALL AT TOP OF COPING  
0.6 m WIDE x 0.6 m TALL  
0.45 m DEPTH
