November 13, 2017

**Subject: Project-Specific Designated Substance Survey Report  
Talbot Dam at Lock 38, 1427 Canal Road, Brechin, Ontario**

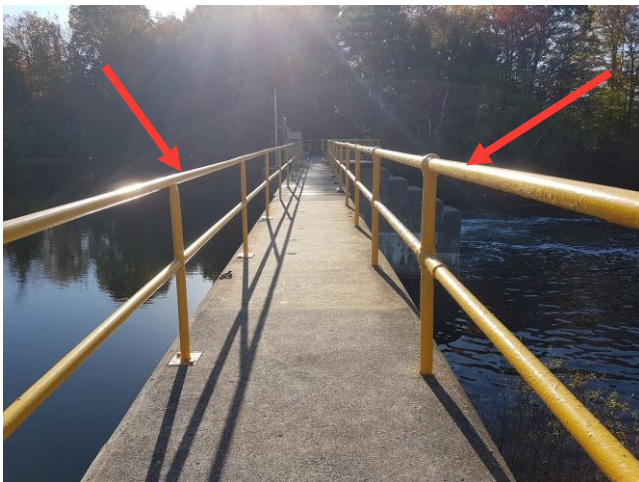
Sample ID: Pb-01

SAMPLE ID	DESCRIPTION / LOCATION	CONDITION	LEAD
			CONCENTRATION <sup>1</sup>
Pb-01	Yellow Paint on Railings <i>Photograph #3</i>	Poor	12,000 ppm
Pb-02	Black Paint on Railings and Equipment <i>Photograph #4</i>	Poor	15,000 ppm

Both of the sampled paint applications were found to be lead-containing.

**Photo #3:** View of lead-containing yellow paint on railings throughout the subject area.

- Follow **Type 1** – if the coating is to be removed with a chemical gel or paste;
- Follow **Type 2a** – if the coating is to be removed by scraping or sanding using non-powered hand tools, or manual demolition of lead-painted structural components by striking with sledgehammer or similar tool;
- Follow **Type 3a** – if the coating is to be removed using power tools; or
- Follow **Type 3b** – if the coating is to be removed by abrasive blasting.

Disturbance or removal of lead-containing paint should follow the safe work practices prescribed by the *Ministry of Labour's Guideline for Lead on Construction Projects*, and the *Environmental Abatement Council of Ontario's (EACO) "Lead Guideline for Construction, Renovation, Maintenance or Repair"*.

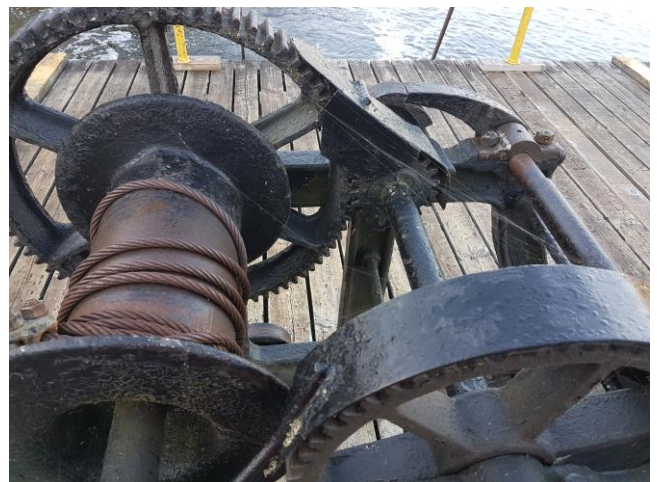
Sample ID: Pb-02

**Photo #4:** View of lead-containing black paint on equipment within the subject area.
