Small Craft Harbours,
Fisheries and Oceans Canada

Port Dalhousie, ON – Harbour Wall Engineering Inspection Report

60432205

December, 2015

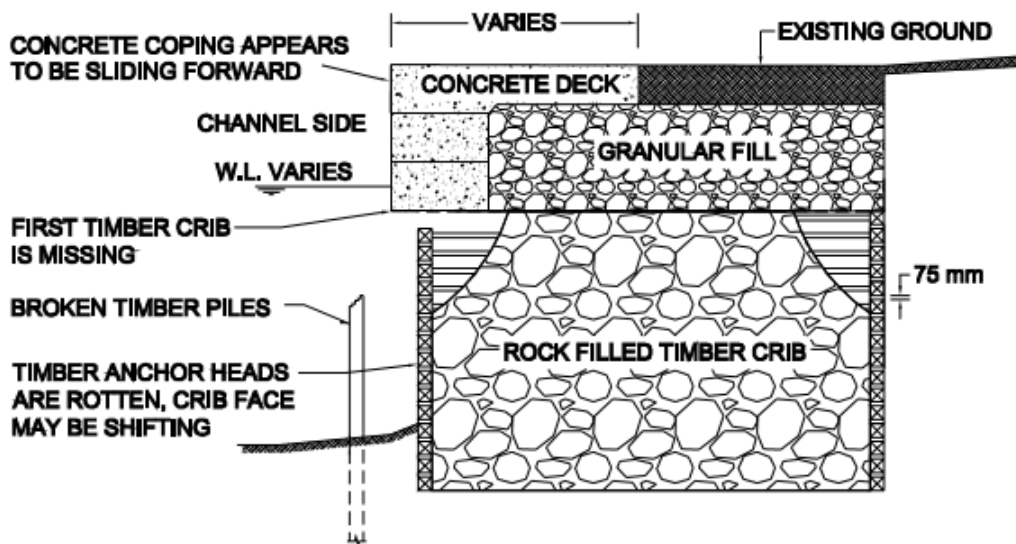
Figure 10: Typical Current Condition of the East Concrete Wall

Based on our inspection, we have given the concrete deck and concrete coping units a Condition Rating of 1 and the timber cribs a Condition Rating of 2. The crib facing appears to be in good condition, but this is misleading as the timber anchors that secure the facing are rotten. The East Concrete Wall is performing poorly. There is a risk that the coping will fail or that excessive soil movements will rupture the buried fuel lines. Immediate action is warranted.

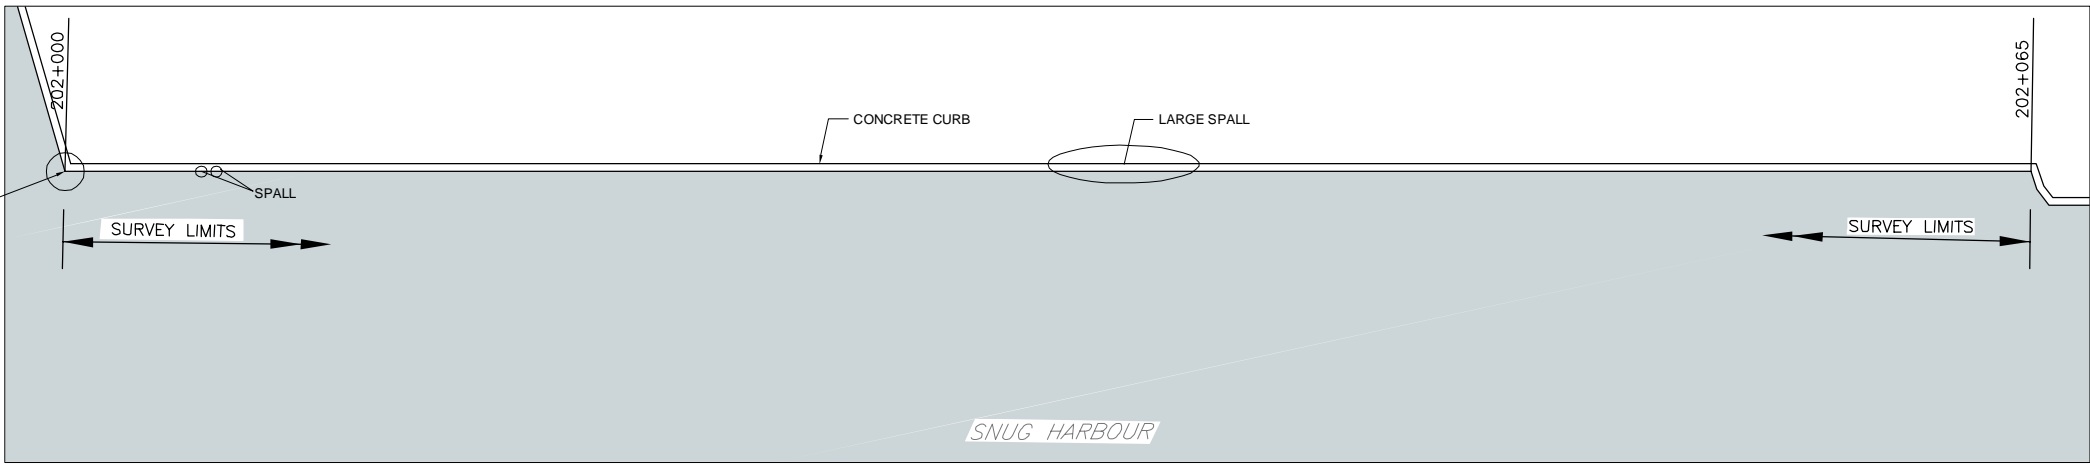
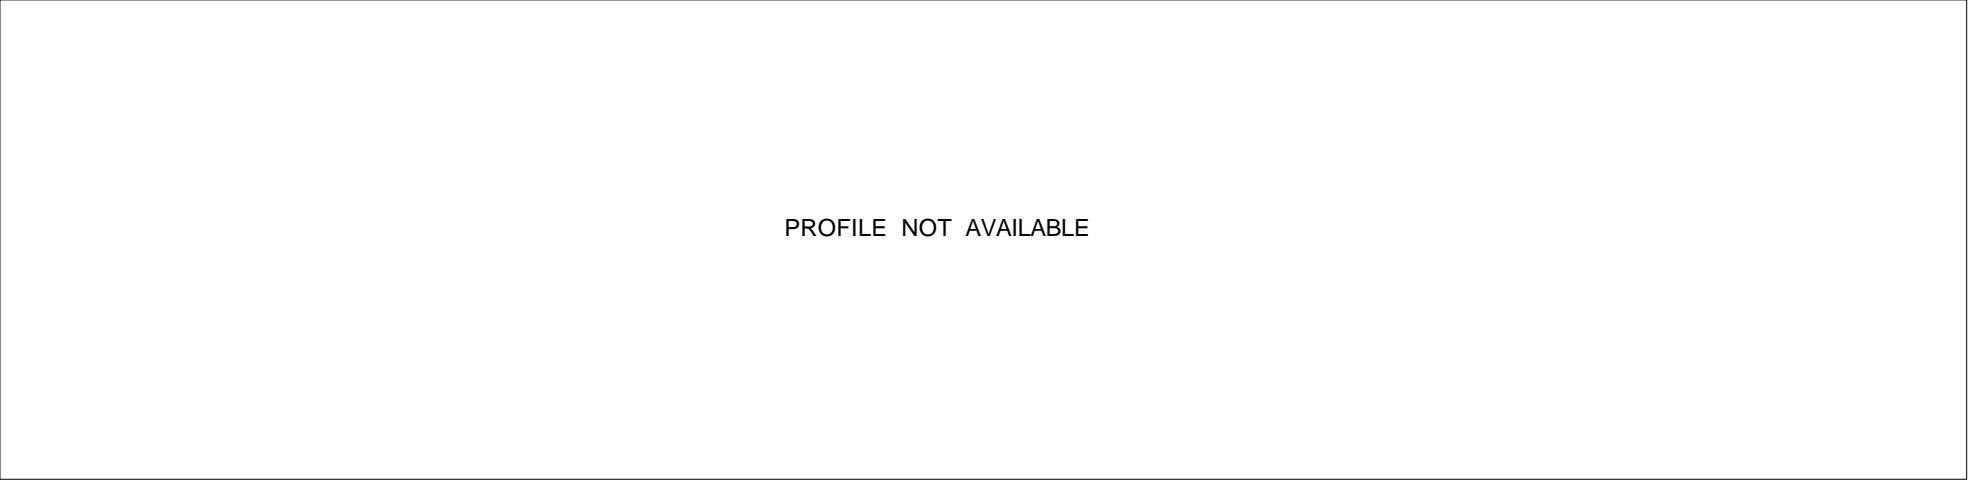
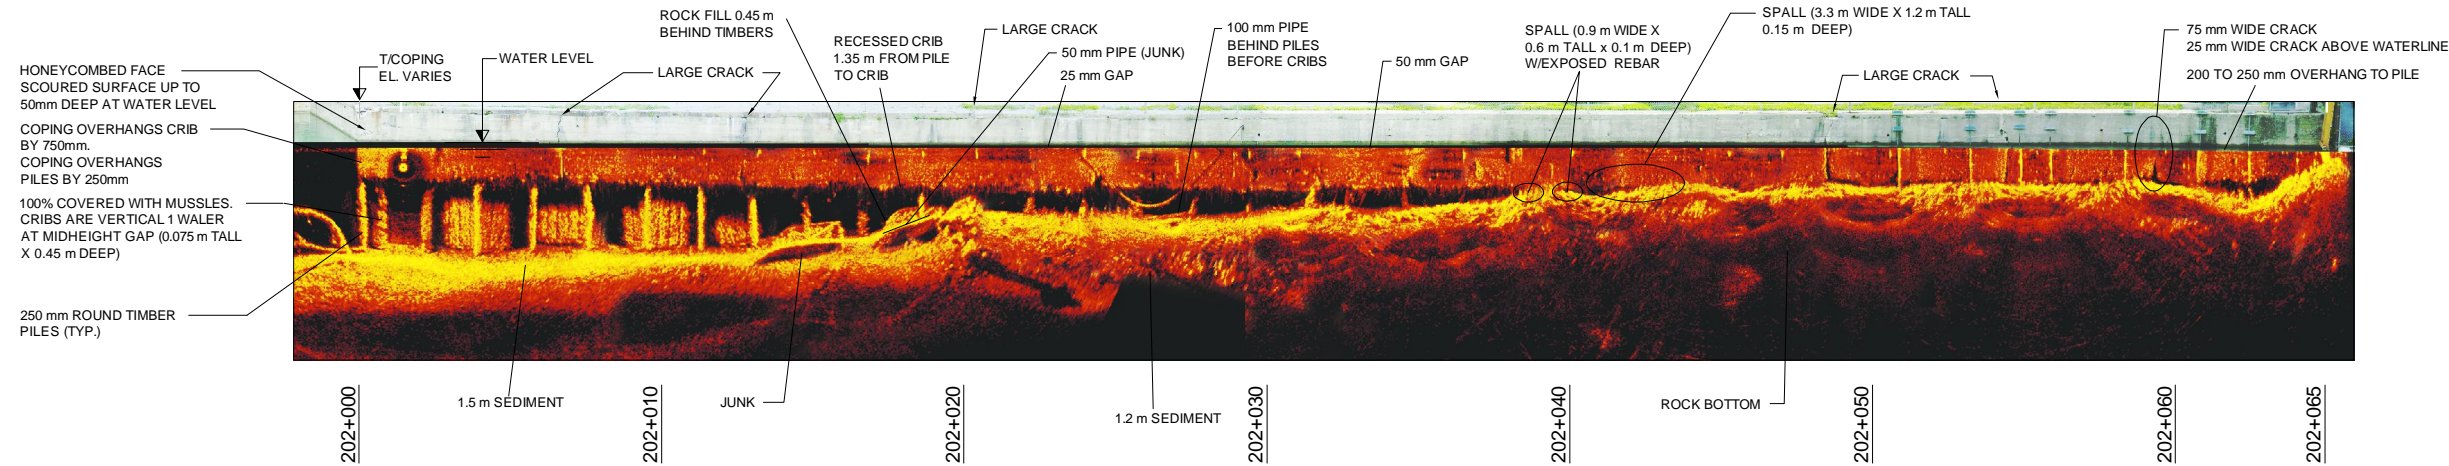
PLAN - SNUG HARBOUR BASIN STA. 202+000 TO 202+065

LARGE SPALL AT TOP OF COPING
0.6 m WIDE x 0.6 m TALL
0.45 m DEPTH

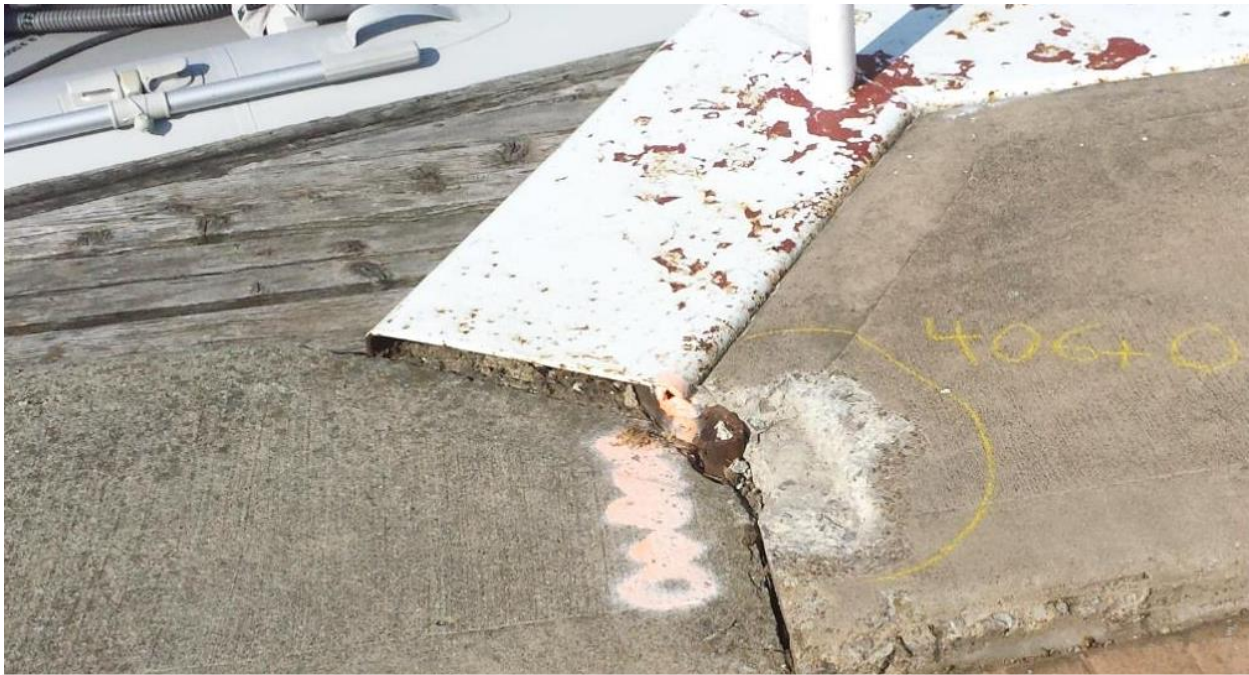
Photo #4, Concrete Deck Slab
Port Dalhousie
July 2015

The deck over the Dalhousie Yacht Club Wall appears to be in good condition. Medium cracks were observed at Station 406+013, Station 406+014, and Station 406+027 (See Photos 4-6 in Appendix B). One (1) small delaminated area was detected on the deck slab at Station 406+000 (See Photo 3 in Appendix B).
