Small Craft Harbours,  
Department of Fisheries and Oceans

## **Port Dalhousie, ON – East and West Piers Condition and Structural Evaluation Report**

60334134

March, 2015

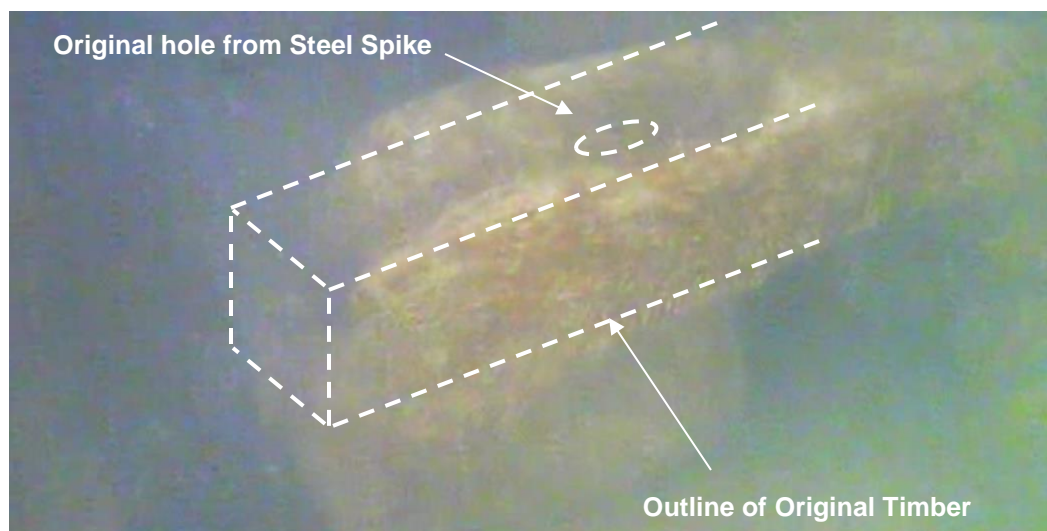
The majority of the timber cribs inspected by the ASI Group divers were observed to be in fair-to-poor condition. The ends of many of the timber headers (facing members) have decayed to such a degree that they are no longer securely fastened to the timber cross-ties. Ends of both headers and cross-ties have rotted and disintegrated around the steel spikes (See Figures 8 and 9 below, which contain enhanced photos from the underwater inspection). In other locations, the timber ends were found to be intact but severely rotted and easily disintegrated when probed, exposing the steel spikes that hold the crib walls together. During the underwater inspection, a section of crib facing, located at Station 0+465 on the east side of the West Pier, collapsed when a timber was probed by the diver. In many cases, the top two header timbers are missing from the crib (See Figure 10). In many places, the crib headers were observed to be bulging outward into the channel or were completely missing (see Figure 11 on page 13 for an illustrative example). In other places, the remains of the timber piles from the original fender system were observed to be the only thing holding the crib headers in place (see Figure 12 for an illustrative example). No signs of undermining of the timber cribs were observed, although this is likely due to the placement of a toe berm in front of portions of the crib facing during the 1993 repair.

**Figure 8: End of Timber Headers has Split and Pulled Free of Connection**

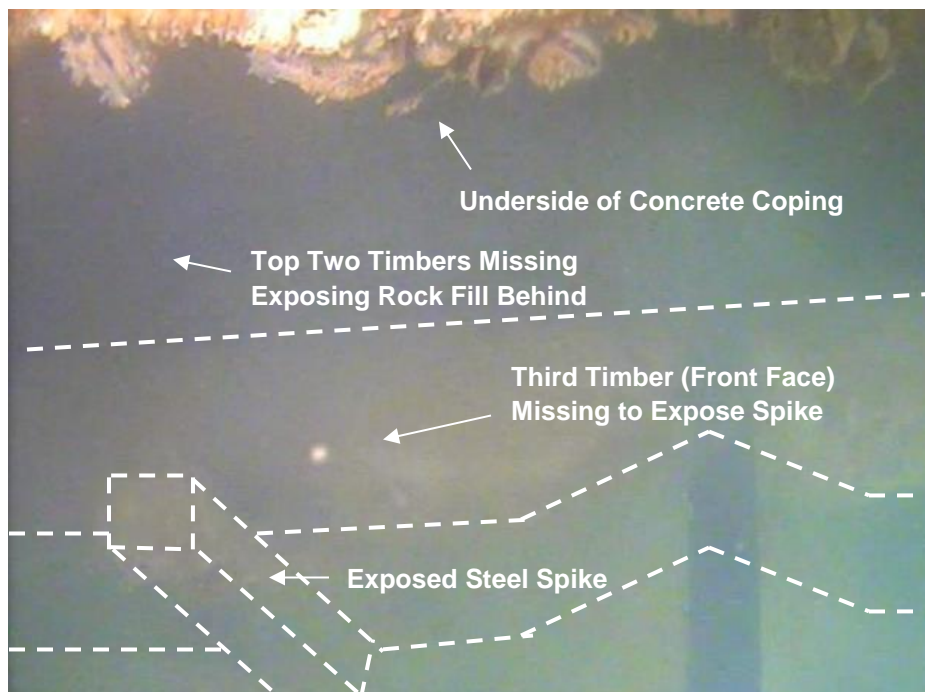
**Figure 10: Top of Timber Crib Facing Missing**

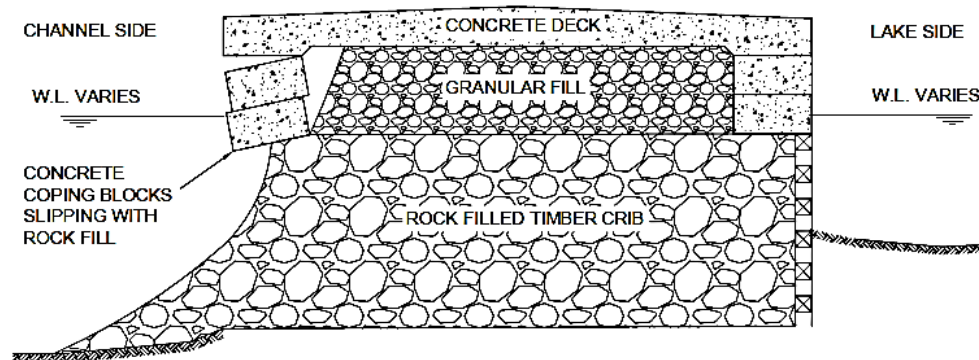
**Figure 11: Typical Pier Section Where Timber Crib Facing Has Fallen Away**

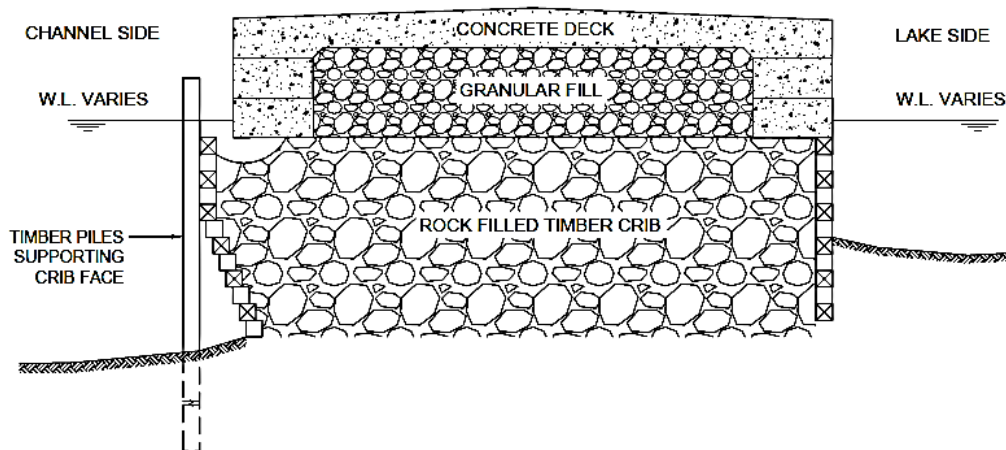
**Figure 12: Typical Pier Section with Crib Facing Held in Place by Piles from Bumper System**

It is interesting to note that the timber headers were observed to be in fair condition and securely fastened to the transverse cross-tie timbers immediately adjacent to the north (downstream) ends of the areas where steel sheet piling has been installed. This was observed at one location on the East Pier; north of the sheet piling wall near the yacht club (Station 0+000). It was also observed on the east (channel) side of the West Pier, north of the sheet piling at Station 0+575. This improved condition was typically observed for a distance of approximately 50 m from the north end of the sheet piling section. The sheet piling projects about 400 mm beyond the timber crib facing and, being immediately upstream, it may shelter the timber cribs from the causes of the decay.

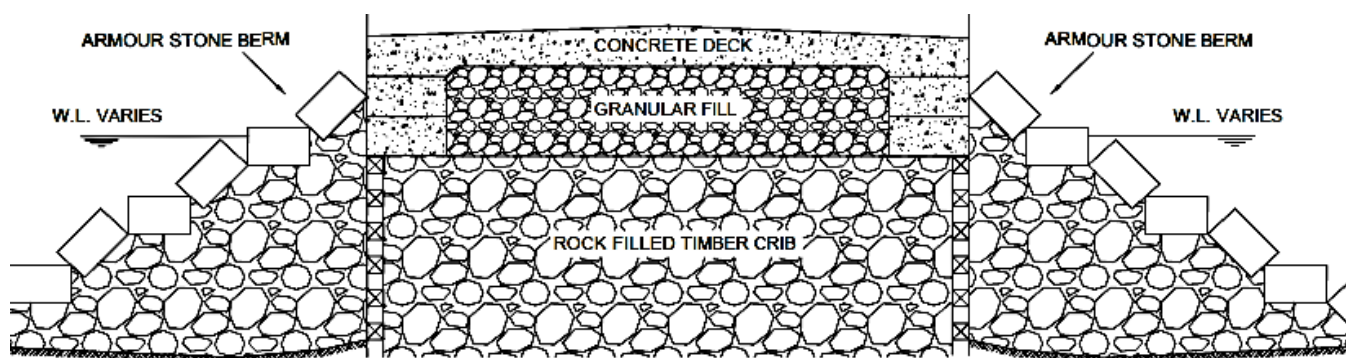
Due to the precarious arrangement of the stones and the risk that some of the stones could be unstable, no underwater inspection of the berms was undertaken.

**Figure 13: Typical Pier Section at Armour Stone Berm (End of Pier)**
