**DESIGNATED SUBSTANCES & HAZARDOUS MATERIALS SURVEY**

Fort George – Four Historic Buildings (Blockhouses)

51 Queens Parade, Niagara-on-the-Lake, ON

**ISSUED:** June 20, 2018

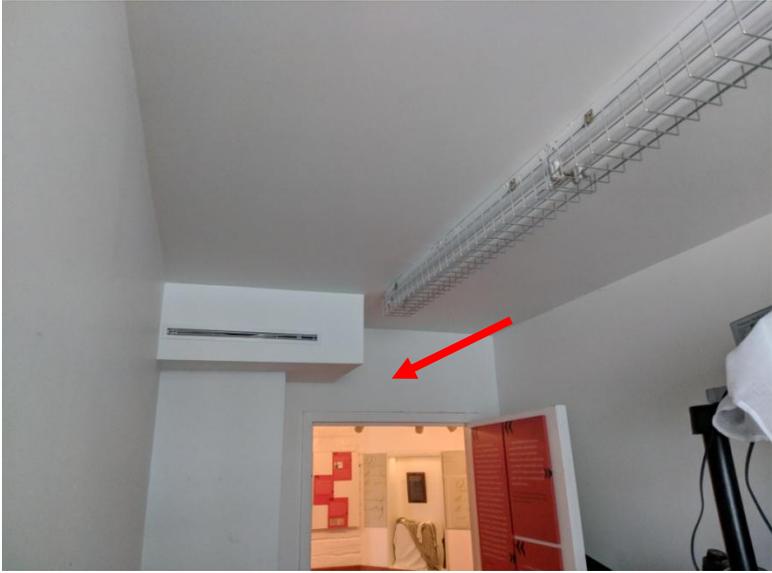
<b>Sample Identification</b> 00090.005.B1-W01 00090.005.B1-W02 00090.005.B1-W03
	<b>Sample Code</b> HW-01
	<b>Sample Location of Material</b> Ground Floor
	<b>Sample Description</b> Gypsum Board with Joint Compound
<b>Note:</b> Please refer to Appendix E - Sample Location Drawings for additional information.	
<b>Analytical Result:</b> None Detected

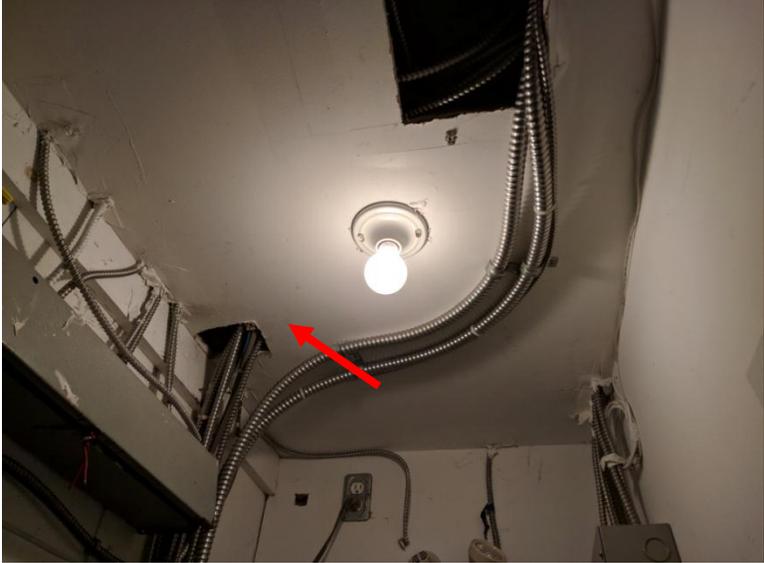
<b>Sample Identification</b> 00090.005.B1-C01 00090.005.B1-C02 00090.005.B1-C03
	<b>Sample Code</b> HC-01
	<b>Sample Location of Material</b> Various
	<b>Sample Description</b> Gypsum Board with Joint Compound
<b>Note:</b> Please refer to Appendix E - Sample Location Drawings for additional information.	
<b>Analytical Result:</b> None Detected

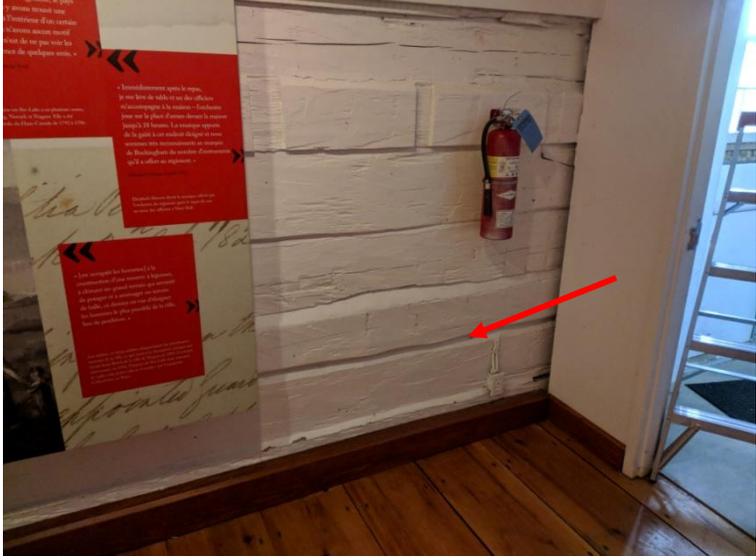
<p><b>Sample Identification</b>                  00090.005.B1-M01                  00090.005.B1-M02                  00090.005.B1-M03</p> <p><b>Sample Code</b>                  HM-01</p>
<p><b>Sample Location of Material</b>                  Ground Floor</p>	<p><b>Sample Description</b>                  Timber Joint Mortar</p>
<p><b>Note:</b> Please refer to Appendix E - Sample Location Drawings for additional information.</p>	
<p><b>Analytical Result :</b> None Detected</p>

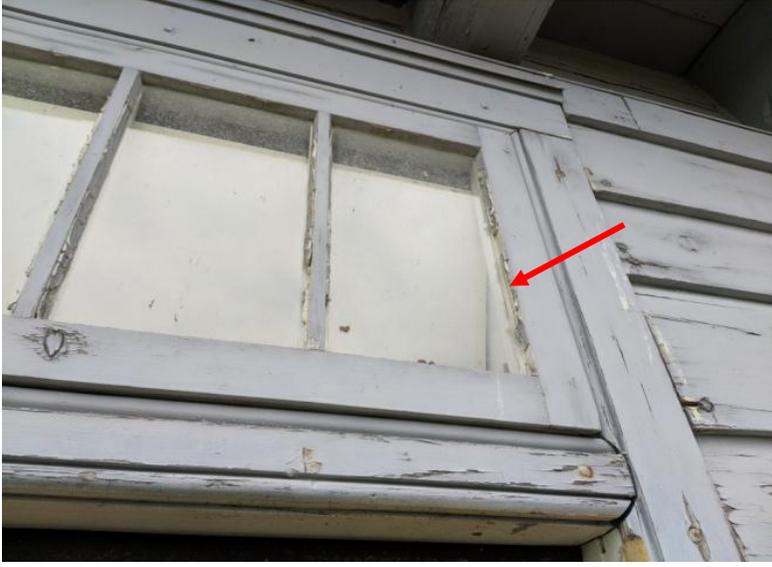
**Asbestos** was detected in window glazing in Blockhouse #1 and vinyl floor tile in Blockhouse #3.

<p><b>Sample Identification</b>                  00090.005.B1-M04                  00090.005.B1-M05                  00090.005.B1-M06</p> <p><b>Sample Code</b>                  HM-02</p>
<p><b>Sample Location of Material</b>                  Exterior</p>	<p><b>Sample Description</b>                  Window Glazing</p>
<p><b>Note:</b> Please refer to Appendix E - Sample Location Drawings for additional information.</p>	
<p><b>Analytical Result :</b> 2% Chrysotile</p>

5. Any activities involving disturbance of asbestos containing window glazing and/or vinyl floor tile be completed using Type 1 asbestos controls in accordance with Ontario Regulation 278/05 Respecting Asbestos on Construction Projects and in Building Repair Operations (as amended).

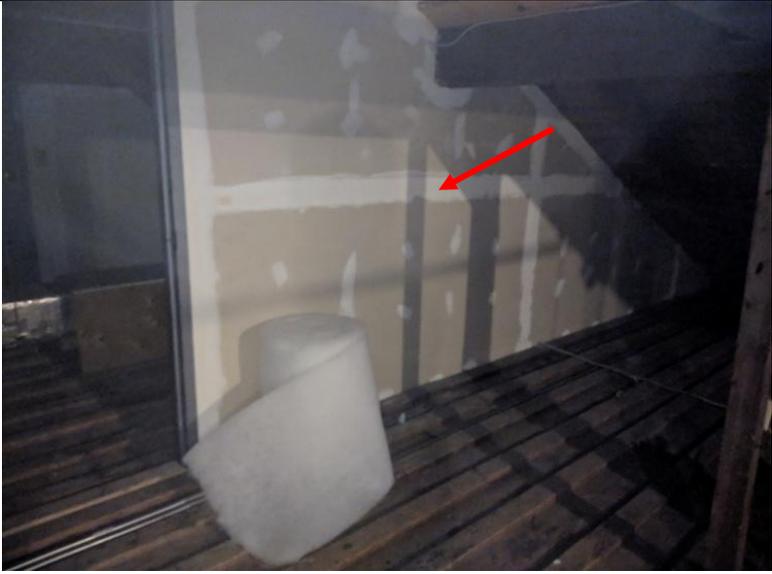
<p><b>Sample Identification</b>                  00090.005.B2-W01                  00090.005.B2-W02                  00090.005.B2-W03</p> <p><b>Sample Code</b>                  HW-01</p>
<p><b>Sample Location of Material</b>                  Ground Floor</p>	
<p><b>Sample Description</b>                  Gypsum Board with Joint Compound</p>	
<p><b>Note:</b> Please refer to Appendix E - Sample Location Drawings for additional information.</p>	
<p><b>Analytical Result:</b></p>

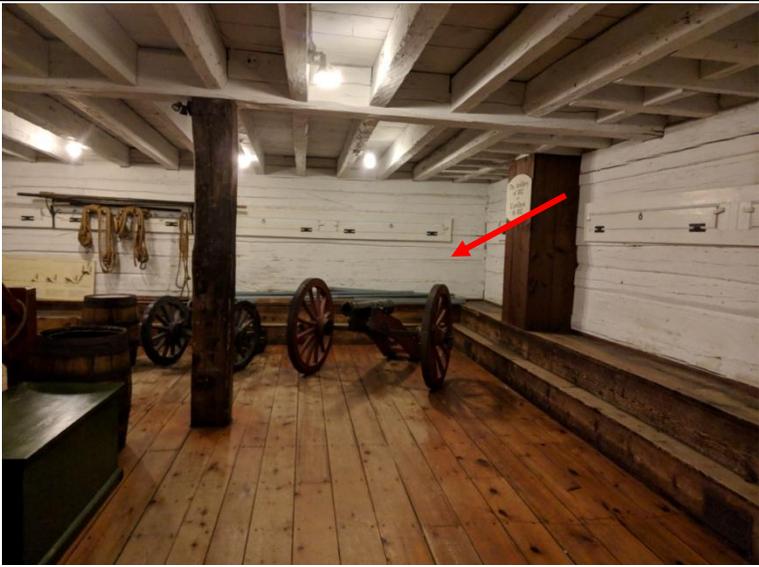
<p><b>Sample Identification</b>                  00090.005.B2-M01                  00090.005.B2-M02                  00090.005.B2-M03</p> <p><b>Sample Code</b>                  HM-01</p>
<p><b>Sample Location of Material</b>                  Second Floor</p>	<p><b>Sample Description</b>                  Timber Joint Mortar</p>
<p><b>Note:</b> Please refer to Appendix E - Sample Location Drawings for additional information.</p>	
<p><b>Analytical Result :</b> None Detected</p>

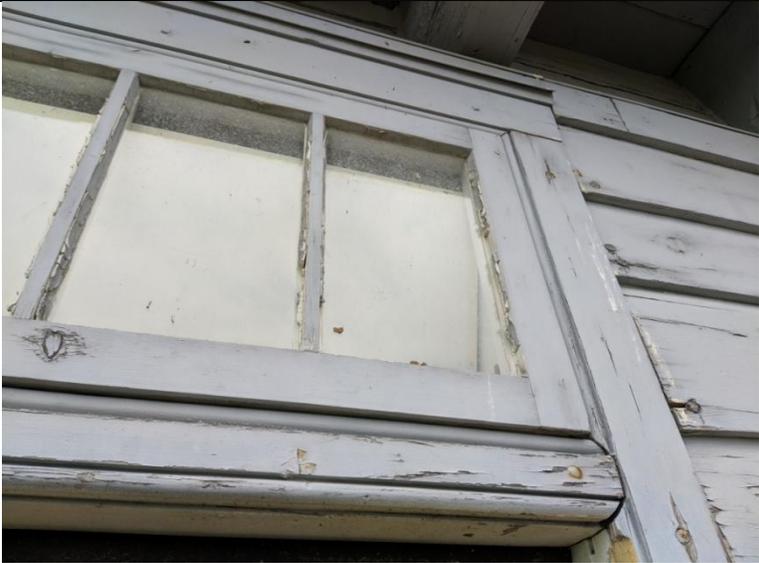
<p><b>Sample Identification</b>                  00090.005.B2-M04                  00090.005.B2-M05                  00090.005.B2-M06</p> <p><b>Sample Code</b>                  HM-02</p>
<p><b>Sample Location of Material</b>                  Ground Floor</p>	<p><b>Sample Description</b>                  Window Caulking</p>
<p><b>Note:</b> Please refer to Appendix E - Sample Location Drawings for additional information. <b>(2)</b> Photo shown is from Blockhouse #1. Material similar in composition, <b>window caulking on blockhouse #2 is not asbestos-containing</b></p>	
<p><b>Analytical Result :</b> None Detected</p>

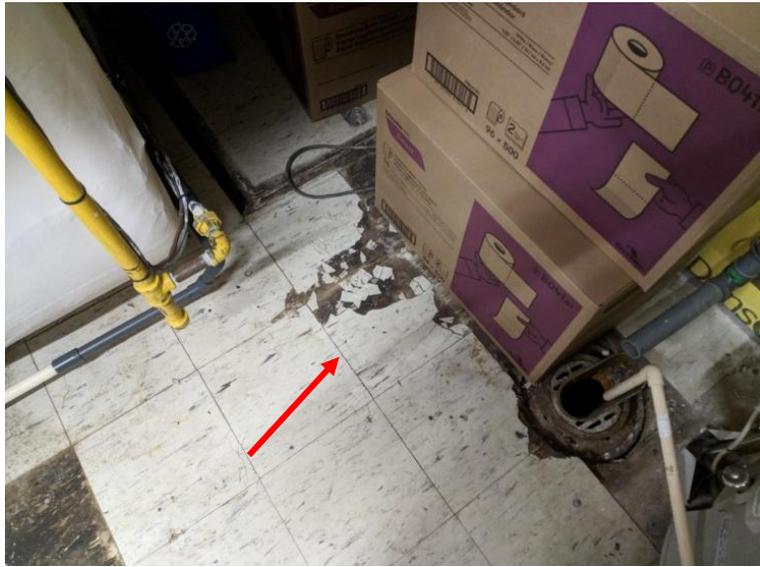
- Asbestos
  - Blockhouse #1 - Window Glazing (exterior)
  - Blockhouse #3 - Vinyl Floor Tile 12" – White with Black Streak (poor condition)

00090.005.B3-F01  
 00090.005.B3-F02  
 00090.005.B3-F03

**Analytical Result:** 2% Chrysotile

**Note:** It is recommended the floor tile present within the mechanical room is removed, flooring was in poor condition at the time of evaluation.

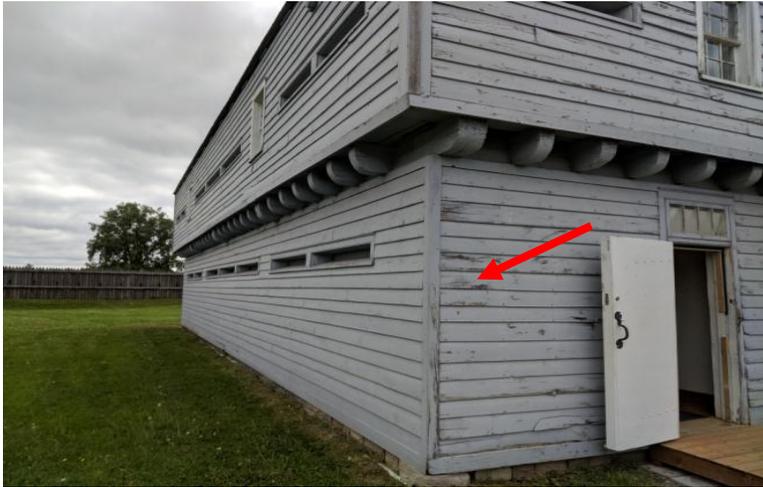
<b>Sample Identification</b> Grey Paint  00090.005.B1-P01
	<b>Arsenic Content</b> <50 µg/g
	<b>Lead Content</b> <b>301 µg/g</b>
	<b>Mercury Content</b> <b>3 µg/g</b>

Notes: (1) Paint coating is peeling in several locations.

6. Prior to the disturbance of paint coatings containing lead, it is recommended the contractor review Ontario's Lead on Construction Project Guideline.
7. Prior to disturbance of paint coatings containing lead and mercury, a procedure should be developed to include for worker protection from lead, control measures and disposal considerations. A sample of the material should be analyzed for Toxicity Leaching Characterization Procedure (TCLP) prior to disposal to determine appropriate waste streaming. OESN recommends the following materials be submitted for TCLP testing.
  - 00090.005.B1-P01 - Grey Paint for Lead TCLP (Blockhouse #1)
  - 00090.005.B1-P02 - White Paint for Lead TCLP (Blockhouse #1)
  - 00090.005.B2-P01 - White Paint for Lead & Mercury TCLP (Blockhouse #2)
  - 00090.005.B4-P01 - Red Paint for Lead TCLP (Octagon Blockhouse)

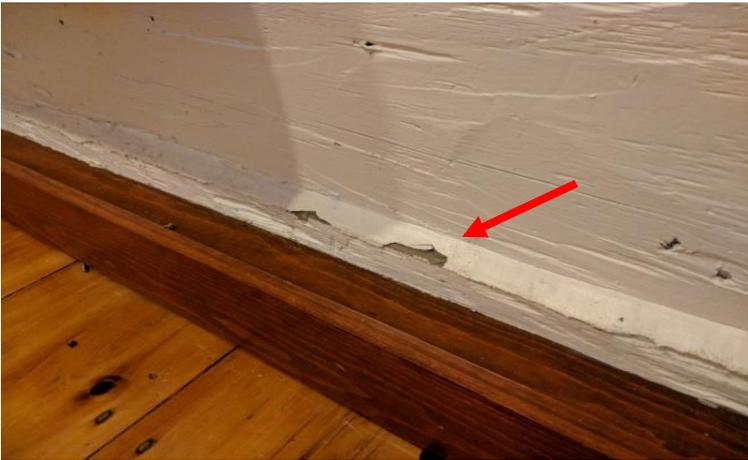
<b>Sample Identification</b> White Paint  00090.005.B1-P02
	<b>Arsenic Content</b> <50 µg/g
	<b>Lead Content</b> <b>172 µg/g</b>
	<b>Mercury Content</b> <b>6 µg/g</b>

Notes: (1) Paint coating is peeling in several locations.

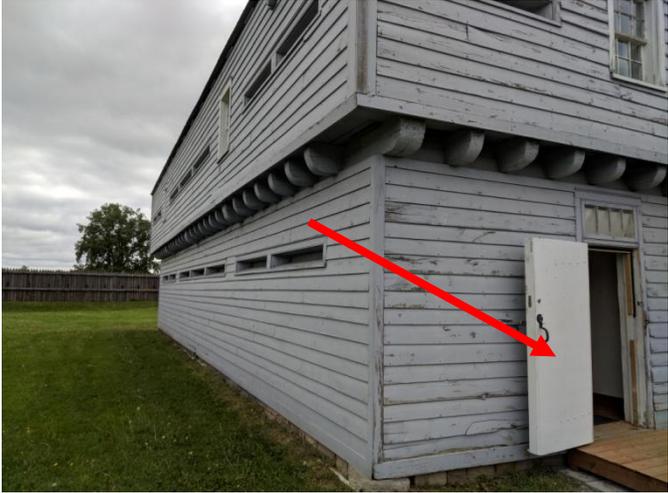
<b>Sample Identification</b> White Paint  00090.005.B2-P01
	<b>Arsenic Content</b> <50 µg/g
	<b>Lead Content</b> <b>1090 µg/g</b>
	<b>Mercury Content</b> <b>25 µg/g</b>

**Notes: (1)** Picture shown above is Blockhouse #1. Blockhouse #2 grey paint sample collected from Blockhouse #2 exterior. A picture was not collected during the site evaluation.

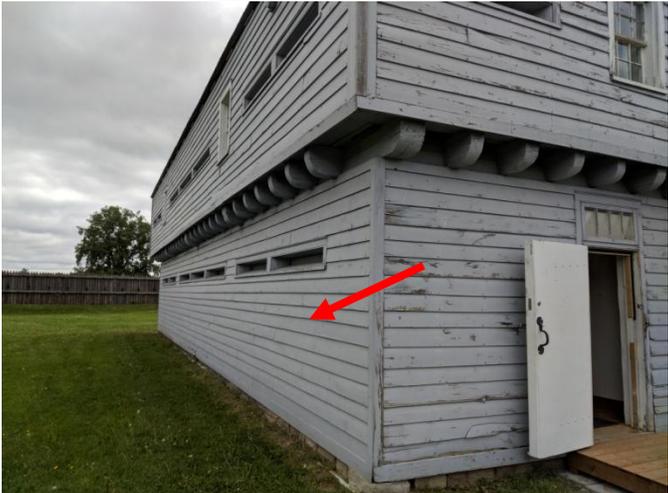
<b>Sample Identification</b> Grey Paint  00090.005.B2-P02
	<b>Arsenic Content</b> <50 µg/g
	<b>Lead Content</b> <b>10 µg/g</b>
	<b>Mercury Content</b> <2 µg/g

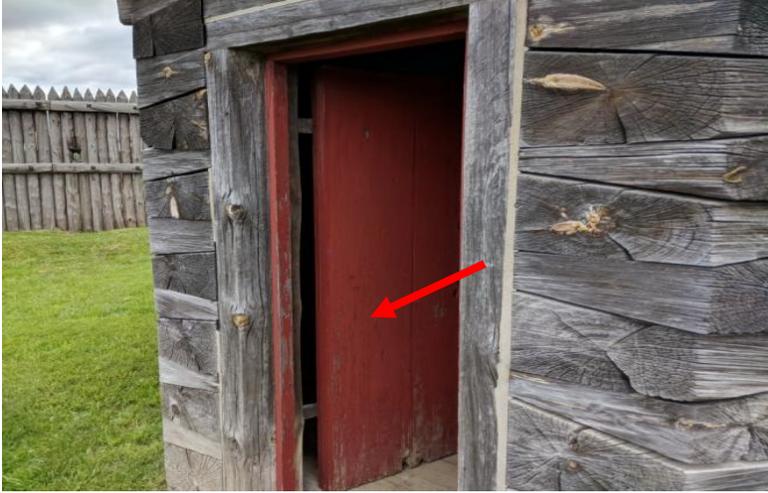
<table><tr><td data-bbox="998 296 1446 485"><b>Sample Identification</b> Red Paint  00090.005.B4-P01</td></tr><tr><td data-bbox="998 485 1446 600"><b>Arsenic Content</b> &lt;50 µg/g</td></tr></table>

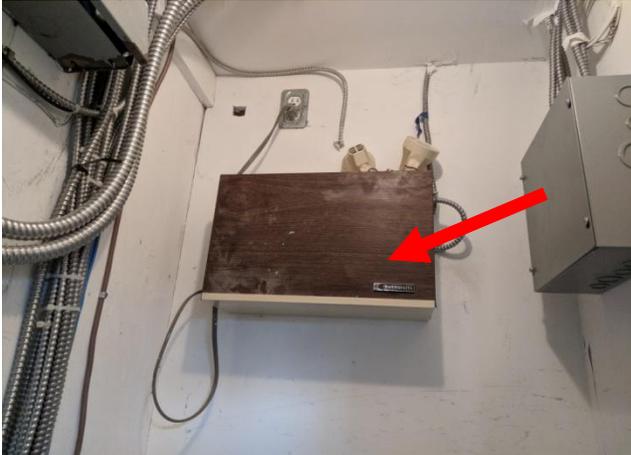
<p><b>Notes:</b> Emergency lighting system observed within the subject building. Emergency lighting systems contain (1) one or (2) two lead acid batteries. Several styles of emergency lighting systems were observed in the subject building.</p>
---	---

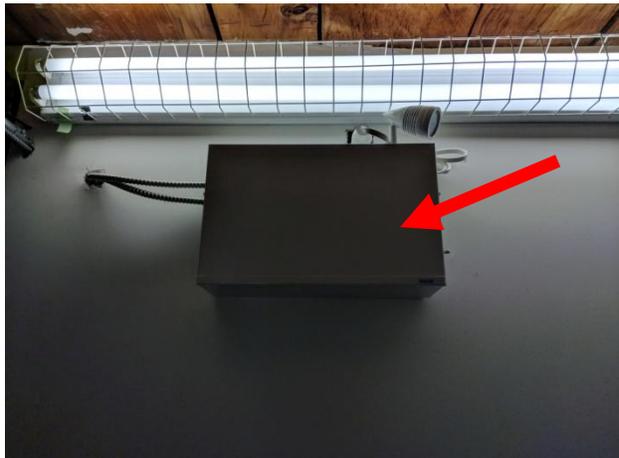
<p><b>Notes:</b> Emergency lighting system observed within the subject building. Emergency lighting systems contain (1) one or (2) two lead acid batteries. Several styles of emergency lighting systems were observed in the subject building.</p>
--	---

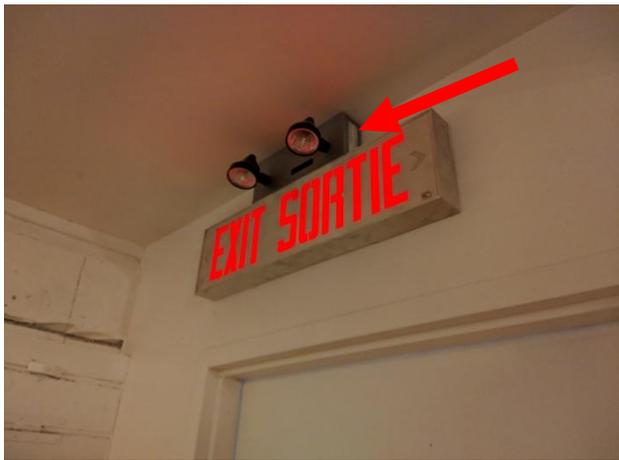
<p><b>Notes:</b> Emergency lighting system observed within the subject building. Emergency lighting systems contain (1) one or (2) two lead acid batteries. Several styles of emergency lighting systems were observed in the subject building.</p>
---	---

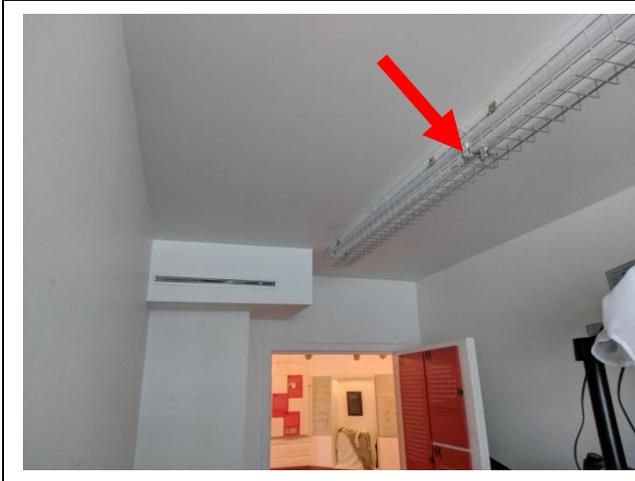
**Notes:** Fluorescent lighting systems are present. Lighting systems contain mercury light tubes and potentially PCB containing light ballasts. At the time of evaluation, OESN did not access the lighting systems to observe ballast codes.

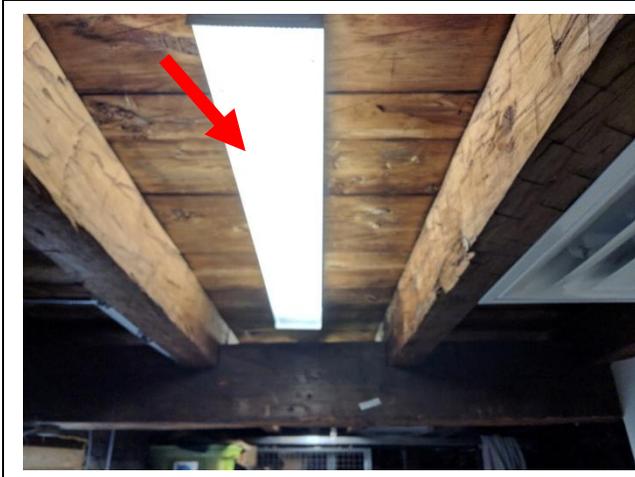
**Notes:** Fluorescent lighting systems are present. Lighting systems contain mercury light tubes and potentially PCB containing light ballasts. At the time of evaluation, OESN did not access the lighting systems to observe ballast codes.

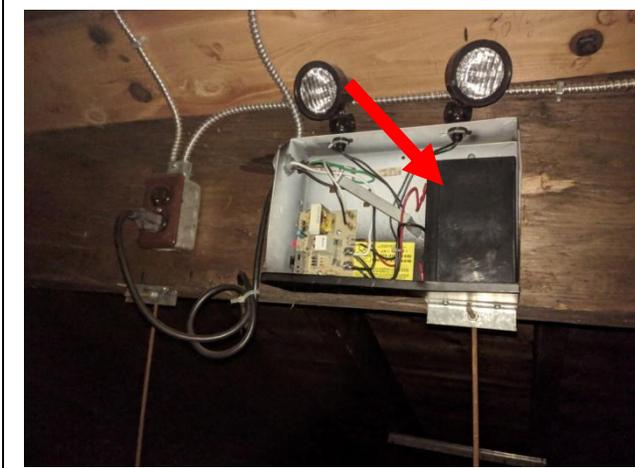
**Notes:** Emergency lighting system observed within the subject building. Emergency lighting systems contain (1) one or (2) two lead acid batteries. Several styles of emergency lighting systems were observed in the subject building.

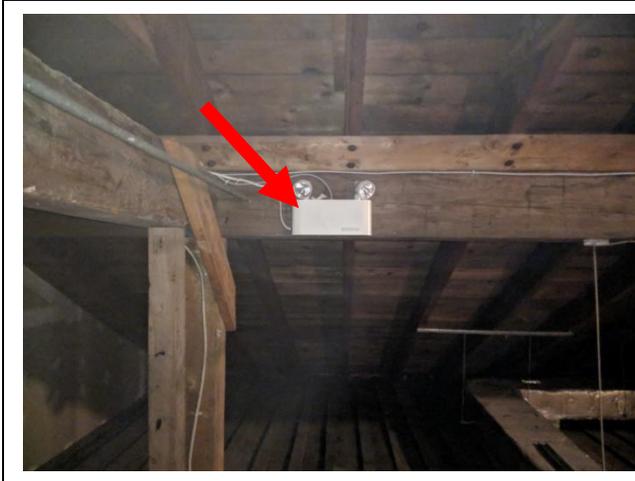
**Notes:** Emergency lighting system observed within the subject building. Emergency lighting systems contain (1) one or (2) two lead acid batteries. Several styles of emergency lighting systems were observed in the subject building.

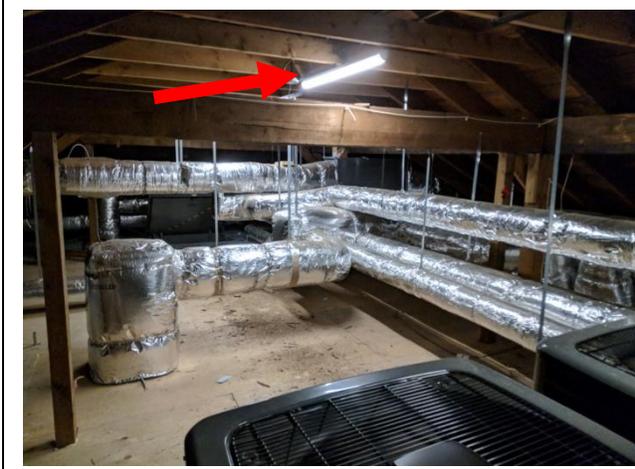
**Notes:** Fluorescent lighting systems are present. Lighting systems contain mercury light tubes and potentially PCB containing light ballasts. At the time of evaluation, OESN did not access the lighting systems to observe ballast codes.
