Fire Alarm System Annual Test & Inspection Report – Individual Device Record

Hazardous Building Materials GAP Assessment

Hazardous Building Materials GAP Assessment - Revised

Grierson Institution
9530 – 101 Avenue, Edmonton,
Alberta

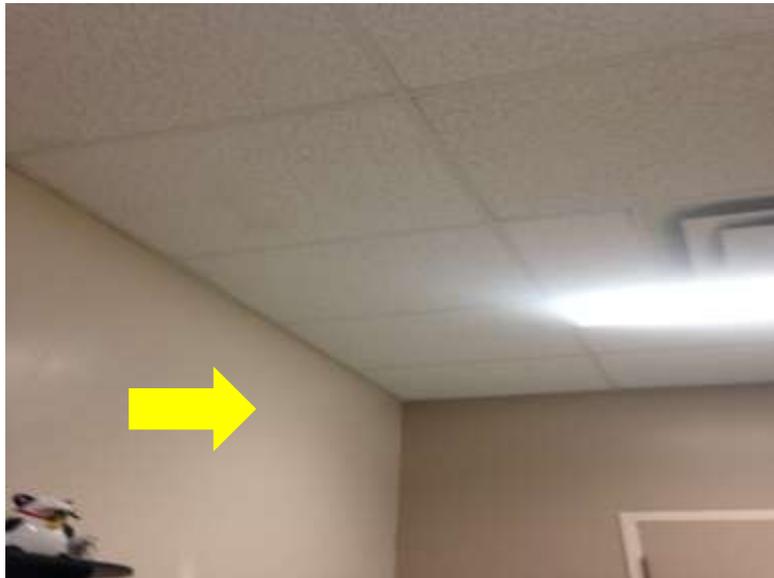
Asbestos-containing Drywall and Joint Compound, White, (Sample S0003), 1-128 (Location:21)

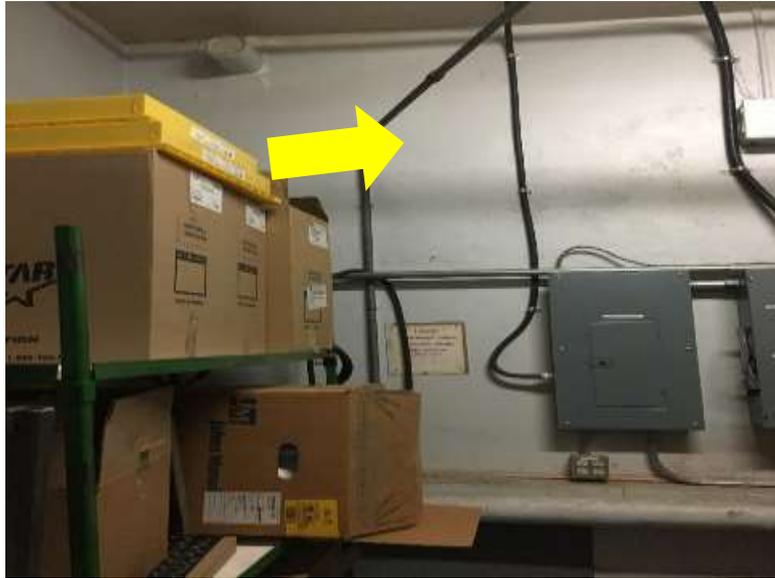
Asbestos Drywall Joint Compound, Ref G-3-012-003/3-015-008 (Sample S0001F), 3-001 (Location:5)

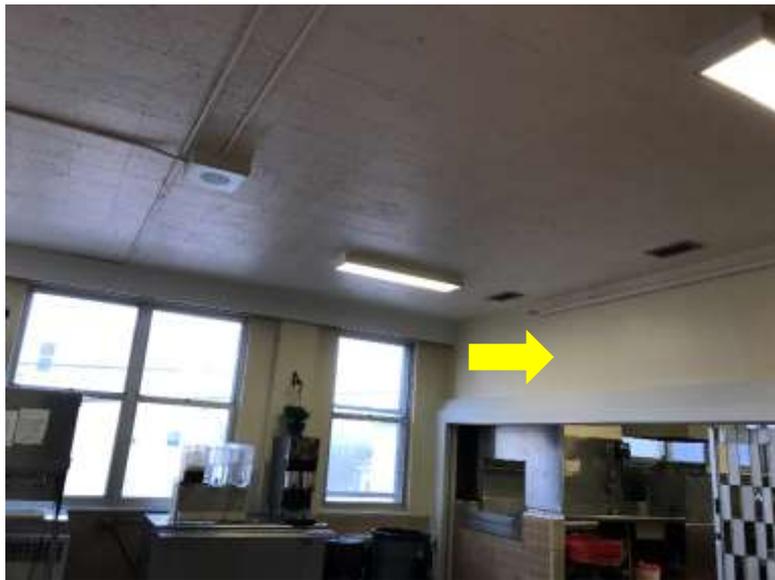
Asbestos Drywall and Joint Compound (Sample S0002), 4-135 (Location:13)

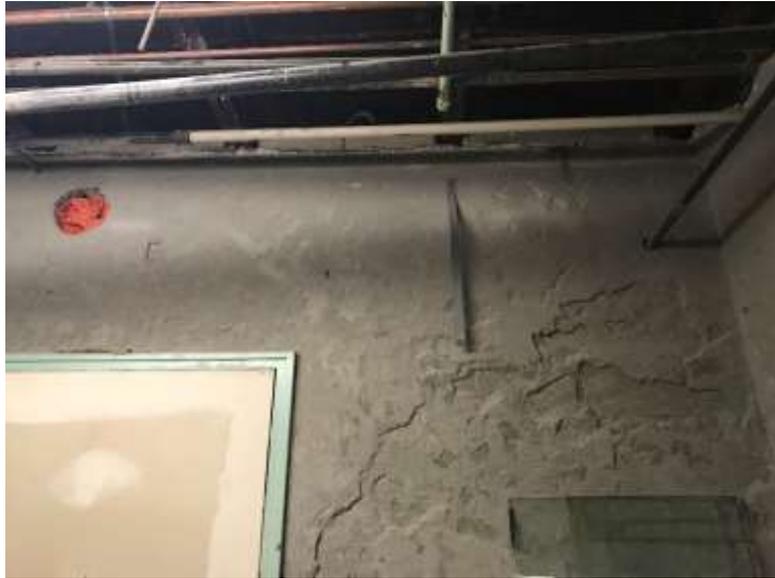
Asbestos Masonry Block Wall Coating (Sample S0004), 4-002 (Location:41)

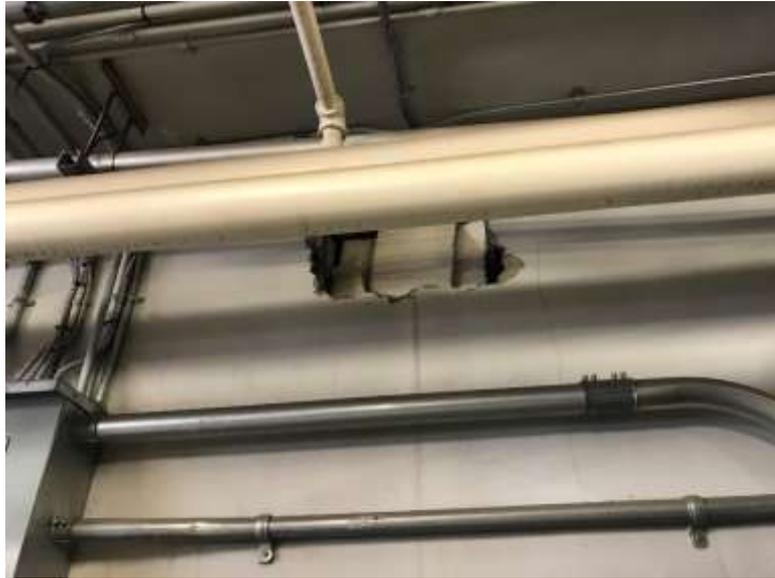
Asbestos Plaster (Sample S0011), 4-025 (Location:46)

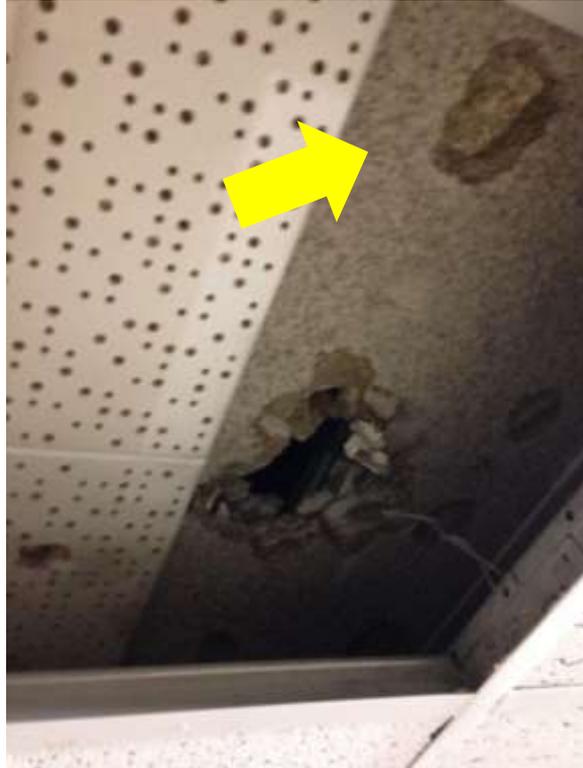
Asbestos Mastic behind Ceiling Tiles (Sample S0014), 4-202 (Location:52)

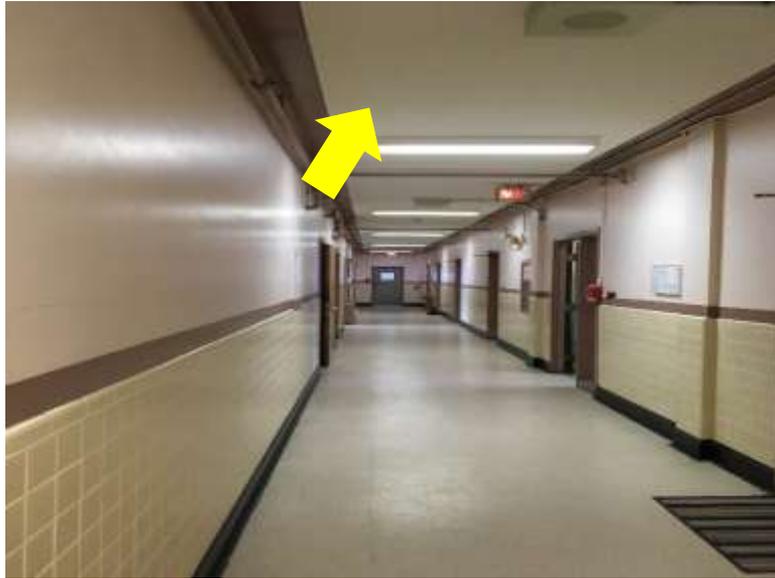
Asbestos Texture Finish Ceiling(Texture Coat), 4-201 (Location:60)

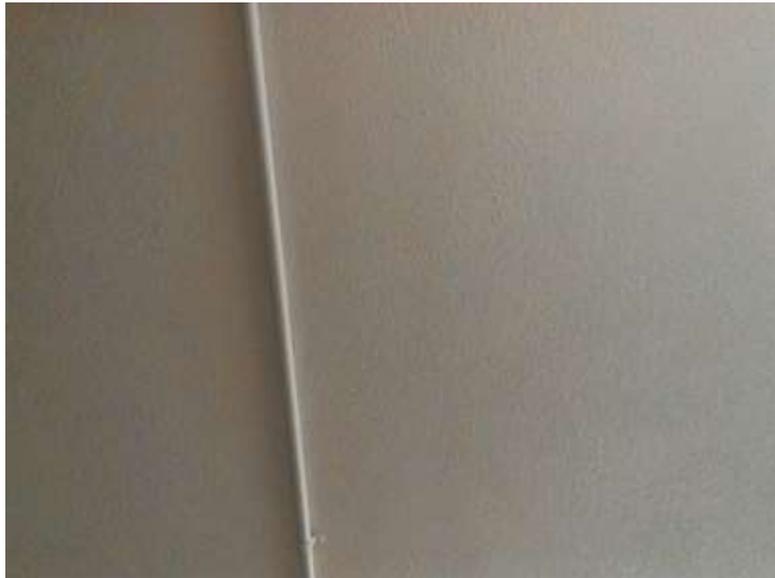
Asbestos Plaster Ceiling, Texture Finish, 4-015 (Location:32)

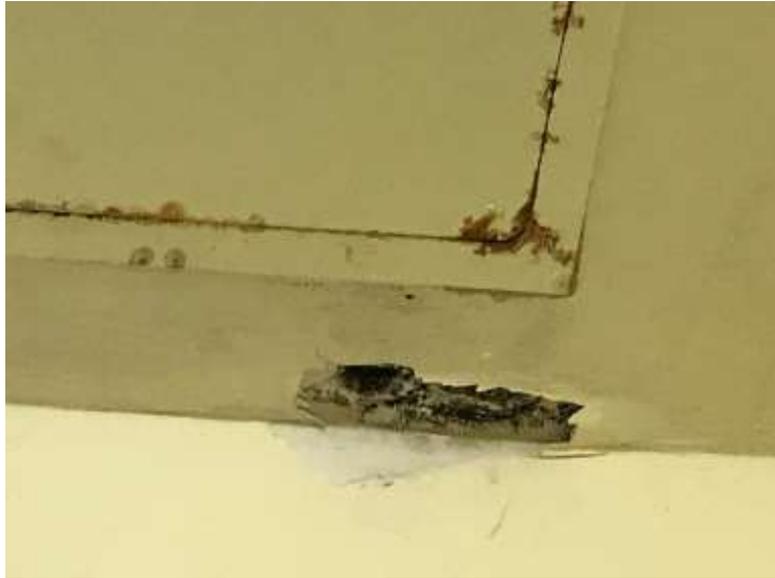
Mould impacted Plaster ceiling, 4-124 (Location:10)

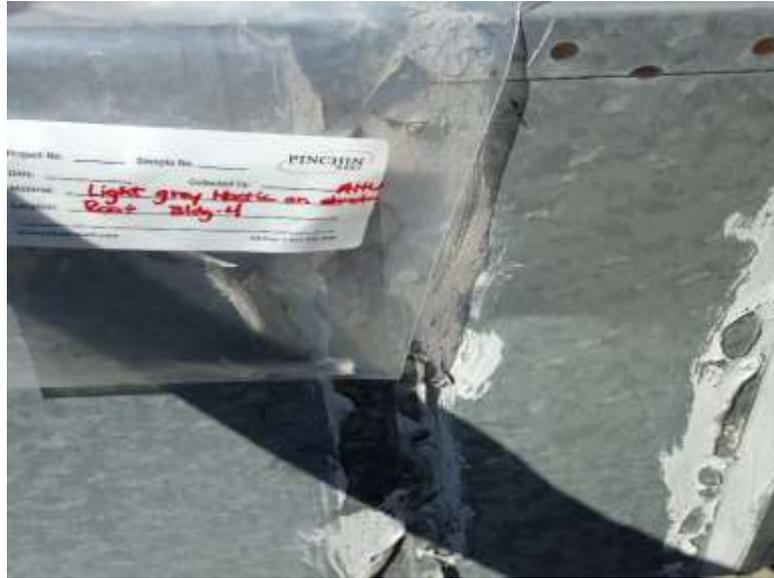
Asbestos-containing light grey mastic on Air Handling Unit, Roof (Location:79)
