Designated Substances Survey Report

Ranger's Cabin, Riding Mountain National Park

LOCATION: Ranger's Cabin, East Park Gate
Riding Mountain National Park, Manitoba

INSPECTION DATE: March 16, 2018

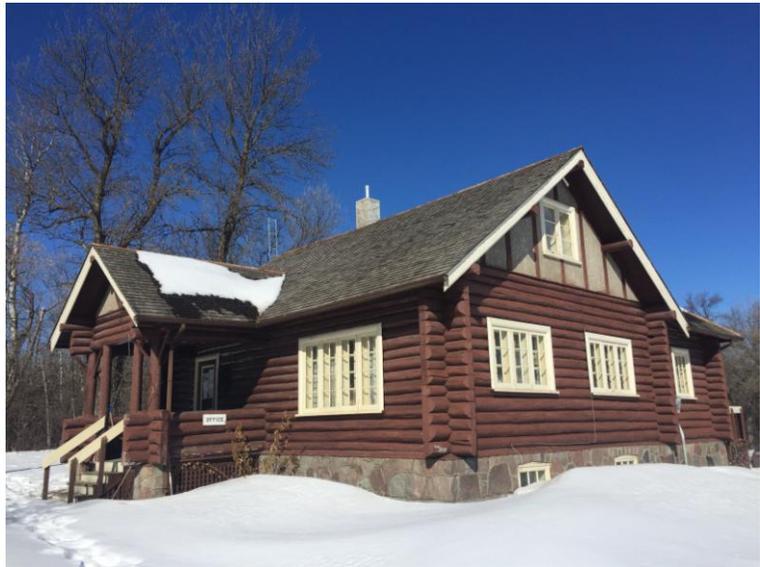
Photo 1

Exterior of subject property, facing the south-east corner of the building.

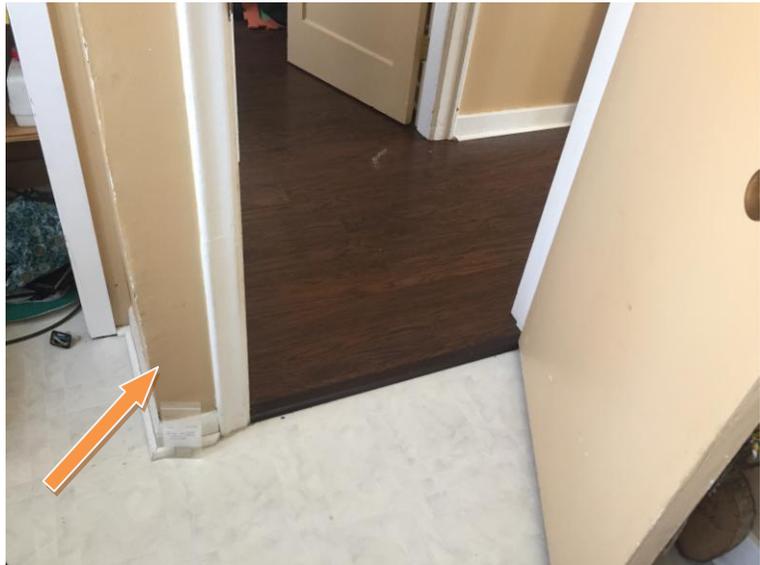
Photo 2

The drywall joint compound (DJC) sampled from the main floor south-west office with access to the front porch and the second floor east bedroom were found to contain approximately 3% chrysotile asbestos.

Photo shows the south-west room being used as an office, which contains an exterior door (front porch).

The sample of drywall joint compound taken from this room was found to contain approximately 3% chrysotile asbestos. Location of Sample 11.

A sample taken on the second floor was also positive. All drywall joint compound present throughout the main floor and second floor should be presumed to contain asbestos unless additional testing demonstrates otherwise.

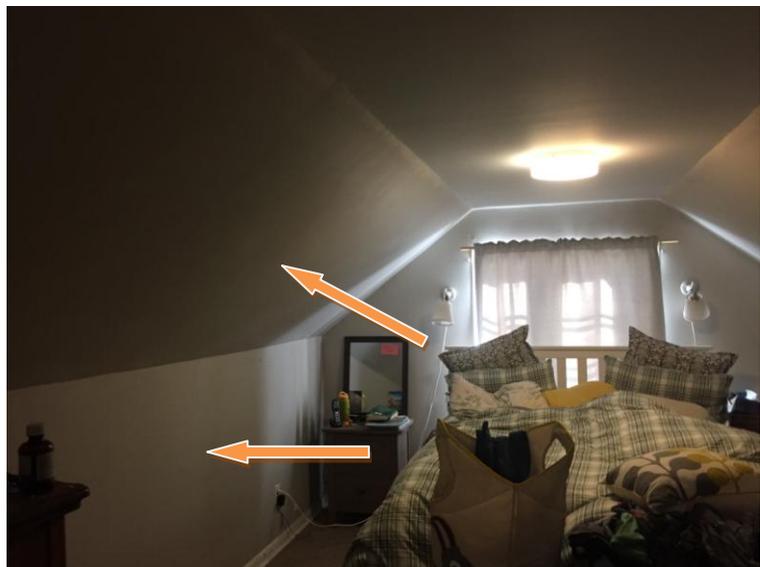
Photo 3

Photo shows the second floor east bedroom.

A sample of joint compound taken from the closet wall was found to contain approximately 3% chrysotile asbestos. Location of Sample 13.

A sample taken on the main floor was also positive. All drywall joint compound present throughout the main floor and second floor should be presumed to contain asbestos unless additional testing demonstrates otherwise.

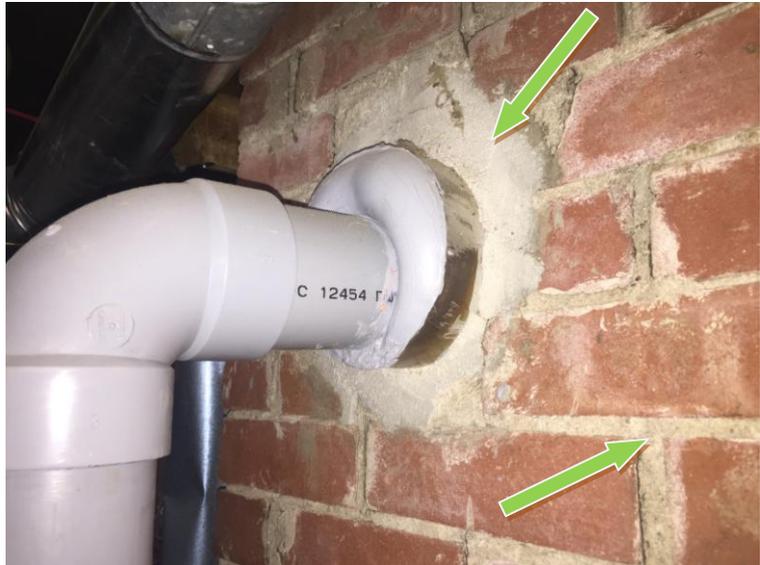
Photo 4

Parging cement around penetrations into the chimney was sampled and was not found to contain asbestos (samples 1 and 2). The mortar in place with the bricks forming the chimney was also sampled and was also not found to contain asbestos (samples 3 and 4).

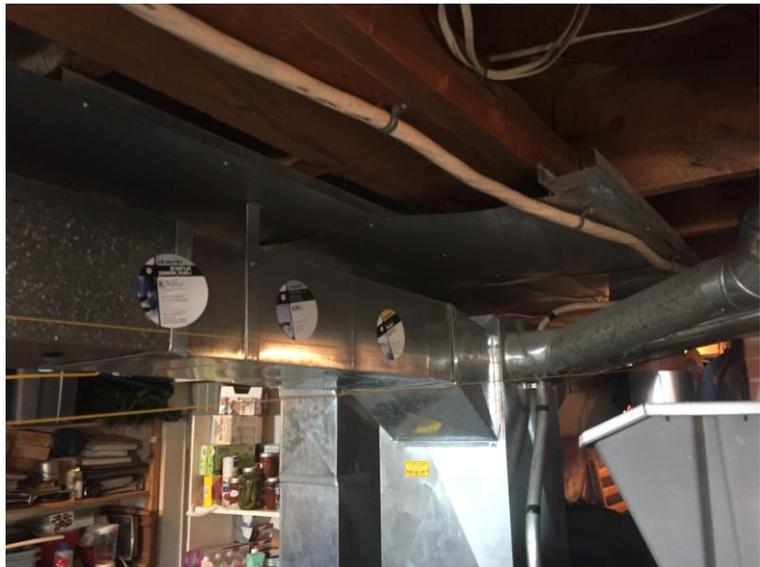
**Photo 5**

Ductwork present in the basement is uninsulated, and mastics which might be suspect ACM were not present. Duct wrap is not present at seams and was not observed at supply registers.

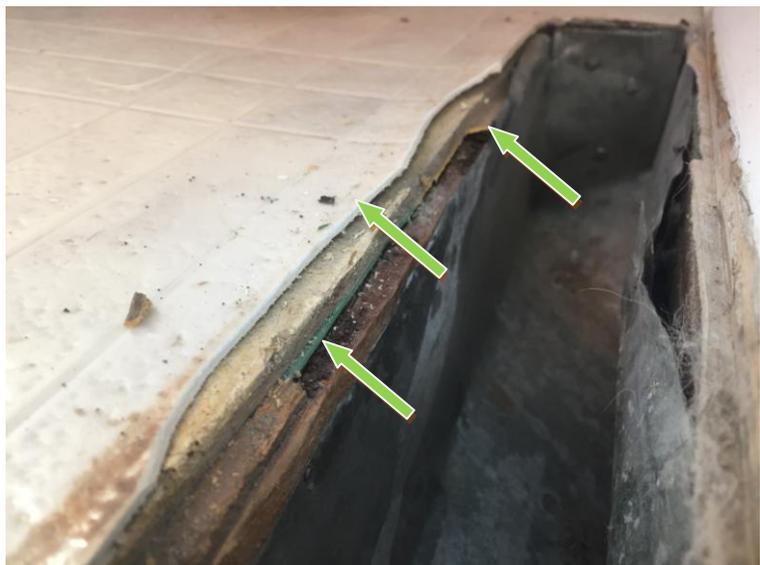
**Photo 6**

The entrance flooring is newer vinyl sheet flooring over top of a subfloor, which is over top beige and green floor tiles, which are presumed to be original. All flooring materials were sampled and materials were not found to contain asbestos (samples 8 - 10). Similar materials are presumed to be under kitchen flooring.

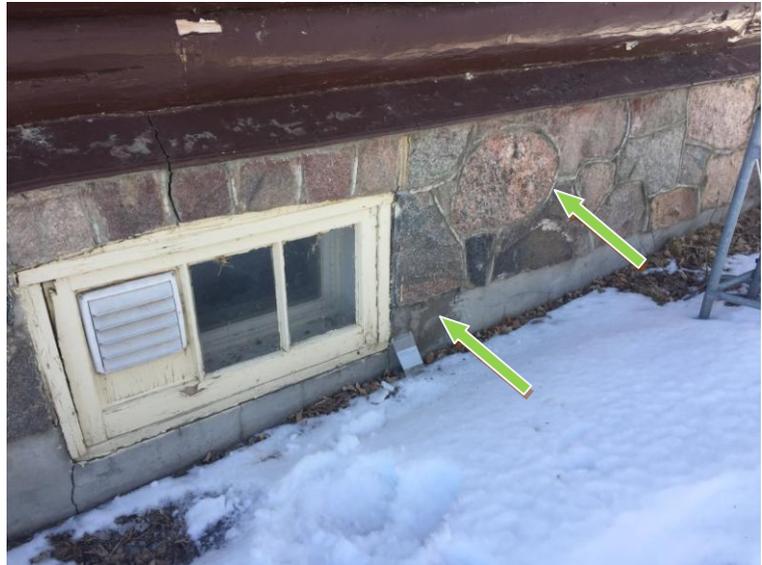
Photo 7

The exterior base of the building consists of a cement foundation and stones.

The cement base (sample 16) and the mortar used with the stones (sample 15) were sampled and were not found to contain asbestos.

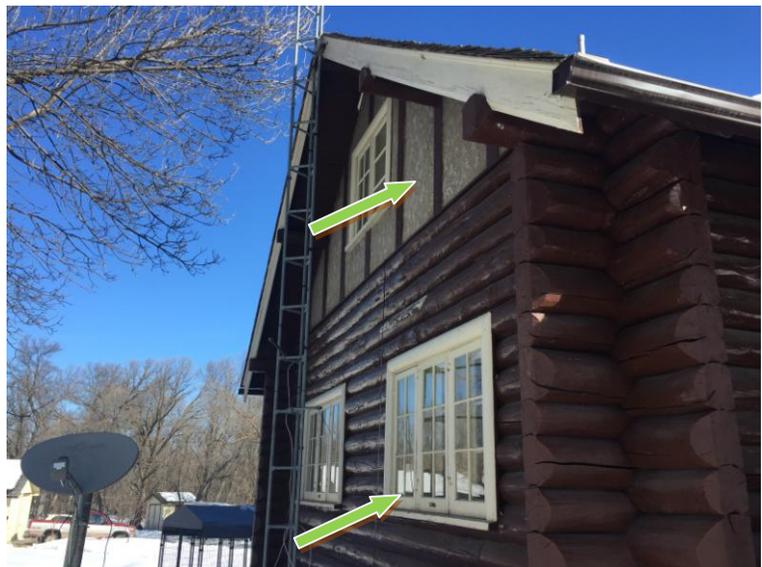
Photo 8

The stucco material for the top portion of the gable end (sample 14) on the west side of the building and the exterior window glazing material (sample 17) were sampled and were not found to contain asbestos.

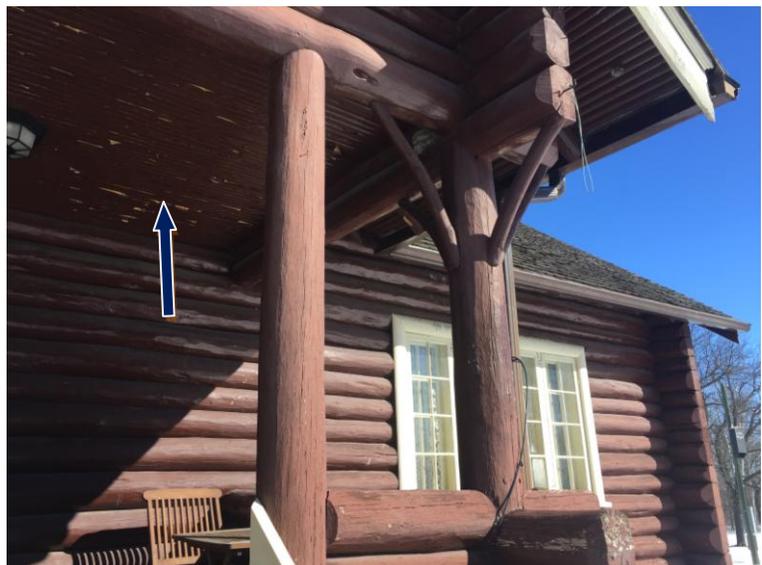
Photo 9

The brown exterior paint was above the 0.009% threshold but well below the 0.5% threshold. These limits are described in Section 3.6.

A sample taken of the brown paint present on front (south) porch was found to contain 0.1% w/w lead (lead sample 1).

The paint appears to be similar to paint applied all exterior surfaces, however additional testing would be required to determine if different areas have different lead content.

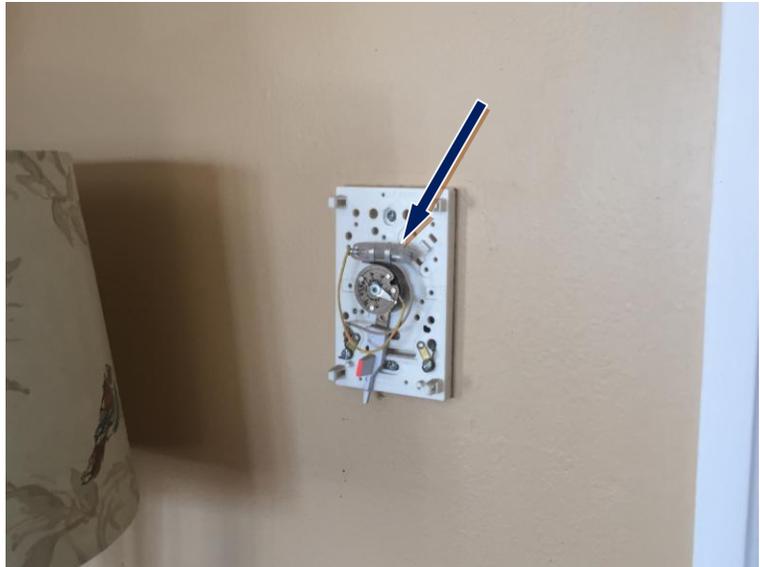
Photo 10

The thermostat located in the main floor living room contains a mercury switch. Refer to Photo 10.

The wall thermostat located in the living room contains a mercury switch.

- 5.3.1. Mercury-containing equipment (MCE) must be removed and properly disposed of prior to any renovation or demolition activities that may disturb this equipment.
- 5.3.2. Manitoba regulations require hazardous materials including mercury be removed prior to building demolition (MR 217/2016 Sec 33.4).

Mercury is toxic and mercury must be removed from the building prior to its demolition. Mercury waste must be disposed of with a licensed hazardous waste facility.
