Designated Substances Survey

Wasauksing Swing Bridge Control House, Parry Sound, Ontario

May 4, 2018

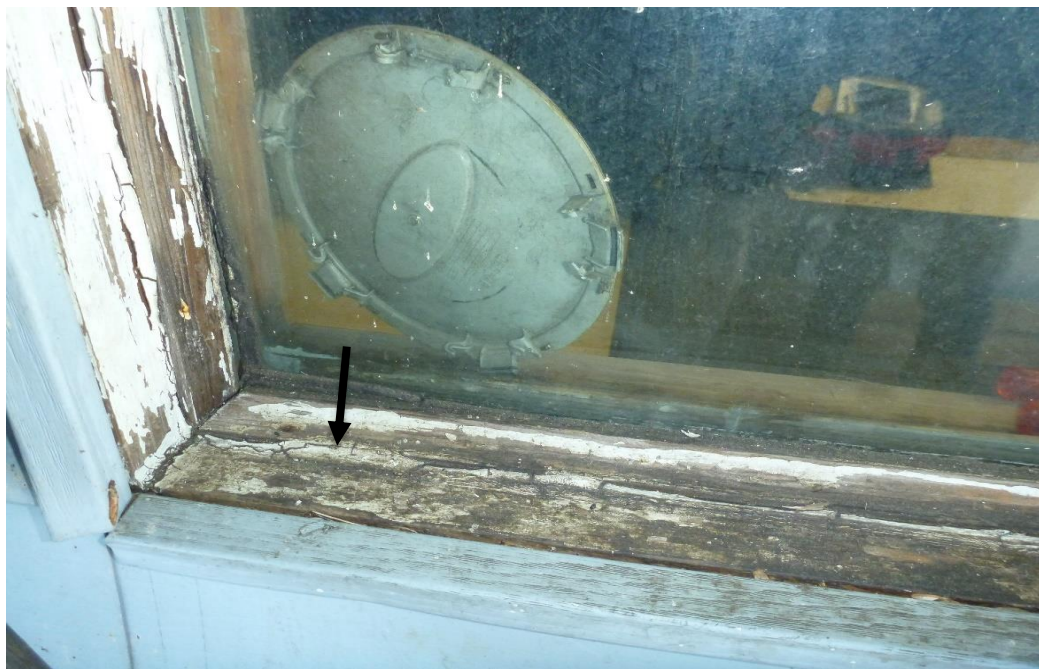
- Exterior window caulking. Approximately 20 linear feet of this material was found on the exterior windows of the structure and observed to be in fair condition
- Roofing materials below metal sheeting, approximately 700 square feet of this material was observed to be fair condition
- One rope gasket associated with the fireplace observed to be in fair condition
- Original electrical wire sheathing throughout the control house, in fair condition where observed (quantity not assessed)

Photo 2: Exterior window caulking, along the northwest side of the control house, presumed to be asbestos-containing. Approximately 20 linear feet of this material was observed to be in fair condition.

The exterior window caulking, rope gasket, electrical sheathing, and roofing materials presumed to be asbestos containing should be sampled prior to disturbance to determine whether or not they contain asbestos. If determined to contain asbestos, they must be removed following Type 1 operations as per O. Reg. 278/05 prior to disturbance.

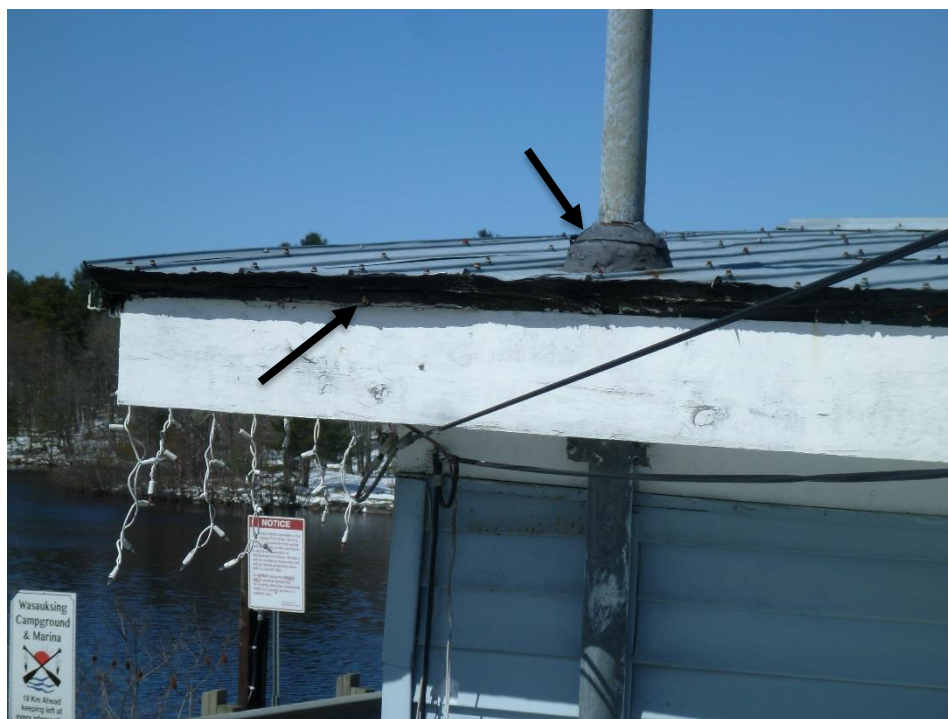
Photo 3: Roofing materials present under metal sheeting and as caulking presumed to be asbestos-containing.

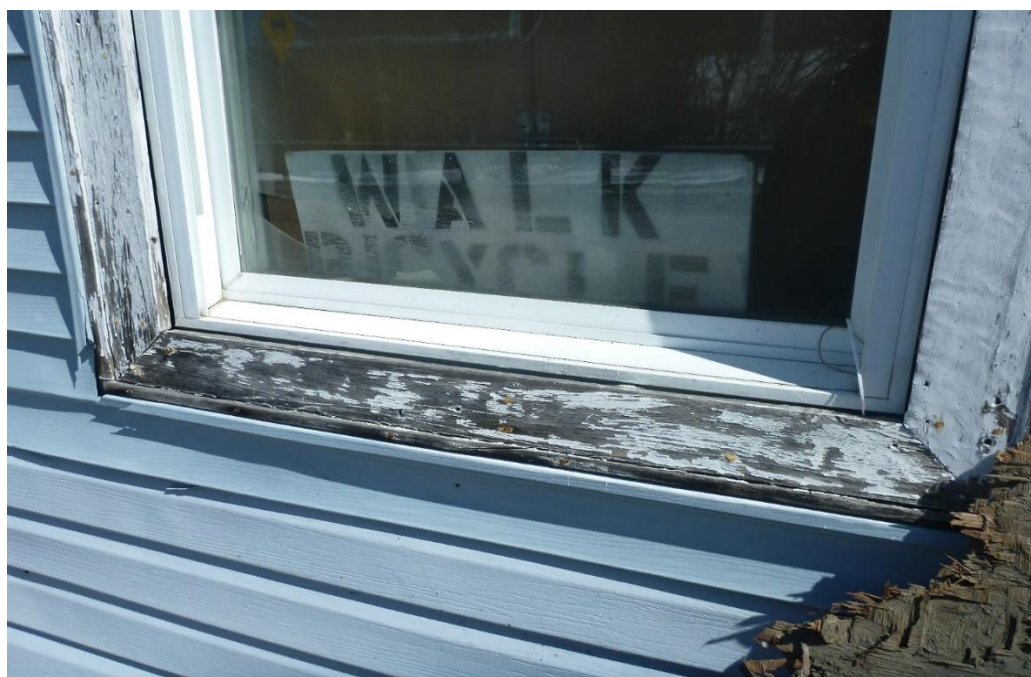
Photo 4: Exterior wooden window frame with white paint determined to contain trace amounts of lead (140 ppm).

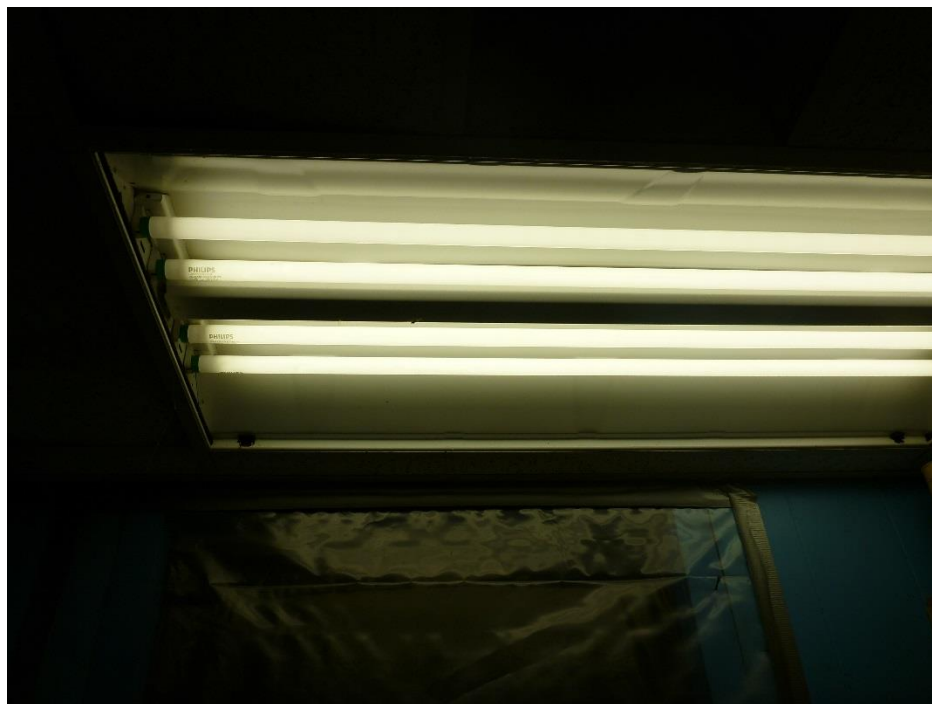
Photo 5: Fluorescent light tubes containing trace amounts of mercury vapour.

Mercury is suspected as vapour within fluorescent light tubes observed as well as metal halide bulbs present in the exterior lighting and the small thermometer outside the building. It is not expected that these materials will be disturbed as part of regular operating activities at the Site. If these materials are removed or disturbed, they must be kept separate from all other waste to prevent damage to the tubes containing the mercury. Mercury must be sent to a licensed mercury recycler or hazardous waste transfer station.

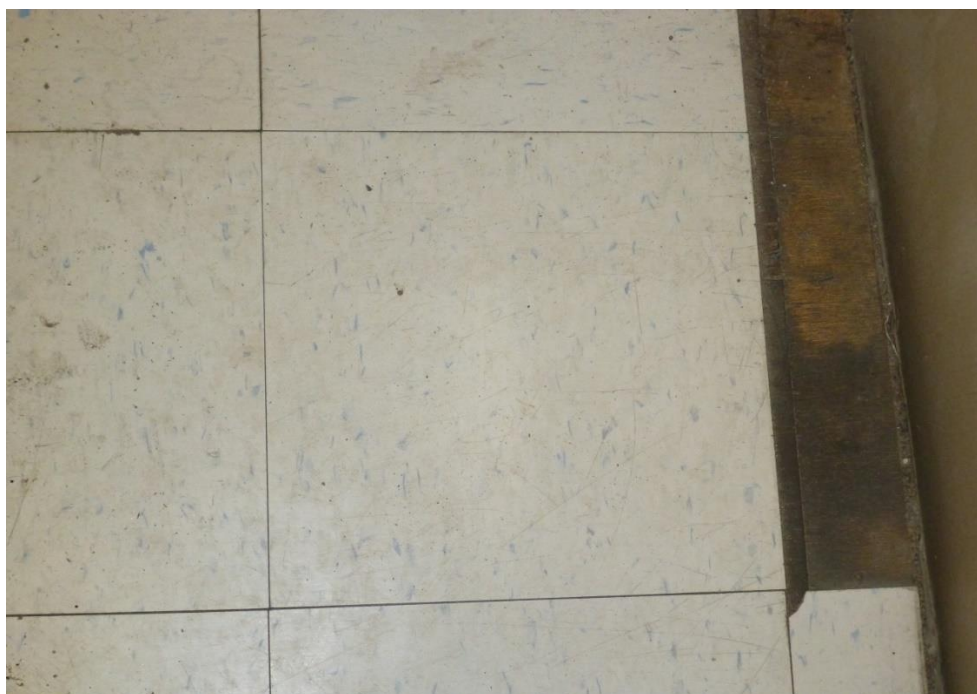
Photo 6: 12"x12" vinyl floor tile and associated brown mastic located in the bathroom and control room, determined to be non-asbestos.

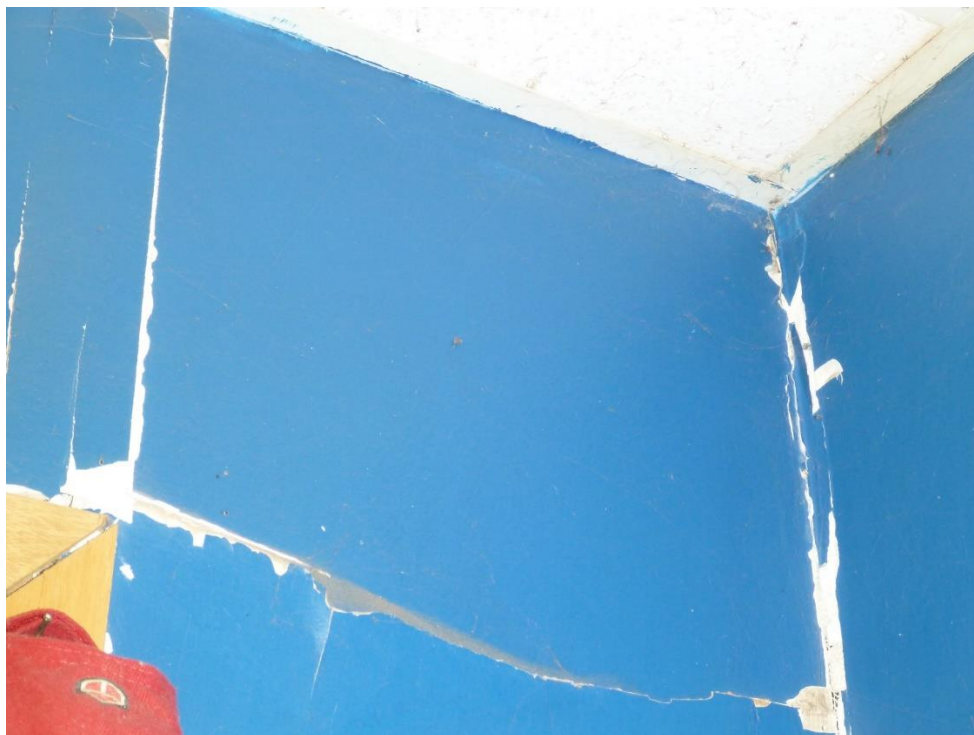
Photo 7: Drywall joint compound located in the control room and kitchen, determined to be non-asbestos.

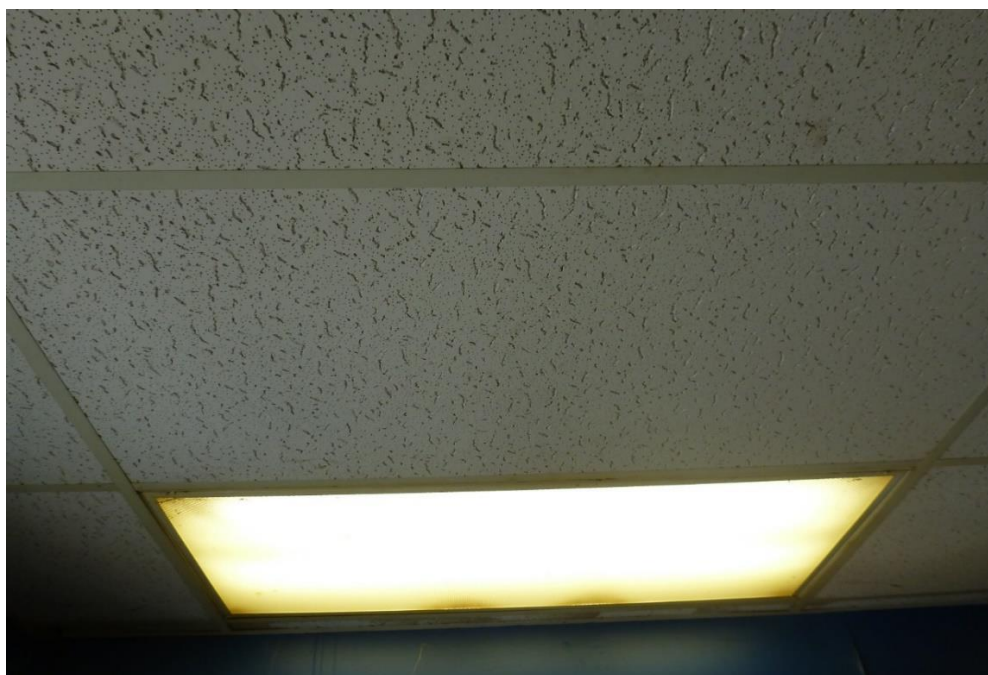
Photo 8: 2' x 4' acoustic ceiling tile located in the control room, bathroom and storage room determined to be non-asbestos.

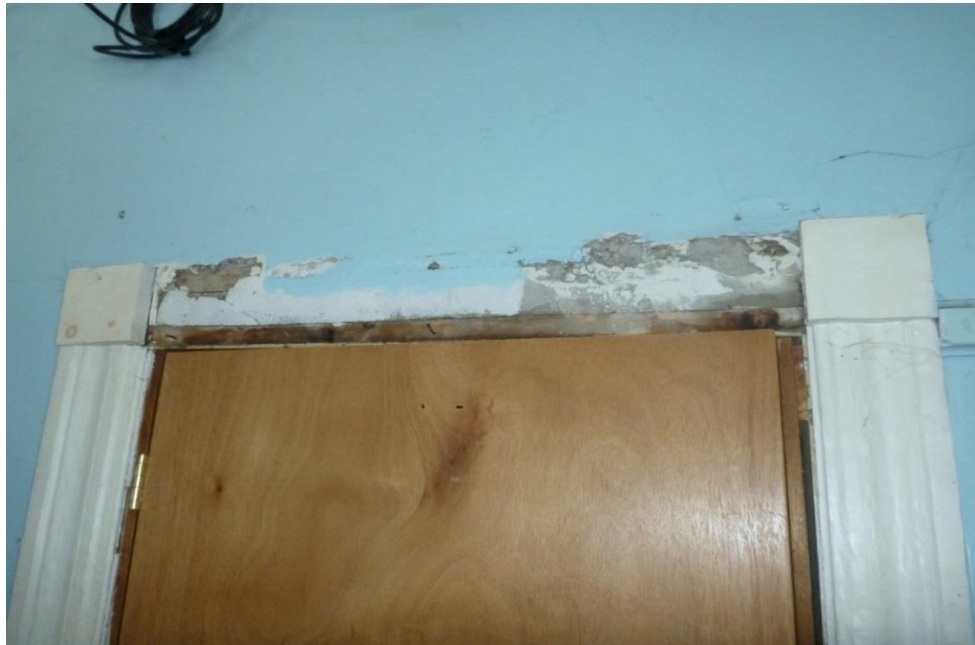
Photo 9: Plaster wall material determined to be non-asbestos, as well as light blue paint determined to contain trace amount of lead (320 ppm).

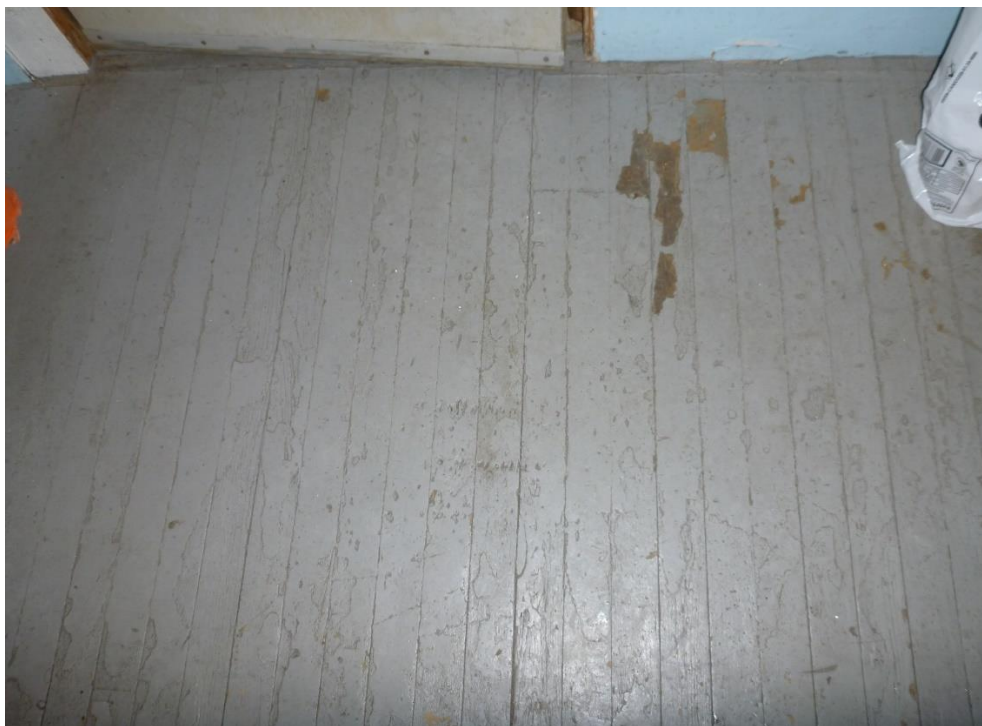
The grey floor paint on the hardwood floors (1789780-Pb-02) at the Site was confirmed to be classified as a lead-based paint. Paints containing less than 0.1% (1,000 ppm) lead by weight do not require lead handling procedures provided that the disturbance is consistent with the methods and guidelines discussed in Appendix A.

Photo 10: Grey paint on hardwood flooring in the kitchen and storage room, determined to be lead-based (25,000 ppm).

Disturbance of painted surfaces confirmed to contain greater than 0.1% lead by weight (1,000 ppm) must be completed as per the MOL Guideline, Lead on Construction Projects, 2004 (and revised in April 2011). Paints presumed to contain lead should be sampled prior to disturbance. In the event that LCP is required to be removed from the building and disposed of as waste, waste characterization should be performed including analysis of both the painted surface and the underlying substrate for lead leachate, using the Toxicity Characteristic Leaching Procedure (TCLP) as prescribed under O. Reg. 347/90. Based on the results of the TCLP analysis, removed lead containing materials (LCM) would either be considered as construction waste or leachate toxic waste. The building would also require registration as a Hazardous Waste Generator for this class of material should any of the materials be considered as leachate toxic waste. All leachate toxic materials would require segregation and final disposal in a landfill licensed by the Ontario Ministry of the Environment and Climate Change (MOECC) to accept leachate toxic waste.

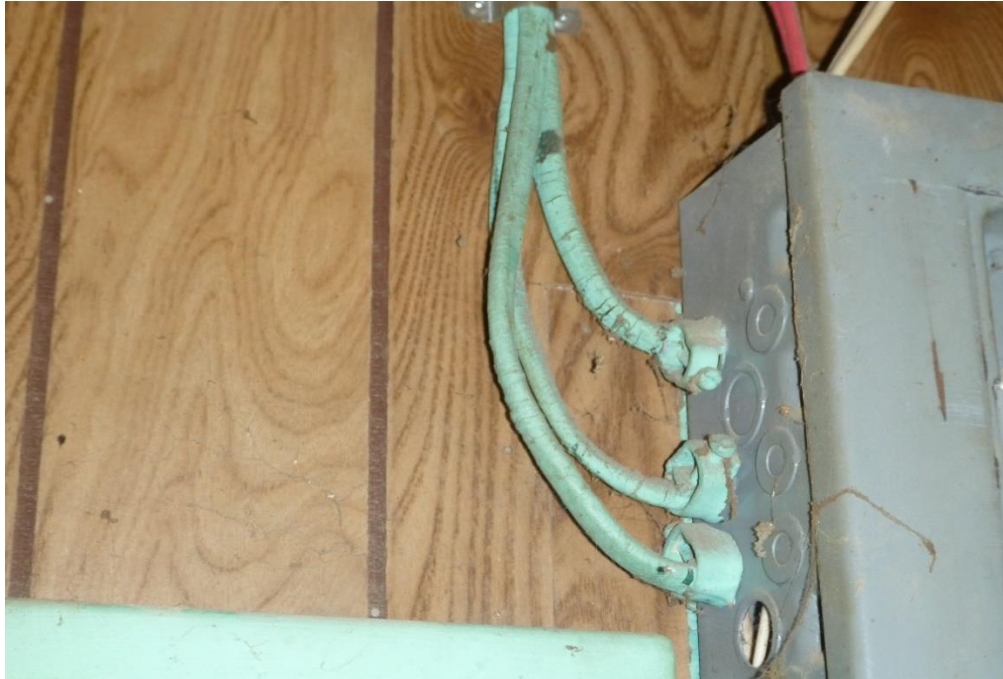
Photo 11: Wire sheathing protruding from the storage room electrical box, presumed to be asbestos-containing.

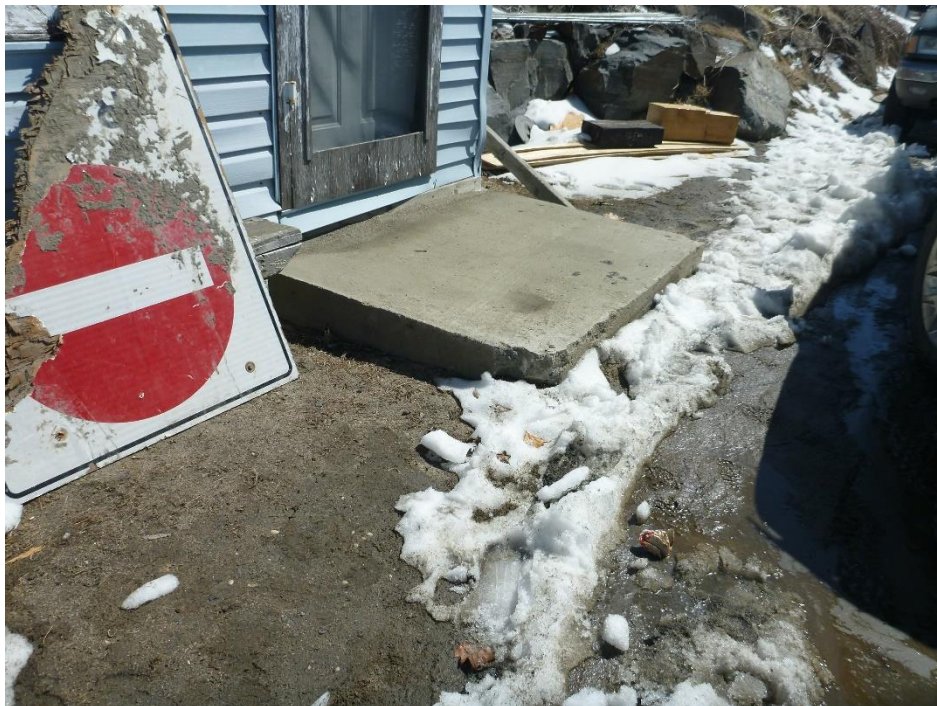
Photo 12: Concrete pad at main entrance presumed to contain silica.

Silica is likely present in the mortar of the original stone and mortar foundation, as well as in the concrete pads at the front entrances. Silica is also potentially present in drywall and acoustic lay-in ceiling tiles throughout the Site. The health risk associated from exposure to silica is due primarily to the inhalation of free crystalline silica, particularly in the form of dust associated with the abrading or cutting of silica-containing materials. Disturbances to potential silica-containing aggregate building materials must be performed in accordance with the MOL Guideline, Silica on Construction Projects, 2004 (and revised in 2011). Drilling, milling, grinding, hammering, cutting, polishing, sanding, or sandblasting of silica-based materials should be minimized to reduce the potential creation of airborne emissions of silica. In the event that such work is required to be conducted, ensure that respirable silica dust does not exceed the TWA of 0.05 mg/m³ for cristobalite, and 0.10 mg/m³ for quartz and tridymite.

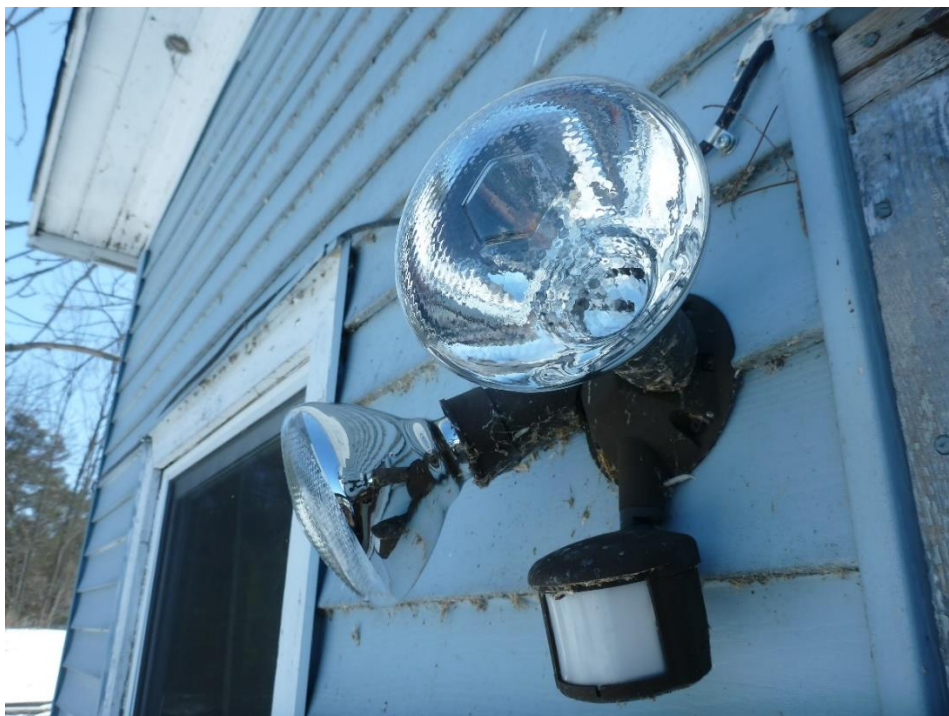
Photo 13: Outdoor lighting, consisting of metal halide bulbs presumed to contain trace amounts of mercury vapour.

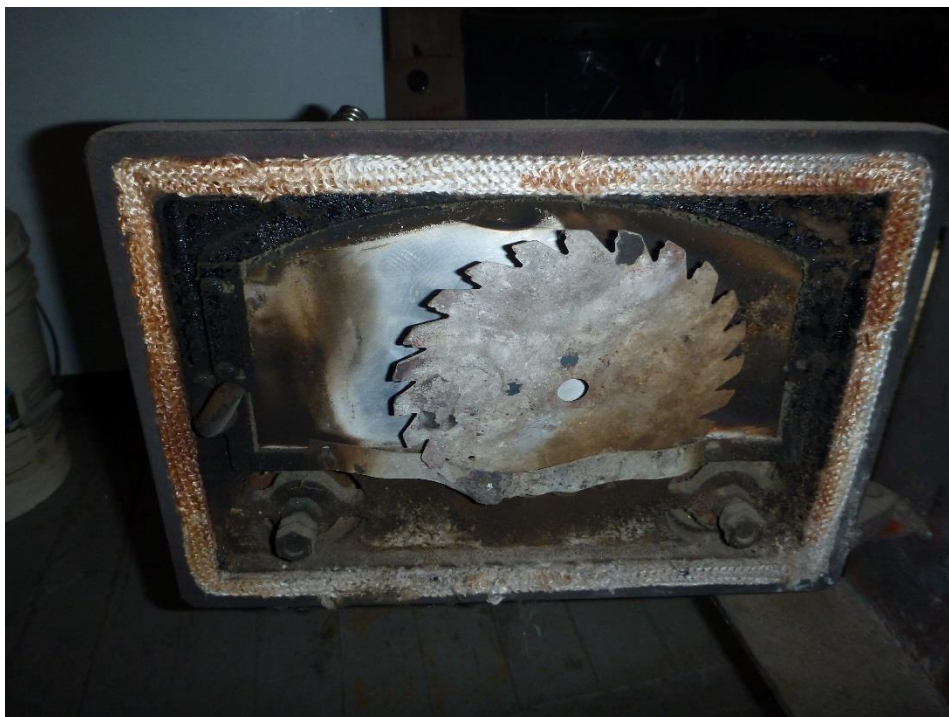
Photo 14: Gasket associated with the wood fireplace, presumed to be asbestos-containing (not sampled to avoid compromising heat source seal).

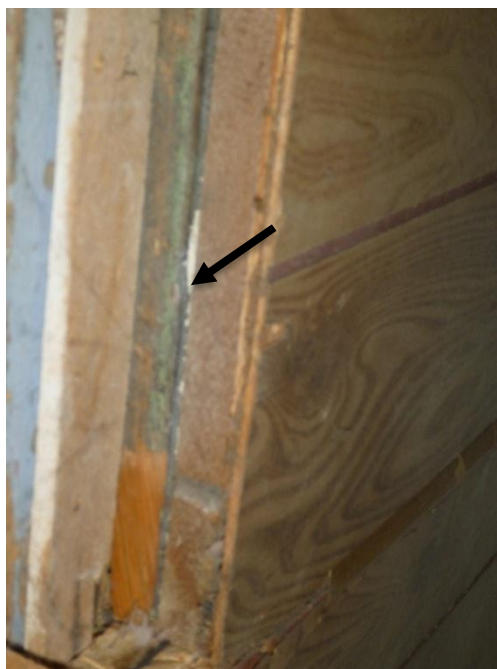
Photo 15: Tar paper present behind vinyl siding on the exterior and behind wood paneling in the storage room, sampled and determined to be non-asbestos.

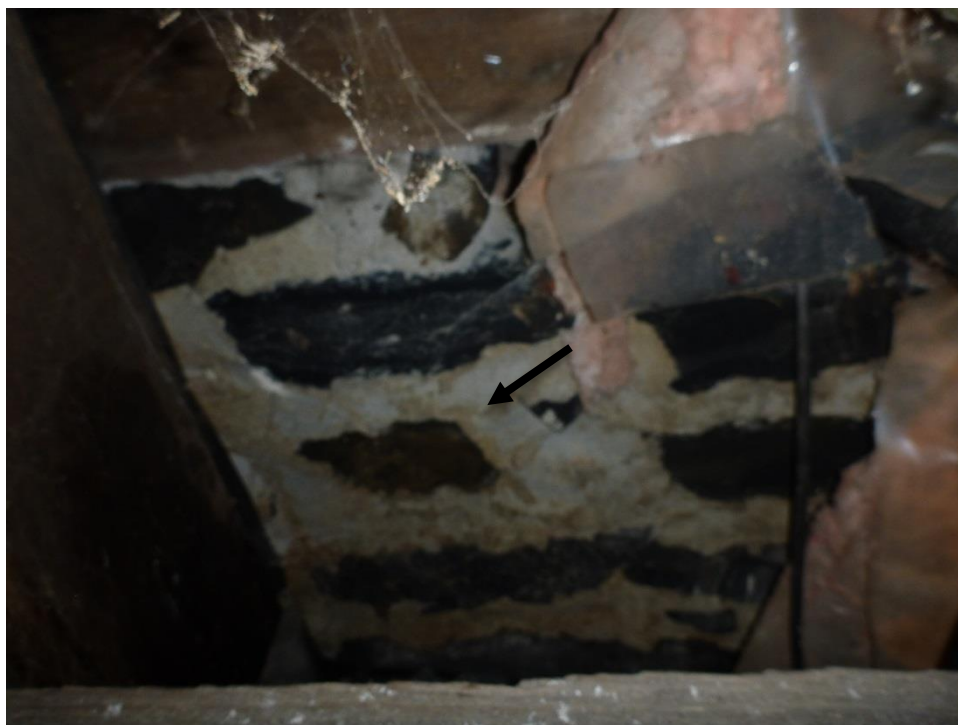
Photo 16: Stone and mortar foundation, with the mortar presumed to contain silica.
