Metal Based Paint Remedial Action Plan

Parks Canada Buildings and
Structures at Georgina Point
(Active Pass) Lightstation,
East Point (Saturna Island)
Lightstation; Portlock Point
Lightstation and Russell Island

Prepared for:
Parks Canada Agency

August 21, 2018

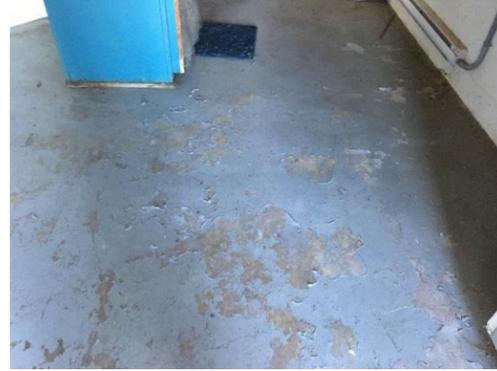
Building	Paint Description/ Condition/Quantity	Paint Lead Concentration (ppm)	Leachable Lead Concentration for Waste (mg/L)	Remedial Action Option Chosen	Scope Details	Photograph
Georgina Point Light Keeper's House	Grey on concrete basement floor is in poor condition, flaking and peeling throughout— approximately 33 m ²	41,000	Assumed >5	Comprehensive removal of LCP from substrate	Remove and dispose of approximately 33 m ² of paint from the concrete floor. It is assumed the leachable lead concentration of the waste will exceed 5 mg/L and thus disposal to landfill will not be an option. Repaint grey as required by Parks Canada.

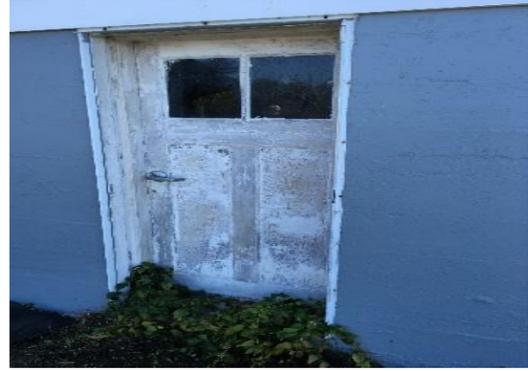
Georgina Point Light Keeper's House	White on wood exterior siding is in good condition except for localized flaking on the rear basement door—approximately 1.5 m ² in poor condition	1,800	<0.40	Localized LCP removal from substrate	Remove and dispose of approximately 1.5 m ² of paint from the exterior of the wood door. Repaint white as required by Parks Canada.

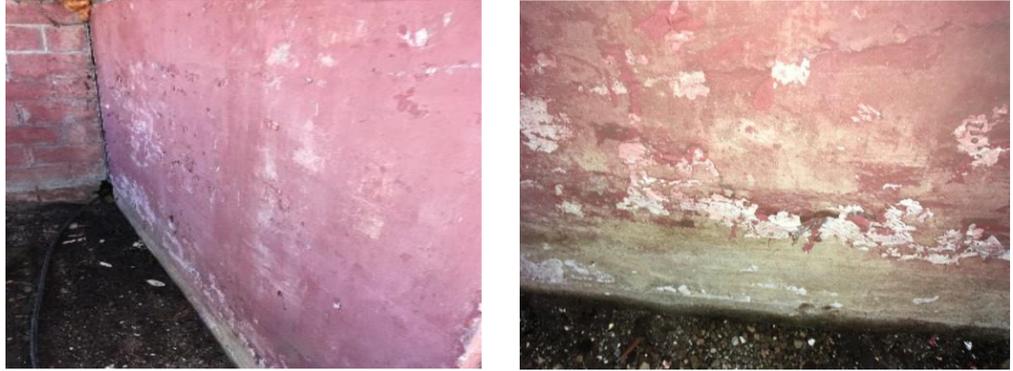
Georgina Point Light Keeper's House	Red on concrete exterior foundation wall under porch is in poor condition, flaking and peeling throughout— Approximately 14.5 m ² Note that some flaking paint was observed to be present on the surface of the soil below	6,700	Assumed >5	Comprehensive removal of LCP from substrate <ul style="list-style-type: none"> Remove the top two inches of soil along the wall where flaking paint is present 	Remove and dispose of approximately 14.5 m ² of paint from the concrete exterior foundation. Remove and dispose of the top two inches of soil (approximately 0.15 m ³ or 300 Kg) along the wall where flaking paint is present. Repaint grey as required by Parks Canada.

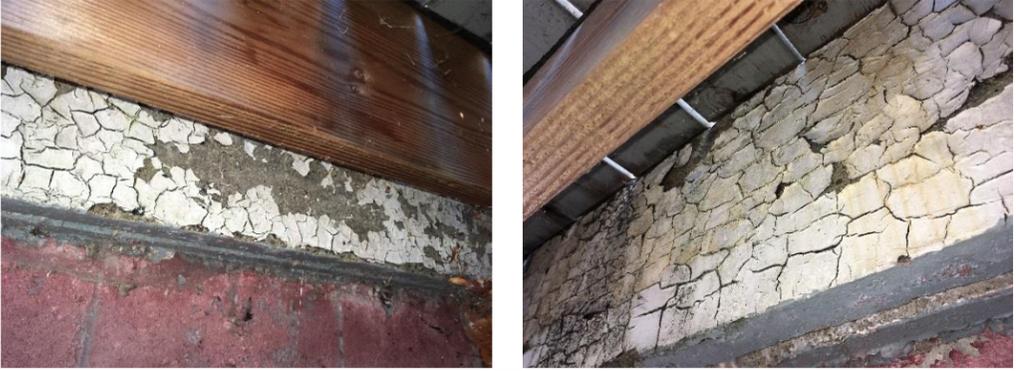
Building	Paint Description/ Condition/Quantity	Paint Lead Concentration (ppm)	Leachable Lead Concentration for Waste (mg/L)	Remedial Action Option Chosen	Scope Details	Photograph
Georgina Point Light Keeper's House	White on concrete edge of deck under porch is in poor condition, flaking and peeling throughout—Approximately 1 m ²	37,000	Assumed >5	Comprehensive removal of LCP from substrate	Remove and dispose of approximately 1 m ² of paint from the concrete edge of the deck under the porch. Repaint grey as required by Parks Canada.

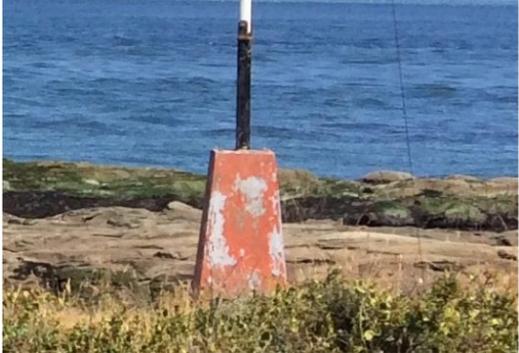
Georgina Point Light Keeper's House	Red paint on concrete base of detached flagpole is in poor condition throughout— Approximately 3 m ²	Presumed LCP; Presumed >5,000 ppm lead	Assumed >5	Comprehensive removal of LCP from substrate	Remove and dispose of approximately 3 m ² of paint from the concrete base of the detached flagpole. Repaint red as required by Parks Canada.

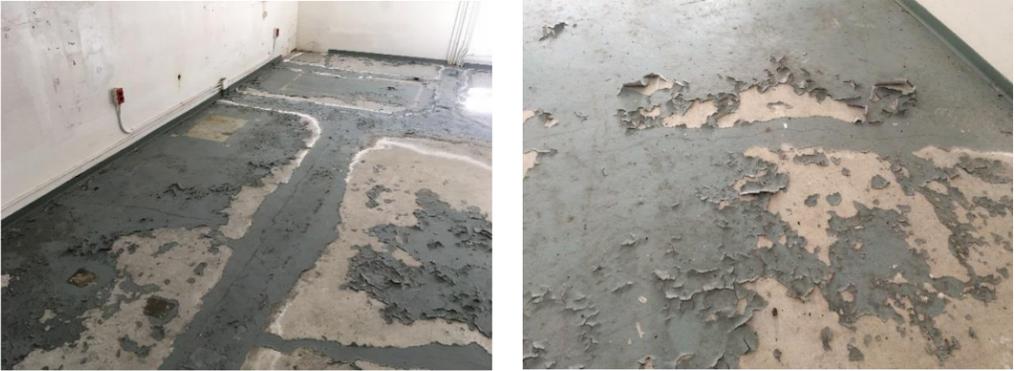
Georgina Point Weather Station	Grey on concrete floor in the electrical room is in poor condition, flaking and peeling throughout—Approximately 37 m ²	2,200	Assumed <5	Comprehensive removal of LCP from substrate	Remove and dispose of approximately 37 m ² of paint from the concrete floor in the electrical room. Leave unpainted.

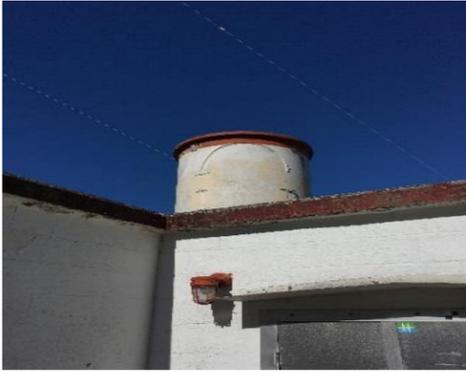
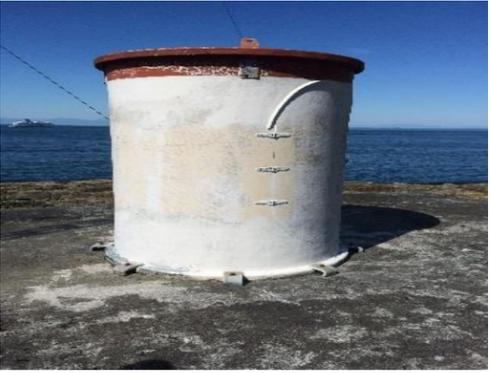
Building	Paint Description/ Condition/Quantity	Paint Lead Concentration (ppm)	Leachable Lead Concentration for Waste (mg/L)	Remedial Action Option Chosen	Scope Details	Photograph	
Georgina Point Weather Station	Red on concrete exterior trim is in poor condition, flaking and peeling throughout—Approximately 5.5 m ²	56,000	Assumed >5	Comprehensive removal of LCP from substrate	Remove and dispose of approximately 5.5 m ² of paint from the concrete exterior trim. Repaint red, as required by Parks Canada.

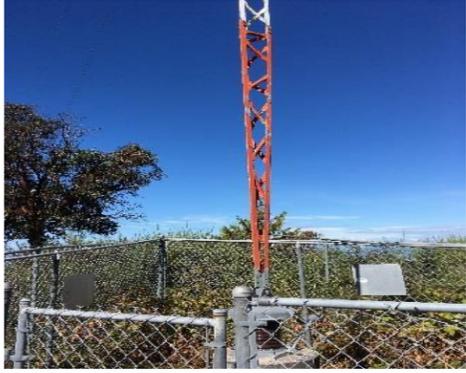
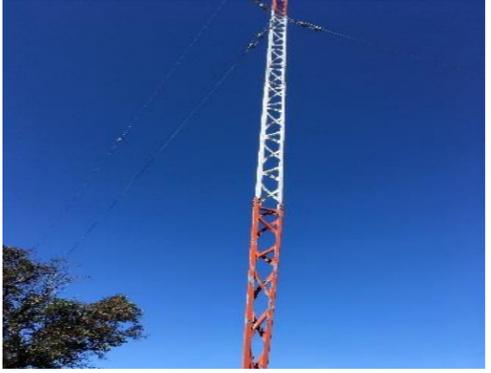
Georgina Point Weather Station	Red and white on metal antenna is in poor condition, flaking and peeling throughout—Approximately 11 m ²	Presumed LCP; Presumed >5,000 ppm lead	Assumed >5	Comprehensive removal of LCP from substrate (assuming paint is LCP)	Undertake sampling to confirm lead content of paint. Assuming paint is lead-containing, remove and dispose of approximately 11 m ² of paint from the metal antenna assuming paint is LCP. Assess surrounding soil for the presence of flaking paint when access is provided. Repaint as required by Transport Canada.

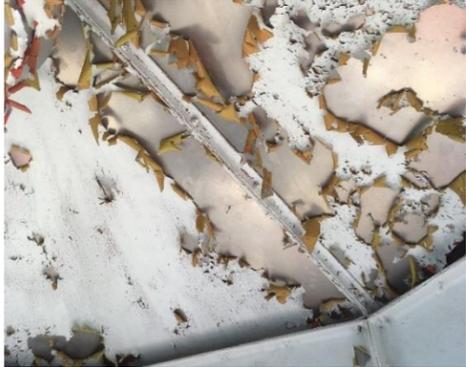
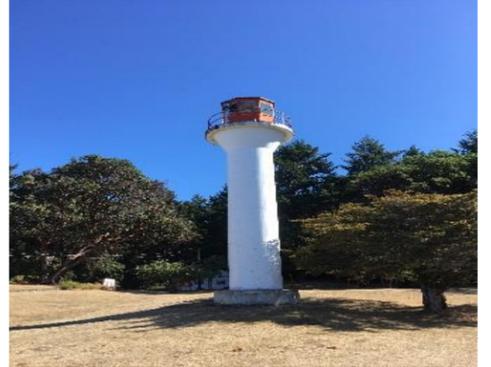
Georgina Point Beacon	White on metal interior of upper level walls and ceiling is in poor condition, flaking and peeling throughout—Approximately 5 m ²	7,500	Assumed >5	Comprehensive removal of LCP from substrate <ul style="list-style-type: none"> If ACM window caulking will be disturbed it should be removed prior to LCP remediation 	Remove and dispose of approximately 5 m ² of paint from the metal walls and ceiling. Undertake removal work such that ACM window caulking is not disturbed in the process. Repaint white as required by Parks Canada.

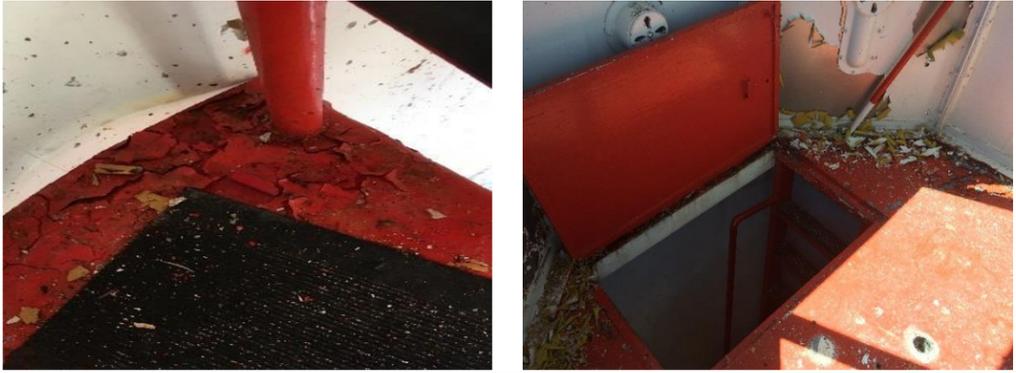
Building	Paint Description/ Condition/Quantity	Paint Lead Concentration (ppm)	Leachable Lead Concentration for Waste (mg/L)	Remedial Action Option Chosen	Scope Details	Photograph
Georgina Point Beacon	Red on metal upper level floor and staircase is in poor condition, flaking and peeling throughout—Approximately 10 m ²	67,000	Assumed >5	Comprehensive removal of LCP from substrate	Remove and dispose of approximately 10 m ² of paint from the metal floor and staircase. Repaint red as required by Parks Canada.

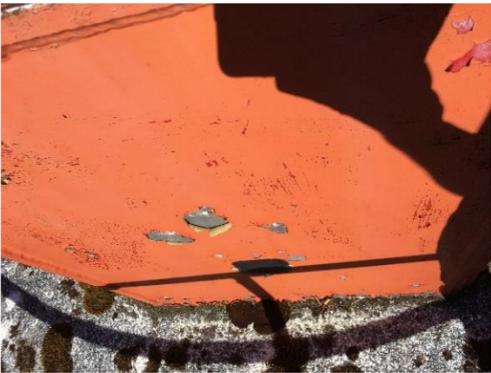
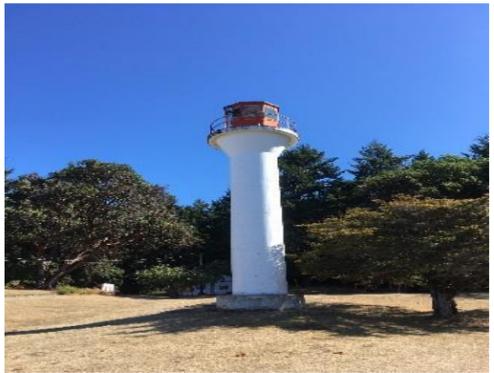
Georgina Point Beacon	Red on metal upper level exterior and railing is in poor condition, flaking and peeling throughout—Approximately 10 m ²	100,000	Assumed >5	Comprehensive removal of LCP from substrate <ul style="list-style-type: none"> If ACM window caulking will be disturbed it should be removed prior to LCP remediation 	Remove and dispose of approximately 10 m ² of paint from the metal exterior and railing. Undertake removal work such that ACM window caulking is not disturbed in the process. Repaint red as required by Parks Canada.

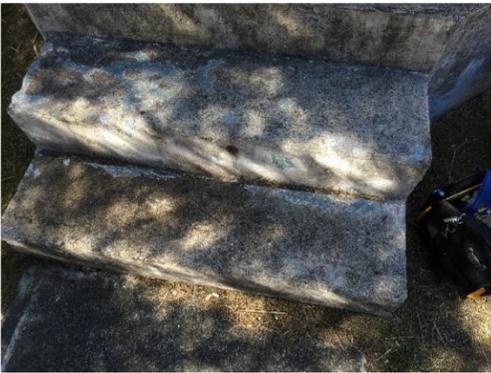
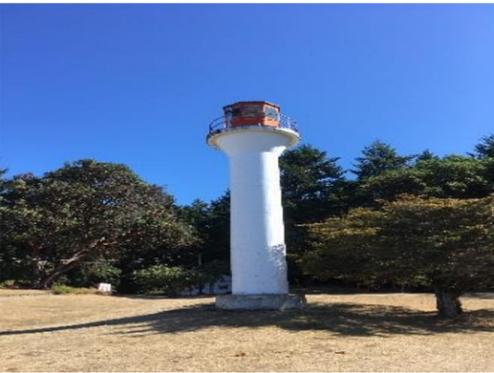
Georgina Point Beacon	Grey on concrete exterior foundation and steps is mostly worn from the surface of the concrete (reportedly previously abated)—Approximately 7.5 m ²	1,300	Assumed <5	Comprehensive removal of LCP from substrate	Remove and dispose of approximately 7.5 m ² of paint from the concrete exterior foundation. Repaint grey as required by Parks Canada.

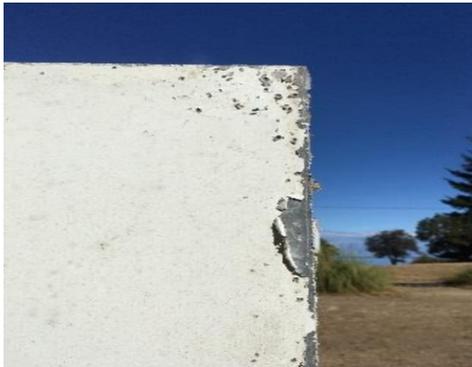
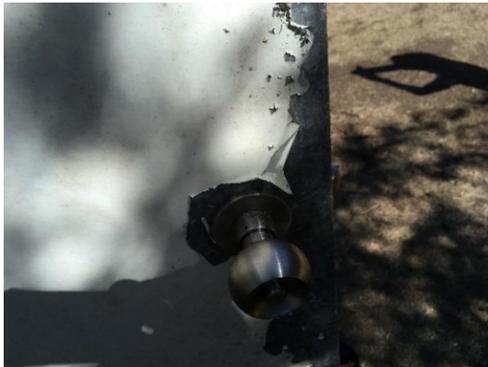
Building	Paint Description/ Condition/Quantity	Paint Lead Concentration (ppm)	Leachable Lead Concentration for Waste (mg/L)	Remedial Action Option Chosen	Scope Details	Photograph	
Georgina Point Beacon	Cream on the interior side of the metal door and frame is in poor condition, flaking and peeling throughout—Approximately 2.5 m ²	2,300	Assumed <5	Comprehensive removal of LCP from substrate	Remove and dispose of approximately 2.5 m ² of paint from the metal door and frame. Leave unpainted.

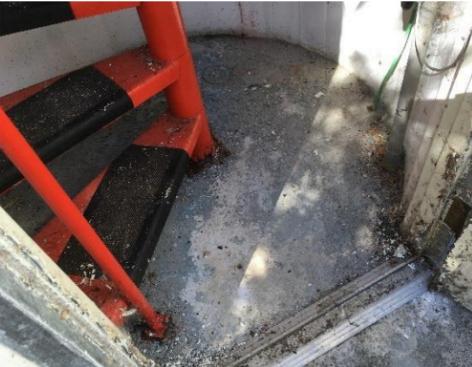
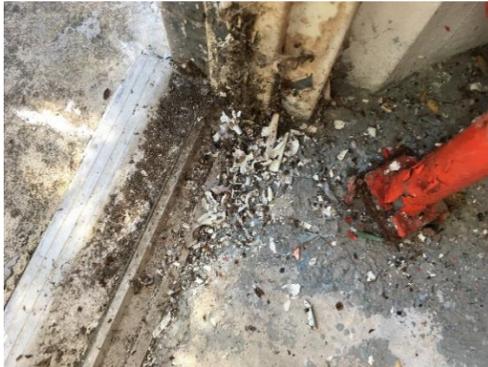
Georgina Point Beacon	Grey on interior concrete floor base is in poor condition, flaking and peeling throughout—Approximately 2.5 m ²	2,400	Assumed <5	Comprehensive removal of LCP from substrate	Remove and dispose of approximately 2.5 m ² of paint from the concrete floor base. Leave unpainted.

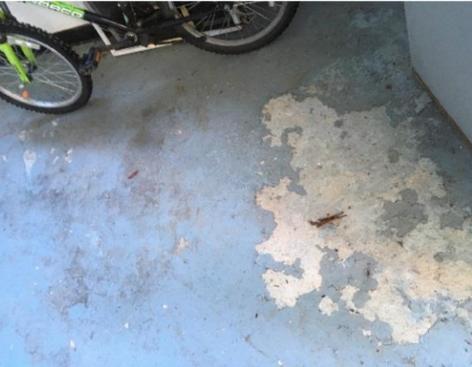
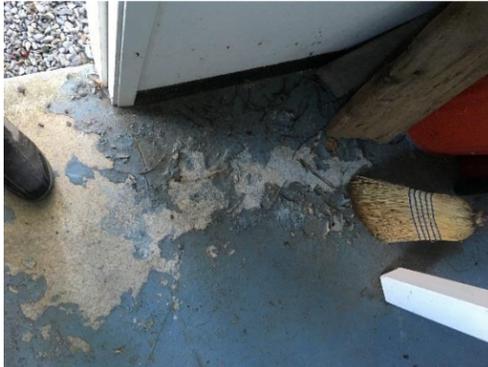
Georgina Point Garage	Grey on concrete floor is in poor condition, flaking and peeling throughout—Approximately 23.5 m ²	1,200	Assumed <5	Comprehensive removal of LCP from substrate	Remove and dispose of approximately 23.5 m ² of paint from the concrete floor. Repaint grey as required by Parks Canada.

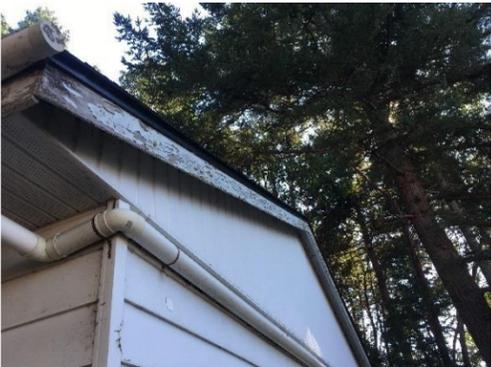
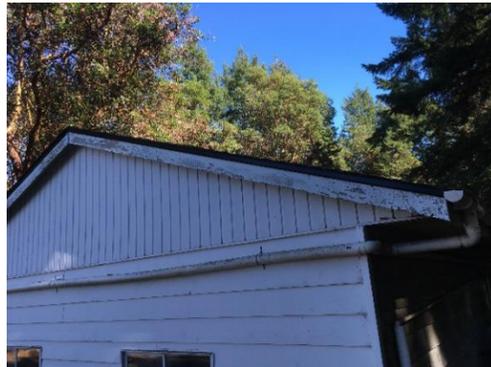
Building	Paint Description/ Condition/Quantity	Paint Lead Concentration (ppm)	Leachable Lead Concentration for Waste (mg/L)	Remedial Action Option Chosen	Scope Details	Photograph	
Georgina Point Garage	White on wood exterior fascia is in poor condition, flaking and peeling throughout— Approximately 4 m ²	1,100	Assumed <5	Comprehensive substrate removal	Remove and dispose of approximately 4 m ² or 55.8 Kg of exterior fascia. Replace fascia and paint as required by Parks Canada.

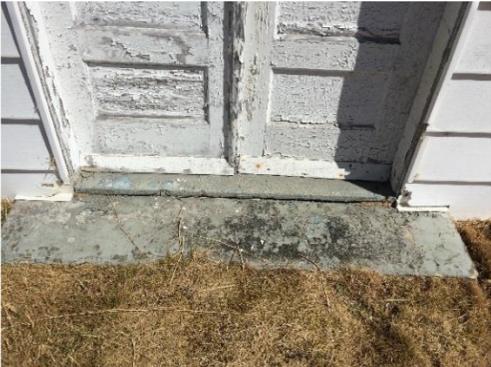
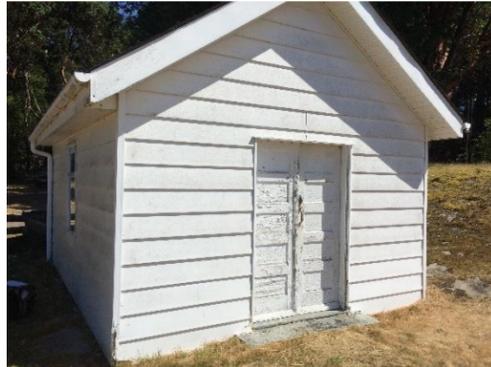
Georgina Point Shed	White on wood exterior siding is in good condition except for localized flaking on the door— Approximately 3 m ² in poor condition	190,000	Assumed >5	Localized removal of LCP from substrate	Remove and dispose of approximately 3 m ² of paint from the wood exterior of the door. Repaint white as required by Parks Canada.

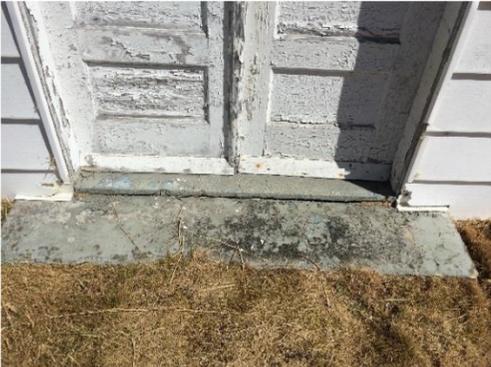
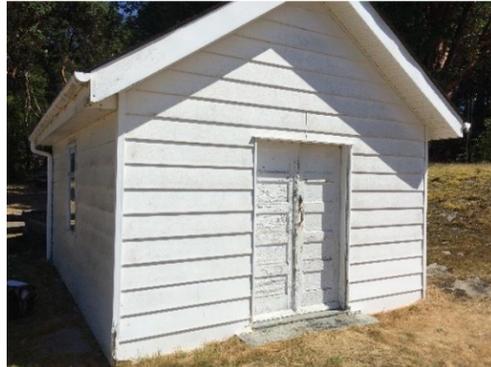
Georgina Point Shed	Grey on concrete front step is in poor condition, flaking and peeling throughout— Approximately 1 m ²	4,400	Assumed <5	Comprehensive removal of LCP from substrate	Remove and dispose of approximately 1 m ² of paint from the concrete front step. Repaint grey as required by Parks Canada.

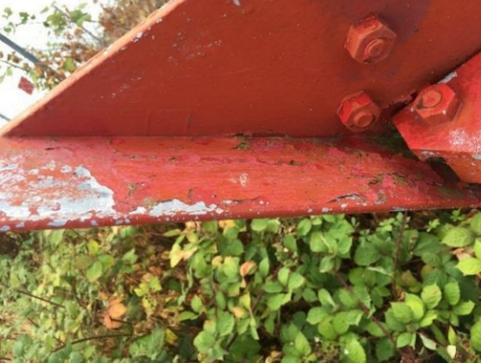
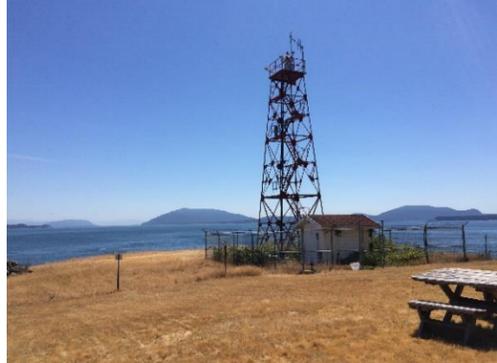
Building	Paint Description/ Condition/Quantity	Paint Lead Concentration (ppm)	Leachable Lead Concentration for Waste (mg/L)	Remedial Action Option Chosen	Scope Details	Photograph	
East Point Light Tower and Shed	Red on the steel tower structure is in poor condition, flaking and peeling throughout— Approximately 120 m ²	39,000	0.89 (paint chips alone without substrate)	Comprehensive removal of LCP from substrate	Remove and dispose of approximately 120 m ² of paint from the steel tower structure. Repaint as required by Parks Canada.

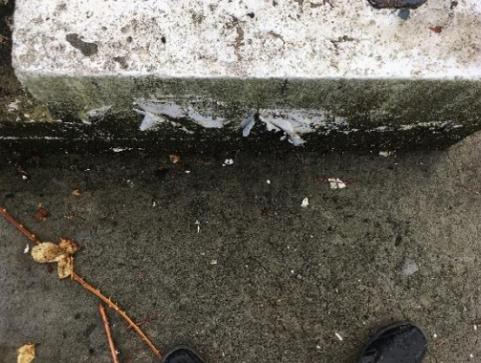
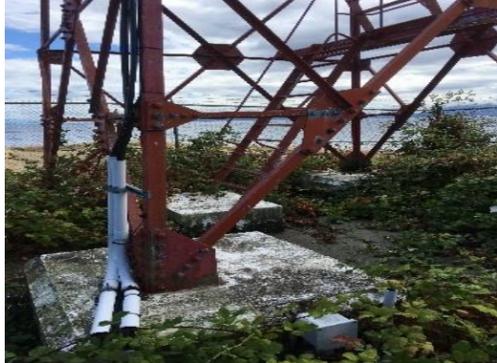
East Point Light Tower and Shed	White on concrete tower footings is in poor condition, flaking and peeling throughout—Approximately 18 m ²	1,100	Assumed <5	Comprehensive removal of LCP from substrate	Remove and dispose of approximately 18 m ² of paint from the concrete tower footings. Repaint white as required by Parks Canada.

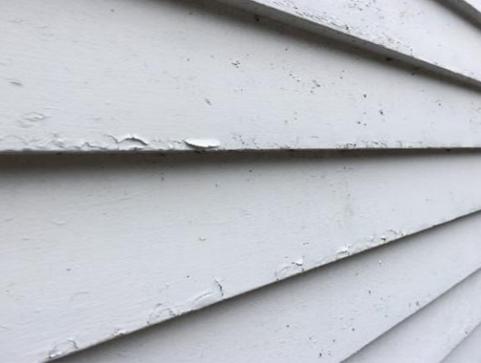
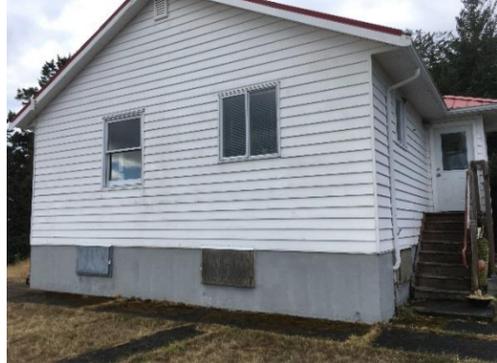
East Point Bunkhouse	White on wood exterior siding is in poor condition flaking and peeling over a significant portion of the building— Approximately 70 m ² in poor condition	2,000	<0.40	Comprehensive substrate removal	Remove and dispose of approximately 200 m ² or 2.79 tonnes of wood exterior siding. Replace with wood exterior siding and paint as required by Parks Canada.

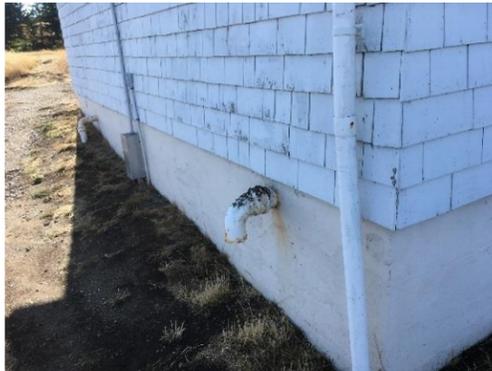
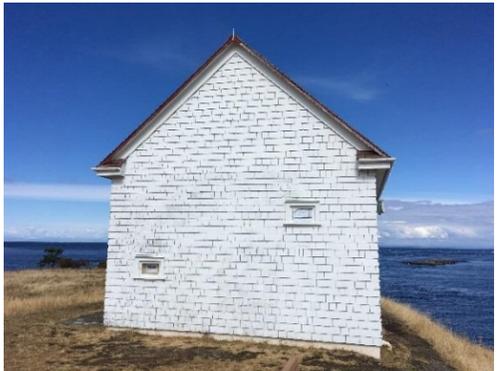
Building	Paint Description/ Condition/Quantity	Paint Lead Concentration (ppm)	Leachable Lead Concentration for Waste (mg/L)	Remedial Action Option Chosen	Scope Details	Photograph
East Point Fog Horn Building	White on wood exterior siding is generally in good condition with minor flaking and peeling in some locations - Approximately 5 m ² Note that some flaking paint was observed to be present on the surface of the soil below	3,300	<0.40	Localized LCP removal from substrate <ul style="list-style-type: none"> Remove the top two inches of soil along the wall where flaking paint is present 	Remove and dispose of approximately 5 m ² of paint from the wood exterior siding. Remove the top two inches of soil (approximately 0.4 m ³ or 800 Kg) along the wall where flaking paint is present. Repaint to match existing.

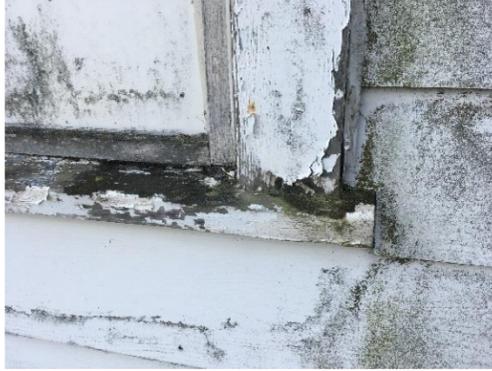
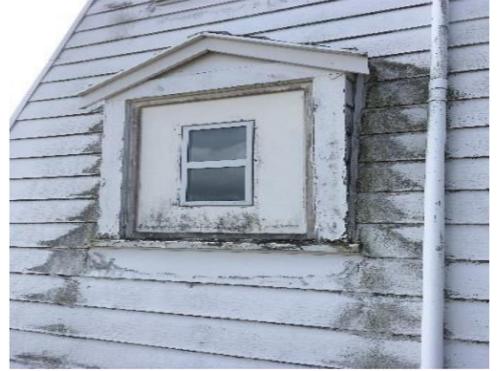
Portlock Point Lighthouse	White on wood exterior trim is flaking and peeling in some locations (window trim and door)—Approximately 4.5 m ² Note that some of the wood window trim is deteriorating due to moisture	72,000	0.58	Comprehensive removal of LCP from substrate <ul style="list-style-type: none"> If ACM building tar and/or window caulking will be disturbed it should be removed prior to LCP remediation 	Remove and dispose of approximately 4.5 m ² of paint from the wood exterior trim. Undertake removal work such that ACM building tar and/or window caulking is not disturbed in the process. Repaint to match existing.

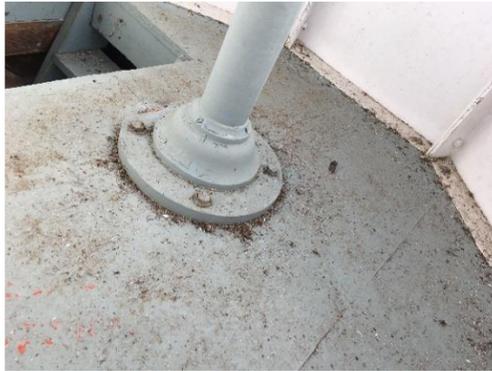
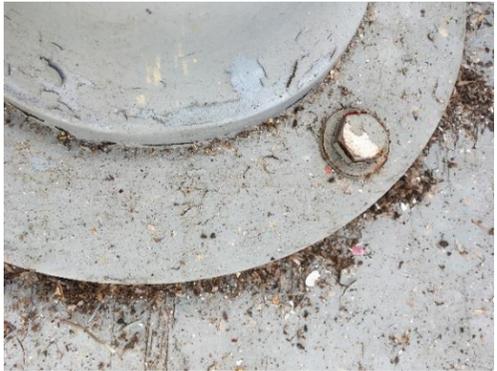
Portlock Point Lighthouse	Grey on metal and wood interior trim and stairs is generally in good condition with minor flaking and peeling around the base of the metal light post)—Approximately 1 m ²	5,400	<0.40	Localized removal of LCP from substrate	Remove and dispose of approximately 1 m ² of paint from the base of the metal light post. Repaint to match existing.

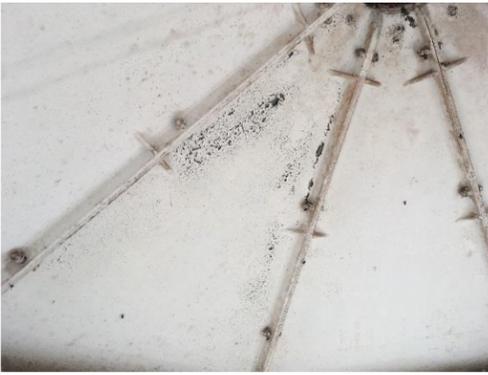
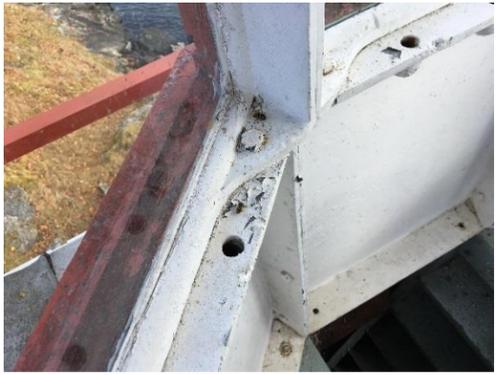
Building	Paint Description/ Condition/Quantity	Paint Lead Concentration (ppm)	Leachable Lead Concentration for Waste (mg/L)	Remedial Action Option Chosen	Scope Details	Photograph
Portlock Point Lighthouse	White on interior metal walls and ceiling on the upper level is flaking and peeling throughout—Approximately 15 m ²	2,900	Assumed <5	Comprehensive removal of LCP from substrate <ul style="list-style-type: none"> If ACM window caulking will be disturbed it should be removed prior to LCP remediation 	Remove and dispose of approximately 15 m ² of paint from the metal walls and ceiling. Undertake removal work such that ACM window caulking is not disturbed in the process. Repaint as required by Parks Canada.

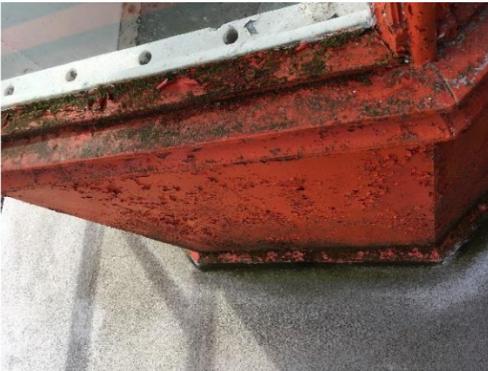
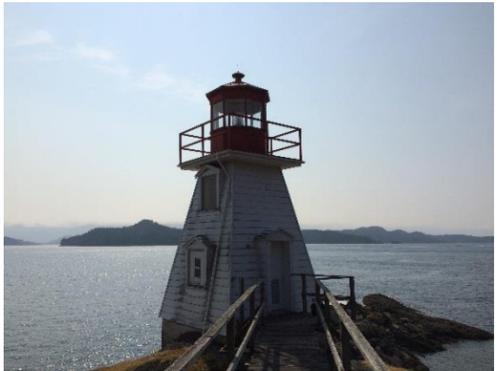
Portlock Point Lighthouse	Red on exterior metal walls and roof on the upper level is flaking and peeling throughout—Approximately 30 m ² Note that wood trim is present directly below the windows and that the window trim is deteriorating due to moisture	110,000	Wood trim: 2.9 Metal walls: Assumed >5	Comprehensive removal of LCP from substrate <ul style="list-style-type: none"> Remove and replace wood trim If ACM window caulking will be disturbed it should be removed prior to LCP remediation 	Remove and dispose of approximately 30 m ² of paint from the exterior metal walls and roof. Remove and dispose of approximately 0.4 m ² or 5 Kg exterior wood window trim. Undertake removal work such that ACM window caulking is not disturbed in the process. Repaint red as required by Parks Canada. Reinstate window trim using fir trim for exterior applications and paint white.

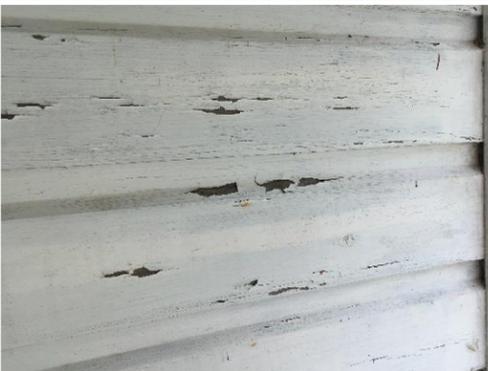
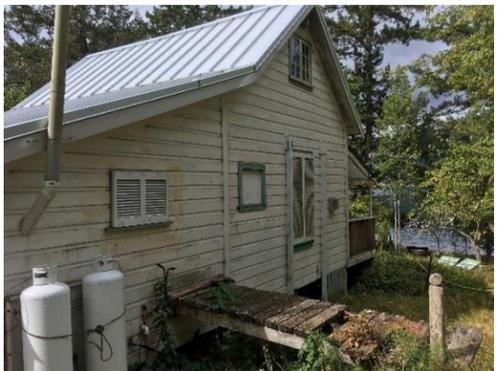
Mahoi House	White on wood exterior siding is generally in good condition with minor flaking and peeling in some locations—Approximately 40 m ² in poor condition	56,000	6.8	Localized LCP removal from substrate	Remove and dispose of approximately 40 m ² of paint from the wood exterior siding. Repaint to match existing.

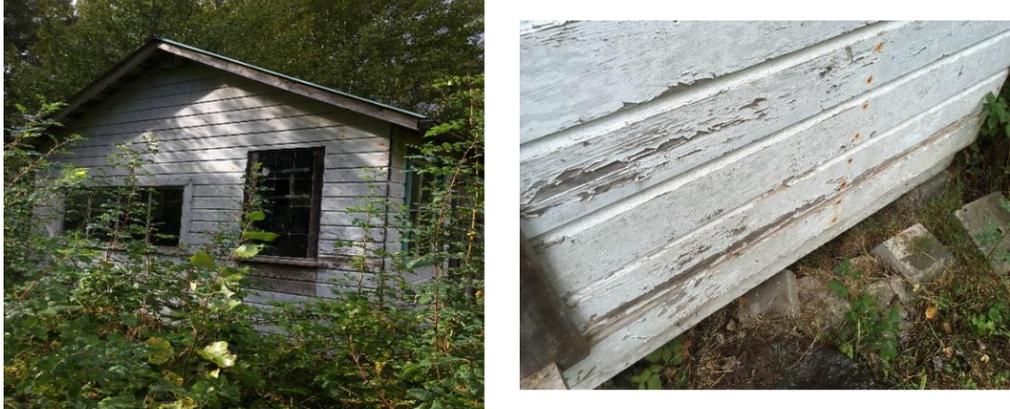
Building	Paint Description/ Condition/Quantity	Paint Lead Concentration (ppm)	Leachable Lead Concentration for Waste (mg/L)	Remedial Action Option Chosen	Scope Details	Photograph
Russel Island Caretaker's Shed	White on wood exterior siding is flaking and peeling over a significant portion of the building—Approximately 20 m ² in poor condition	1,700	<0.40	Comprehensive substrate removal	Remove and dispose of approximately 130 m ² or 1.8 tonnes of wood exterior siding. Replace exterior siding with wood siding and paint white.

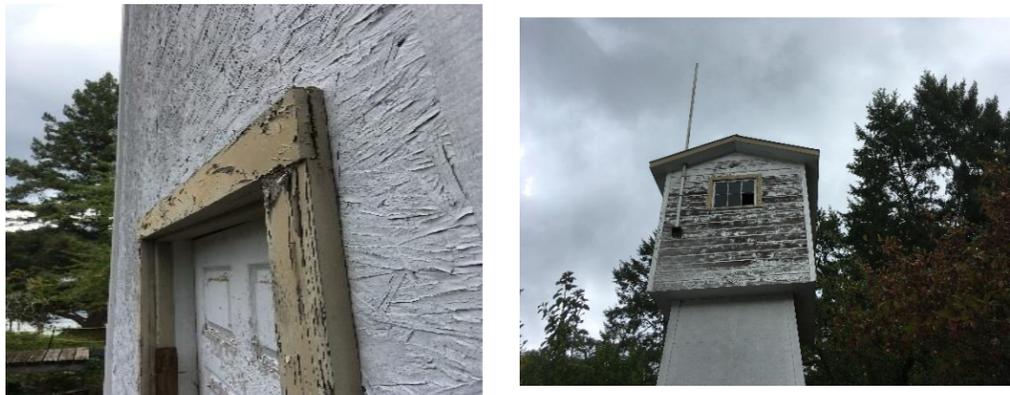
Russel Island Water Tower	Beige on wood exterior trim is flaking and peeling throughout—Approximately 2 m ²	1,800	Assumed <5	Comprehensive substrate removal	Remove and dispose of approximately 3 m ² or 42 Kg of wood exterior trim. Replace exterior trim with like material and repaint same colour.
