# Hazardous Building Materials Assessment

28 Spruce Street,  
Moose Lake, Manitoba

July 27, 2018

Pinchin File: 224301

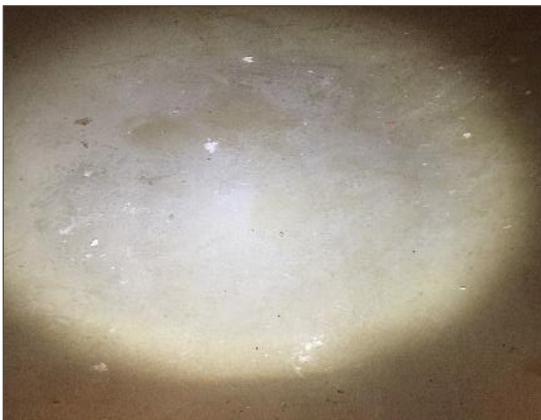
Asbestos-containing vinyl sheet flooring is not present. The vinyl sheet flooring was determined to be non-asbestos by analysis of samples 0003A-C or by the lack of paper backing.

Photo #1 - Non-asbestos vinyl sheet flooring (Samples 0003A-C).

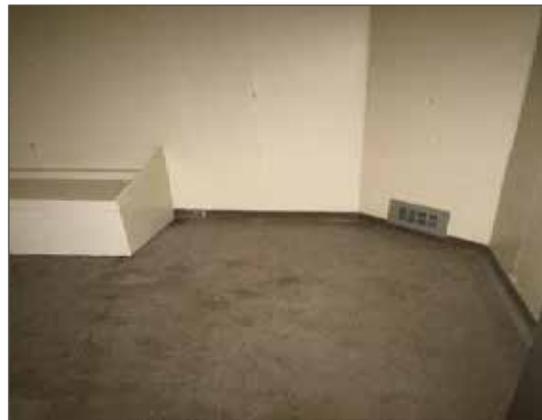
Photo #2 - Non-asbestos poured vinyl flooring with no backing.

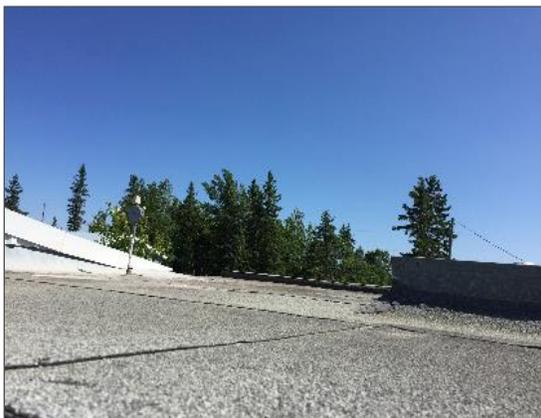
The roof of the building is covered with non-asbestos asphalt shingles (Samples 0005A-C).

Photo #3 - Non-asbestos asphalt shingles.

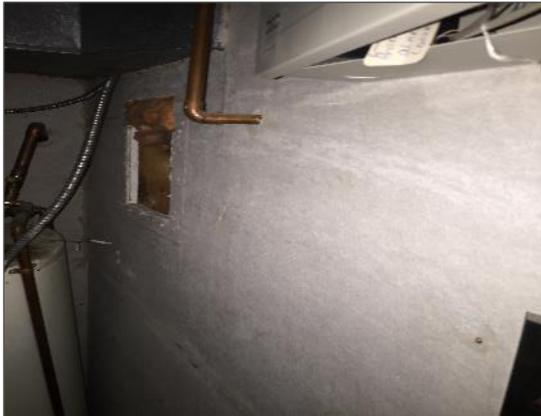
160 SF of cement board containing chrysotile and amosite asbestos is present as wall and ceiling finish within the furnace room (Samples 0002A-C). Cement board is a non-friable material.

Photo #4 – Asbestos-containing cement board within the furnace room.

Remove all asbestos-containing materials (ACM) prior to demolition work.

If the identified ACM will not be removed prior to commencement of the work, disturbance of ACM must follow the appropriate asbestos precautions for the classification of work being performed.

Asbestos-containing materials must be disposed of at a landfill approved to accept asbestos waste.

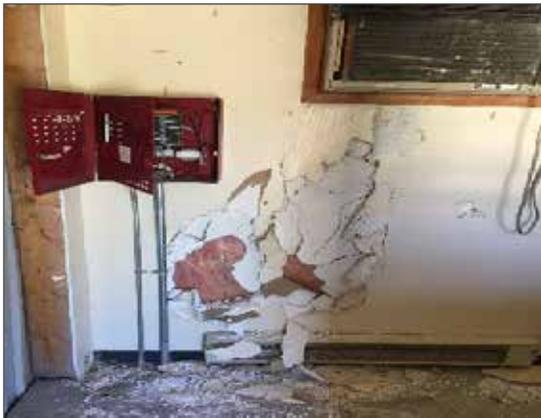
- 20 SF of drywall finish within the entrance; and
- 10 SF of wood ceiling finish within the corridor.

Photo #5 - Mouldy drywall, ceiling tile, and fibreglass batting within the kitchen.

Mould growth was noted in areas affected by the planned work. Use appropriate precautions and protect workers during removal using methods that comply with provincial guidelines.

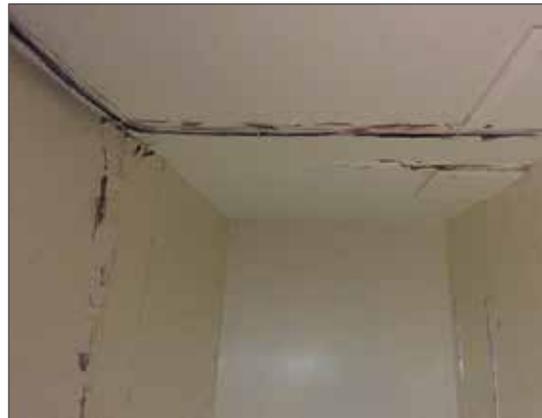
Photo #6 - Mouldy/water stained wood ceiling finish.
