**ESQUIMALT GRAVING DOCK
REPLACE MAIN DISTRIBUTION LINE (RMDL)
BC HYDRO (BCH) POINT OF DELIVERY (POD) SWITCHGEAR
ESQUIMALT, BRITISH COLUMBIA**

**APPENDIX A
PRE-CONSTRUCTION HAZARDOUS BUILDING
MATERIAL AND SURVEY REPORT**

Hazardous Building Material Assessment

Esquimalt Graving Dock – PWGSC Buildings

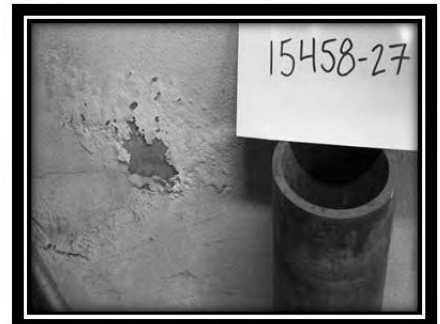
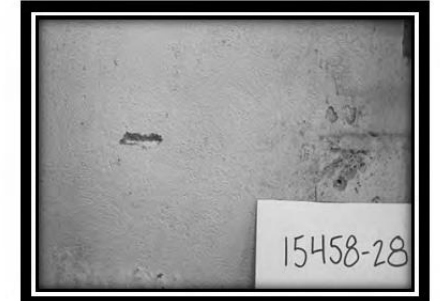
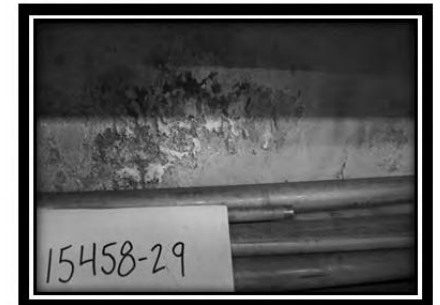
15458-27: Lead Paint 1.9% w.t. – Yellow - South Interior Wall
15458-28: Cementitious Wall Coating (North Interior Wall) - No Asbestos Detected
15458-29: Lead Paint 0.27% w.t. – Lt. Green - South Interior Wall
Exhaust duct with black expansion gasket observed within Welding Shop and suspected of containing asbestos (not sampled).

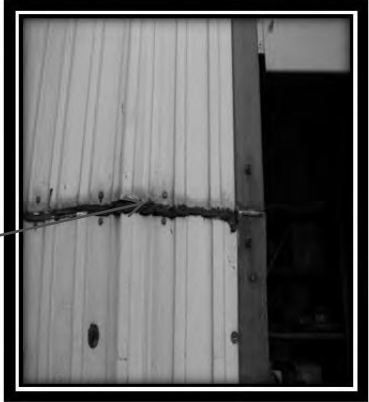
<p>Details:</p> <ul style="list-style-type: none"> • Construction Date Unknown • Ceiling: Metal Sheeting • Walls: Wood Panel/Metal Sheeting • Flooring: Concrete • Roof: Metal Sheeting 	
<p>Hazardous Materials Observed:</p> <ul style="list-style-type: none"> • Lead: [potential] Lead based paint on walls and equipment • Mercury containing equipment: Fluorescent light fixtures present • Ozone depleting substances: None Observed • PCB's: [potential] Fluorescent light ballasts present • Mould: None Observed <p>Samples: 15458-58: Caulking (Exterior) - Chrysotile 7%</p>

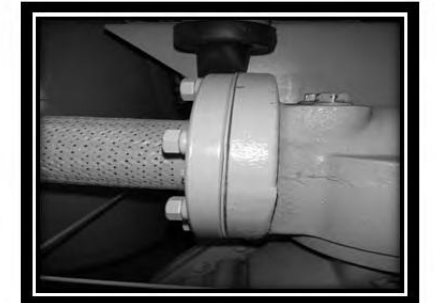
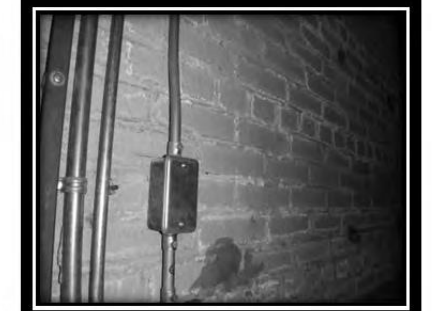
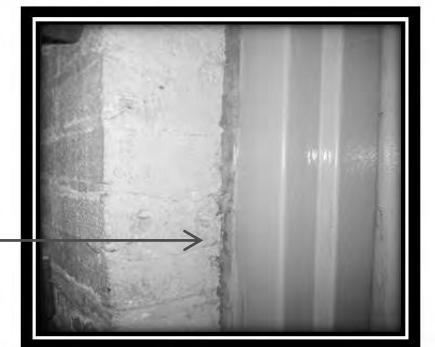
Note: Expansion Gaskets observed in ducting are suspect of asbestos-containing. Not sampled.

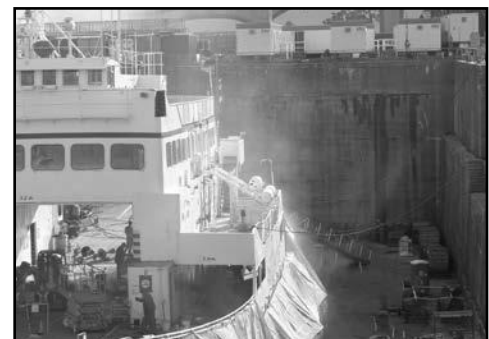
INADEQUATE containment.

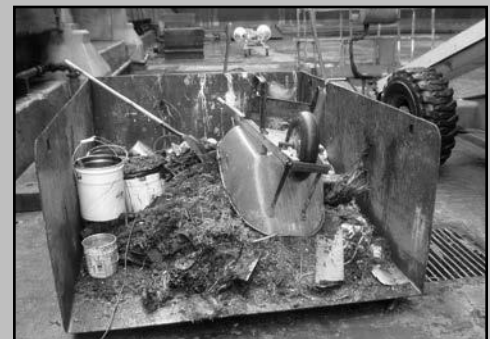
INADEQUATE waste grit storage.

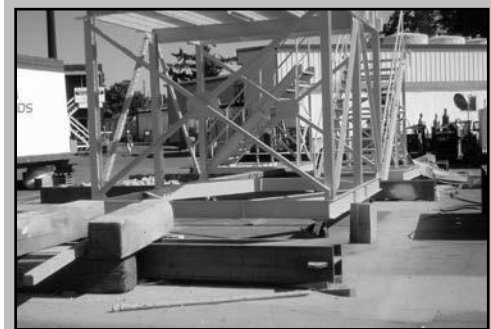
INADEQUATE containment.

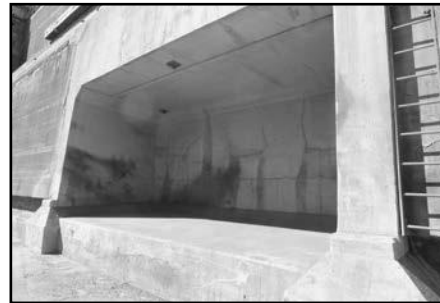
Paint overspray due to INADEQUATE containment stabilizer pocket doors.

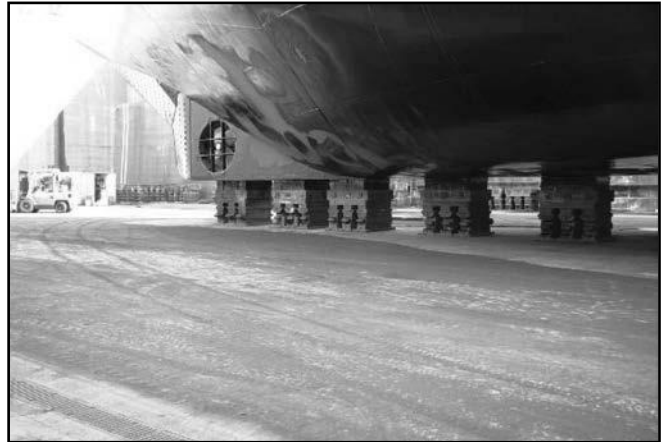
INADEQUATE:
Example of a dock floor that would not pass inspection.

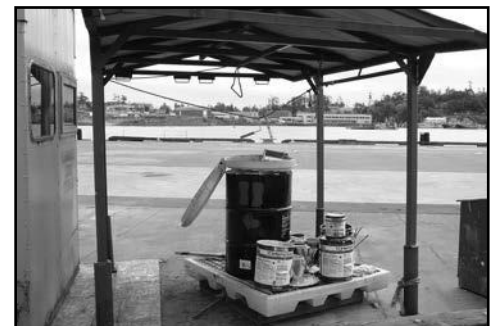
INADEQUATE storage.

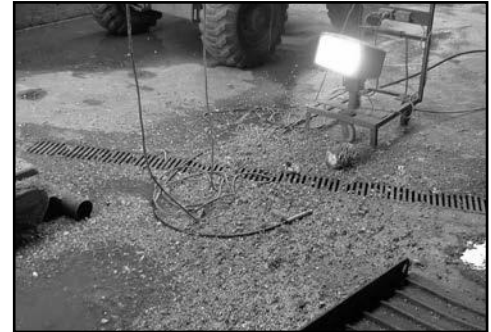
*INADEQUATE containment:
Biological waste on drydock floor near drains.*

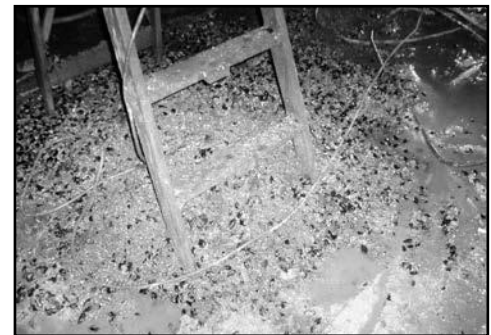
*INADEQUATE containment:
Biological growth mixed with paint waste
on drydock floor.*

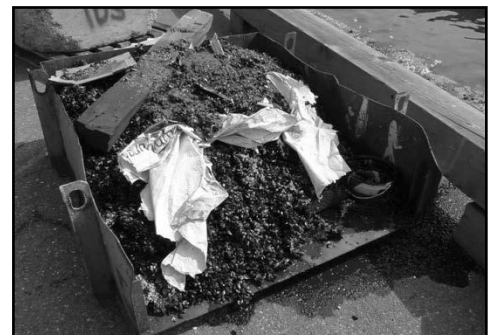
INADEQUATE containment of odorous waste.

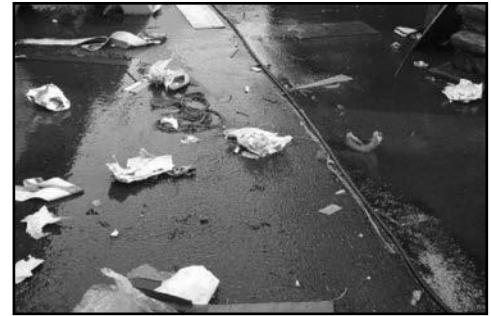
INADEQUATE: Keep work areas neat & orderly.

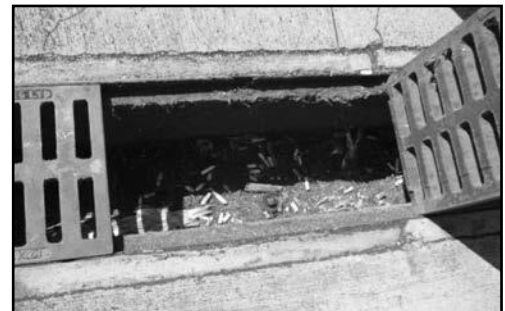
*INADEQUATE:
Keep trench and storm drains free of debris.*

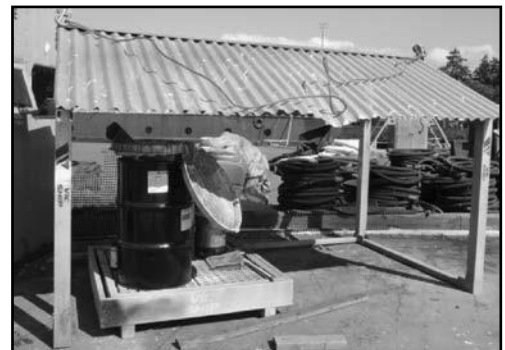
*INADEQUATE:
Ensure storage containers are not left open.*

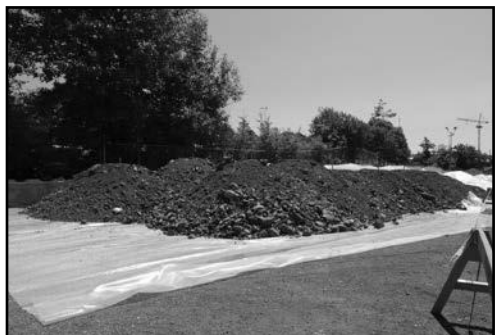
*INADEQUATE stockpile of contaminated soil.
Soil should be covered to prevent exposure to
elements, runoff and people.*
