Metal Based Paint and Supplemental Asbestos Assessment

Parks Canada Buildings and
Structures at Georgina Point
(Active Pass) Lightstation, East
Point (Saturna Island)
Lightstation; Portlock Point
Lightstation and Russell Island

Prepared for:
Parks Canada Agency

January 19, 2018

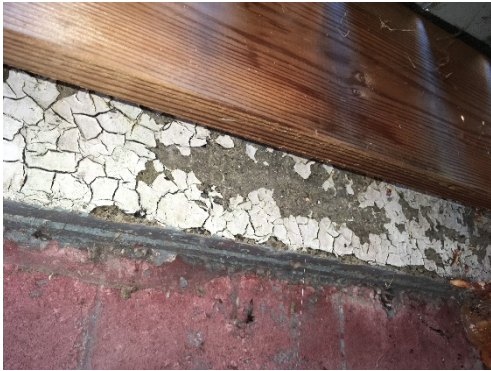
| Additional Identified LCP Description | | Photo |
|---|---|---|
| Site/Structure | Georgina Point Light Keeper's House | |
| Paint colour | White | |
| Substrate | Concrete | |
| Lead content | 37,000 ppm | |
| Condition | Poor | |

| Building | Paint Description/ Condition/Quantity | Paint Lead Concentration (ppm) | Leachate Concentration (mg/L) | Remedial Action Options | Preliminary Cost Estimate | Proceed with RAP |
|---|---|---|---|---|---|---|
| | White on concrete edge of deck under porch is in poor condition, flaking and peeling throughout - Approximately 1 m² | 37,000 | Leachate sampling not practical | Manage in place | | |

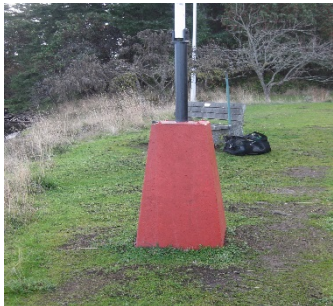
| Additional Identified LCP Description | | Photo |
|---|---|---|
| Site/Structure | Georgina Point Light Keeper's House – detached flagpole | |
| Paint colour | Red | |
| Substrate | Concrete | |
| Lead content | Presumed LCP – see 6.1.2.1 | |
| Condition | Good (reported) | |

Although the flagpole was not listed as a structure to be included in our assessment, it has been reported that the red paint on the base of the flagpole, adjacent to the Georgina Point Light Keeper's House, is suspected to be LCP and is in good condition having been recently repainted. Given that various other visually similar red paints on other structures at the subject site have been tested and confirmed to be lead-containing, the red paint on the concrete base of the flagpole should also be presumed to be lead-containing.

| Building | Paint Description/ Condition/Quantity | Paint Lead Concentration (ppm) | Leachate Concentration (mg/L) | Remedial Action Options | Preliminary Cost Estimate | Proceed with RAP |
|---|---|---|---|---|---|---|
| | Red paint on concrete base of detached flagpole is in poor condition throughout – Approximately 1 m² | Presumed LCP | Leachate sampling not practical | Manage in place | | |

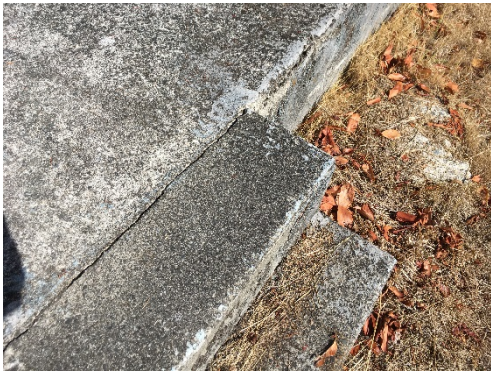
| Additional Identified LCP Description | | Photo |
|---|---|---|
| Site/Structure | Georgina Point Weather Station | |
| Paint colour | Grey | |
| Substrate | Concrete | |
| Condition | Paint worn from surface | |

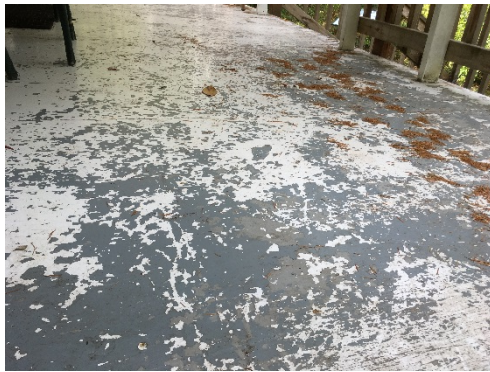
| Additional Identified LCP Description | | Photo |
|---|---|---|
| Site/Structure | Mahoi House | |
| Paint colour | White/grey | |
| Substrate | Plywood | |
| Condition | Poor | |

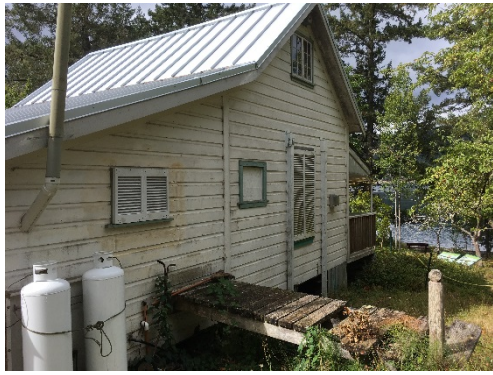
| Identified LCP Description | | Photo |
|---|--|--|
| Site/Structure | Mahoi House | |
| Paint colour | White | |
| Substrate | Wood | |
| Condition | Generally good with localized areas of flaking and peeling | |

With the exception of the above-noted white paint on the wood siding of the Mahoi House, the other LCPs identified through this assessment and the initial assessment would not appear to be posing a significant environmental contamination hazard, in their current condition.

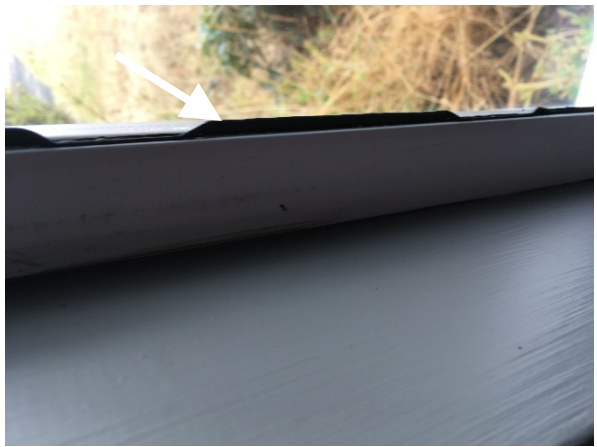
| Identified ACM Description and Condition Information | | Photo |
|---|---|--|
| East Point Garage – Black window pane caulking | | |
| Friability | Non-friable | |
| Condition | Good | |

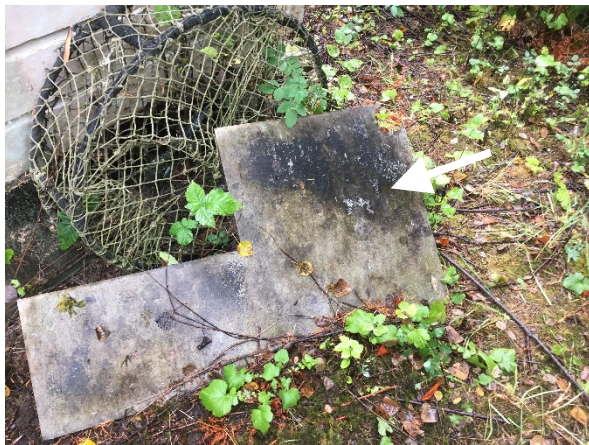
| Identified ACM Description and Condition Information | | Photo |
|---|---|--|
| Russell Island Caretakers Shed – Cement panel stored outside | | |
| Friability | Non-friable | |
| Condition | Good | |
