**Cape Breton Development Corporation
Victoria Junction Tailings Basin
Review of Dam Safety Findings**

ADI Limited
Report: L1573-048.1
Date: January 2010

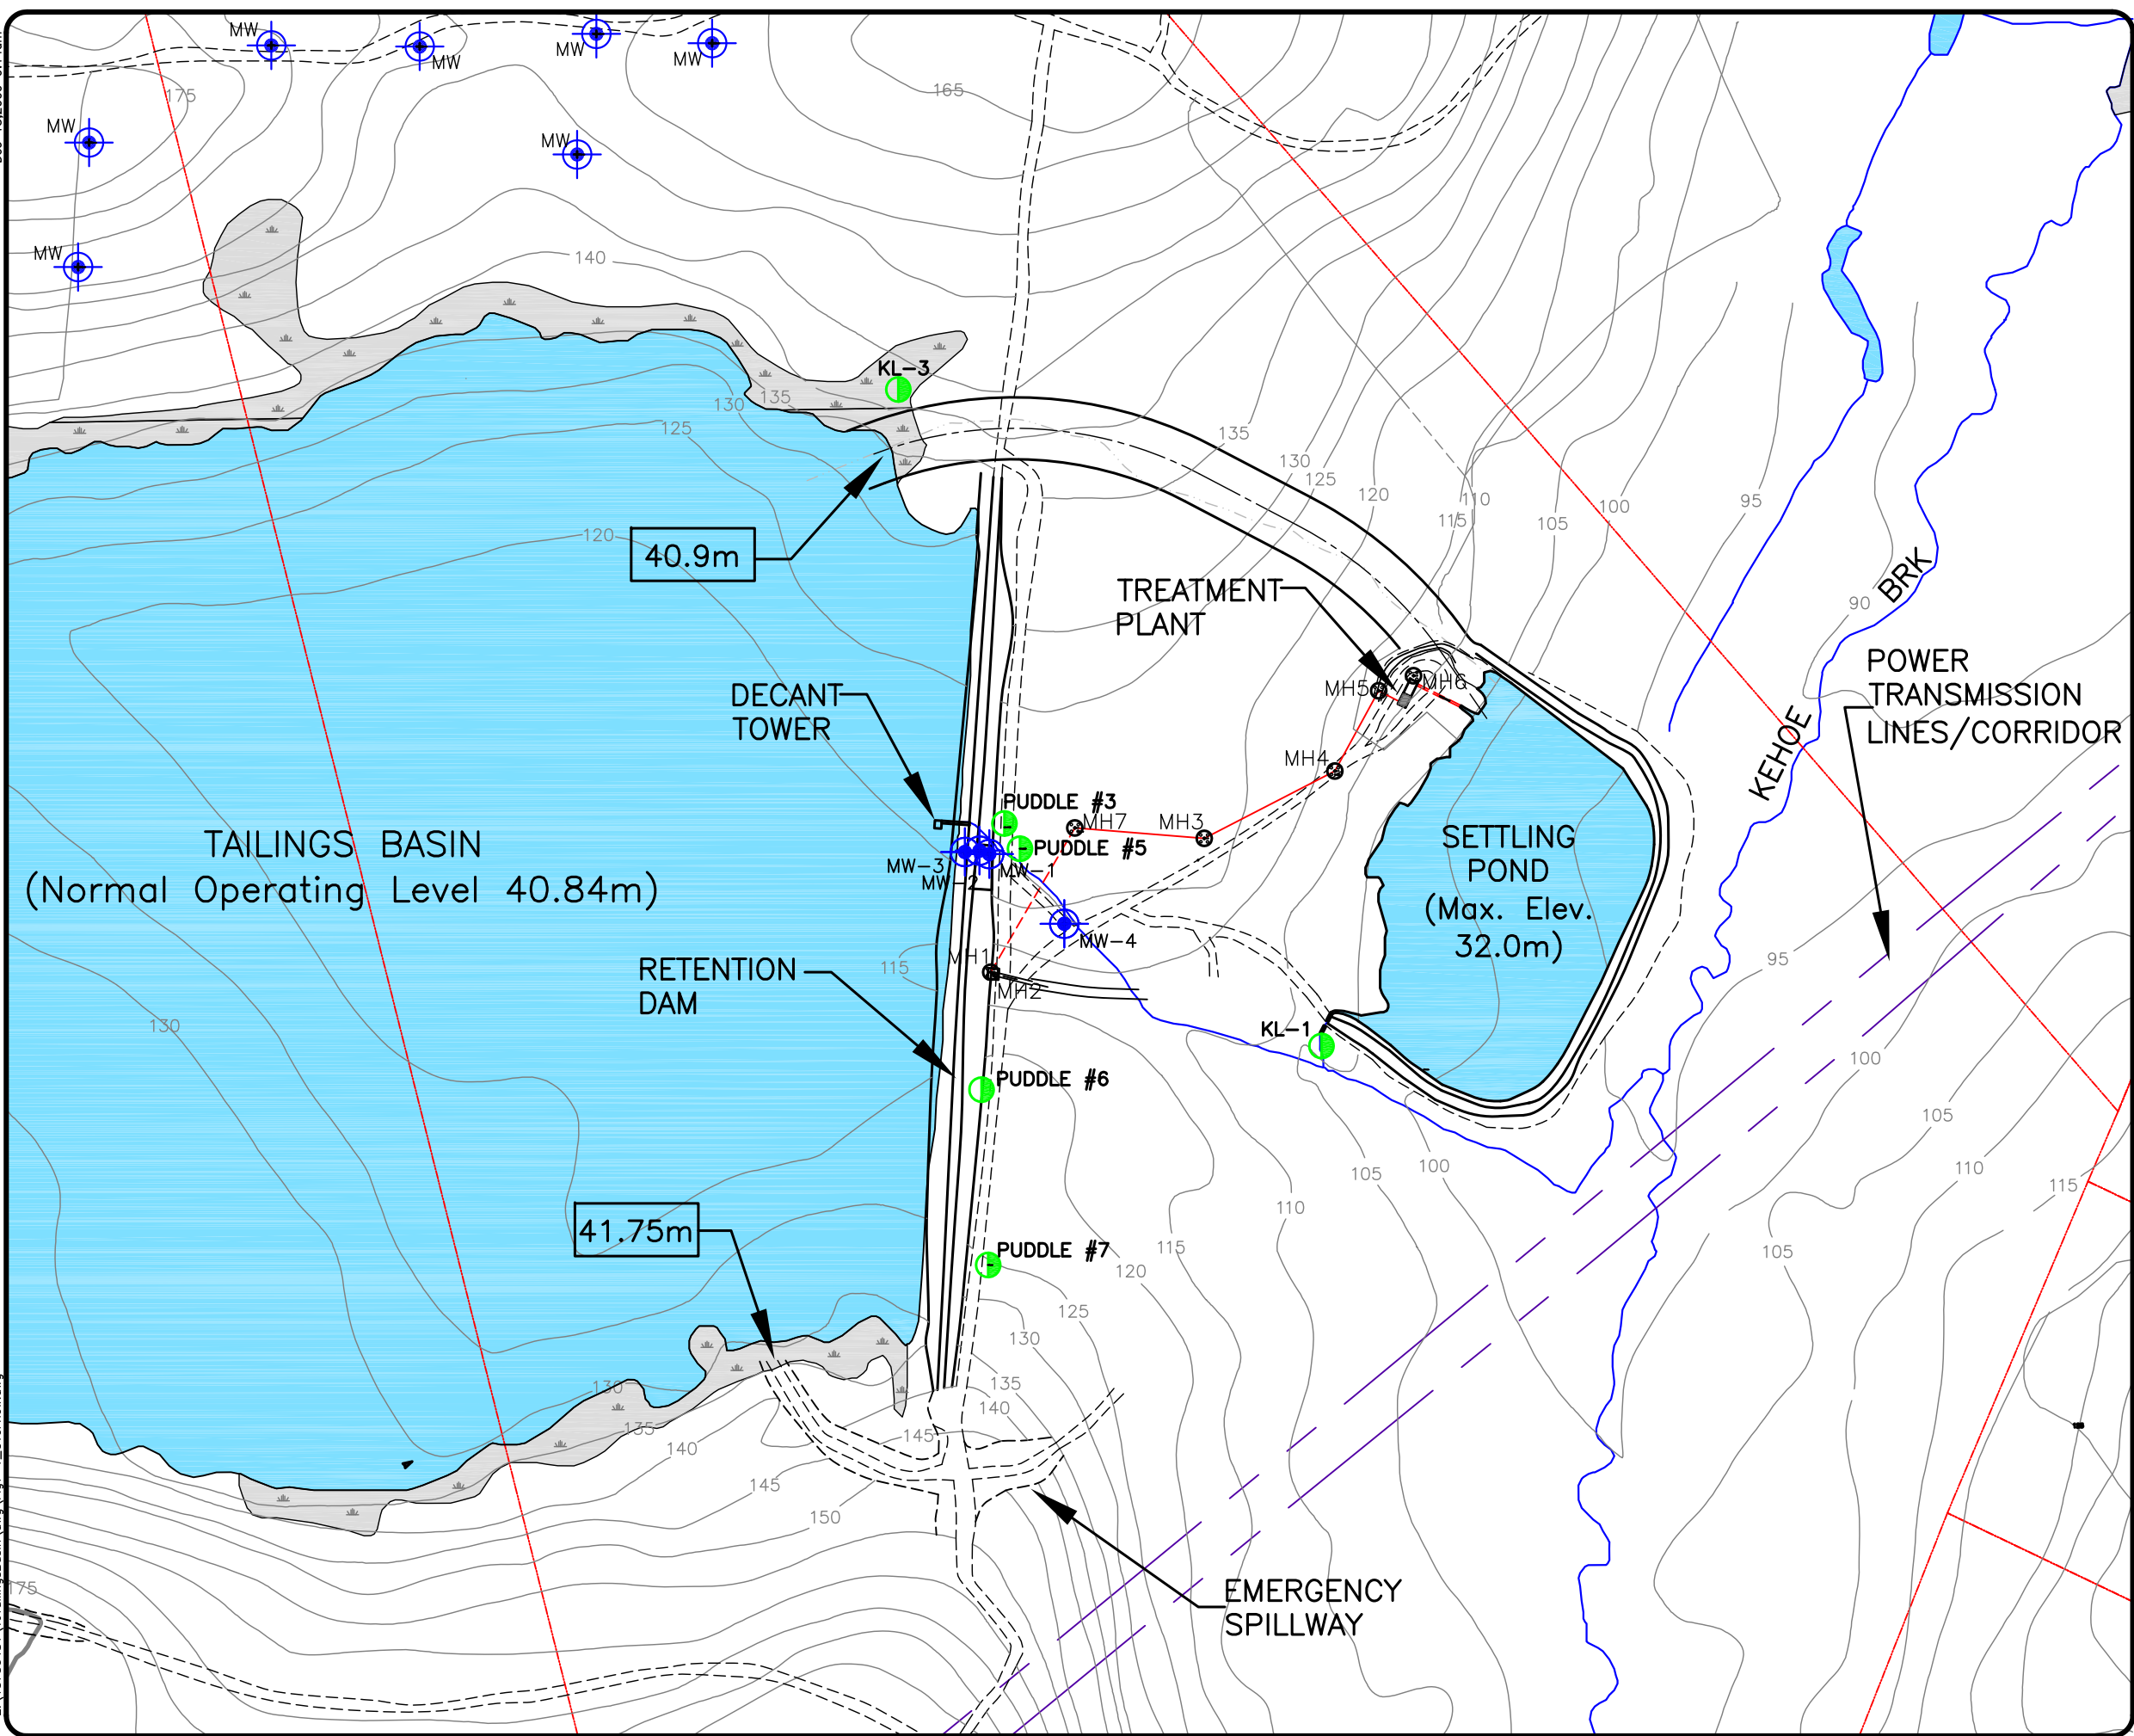
Three monitoring wells were installed in 2004 to allow monitoring of the groundwater level measurements to be taken, as recommended by ADI (1998) and JWA (2003). Two of these monitoring wells contain screened sections extending beyond the contact between the glacial till and bedrock, the third monitoring well extends into the glacial till layer. The 2008 AMEC Dam Safety Review reports high water levels in the monitoring wells, approximately 0.4 metres to 1.2 metres above the contact between the native till and the embankment fill. The locations of the monitoring wells (MW1, MW2 and MW3) are shown on Figure T-1 (Inset).
