Waterton RCMP Detachment

Asbestos Abatement Project Close-Out Report

November 29th, 2017

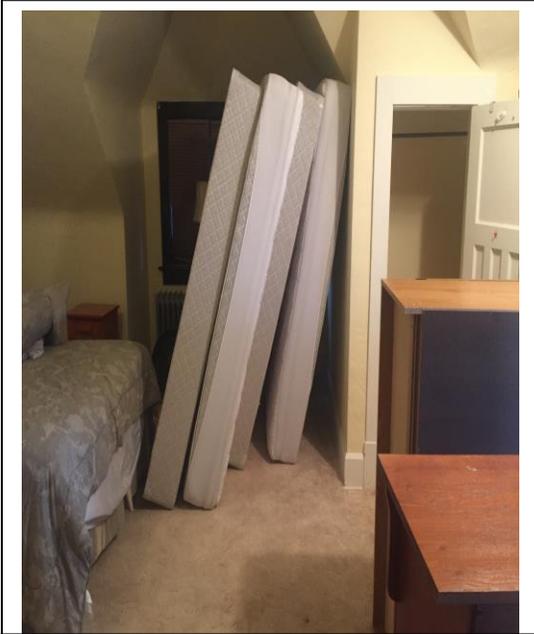
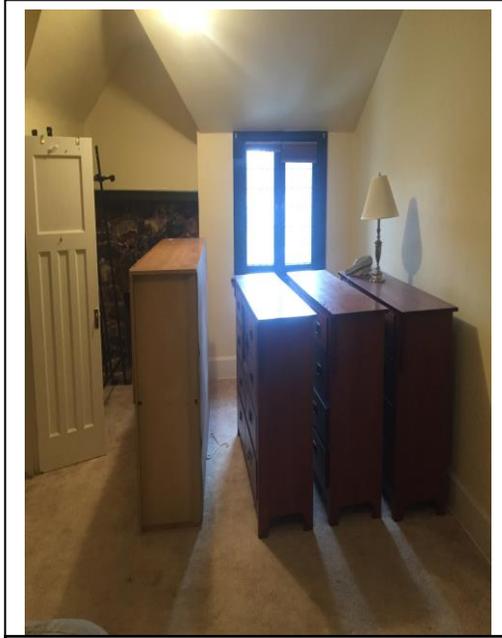
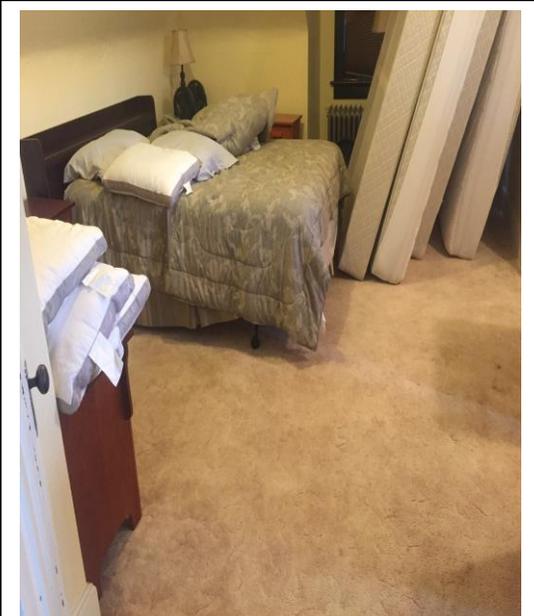
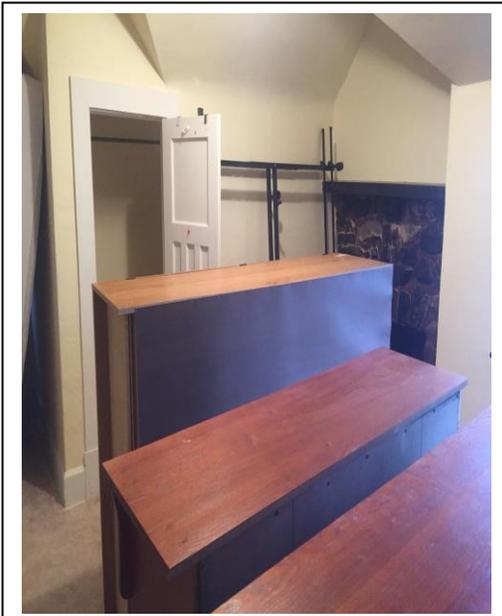
- a) During our initial site tour, it was discovered that the recreation room still contained house furnishings (beds, mattresses, dressers, etc.). These items were wiped with a damp rag and/or HEPA-vacuumed prior to being relocated to the main floor. (see Figure 1-4)

Figure 1: Recreation Room Furnishing

Figure 2: Recreation Room Furnishing

Figure 3: Recreation Room Furnishing

Figure 4: Recreation Room Furnishing

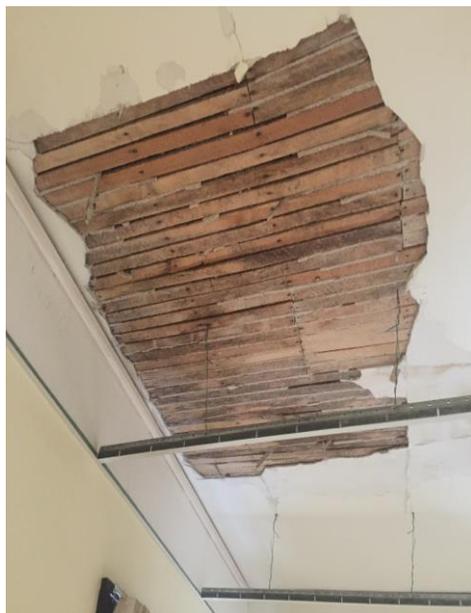
- b) The floor covering of the office area attached to the kitchen had been previously been abated by others. In the same office area, there was an area of the lath and plaster ceiling that had also been previously demolished by others.

Figure 5: Mess Hall Ceiling

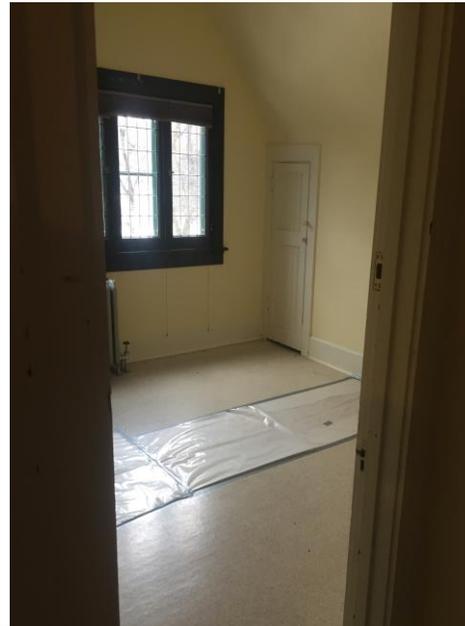
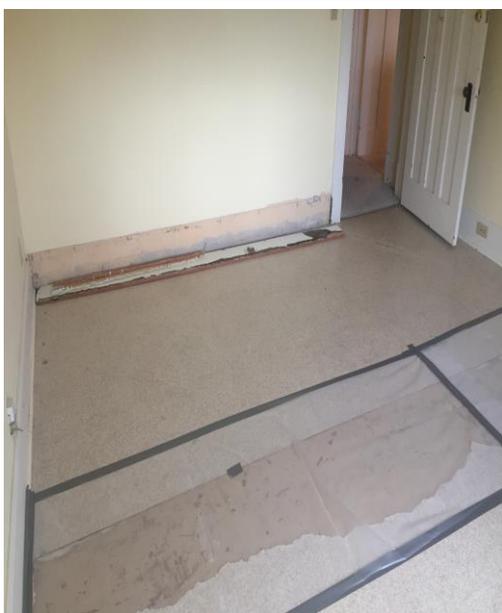
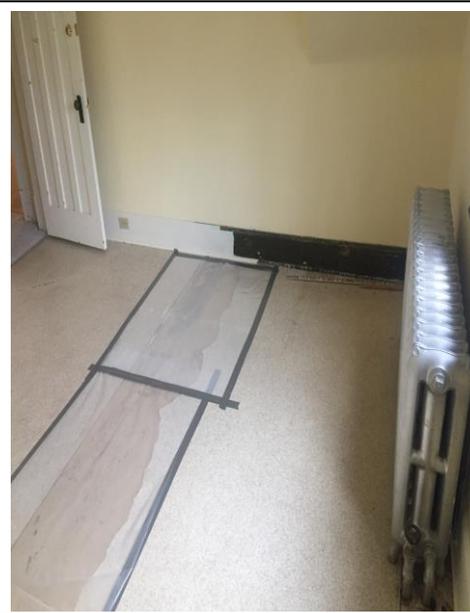
- c) In the bedroom located directly across from the second-floor level washroom, there was an area of the linoleum sheet flooring had been previously removed. (see Figure 6-8) The exposed asbestos-containing paper backing had been covered with clear polyethylene sheeting with all seams and edges sealed with duct tape.

Figure 6: Bedroom 1 – Removed Linoleum

Figure 7: Bedroom 1 – Removed Linoleum

Figure 8: Bedroom 1 – Removed Linoleum

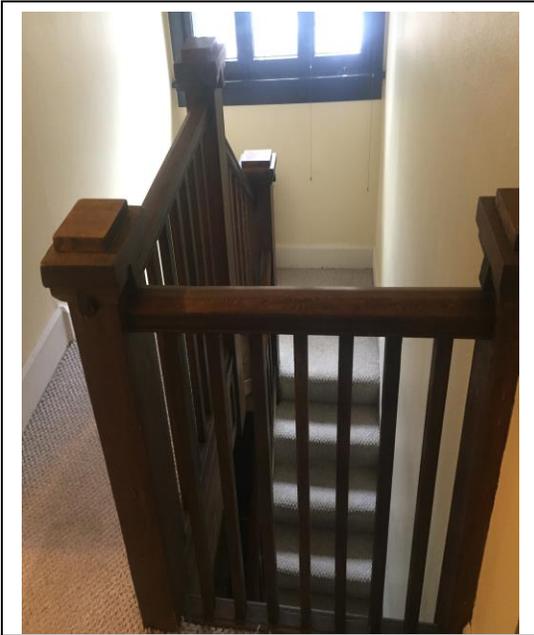
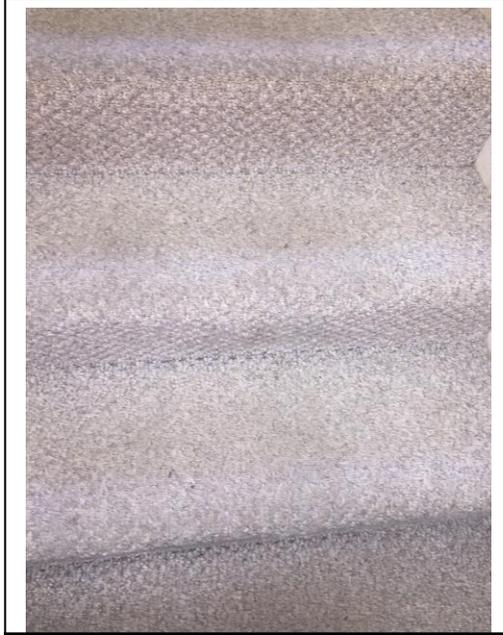
- d) The carpeting on the stairs leading to the second-floor level was suspected of possible past cross-contamination. (see Figure 9-10) The carpeting on the stairs was HEPA-vacuumed, removed and disposed of as non-contaminated waste by Renegade

Figure 9: Stairway – Carpet

Figure 10: Stairway – Carpet

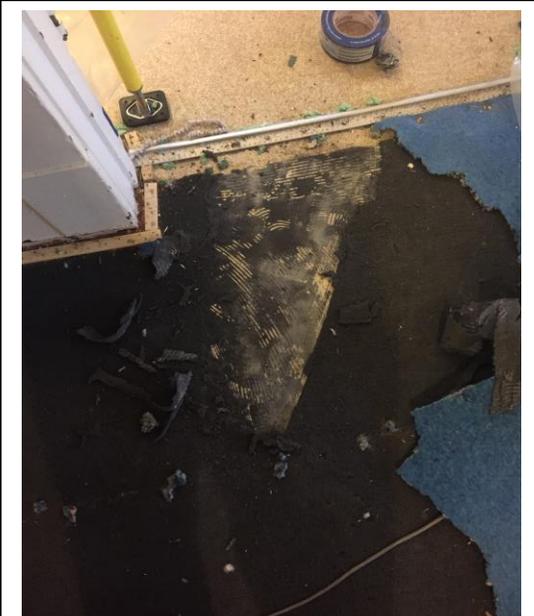
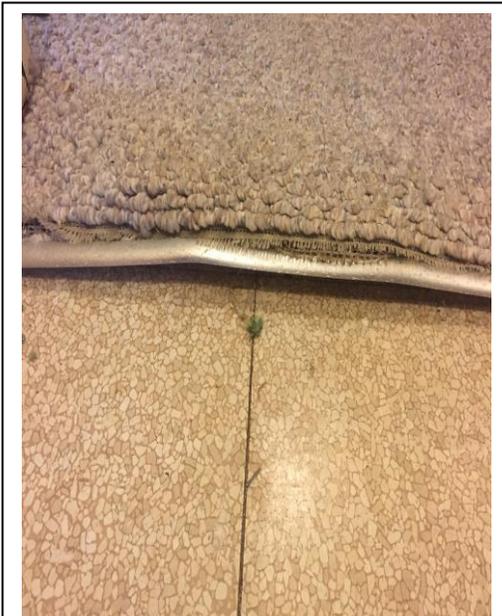
- e) The linoleum sheet flooring from all second-floor rooms continued out into the connecting hallway. Upon RCMP approval, the linoleum sheeting was removed by Renegade as an extra to the contract. (see Figure 15-16)

Figure 15: Hallway Linoleum

Figure 16: Hallway Linoleum

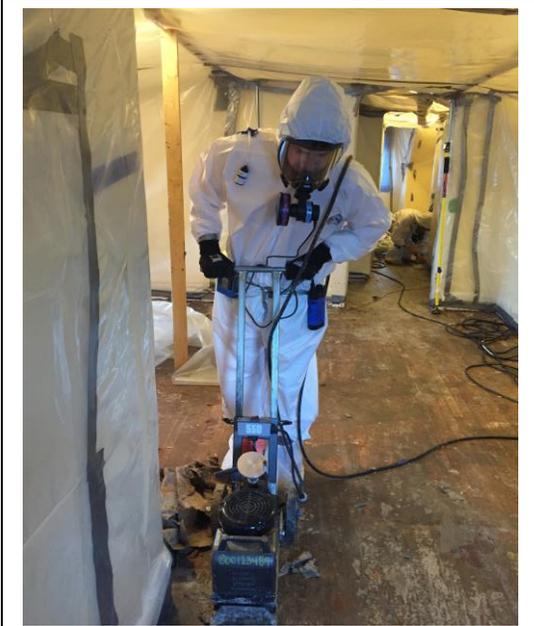
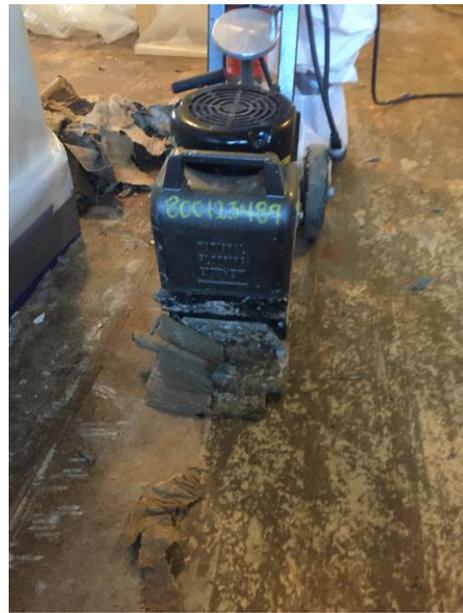
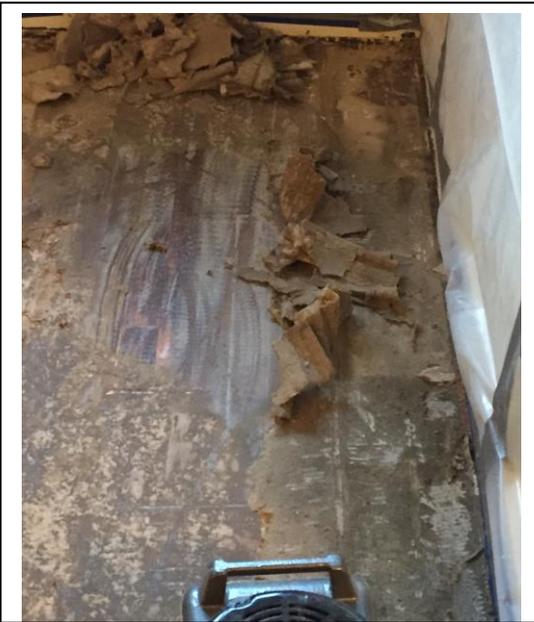
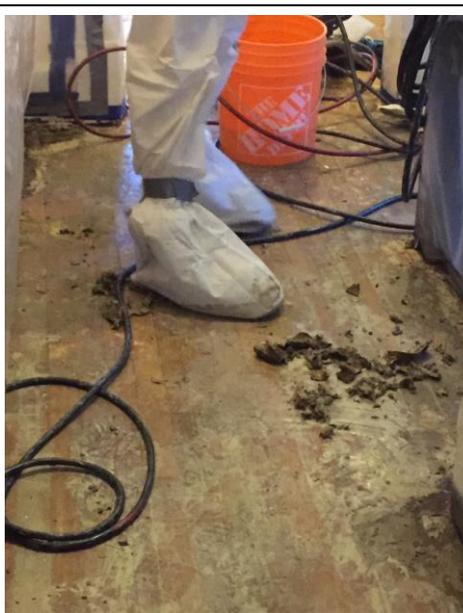
- l) The bulk removal of the rubber top coat of the linoleum sheeting was performed using a 120-lb electric floor scrapper. The blade of the scrapper was set at the proper depth to removal the top rubber coat and leave behind the asbestos-containing paper backing in place. (see Figure 25-28)

Figure 25: Floor Scraper

Figure 26: Removal of Paper Backing

Figure 27: Removal of Paper Backing

Figure 28: Mastic Remaining

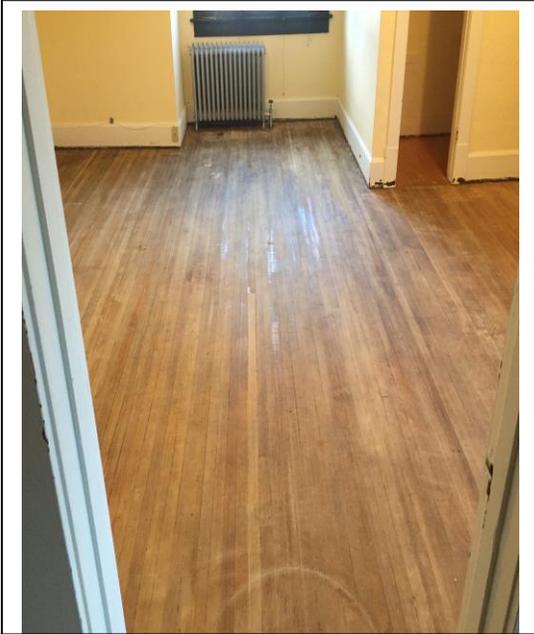
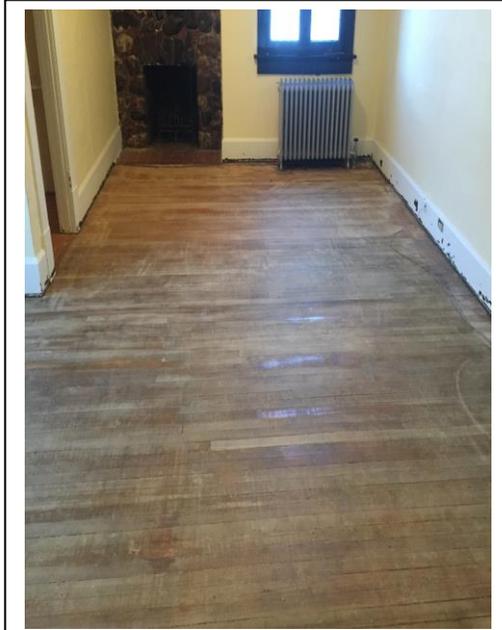
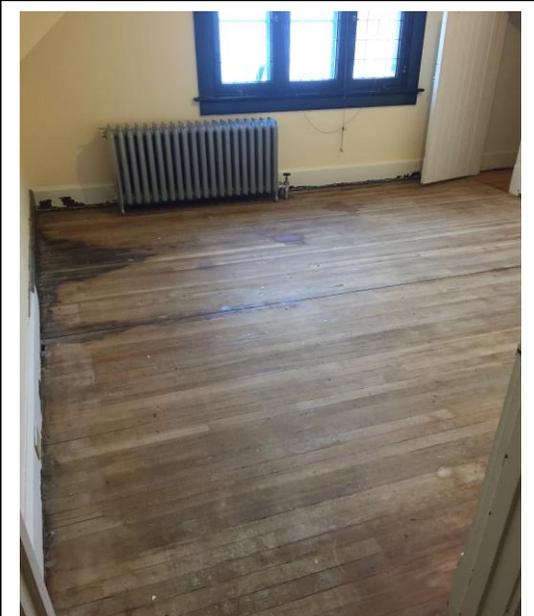
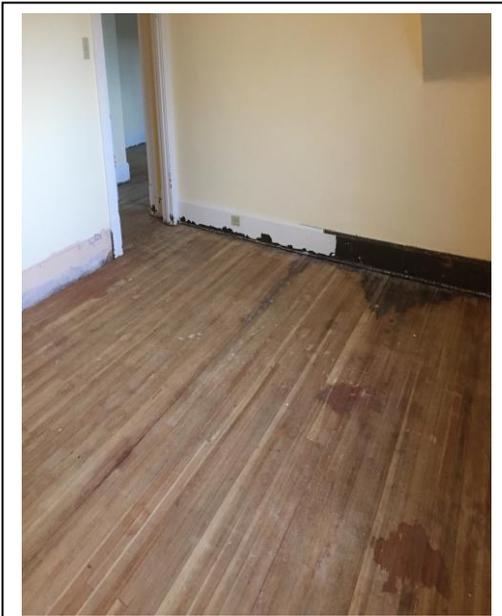
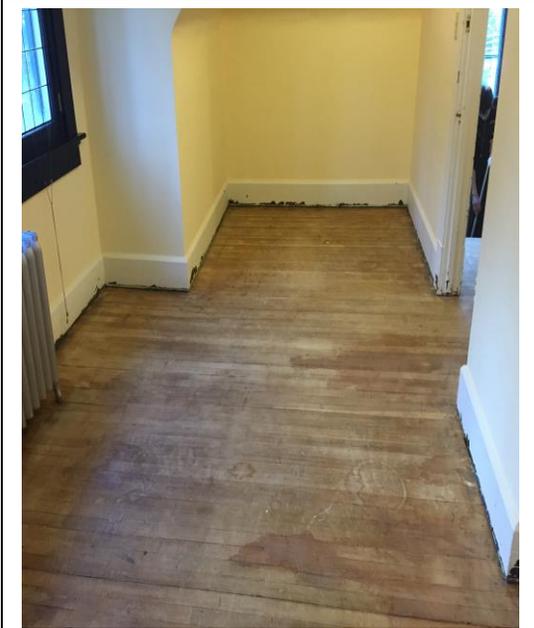
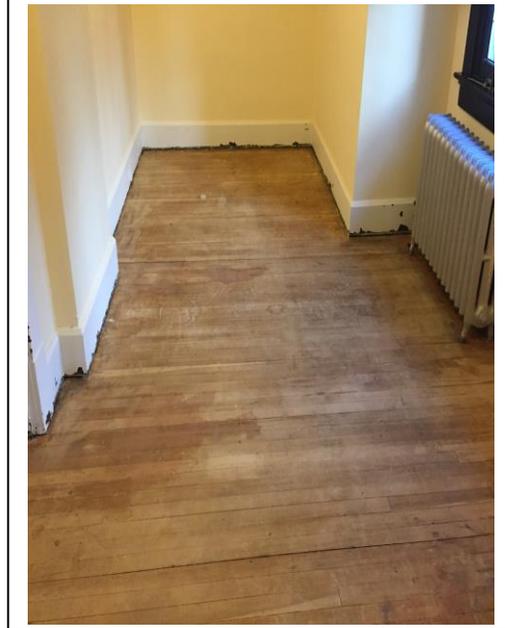
- n) Final cleaning of the work area involved wet wiping and HEPA-vacuuuming techniques. The wood floor surfaces were cleaned with amended water (a mild chemical floor cleaner and water solution) to remove the residual mastic adhesive. The polyethylene sheeting of the work area containment system was wet wiped. The plastic sheeting covering the heaters in each room was removed and all surfaces of the heaters were vacuumed and wet-wiped. (see Figure 29-40)

Figure 29: Completed Rec Room

Figure 30: Completed Rec Room

Figure 31: Completed Bedroom #1

Figure 32: Completed Bedroom #1

Figure 33: Completed Bedroom #2

Figure 34: Completed Bedroom #2

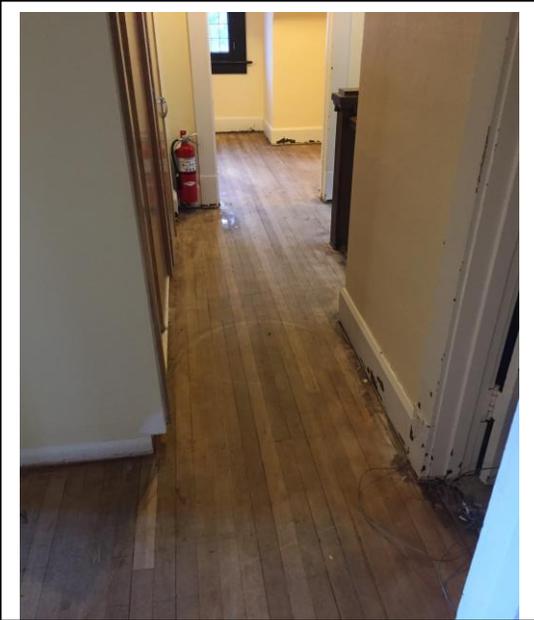
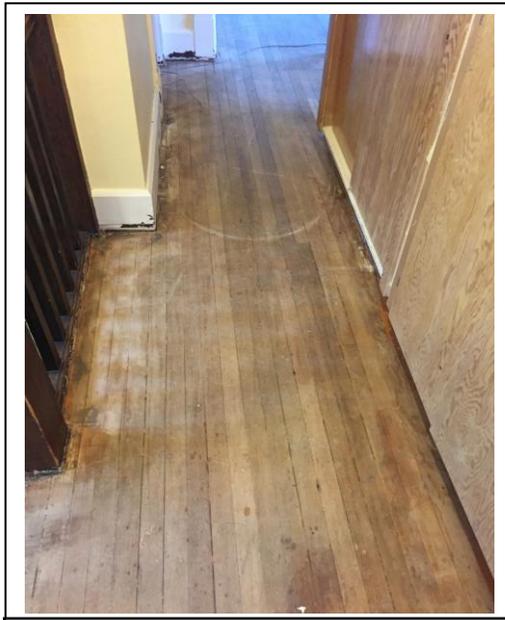
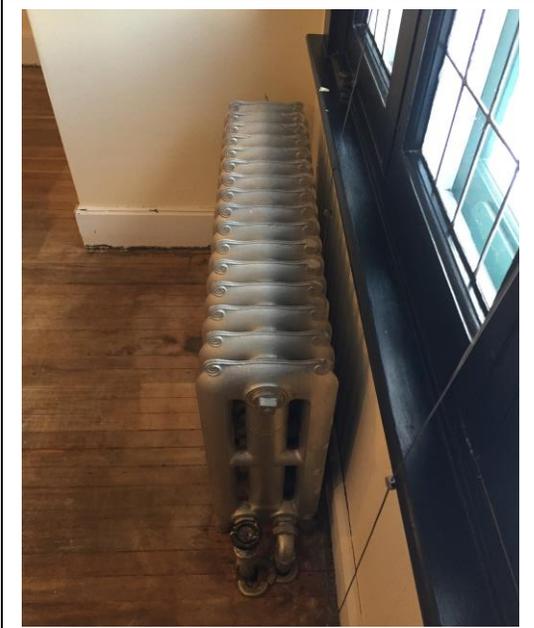
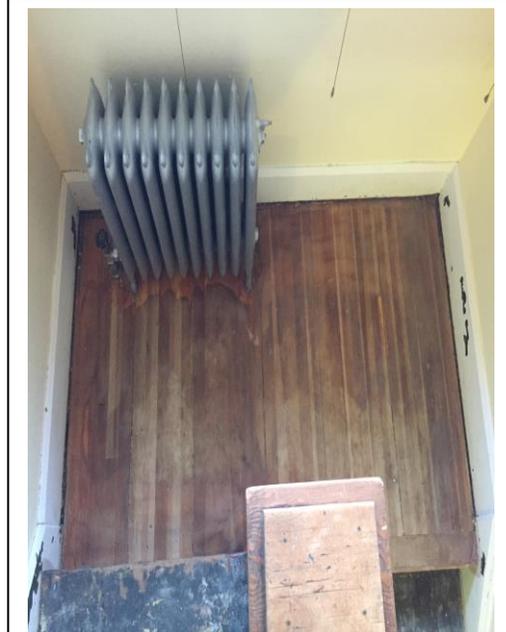
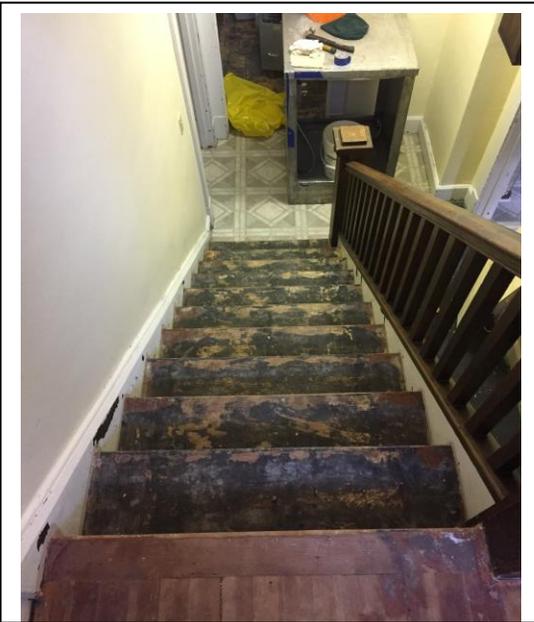
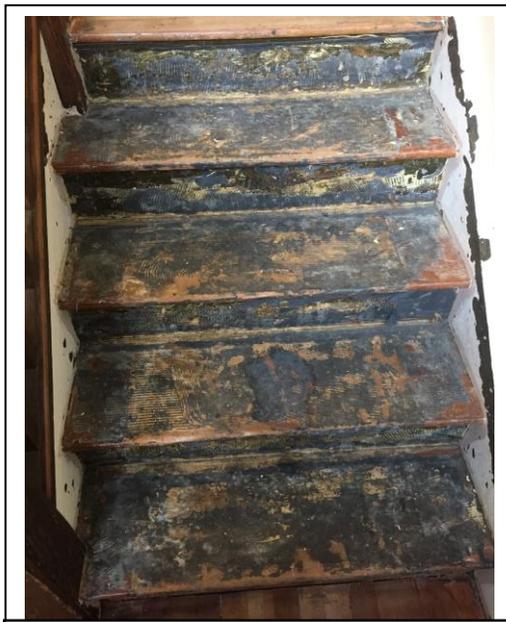
Figure 35: Completed Hallway

Figure 36: Completed Hallway

Figure 37: Final Cleaned Heater /Window Sill

Figure 38: Completed Landing

Figure 39: Completed Stairs

Figure 40: Completed Stairs
