Prepared for:
Canadian Coast Guard

CCGS SIR WILFRID LAURIER Asbestos Condition Report

**North West
Environmental Group Ltd.**

NWest Project No. 31632
Date Issued: March 31st, 2017

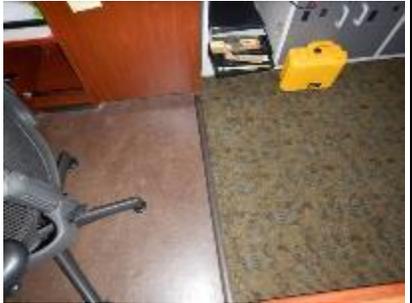
Officer's Deck							Chief Officer Office (304)
Inspection Zone	Material	Hazardous Content	Condition	Friability	Accessibility	Recommended Action	Picture
Deck	Carpet and resilient sheet flooring over deck screed.	No asbestos suspected in carpet, adhesives, or sheet flooring.	N/A	N/A	N/A	N/A

Deck screed may contain asbestos.	Exposed – good condition Concealed – unknown condition	Non-friable	C	7, or additional samples to rule out presence of asbestos.	
Other	None observed.						
Comments	N/A

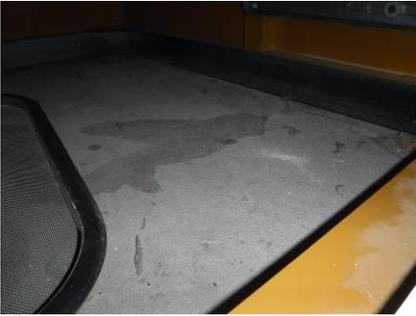
<ul style="list-style-type: none"> 31632-9 Deck screed (no asbestos detected). 	Exposed – good condition Concealed – unknown condition	Non-friable	C	7, or additional samples to rule out presence of asbestos.	
Other	Penetration caulking – Red	No asbestos suspected (3 out of 3 samples negative for asbestos).	N/A	N/A	N/A	N/A	No photograph available
	Penetration caulking – Yellow	No asbestos suspected (3 out of 3 samples negative for asbestos). 31632-8 Third Officer's Cabin – Penetration Caulking (yellow; No asbestos detected)	N/A	N/A	N/A	N/A	
Comments	N/A

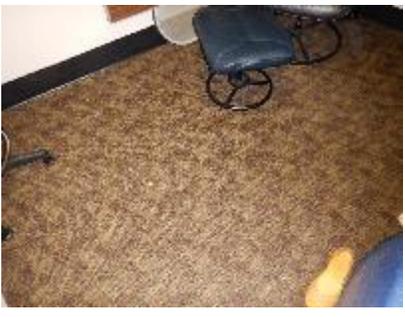
Deck screed may contain asbestos.	Exposed – good condition Concealed – unknown condition	Non-friable	C	7, or additional samples to rule out presence of asbestos.	
Other	None observed.	N/A	N/A	N/A	N/A	N/A	
Comments	N/A
