Geotechnical Investigation

Proposed Bennett Lake Dam Replacement Fundy National Park, Alma, NB

**GEMTEC** Limited

FILE: 6032.01-R01 October 2008

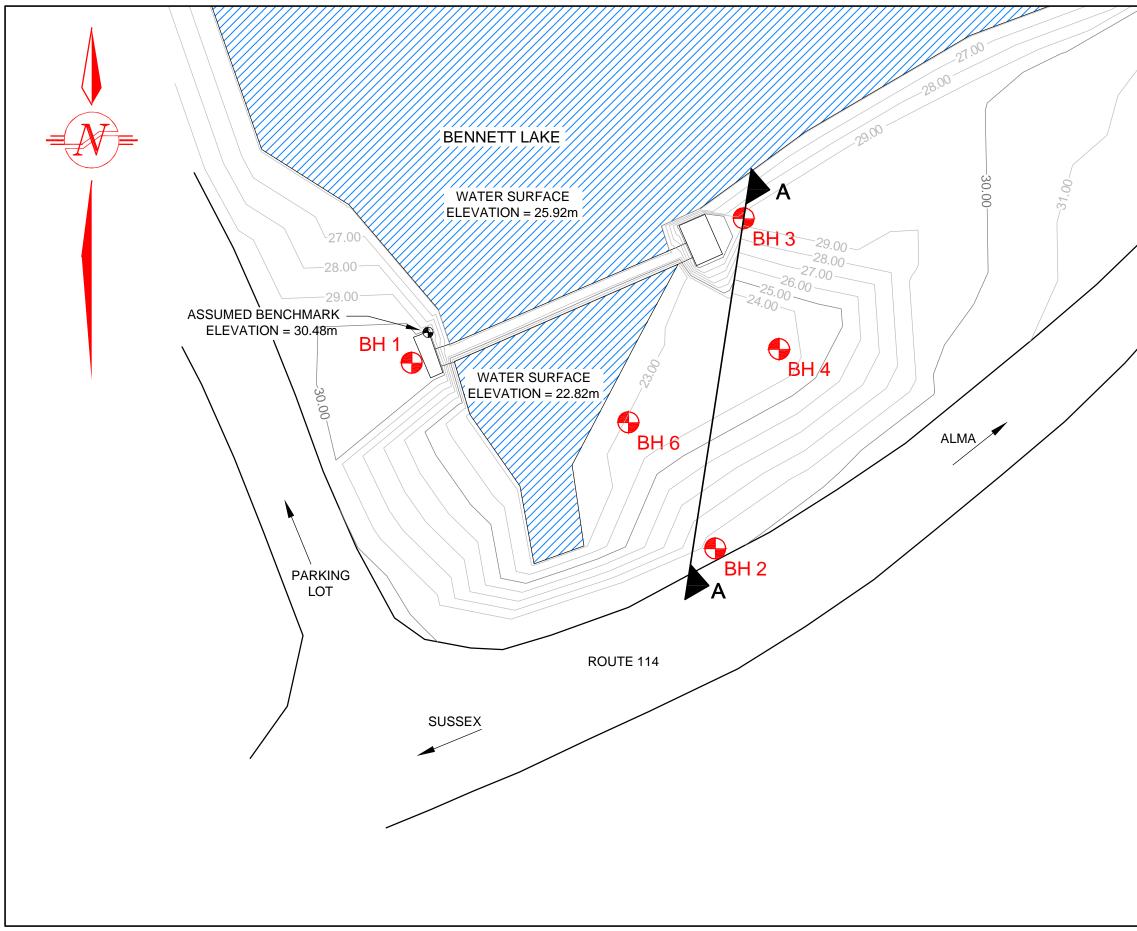
Refer to Figure 1 for approximate borehole locations. An interpretive cross section of site is shown in Figure 2. Detailed borehole logs are appended (Appendix A).

The existing dam is constructed between two former bridge abutments. BH 1 and 3 were put down within the west and east abutments, respectively.

Water seepage was observed near the toe of the east embankment, and also from the springs at the ground surface. Streams generating from springs were observed within the area between the existing dam and roadway embankments, likely due to seepage from the existing dam.
