NRC HERZBERG ASTRONOMY & ASTROPHYSICS

ATP INTEGRATION FACILITY

Hazardous Materials Survey

Site Services Building

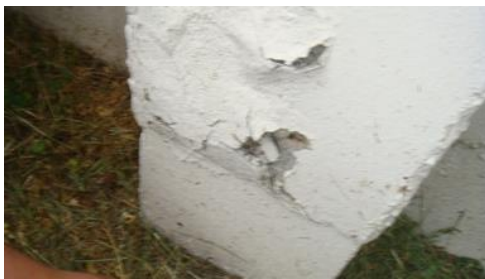
20127-12 Paint Chips - White (lead content: 9.3 mg/kg)

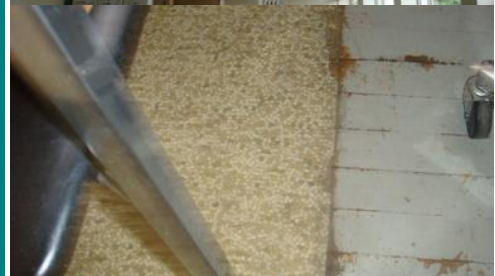
Asbestos containing materials were identified to be in the following materials/locations:			
Sample ID	Building	Material	Recommendation
20127-02	Site Services – Room 013	Sheet Flooring – Green Stone Mosaic	Action 5/6

- 20127-02** Sheet Flooring 2 – Green Stone Mosaic (Chrysotile 15%)
- 20127-06** Drywall Joint Compound (No asbestos detected)
- 20127-08** Pipe Wrap Textile (No asbestos detected)
- 20127-09** Parging on Concrete (No asbestos detected)

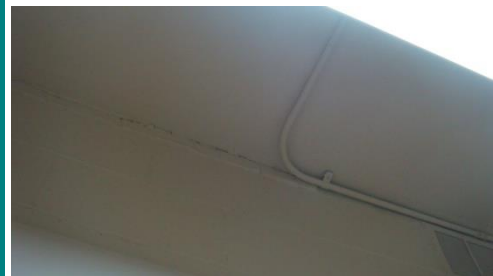
20127-03 Drywall Joint Compound (no asbestos detected)

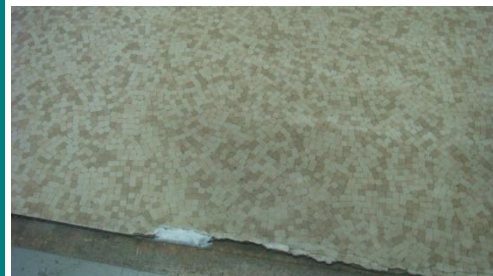
20127-01 Sheet Flooring 1 – Brown Stone Mosaic
(no asbestos detected)

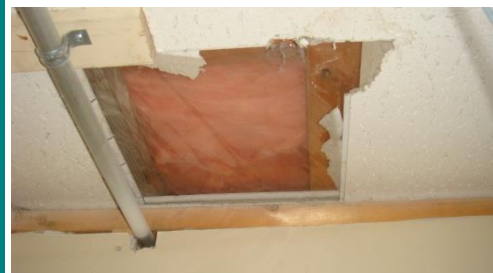
20127-10 Ceiling Tile 3 (no asbestos detected)

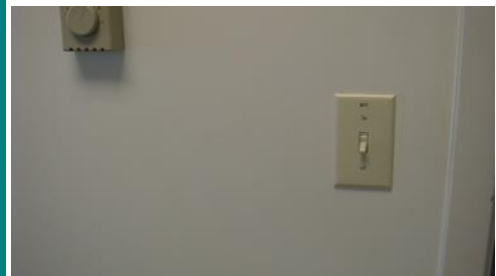
20127-04 Drywall Joint Compound (no asbestos detected)
