BID DOCUMENTS AND SPECIFICATIONS

CCIW - 867 LAKESHORE ROAD, BURLINGTON
WTC ROOF REPLACEMENT

JUNE 15, 2018

ROOF CONDITION ASSESSMENT REPORT

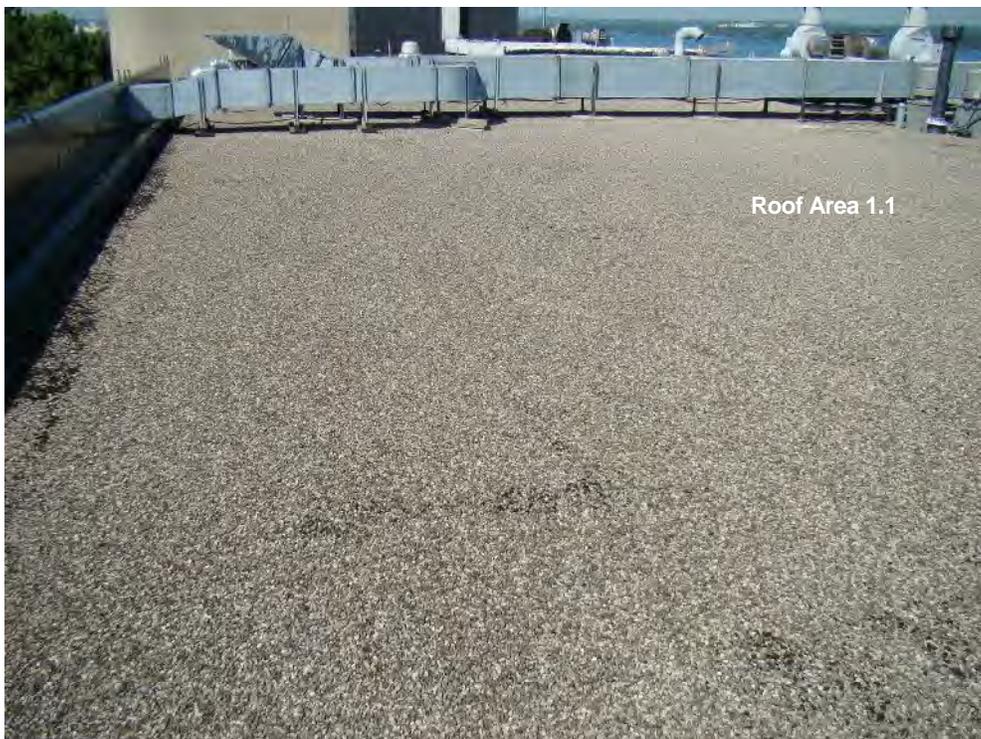
Photograph 3: Roof Area 1.1 – Overall view looking south. This roof area is situated over the east addition to the building and consists of a conventional 4 ply built up bituminous membrane system installed in 1996.

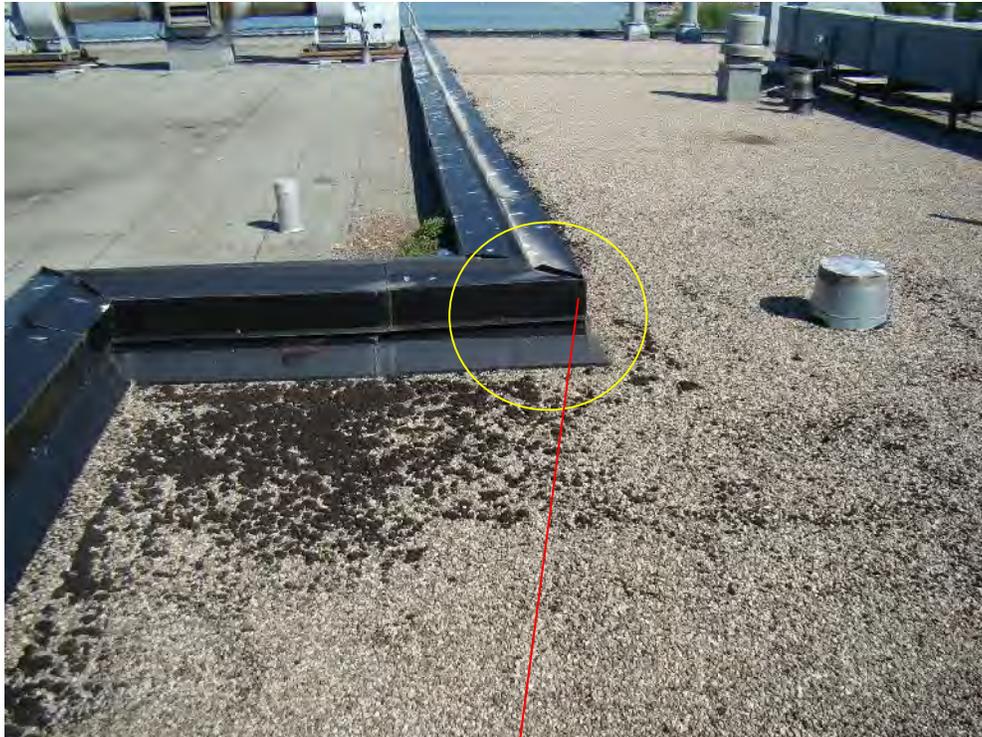
Photograph 6: Roof Area 1.1 – Membrane flashings where exposed for review appeared in serviceable condition with the asphalt glaze coating still in tact.

4. Membrane flashings where exposed for review appeared in serviceable condition with the asphalt glaze coating still in tact (photograph 6). Localized membrane flashing cracking was found at the south end of the west expansion joint (photographs 7 and 8).

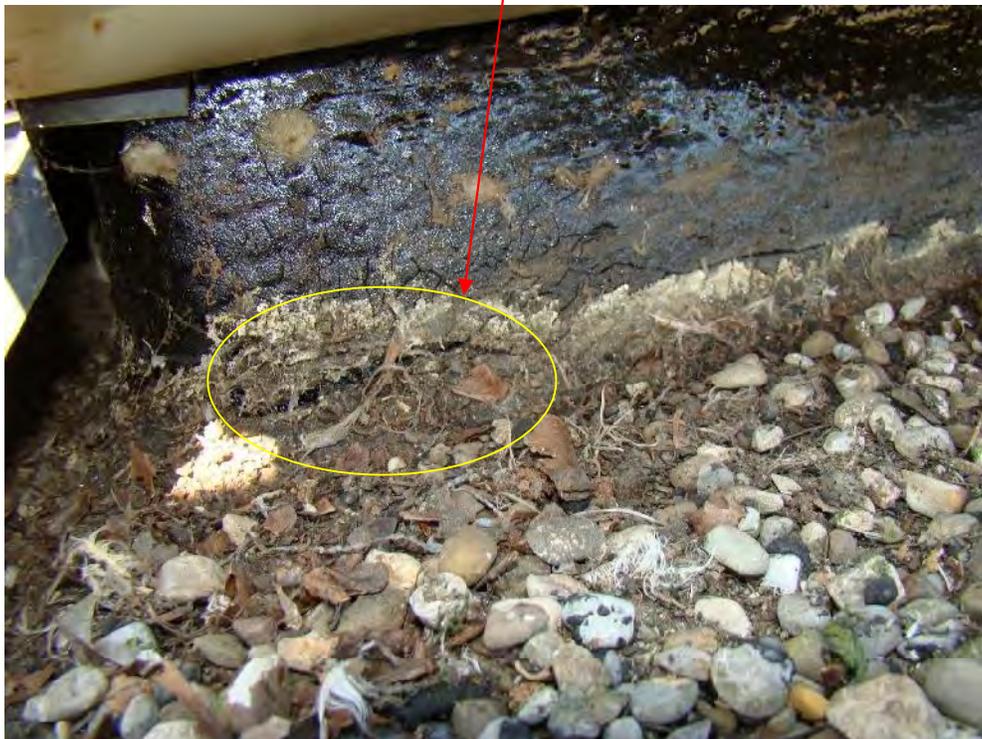
Photograph 7: Roof Area 1.1 – View of expansion joint between original building and east addition. Yellow circle indicates location where deteriorating flashings were found. See next photo.

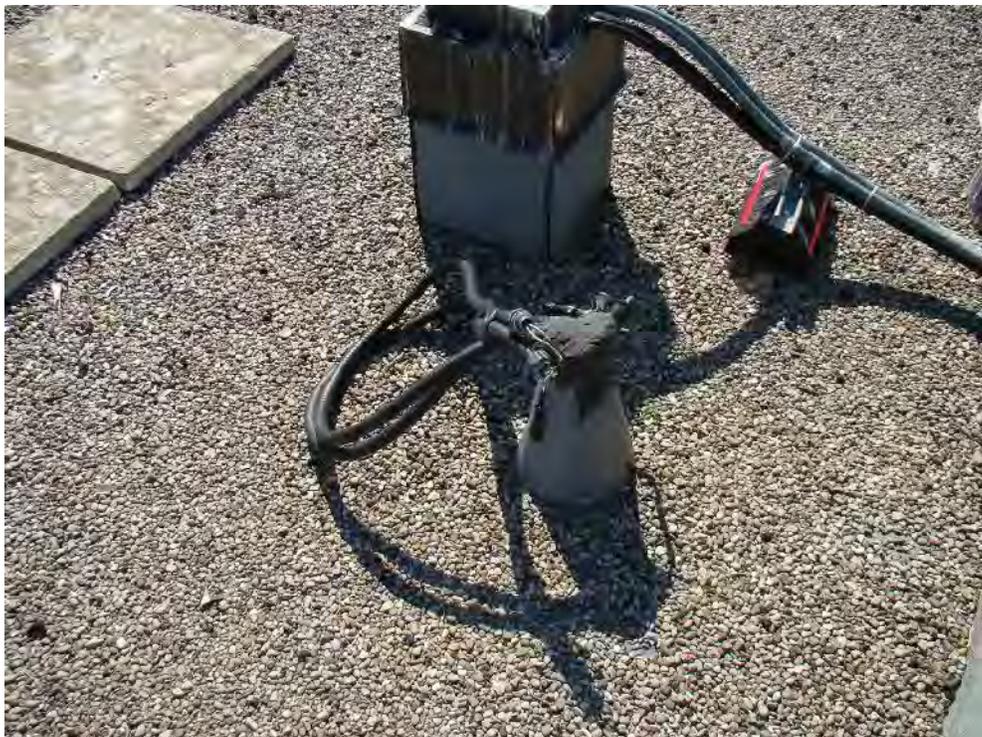
Photograph 11: Roof Area 1.1– Deterioration of the filler material was evident at pitch pocket penetrations along mechanical ductwork supports.

6. Deterioration of the filler material was evident at pitch pocket penetrations along mechanical ductwork supports (photograph 11).
7. Unused cone penetrations are evident in various locations (photograph 12) and should be removed at the time of the next roof replacement.

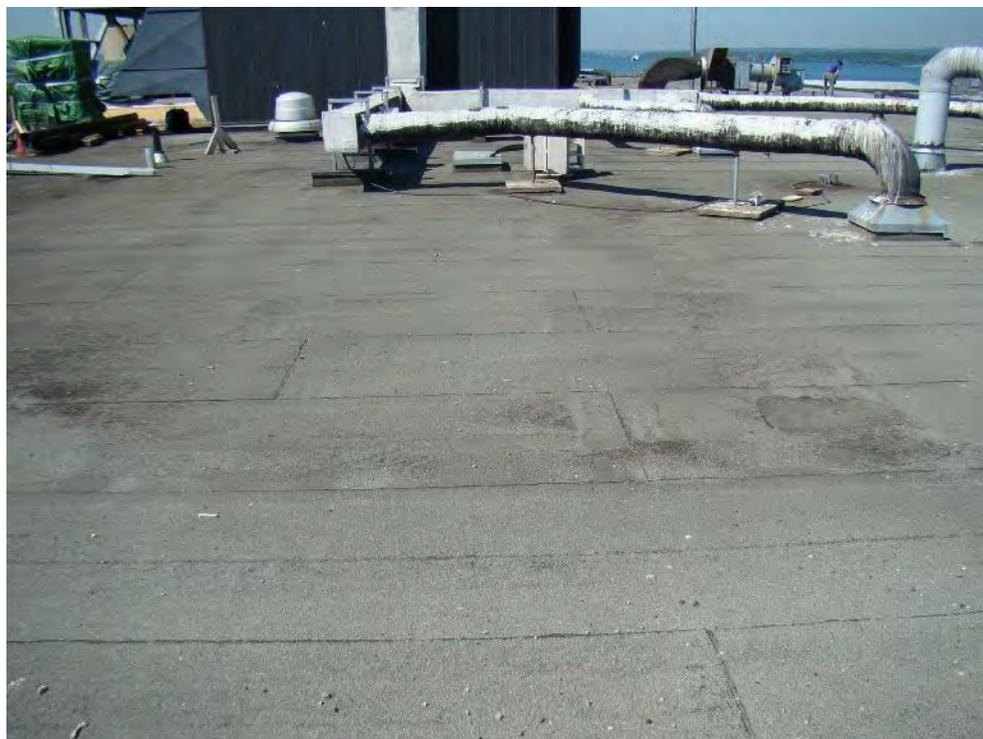
Photograph 13: Roof Area 1.2 – View looking west along the north portion of the roof area. This roof area is situated over the majority of the second floor level and consists of a modified bitumen membrane system installed in the early to mid 1990's.

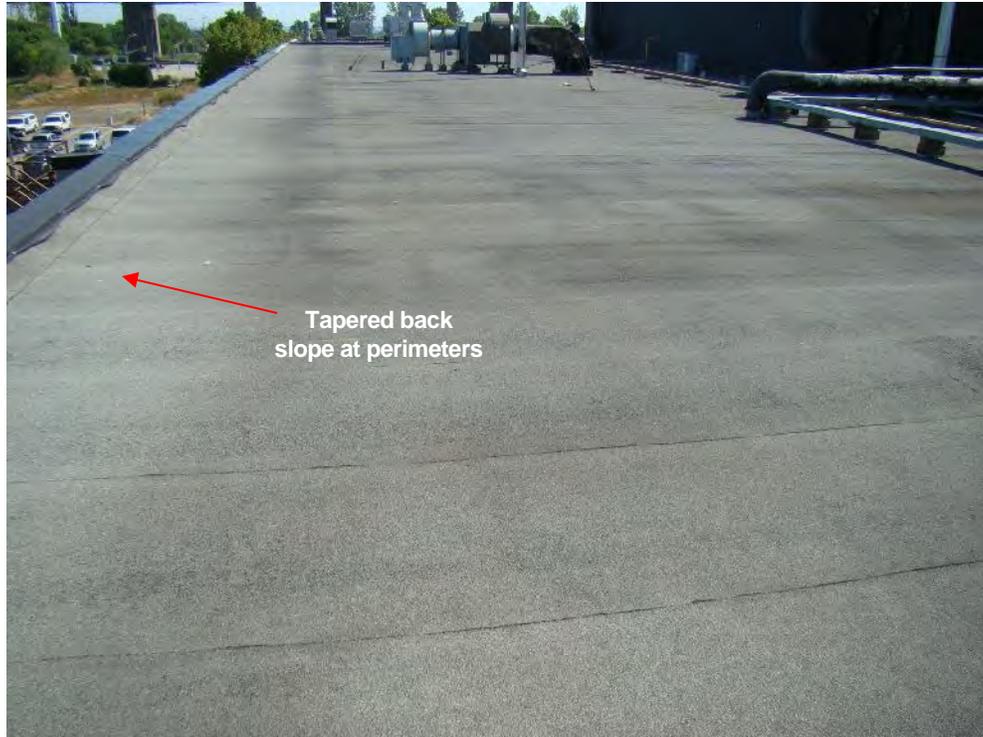
Photograph 14: Roof Area 1.2 – View looking west along the central portion of the roof area. Evidence of heavy ponding is noted by the dark colouration of the membrane.

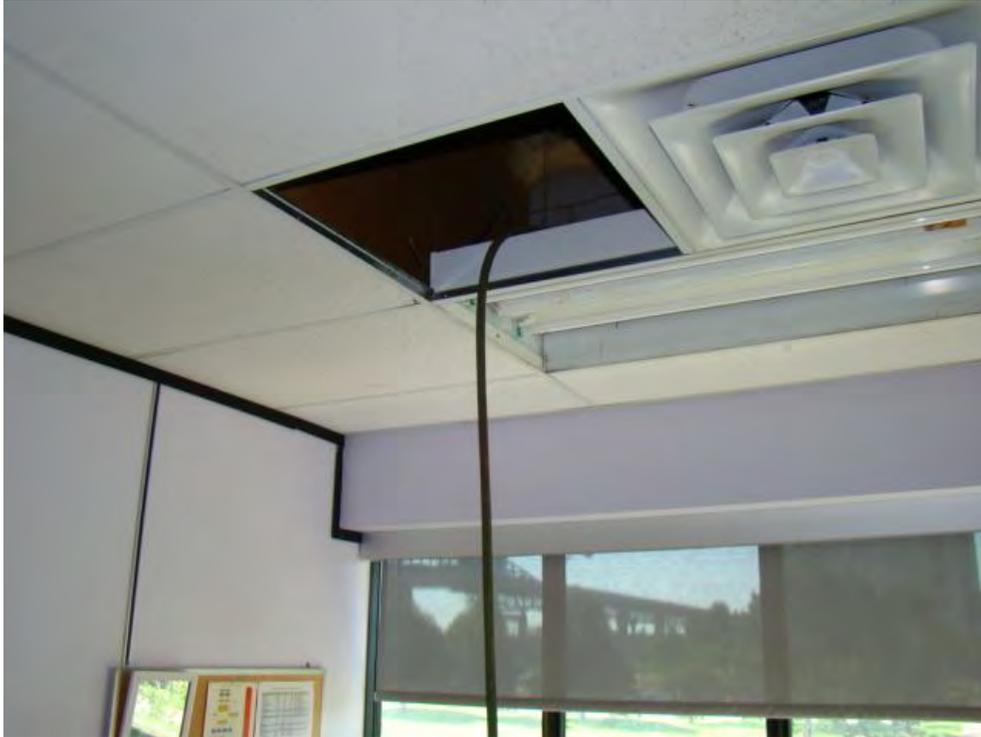
| Roof Area (Refer to Roof Plan) | Leak Details |
|---|--|
| Roof Area 1.2 Room S208 | Missing ceiling tile along east wall due to ongoing roof leak (photograph 18). Leaks along high wall transition of stairwell. Review of roof above this location indicated significant moisture contamination of the insulation below the membrane (photograph 25). |

Photograph 18: Roof Area 1.2 (Interior) – Missing ceiling tile along east wall of office S208 due to ongoing roof leak at transition with the central stairwell wall.

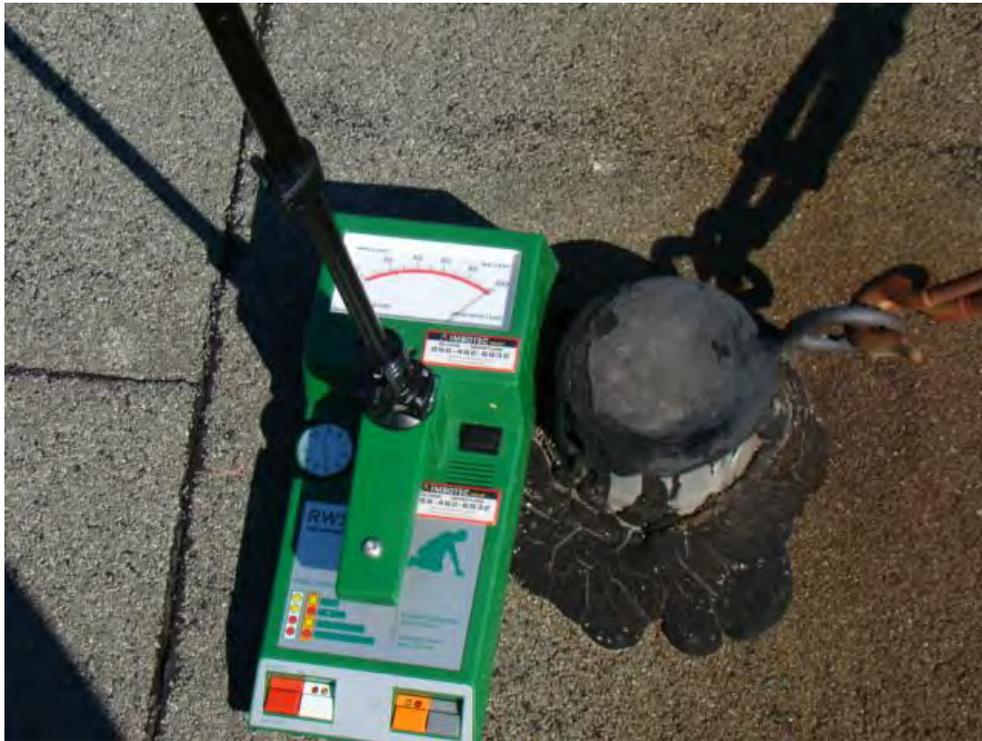
Photograph 22: Roof Area 1.2 – Closer view showing high moisture readings at location shown in previous photo.

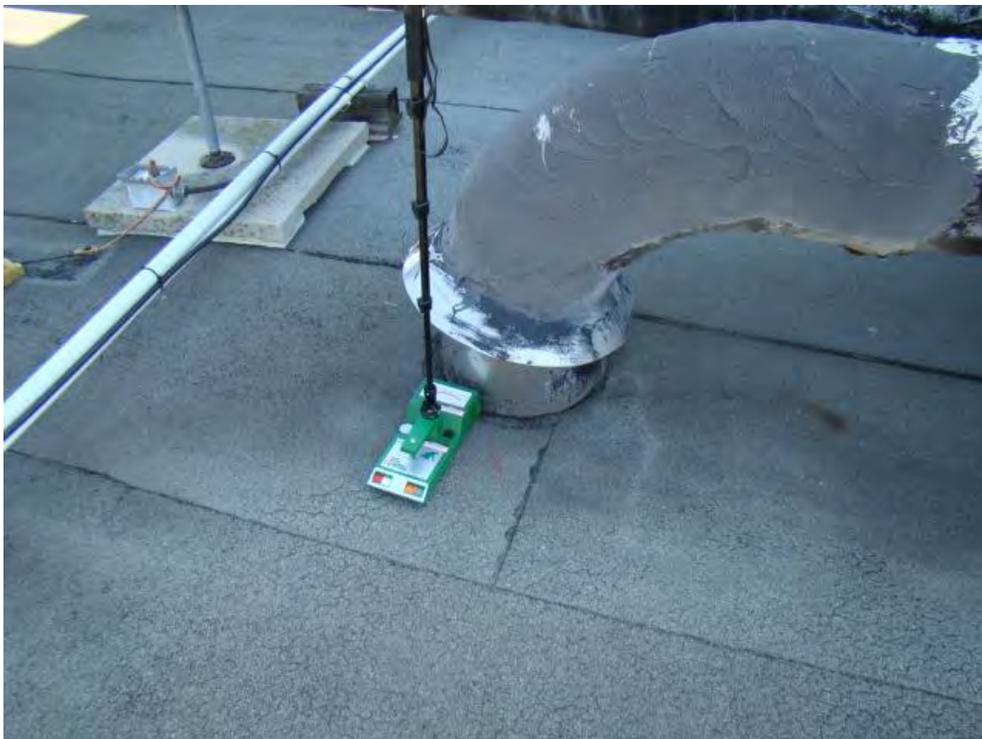
Photograph 23: Roof Area 1.2 – Moisture detected adjacent to guy wire pitch pocket penetrations.

13. Membrane flashing and sealant failure was observed around the base of b-vent chimneys and pitch pockets at the west end of the roof. Moisture contamination under the membrane was detected by the Tramex Meter at these locations (photographs 23 and 24).

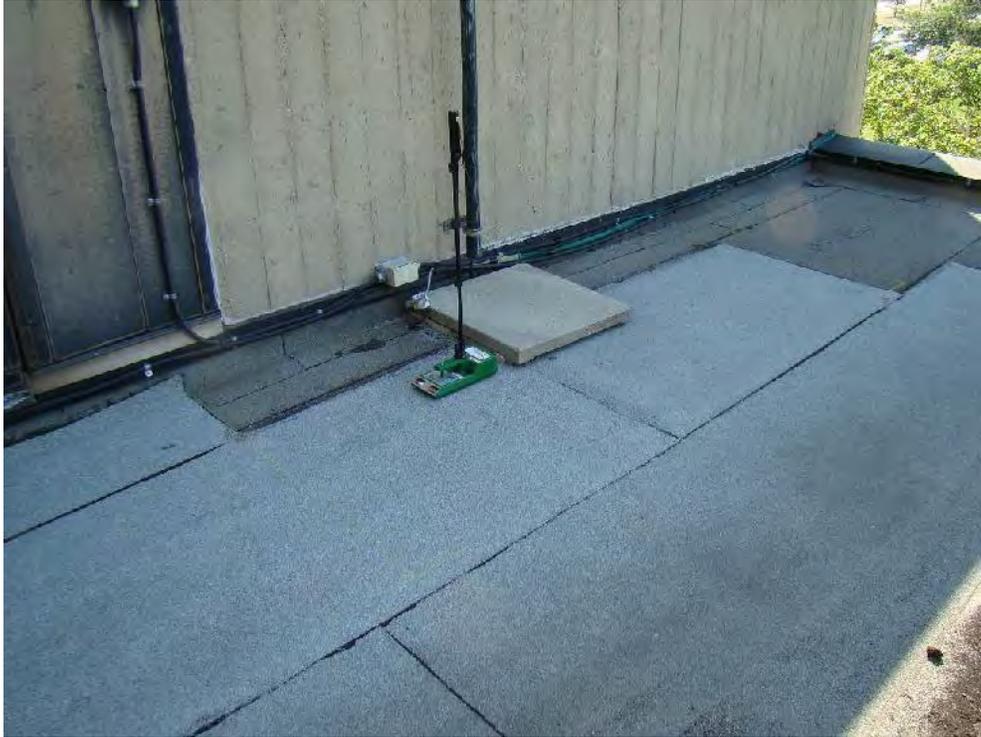
Photograph 24: Roof Area 1.2 – Moisture detected adjacent to tall cone chimney penetrations due to membrane flashing delamination and sealant failure.

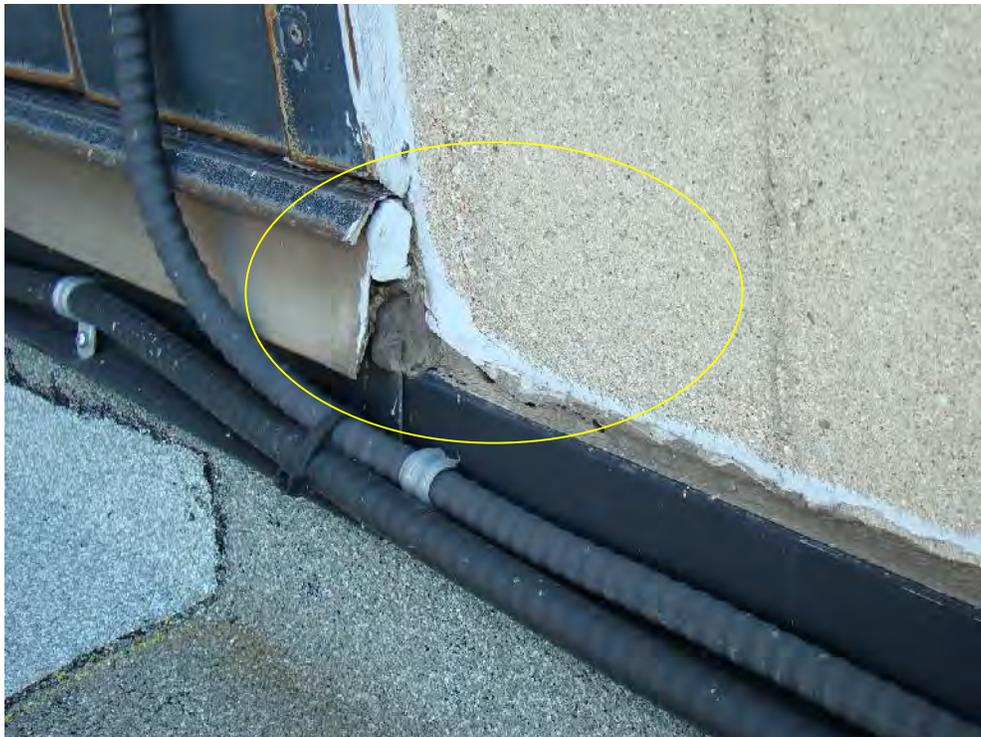
Photograph 25: Roof Area 1.2 – Moisture detected adjacent to the stairwell wall transition above office S208. This location is actively leaking notwithstanding recent membrane repairs (see photo 18).

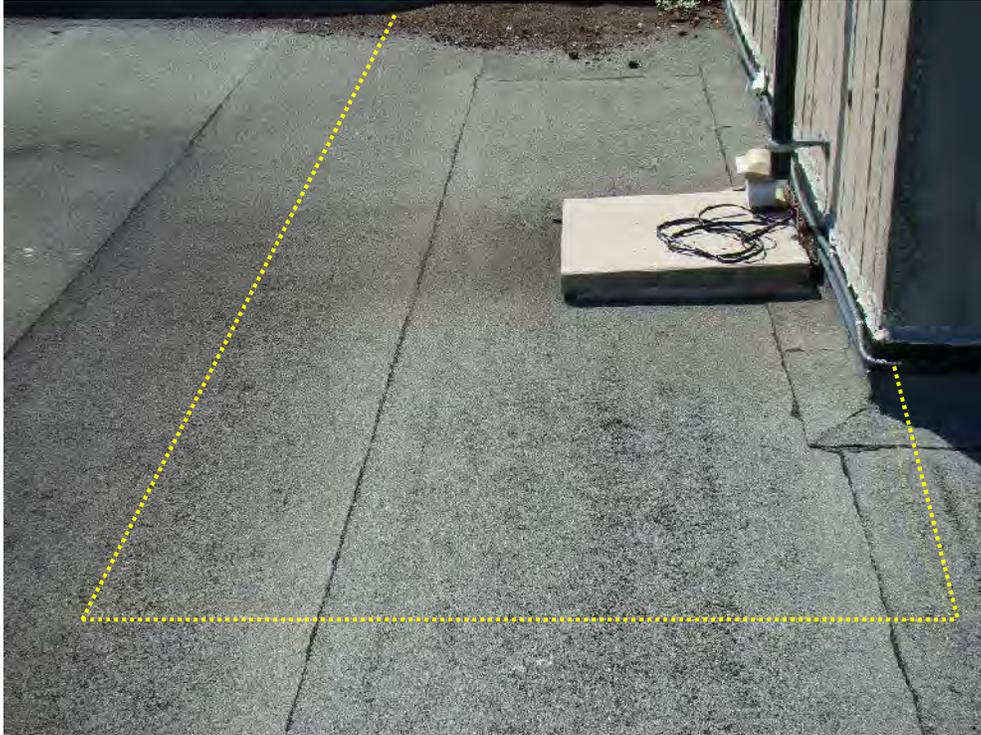
Photograph 26: Roof Area 1.2 – Openings in sealant along reglet flashing details may be contributing to leakage.

8. Failed sealant along the wall reglet details at raised stairwells is resulting in water entry (photograph 26).
 9. Sealant failure exists at the door frame along the north wall of the east stairwell penthouse (roof area 2.3) (photograph 42). Evidence of water entry was observed along the base of the door into the stairwell (photograph 43) which could be related to the sealant deterioration or due to inadequate weather stripping along the bottom of the door.

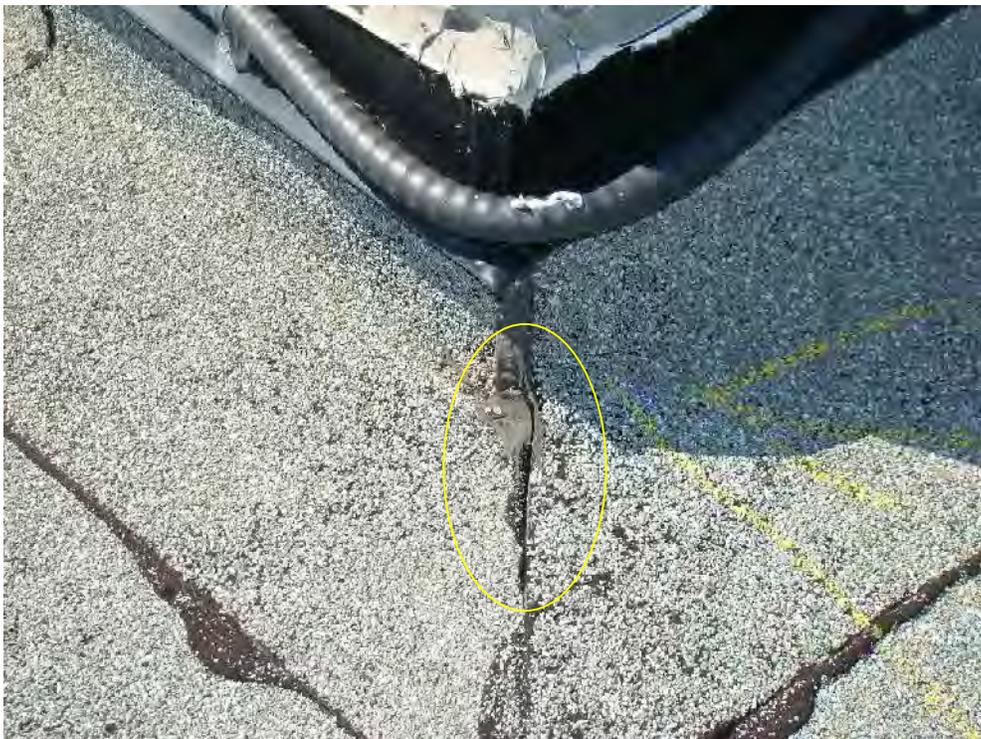
Photograph 27: Roof Area 1.2 – An area of moisture contamination was detected at the base of the southwest stairwell wall transition.

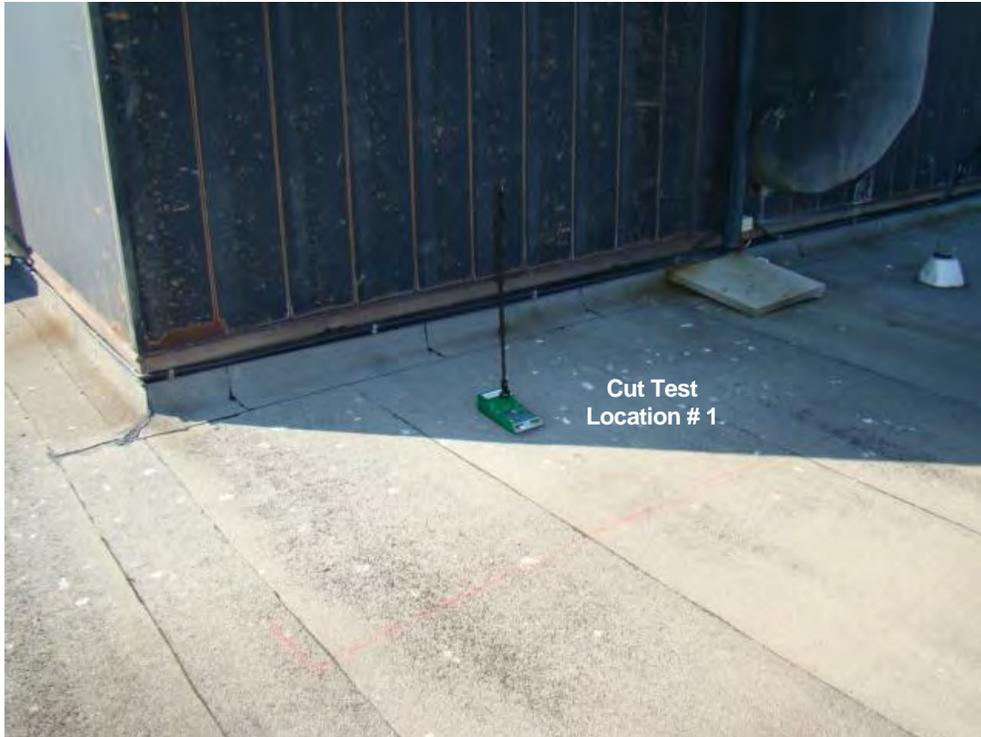
Photograph 28: Roof Area 1.2 – Open membrane flashings were observed to be causing moisture entry at the corner of the stairwell wall.

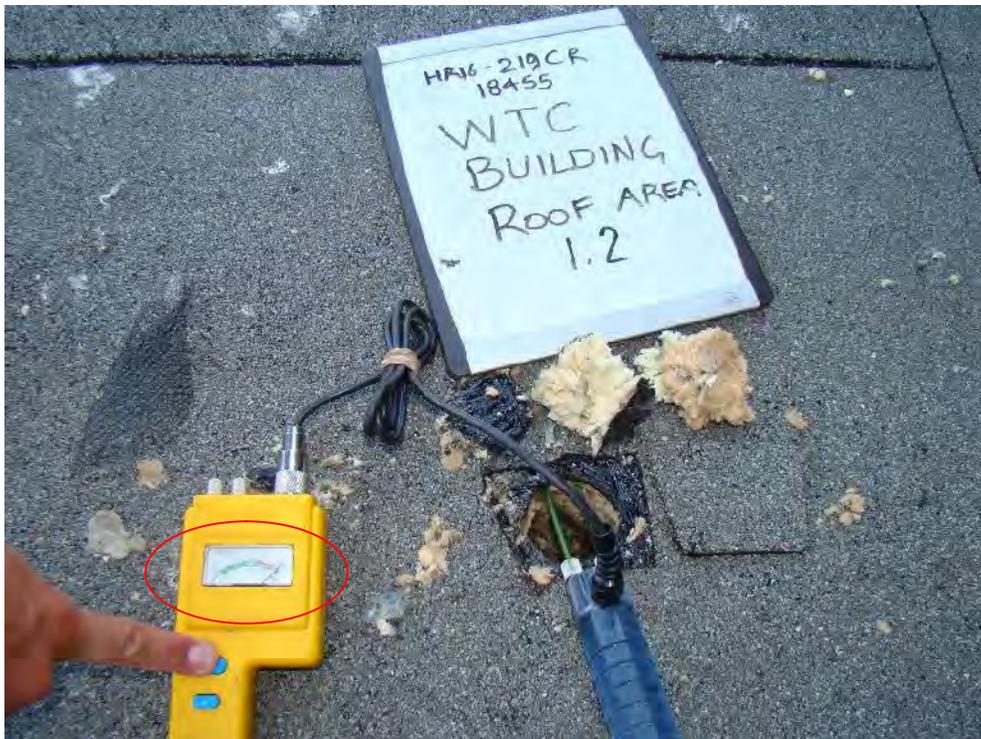
Photograph 29: Roof Area 1.2 – **Test Cut #1** - The first test location was in a suspected area of moisture contamination along the north penthouse wall transition.

Cut Test #1 - The first test location (photographs 29 and 30) was in a suspected area of moisture contamination along the north penthouse wall transition. Probes confirmed high readings of "70" to "95" within the thermal insulation layers below the membrane. The insulation at this location was visibly wet and moisture damaged.

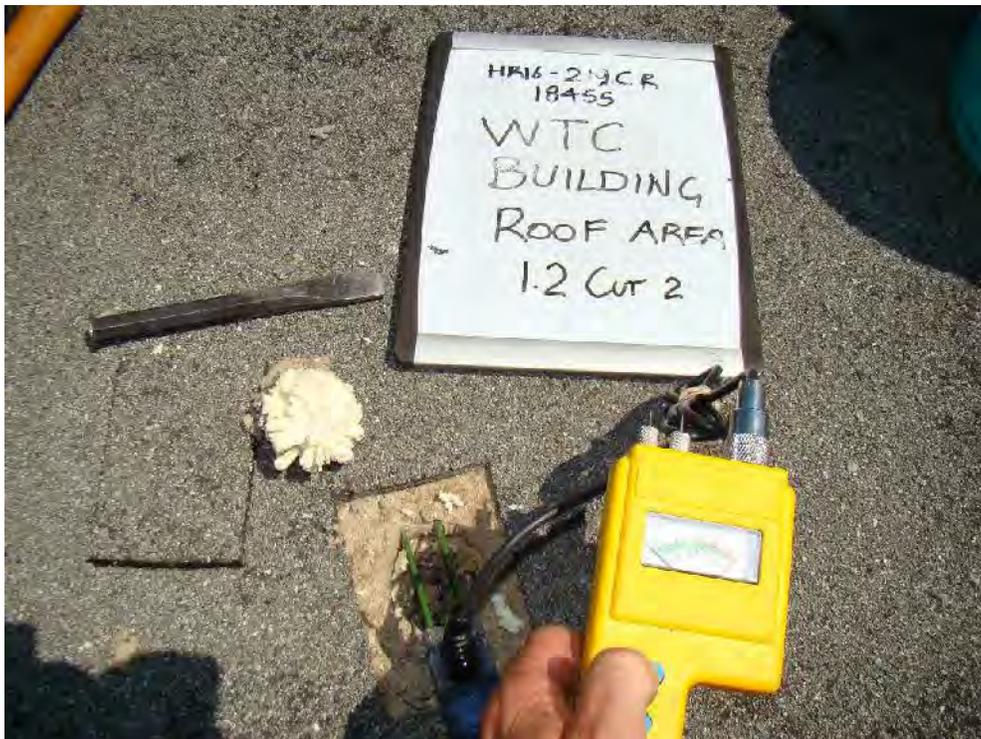
Photograph 31: Roof Area 1.2 – **Test Cut #2** - The second test location was in the field of the roof adjacent to the west roof drain.

- Cut Test #2** - The second test location (photographs 31 and 32) was in the field of the roof adjacent to the west roof drain. Probes taken at this location revealed no moisture present in the insulation layer or within the membrane interply.

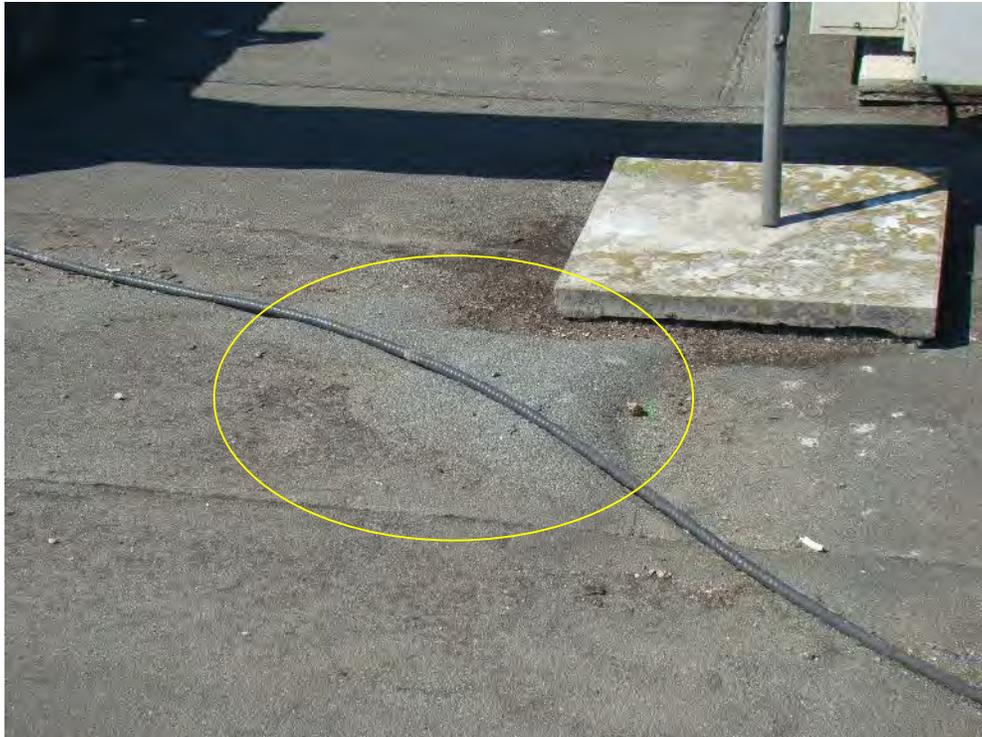
Photograph 36: Roof Area 1.2 – Severe surface deterioration and cracking, typical of advanced aging.

4. The membrane exhibits widespread and severe granule surface loss and weathering (photographs 33, 34, 35 and 36). This condition is related to advanced aging of the membrane, exposure to prolonged ponding and erosion due to regular foot traffic patterns and wind scouring (this roof would be exposed to high winds due to its proximity to open water).

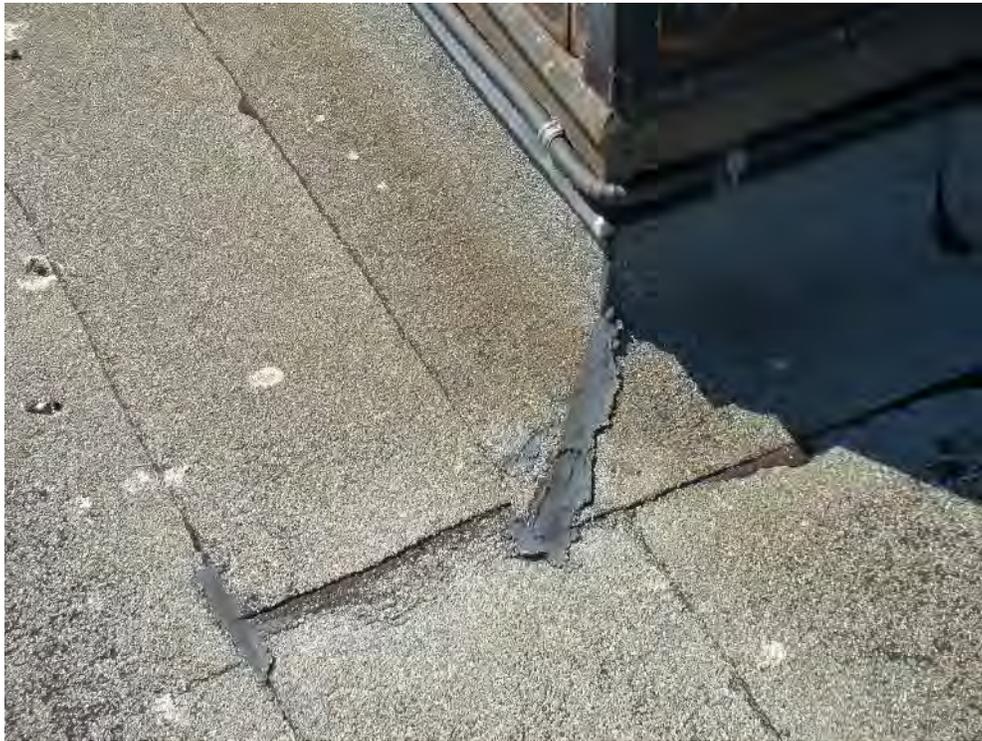
Photograph 40: Roof Area 1.2 – Delaminating membrane flashings were typically found at the corners of mechanical curb flashings.

6. Delaminating membrane flashings were typically found at the corners of mechanical curb flashings (photograph 40).
 7. Failed sealant repairs were observed at several corner transitions (photograph 41).

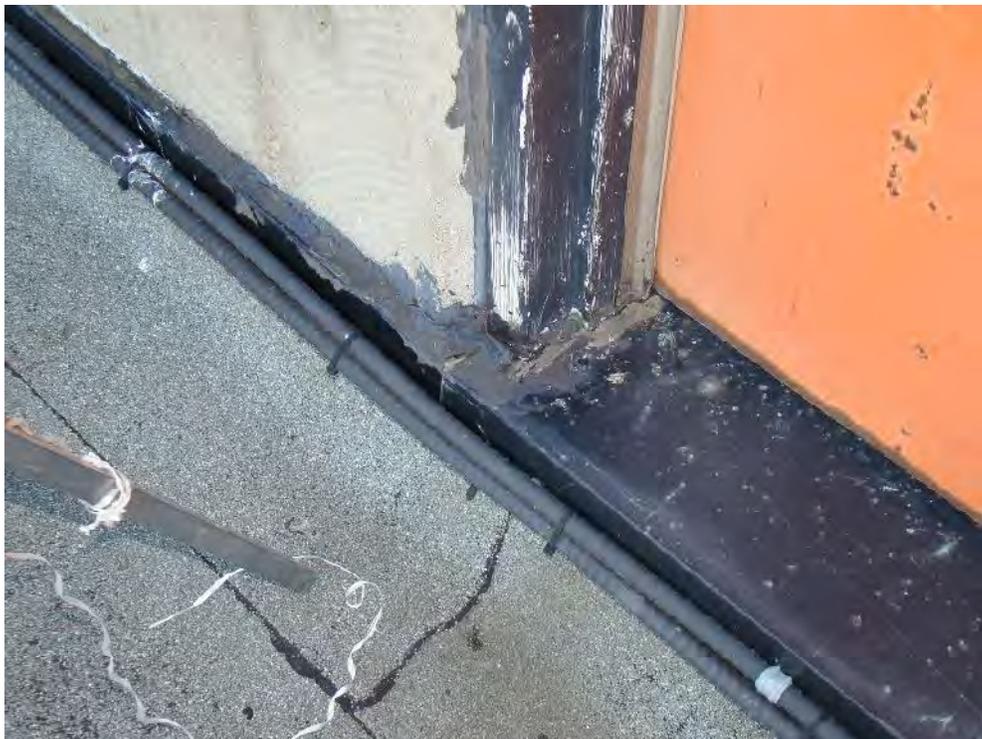
Photograph 41: Roof Area 1.2 – Failed sealant repairs were observed at several corner transitions.

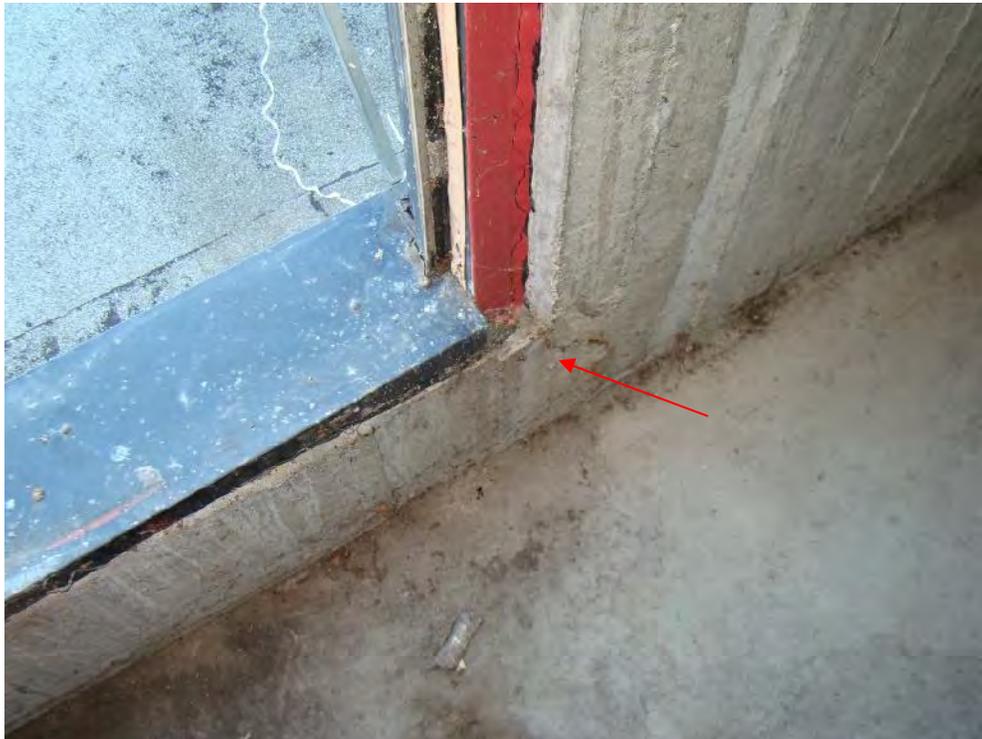
Photograph 42: Roof Area 1.2– Sealant failure exists at the door frame along the north wall of the east stairwell penthouse.

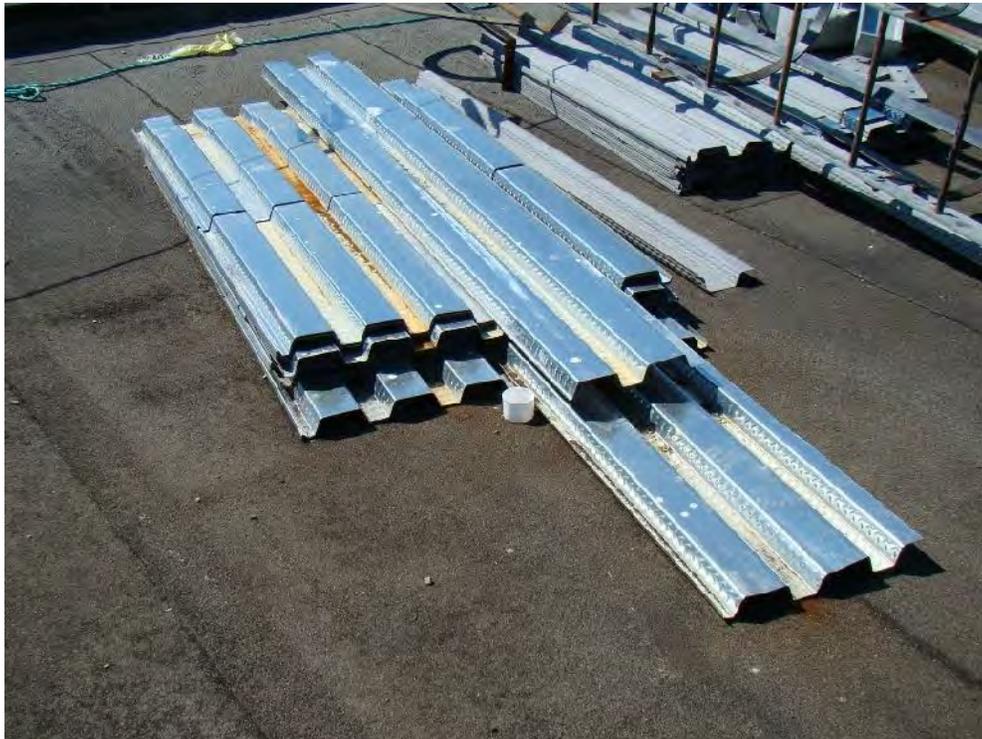
Photograph 44: Roof Area 1.2 – Heavy construction materials have been stockpiled on the membrane in the southeast corner of the roof area.

10. Heavy construction materials have been stockpiled on the membrane in the southeast corner of the roof area (photograph 44). Inadequate protection has been provided under the materials which will result in damage to the membrane (photographs 45 and 46).

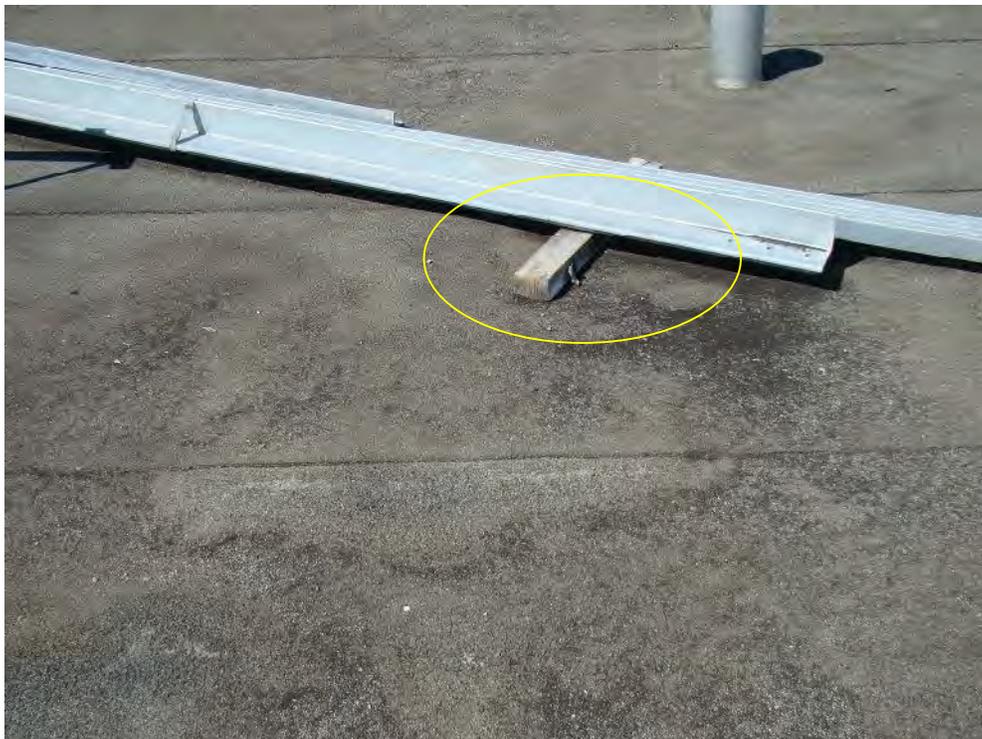
Photograph 45: Roof Area 1.2 – Inadequate protection has been provided under the materials which will result in damage to the membrane.

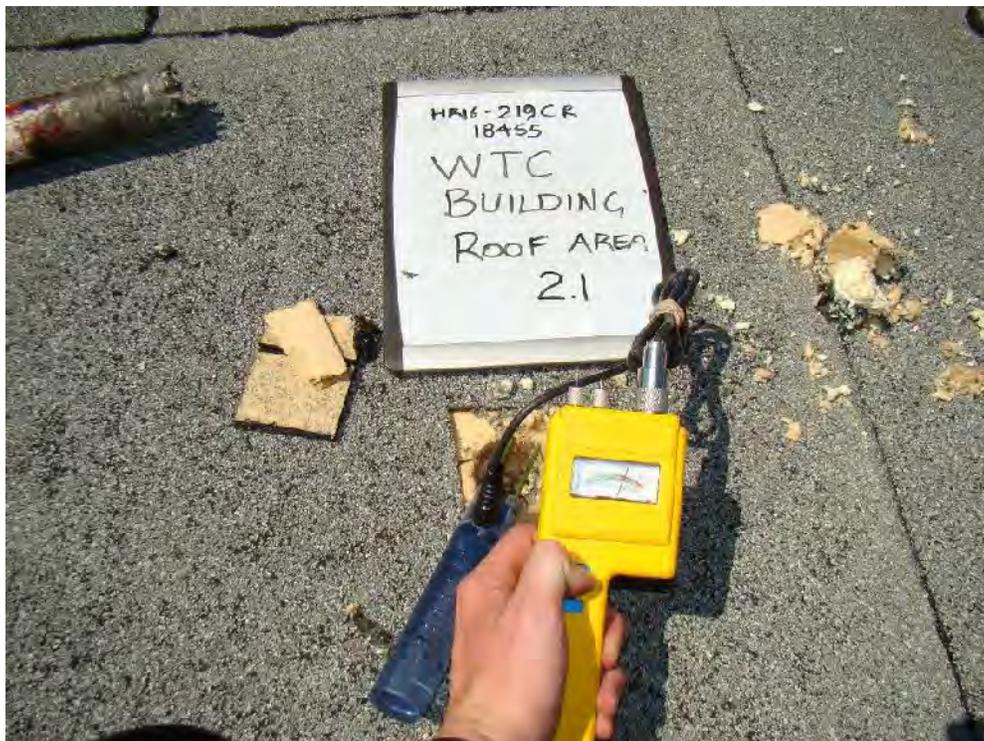
Photograph 55: Roof Area 2.1 *Test Cut* – High moisture levels were detected within the base layer of polyisocyanurate insulation.

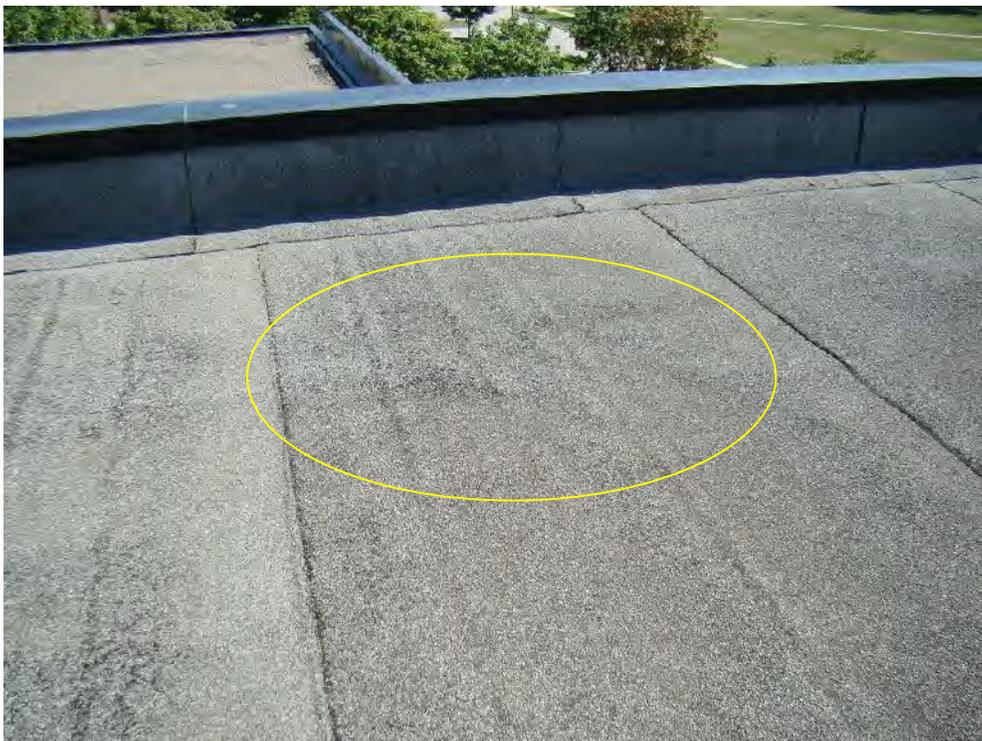
Photograph 63: Roof Area 2.3 – The cap sheet membrane appears weathered and worn with general granule surface loss throughout

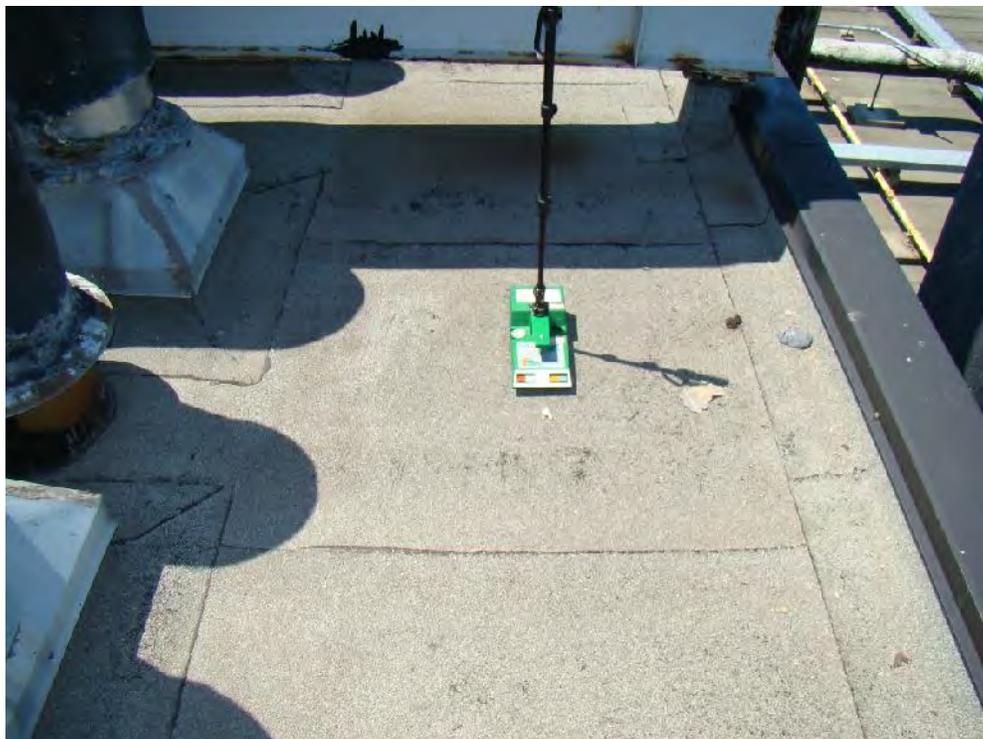
Photograph 68: Roof Area 3.1 – The roof is covered with a heavy concentration of mechanical equipment and ductwork which would tend to increase roof replacement costs significantly.

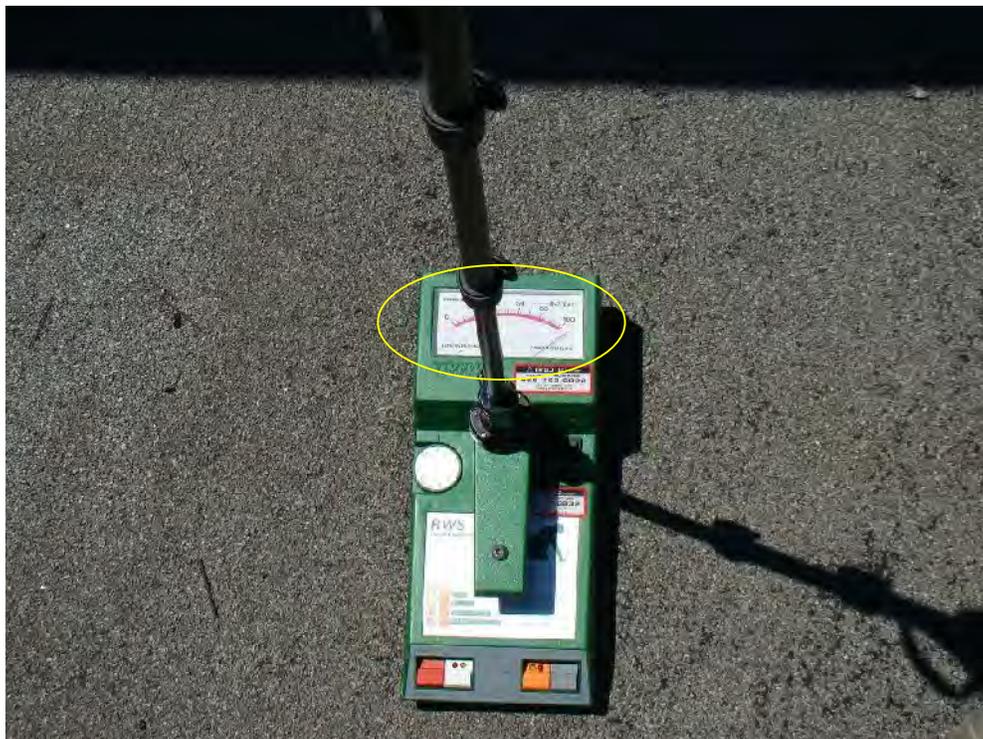
Photograph 69: Roof Area 3.1 – Testing with the Tramex Moisture Detection Instrument detected moisture contamination of the underlying insulation components throughout the entirety of the roof. The entire roof was noticeably “soft” under foot indicative of insulation which is saturated.

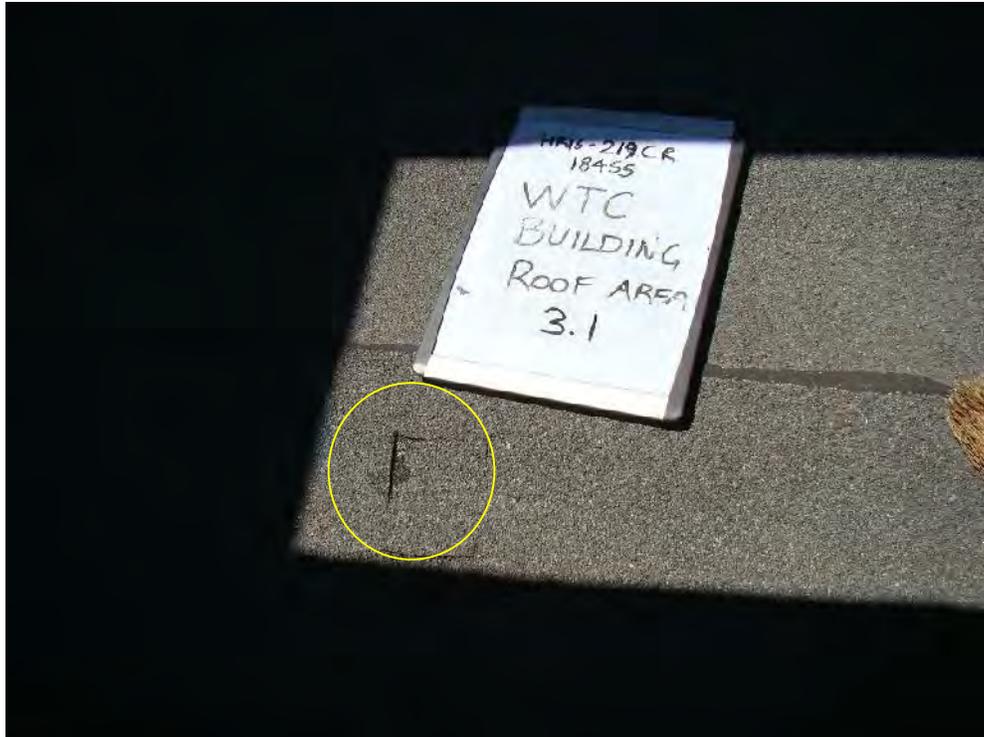
Photograph 70: Roof Area 3.1 – Closer view showing the high moisture readings typically recorded throughout the roof.

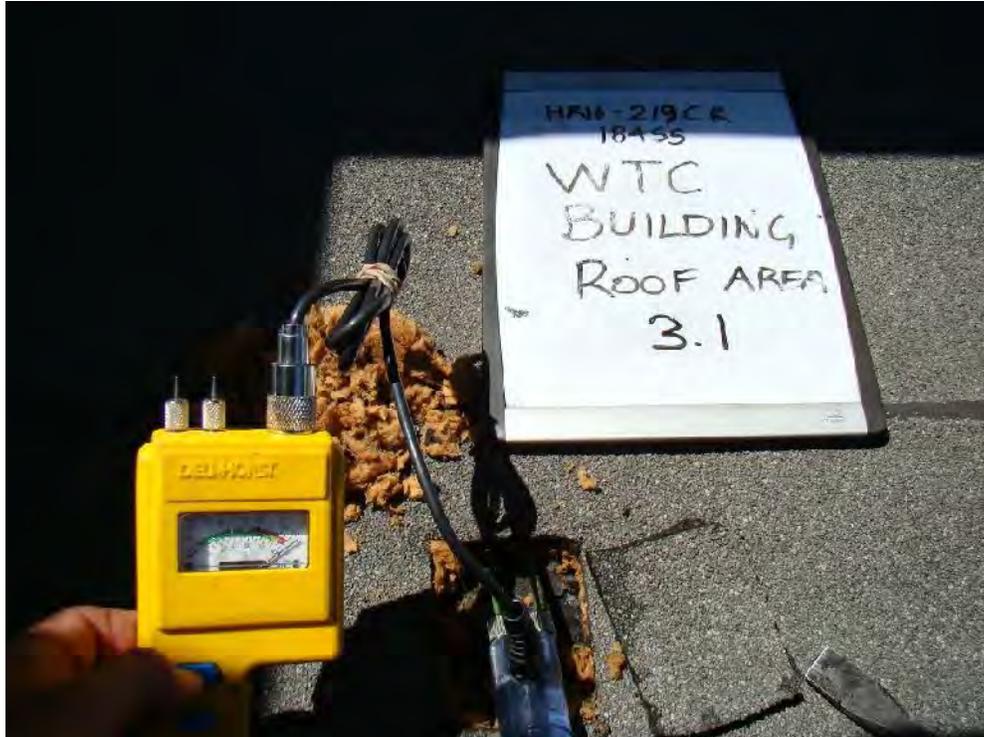
Photograph 71: Roof Area 3.1 *Test Cut* – Upon cutting into the membrane, water was observed exiting from the incision indicating saturation of the underlying insulation.

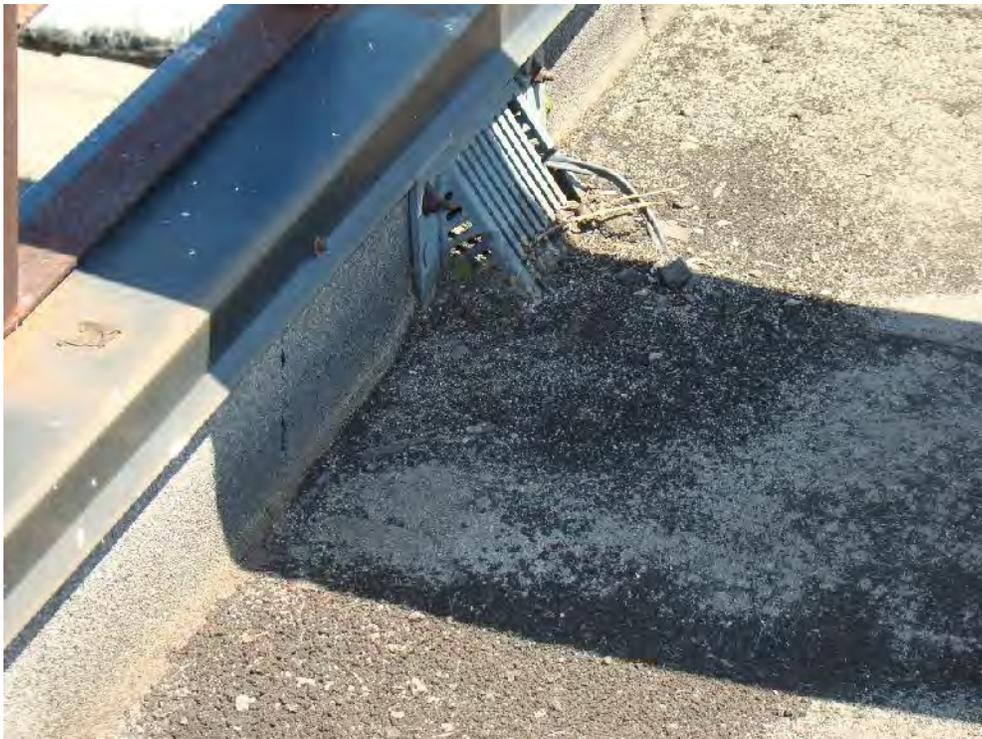
Photograph 75: Roof Area 3.1 – Overall drainage patterns appear inadequate with evidence of ponding throughout along with organic debris build up at perimeters.

6. Overall drainage patterns appear inadequate with evidence of ponding throughout along with organic debris build up at perimeters and at scuppers (photographs 75 and 76).
