BID DOCUMENTS AND SPECIFICATIONS

CCIW - 867 LAKESHORE ROAD, BURLINGTON
WTC ROOF REPLACEMENT

JUNE 15, 2018

ROOF CONDITION ASSESSMENT REPORT

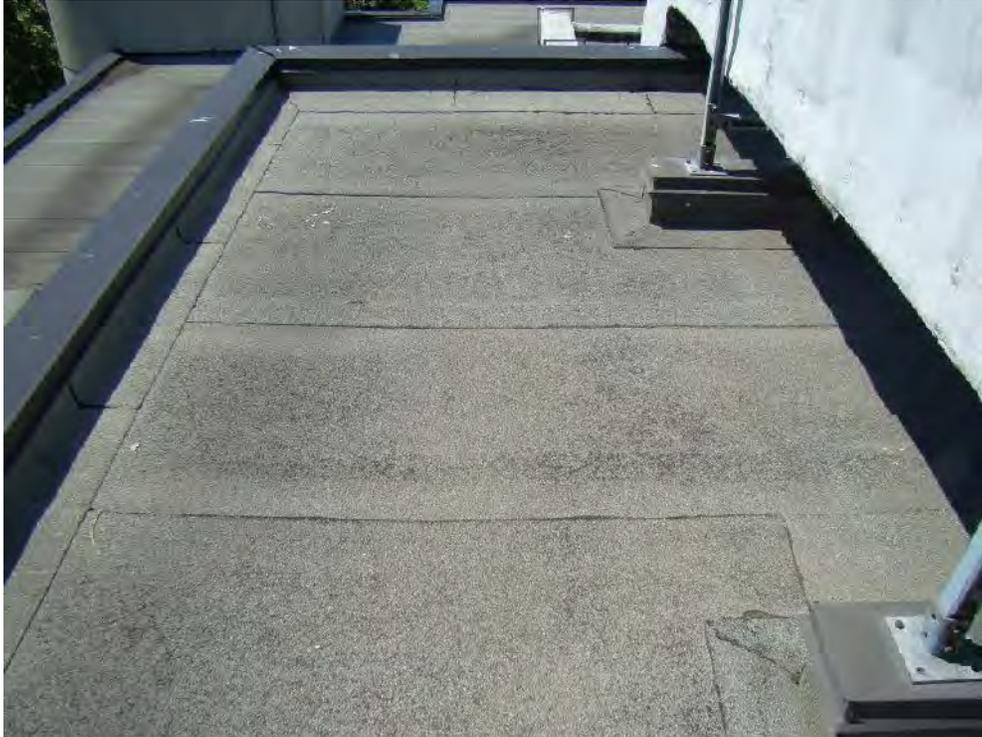
Photograph 76: Roof Area 3.1 – The primary drainage for this roof area is provided by two – six inch scuppers along the north perimeter. Both scuppers are heavily obstructed by debris.

6. Overall drainage patterns appear inadequate with evidence of ponding throughout along with organic debris build up at perimeters and at scuppers (photographs 75 and 76).

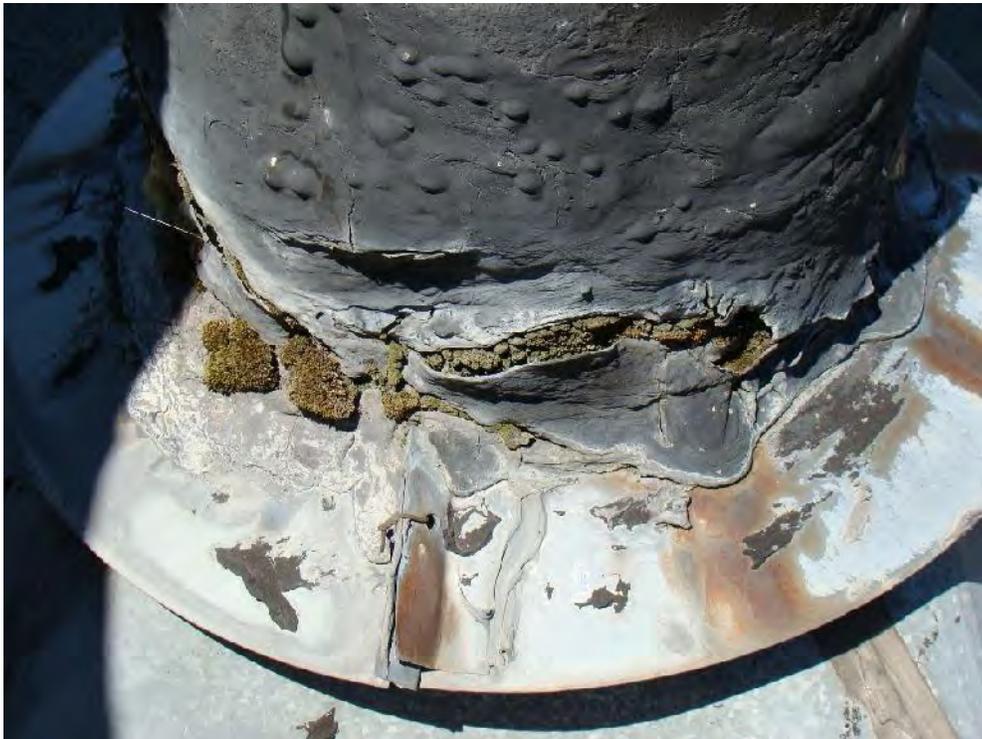
Photograph 79: Roof Area 3.1 – The existing waterproofing application over mechanical ductwork was assessed to be in poor condition.
