DESIGNATED SUBSTANCES AND HAZARDOUS MATERIALS SURVEY – PHASE 0 LAB MODERNIZATION PROGRAM AND SPRINKLER SYSTEM UPGRADE

Canada Centre for Inland Waters
837 Lakeshore Road
Burlington, Ontario

Revised February 28, 2018

702345-009

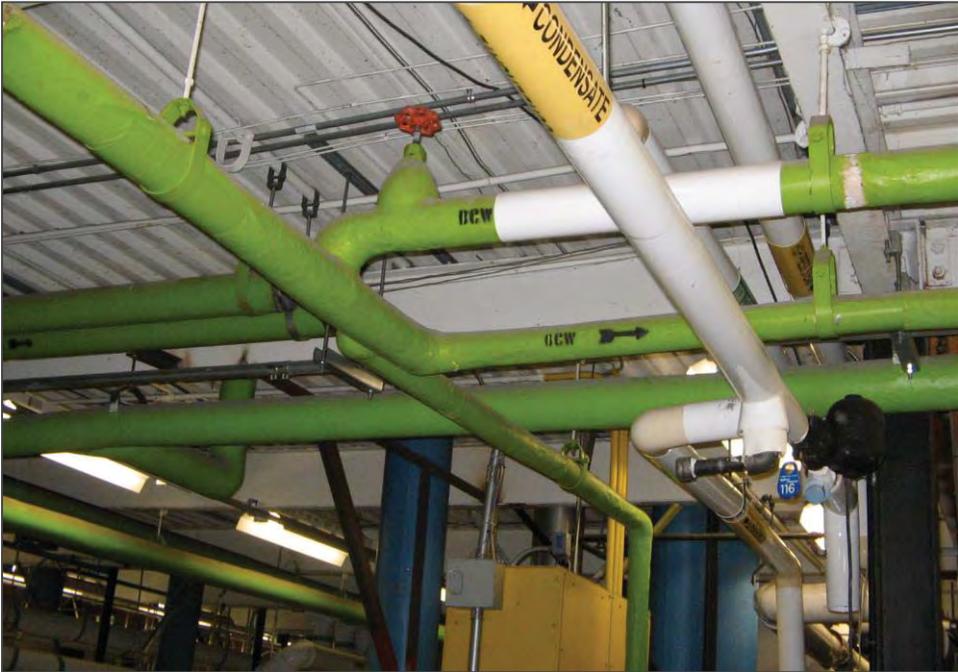
Photo: 7
Date:
August 4, 2017.
Description:
Asbestos pipe insulation.
Location:
A&L Eighth floor Mechanical
Room.
