## **Hazardous Building Materials Assessment**

Exeter Radar Station  
41651 Thames Road, Exeter,  
Ontario

January 31, 2019

Pinchin File: 229221.004

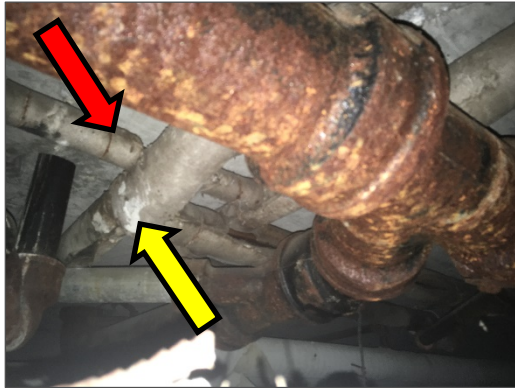
Parging cement, presumed to contain asbestos, is present on pipe fittings (elbows, valves, tees etc.) on pipe systems above solid ceilings. The insulation was not sampled due to lack of access. Parging cement is a friable insulation, jacketed with canvas and ranged from damaged to good condition.

Asbestos-containing parging cement on pipe fitting insulation (yellow arrow) and non-asbestos sweat wrap insulation (red arrow) within the Storage Room (Location 9)

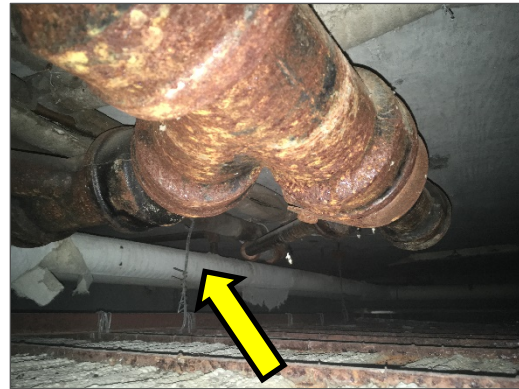
A white corrugated paper insulation (trade name Aircell), containing chrysotile asbestos, is present on straight sections of abandoned heating system pipes above solid ceilings (samples 0010A-C). Aircell is a friable insulation, jacketed with canvas and ranged from damaged to good condition.

Asbestos-containing Aircell pipe straight insulation within the Storage Room (Location 9)

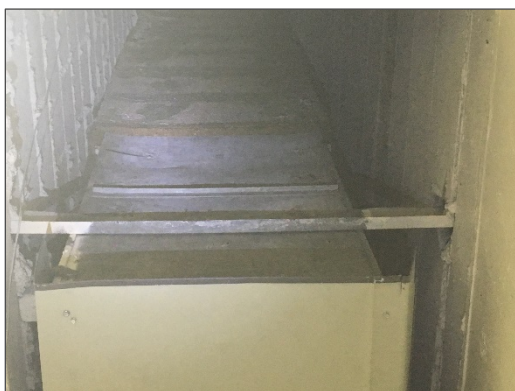
Black mastic, containing chrysotile asbestos, is present on the seams of cork duct insulation in the duct chase located in Location 8 (samples 0001A-C). Mastic is a non-friable material and in good condition. Ducts insulated with asbestos-containing insulations may be present above inaccessible ceiling spaces.

Asbestos-containing black mastic present on the seams of cork duct insulation within the Basement (Location 8)

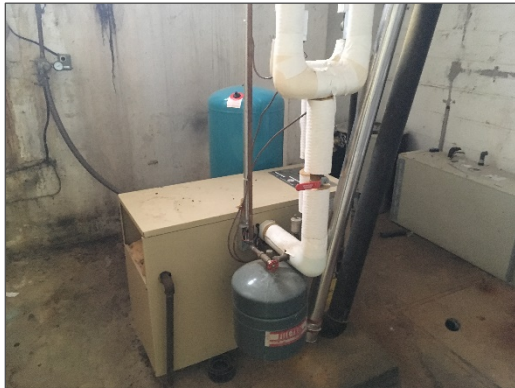
Externally un-insulated furnace within the Sump Pump Room (Location 10)

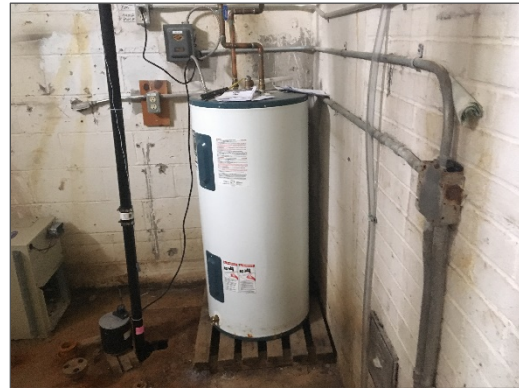
Externally un-insulated hot water tank within the Sump Pump Room (Location 10)

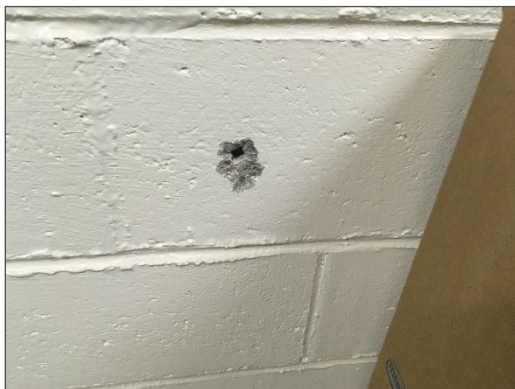
Destructive testing in masonry block wall within the Furnace Room (Location 4)

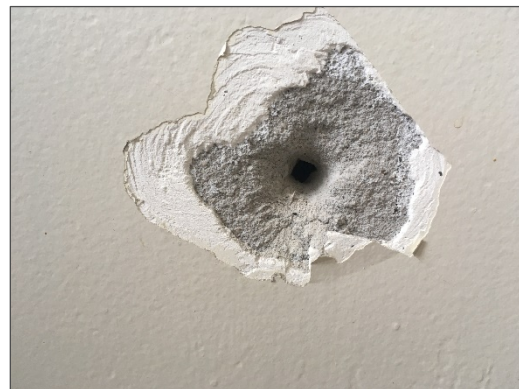
Destructive testing in plaster wall within the Kitchen (Location 2)

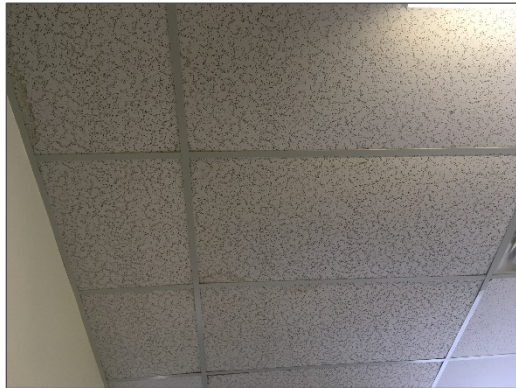
Size, Type, Pattern and Photo #	Location #	Sample Number or Date Code	Asbestos Type
24"x48", lay-in, random fissure and pinhole, Photo 1	Locations 6, 7, 13 and 14	Previously identified	None Detected

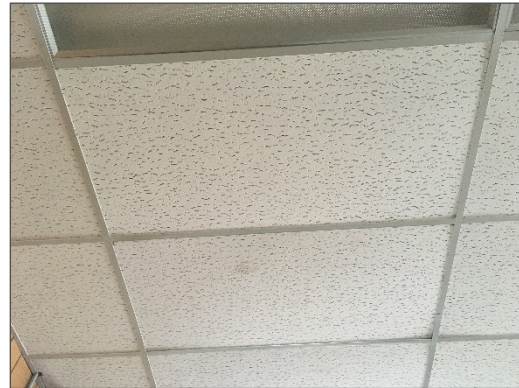
Size, Type, Pattern and Photo #	Location #	Sample Number or Date Code	Asbestos Type
24"x48", lay-in, white with horizontal fissure and pinhole, Photo 2	Location 5	Previously identified	None Detected

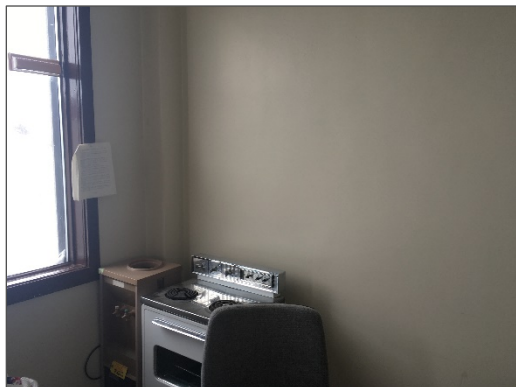
Non-asbestos smooth plaster within the Kitchen (Location 2)

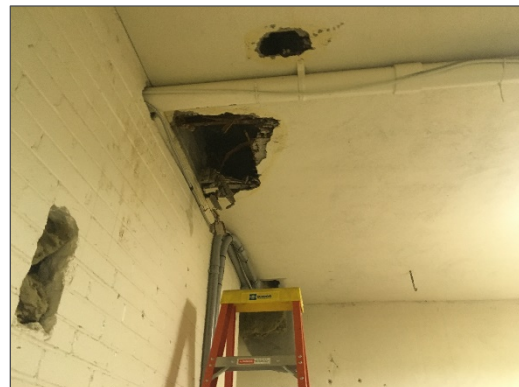
Non-asbestos grey cementitious grey plaster present within the Storage Room (Location 9)

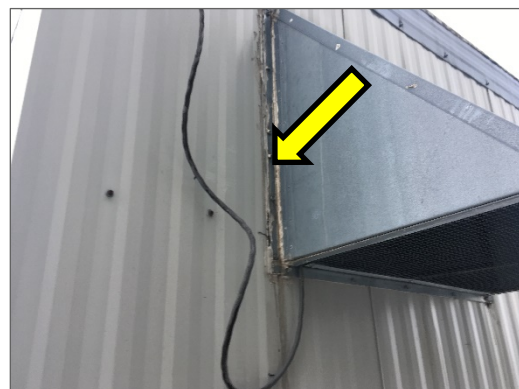
Caulking, white, Photo 8	Located around wires at Transformer	0019A-C	None Detected

Caulking and sealants are non-friable materials and in good condition.

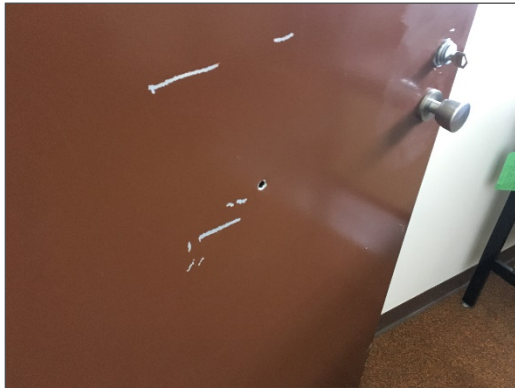
Non-asbestos brown paper is present inside the door within Location 7 and 13 (samples 0011A-C).

Non-asbestos brown paper inside door within the Office  
(Location 7)

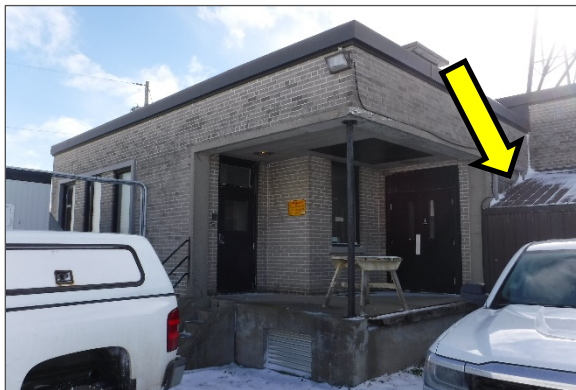
Tar, previously identified to contain chrysotile asbestos, is present on exterior roof flashing on the Ramp Shed (Location 15). Tar is non-friable and are in good condition.

Asbestos-containing tar on flashing above Ramp Shed

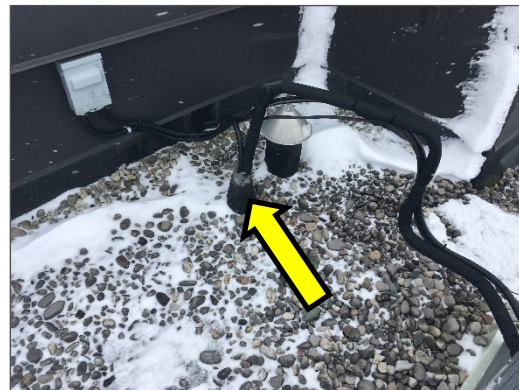
Non-asbestos tar is present around roof vents (samples 0018-A-C).

Non-asbestos tar around roof vent on the Roof

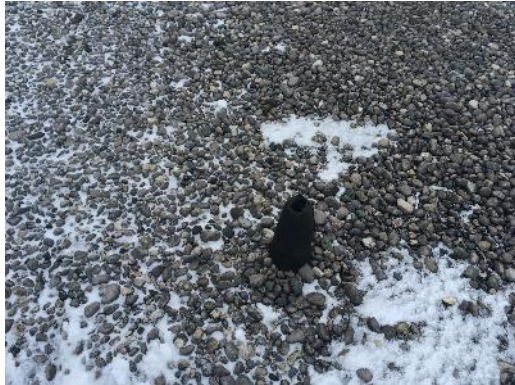
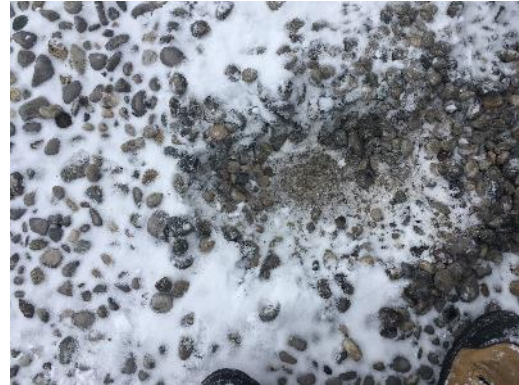
The roofing over the building is presumed to be non-asbestos due to the type of roof (EDPM) which is known not to contain asbestos, however, the original roofing may have contained asbestos. Residual asbestos-containing tar may be present on the deck below the non-asbestos roofing.

Roofing materials

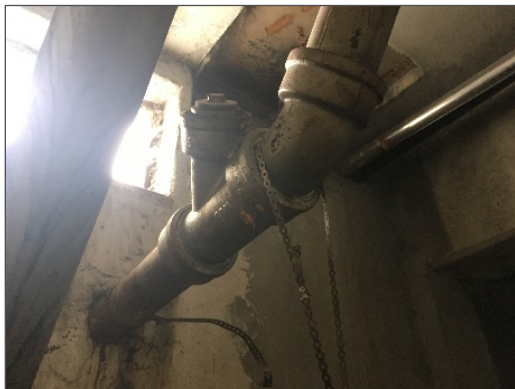
Lead caulking is present in bell and spigot fittings on cast iron pipes.

Lead caulking in pipe line within the Sump Pump Room  
(Location 10)
