Building Condition Report
October 2015

Environment Canada
Exeter Weather Radar Station
Exeter, ON

Technical Services
Professional and Technical Services
Real Property Branch
Ontario Region
PWGSC

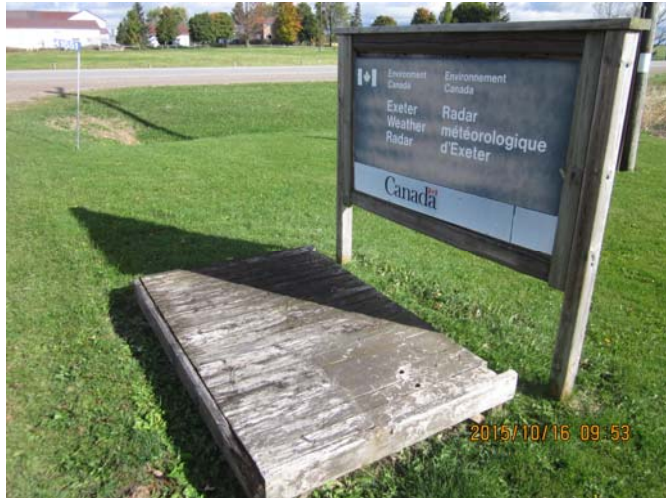
Condition - The component is considered to be in fair overall condition, performing as intended and with no visible signs of damage; however, the sign is moderately faded.

PS-001 – Fading surfaces at site identification sign.

<i>Description:</i> Sign replacement	
<i>Action Year:</i> 5	<i>Estimated Cost</i>
It is recommended that an allowance be made for replacement of the FIP site identification sign at the end of its effective service life.	<i>Material & Labour:</i> \$5,500
	<i>Contingency:</i> \$825
	<i>Project Soft Costs:</i> \$1,898
	<i>Total:</i> \$8,223

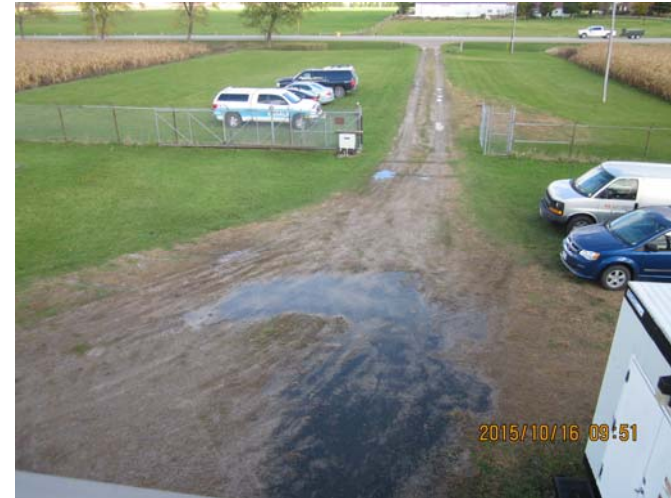
- Significant vegetation growth was noted throughout the granular paved areas.
- Standing water was noted at several locations.

Design Problems/Deficiencies - The only design problem/deficiency identified with the component is inadequate grading to facilitate drainage of surface water.

PS-002 – Standing water and vegetation growth at various locations throughout gravel paving.

<i>Description:</i> Pavement refurbishment	
<i>Action Year:</i> 1, 11, 21	<i>Estimated Cost</i>
It is recommended that an allowance be made in each 10-year period for the refurbishment of granular paved surfaces (including scarifying surfaces, adding additional granular material as required, grading to facilitate drainage, and compaction) in order to continue their effective service lives.	<i>Material & Labour:</i> \$5,000
	<i>Contingency:</i> \$750
	<i>Project Soft Costs:</i> \$1,725
	<i>Total:</i> \$7,475

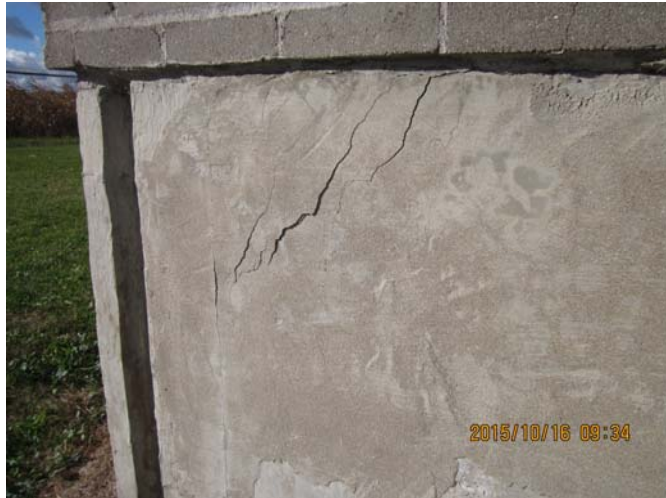
AR-005 – Spalling concrete at foundation.

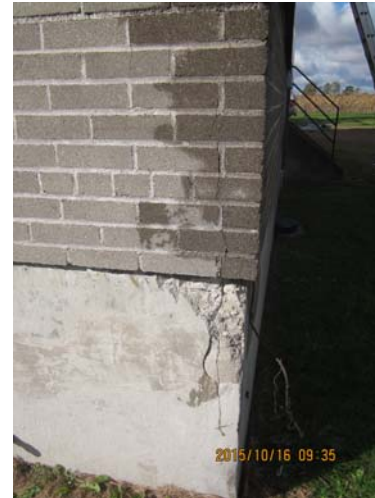
AR-006 – Deteriorated concrete at foundation corner.

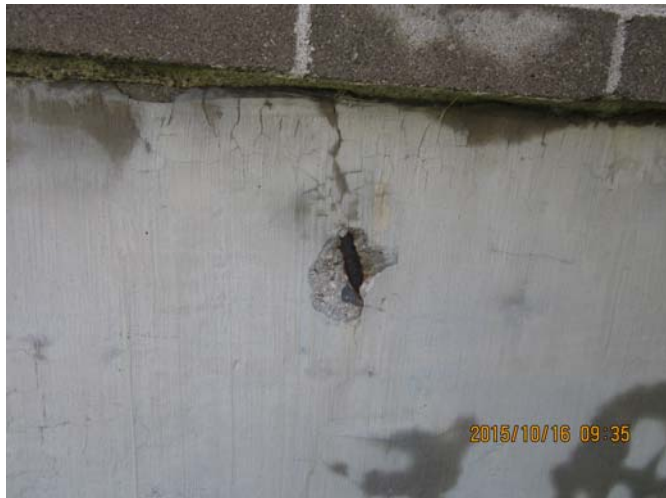
AR-007 – Spalled concrete and exposed rebar with corroded surface at foundation.

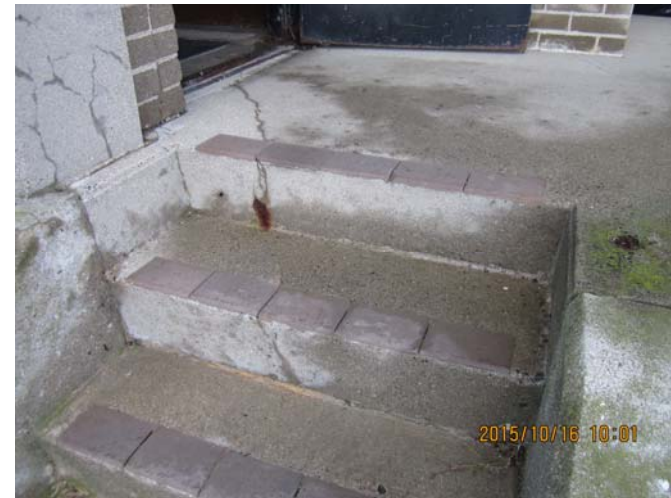
AR-008 – Loading dock stair with missing guard (right), cracked concrete with rusting rebar staining, and open joints at tile nosing - leakage below.

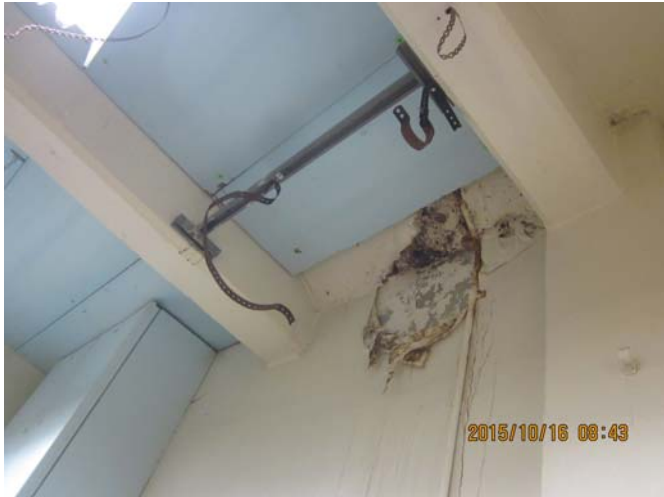
AR-009 – Water damage in basement electrical room -
at underside of loading dock stair.

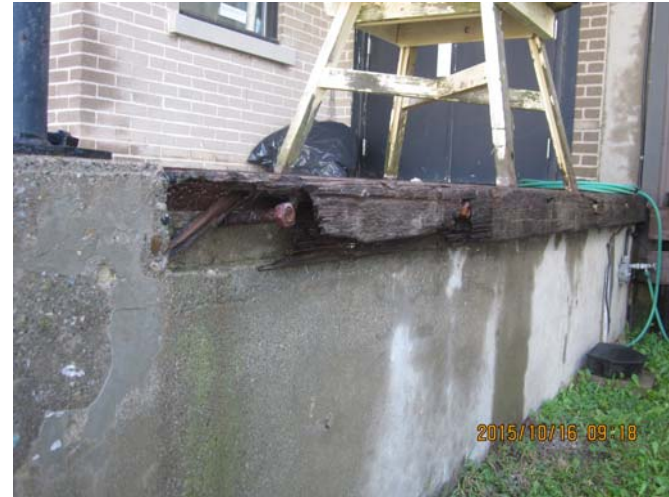
AR-010 – Deteriorated wood bumper at loading dock edge.

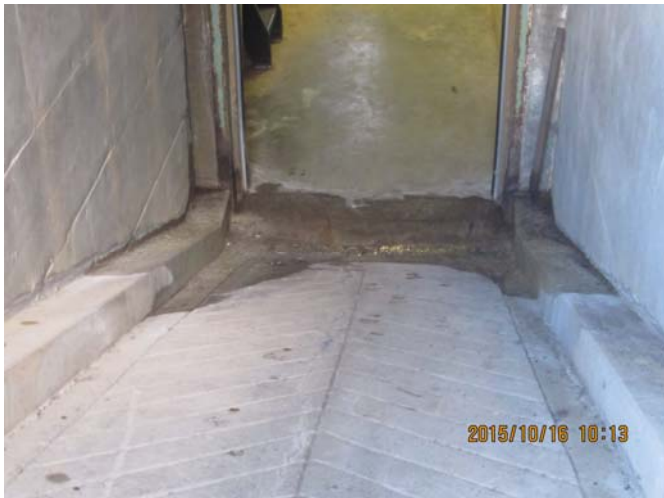
AR-011 – Water at bottom of basement access ramp.

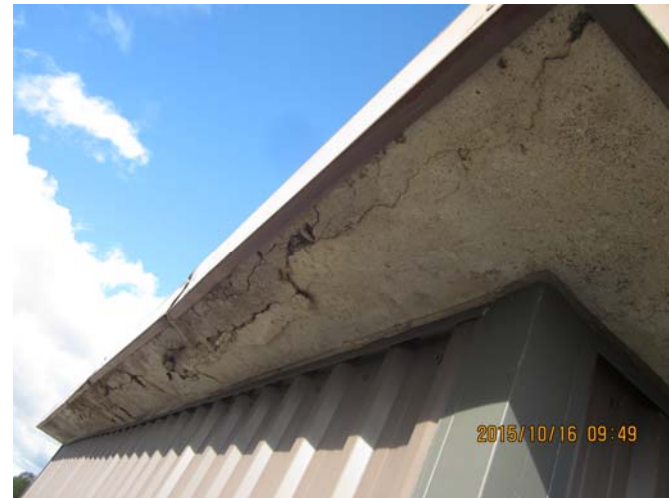
AR-012 – Deteriorated concrete at underside of penthouse roof slab.

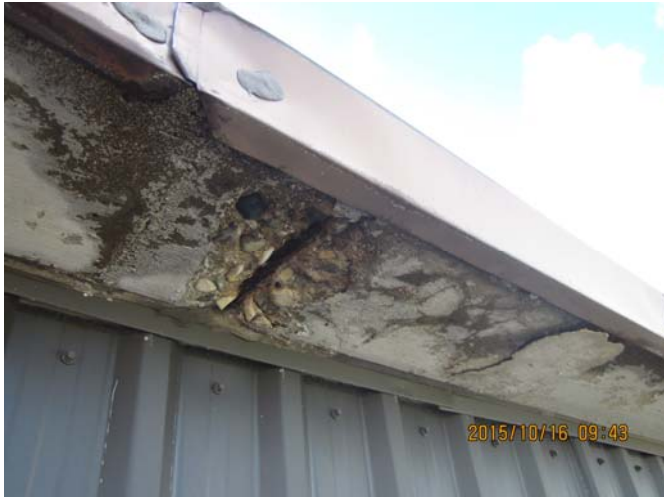
AR-013 – Spalled concrete and exposed rebar with corroded surface at underside of penthouse roof slab.

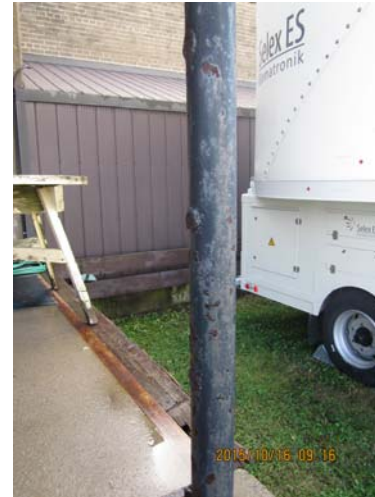
AR-014 – Deteriorated paint finish and corroded metal surfaces at loading dock canopy column.

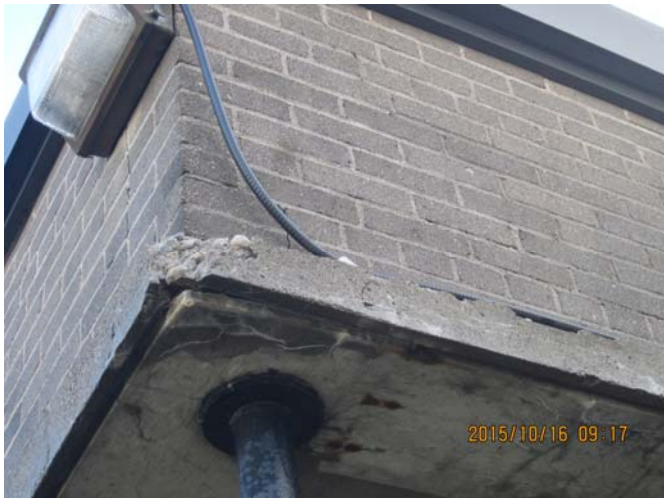
AR-015 – Deteriorated concrete along top edge of loading dock canopy.

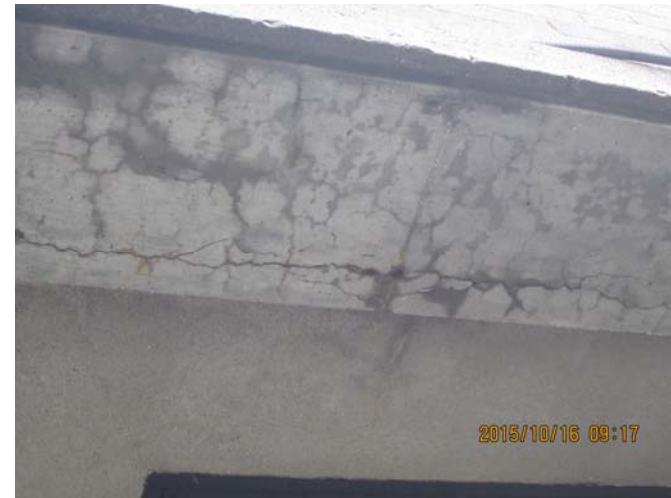
AR-016 – Deteriorated concrete at underside of loading dock canopy.

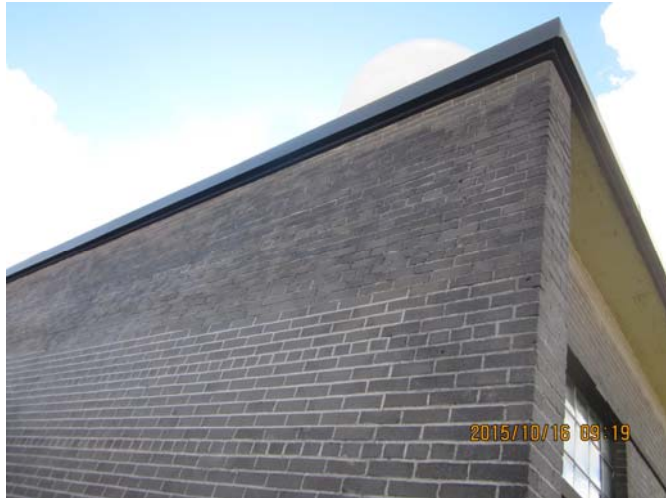
AR-017 – Deteriorated mortar joints at north elevation (area above classroom ceiling).

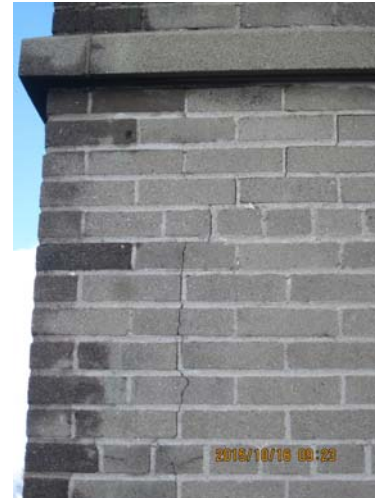
AR-018 – Crack through upper portion of masonry wall.

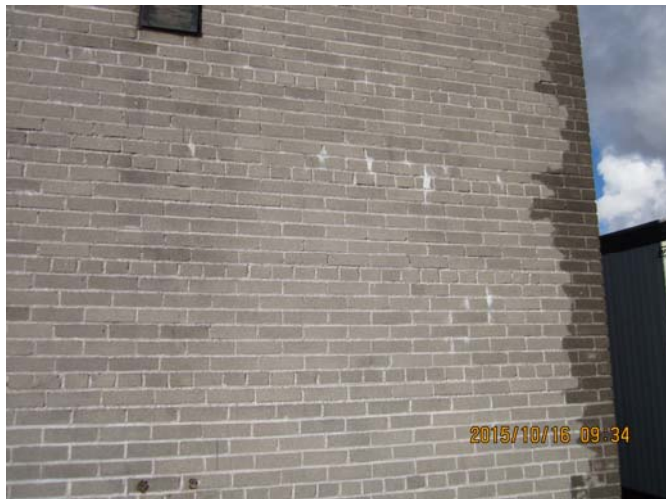
AR-019 – Stained masonry surfaces on east elevation.

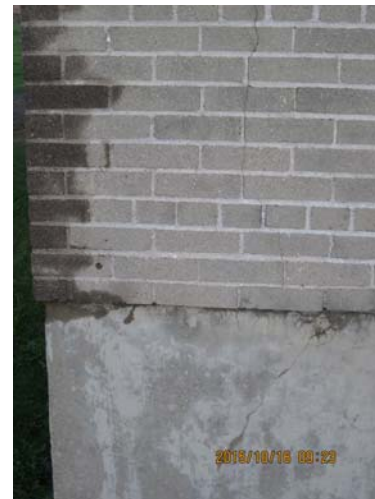
AR-020 – Crack through foundation and lower portion of masonry wall.

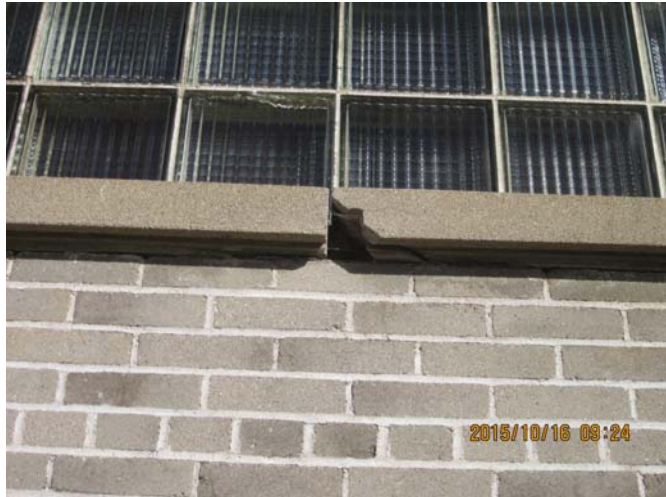
AR-021 – Broken concrete window sill.

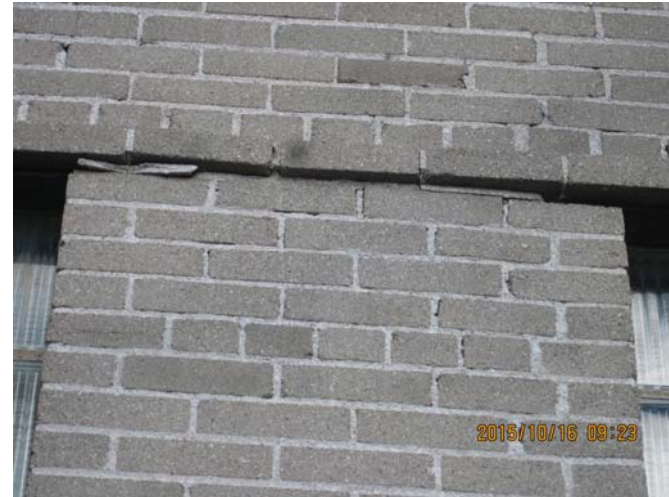
AR-022 – Deteriorating mortar at ends of rusting lintels.

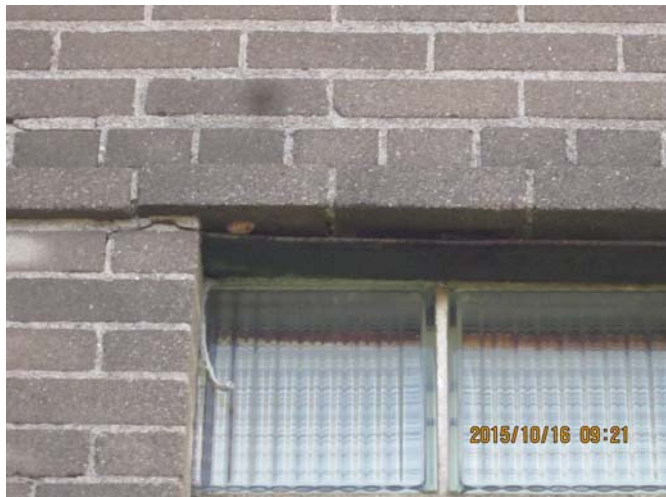
AR-023 – Rusting and deformed lintel and deteriorated sealant at glass block head.

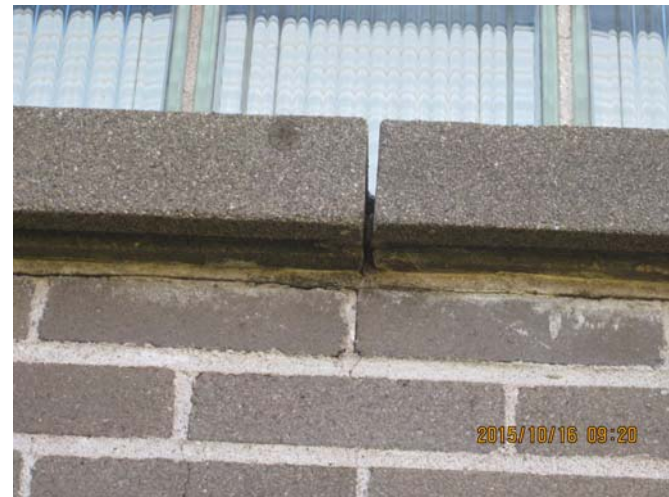
AR-024 – Open joint at concrete window sill.

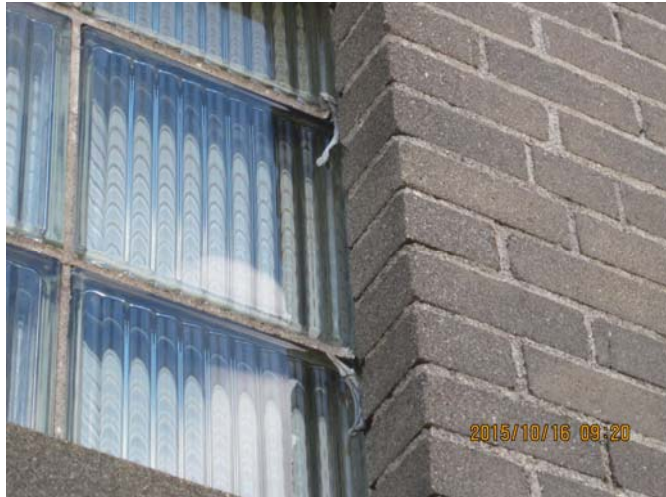
AR-025 – Deteriorated sealant at glass block jamb.

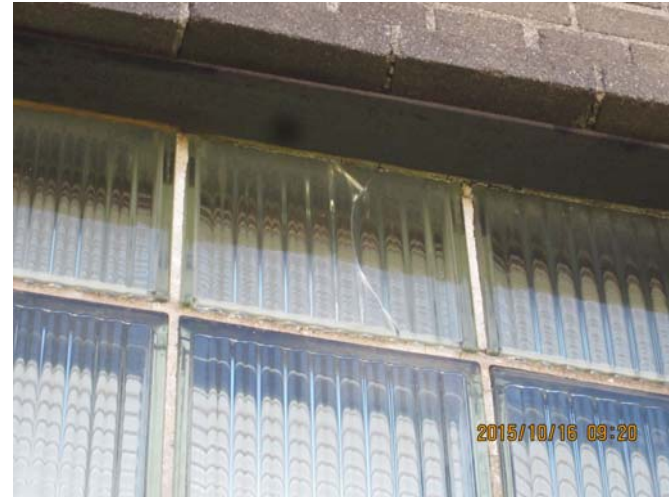
AR-026 – Cracked glass block.

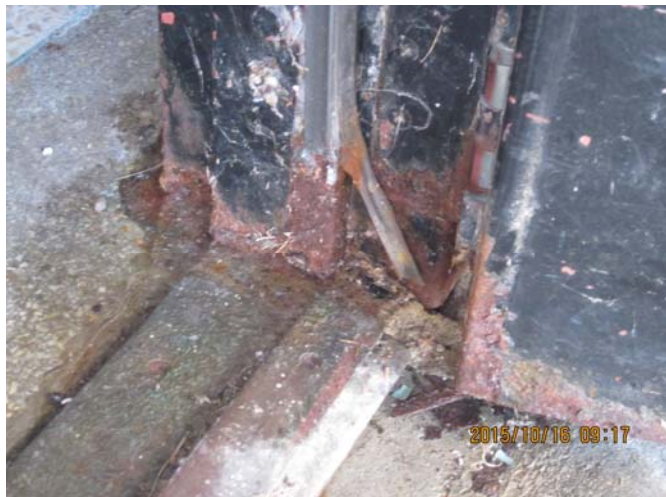
AR-027 – Deteriorated metal at bottom of door and frame.

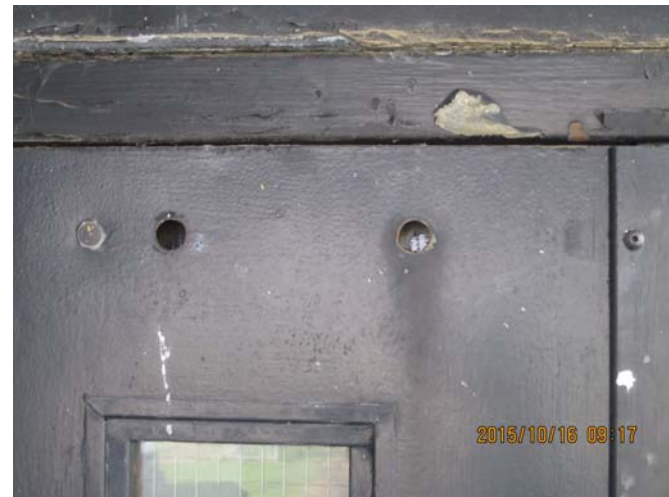
AR-028 – Unsealed holes at door outer surface.

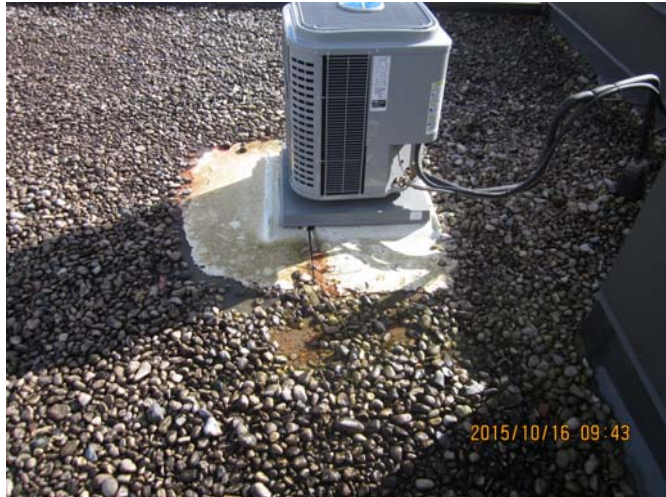
AR-029 – Deteriorated insulation pad below rooftop equipment.

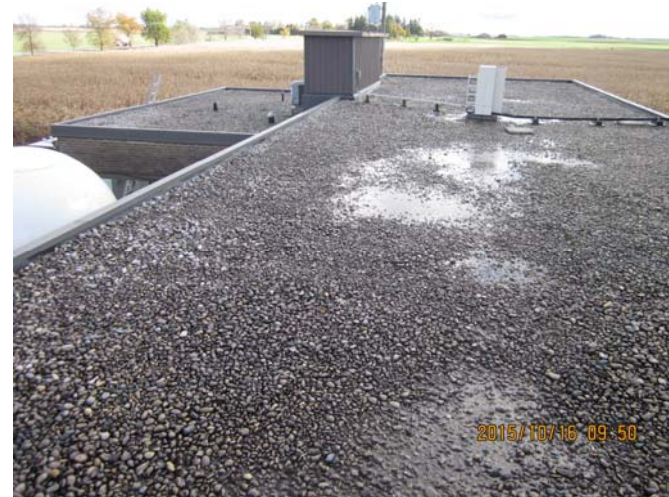
AR-030 – Standing water throughout roof areas.

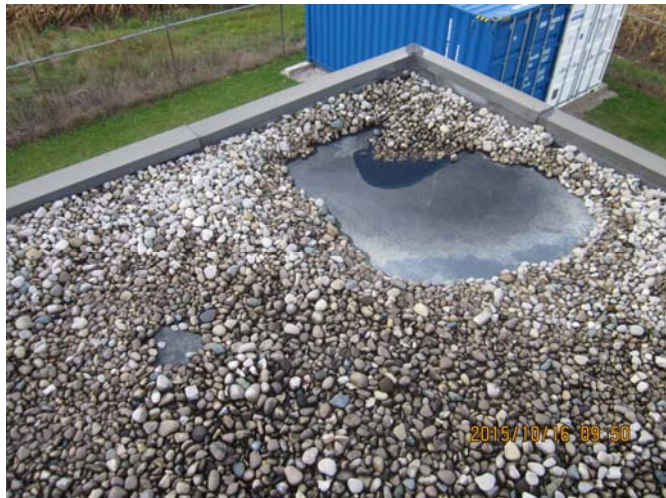
AR-031 – Ballast scouring at southwest corner of upper roof area.

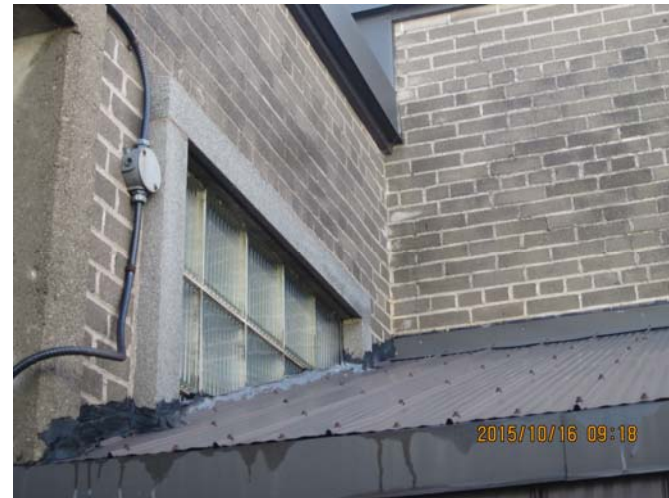
AR-032 – Metal roofing not flashed into wall along edge.

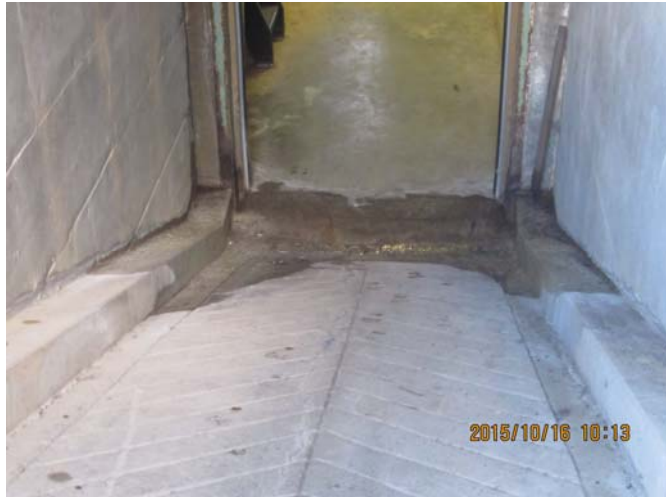
AR-033 – Leakage/seepage at bottom of basement access ramp.

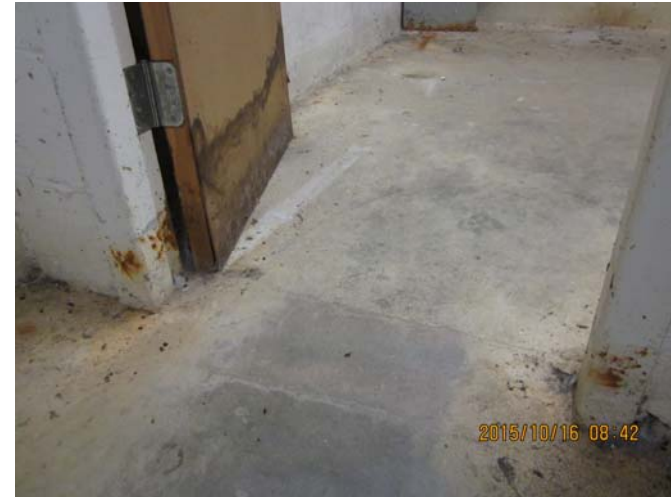
AR-034 – Water damaged door, frame, finishes and electrical equipment at basement electrical room adjacent to access ramp.

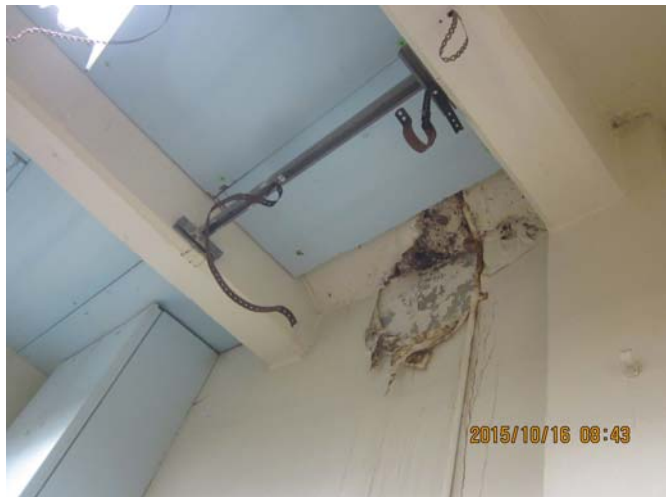
AR-035 – Leakage and damaged finishes in electrical room below exterior stair. Also, inconsistent application of insulation.

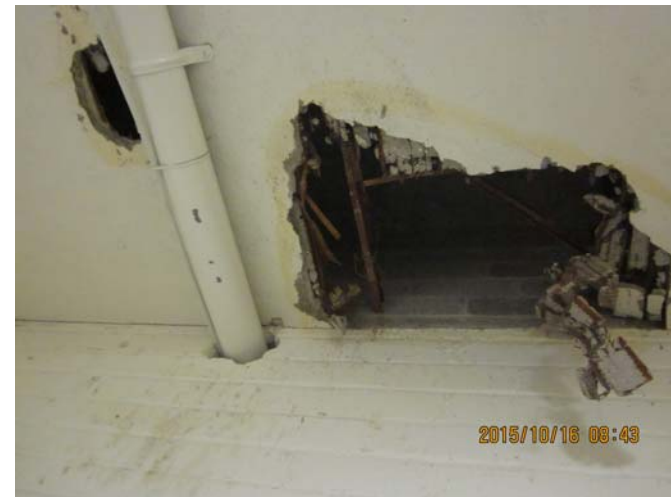
AR-036 – Several damaged areas of suspended plaster ceiling in northeast room of basement – reason unknown.

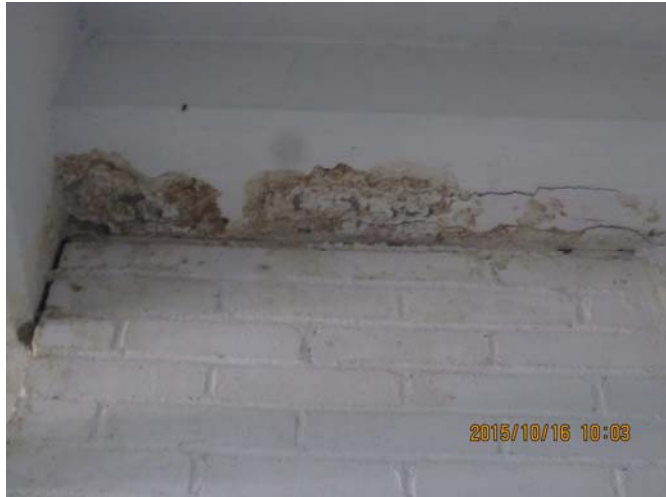
AR-037 – Water damage at underside of penthouse.

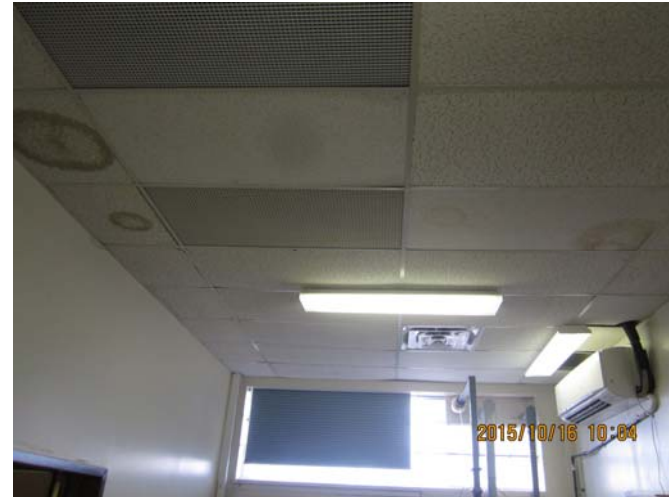
AR-038 – Water damaged ceiling tiles in office area.

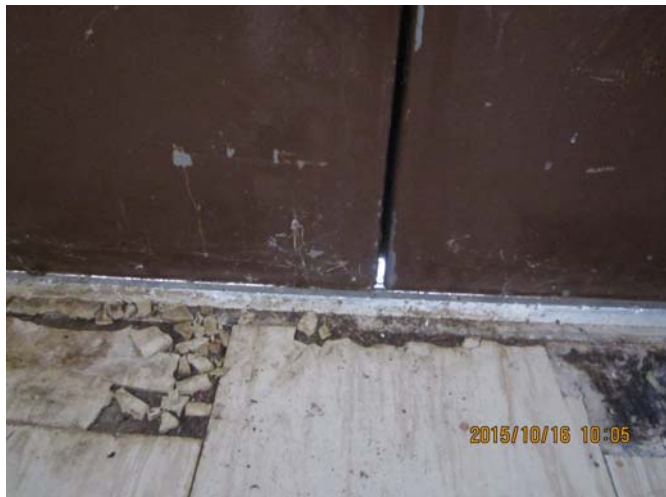
AR-039 – Deteriorating vinyl tile flooring and daylight visible at door edges and sills.

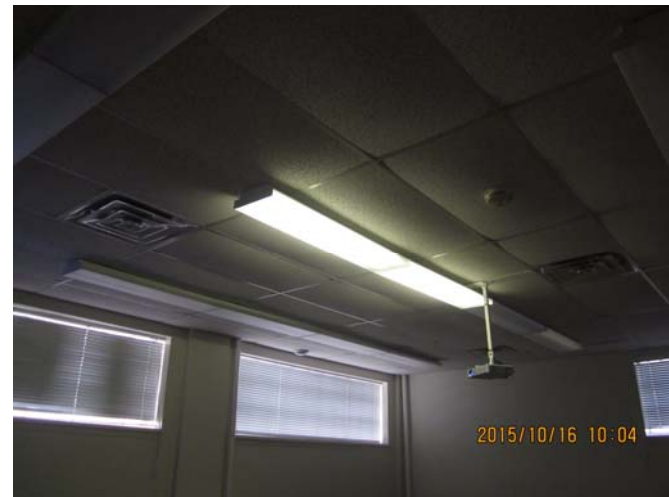
AR-040 – Warped ceiling tiles throughout classroom.

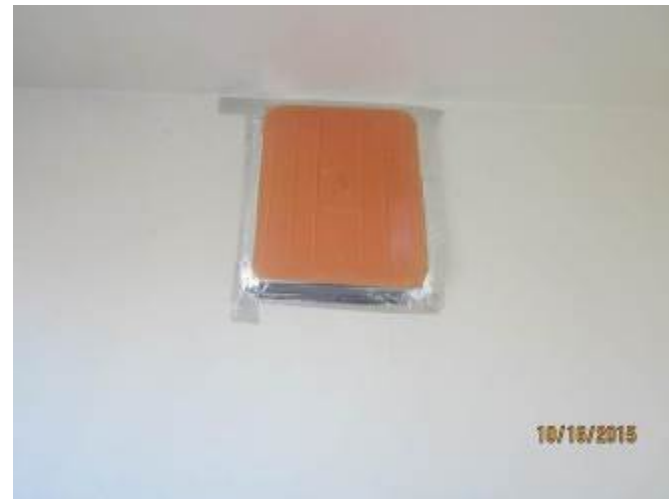
ME-016 – Obstructed exhaust fan (kitchen).

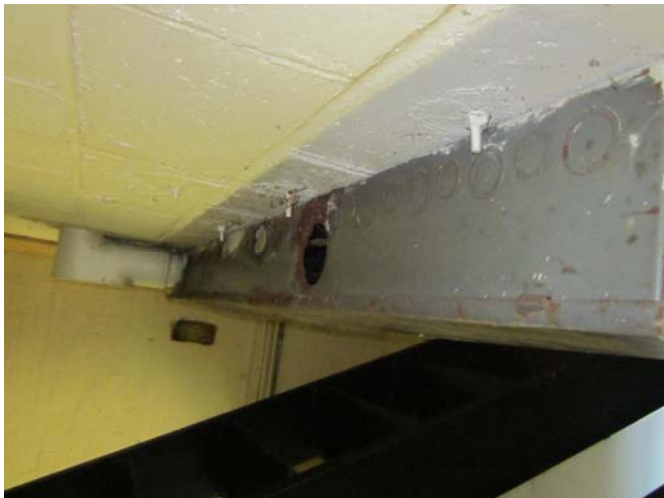
EL-003 – Example of rust-out on service equipment.

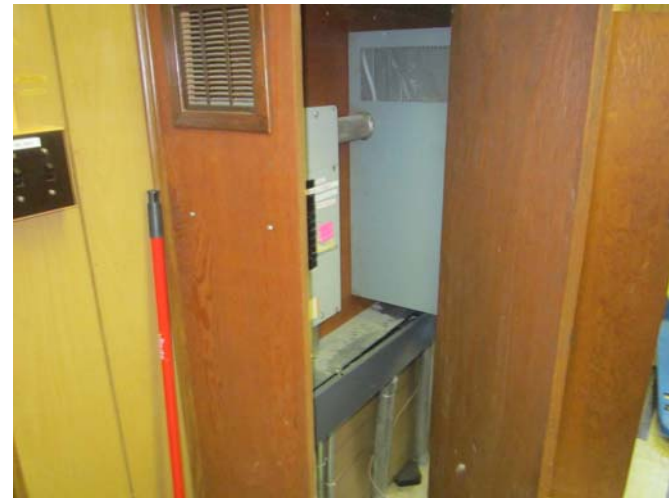
EL-004 – Electrical equipment installed in wood cabinets.

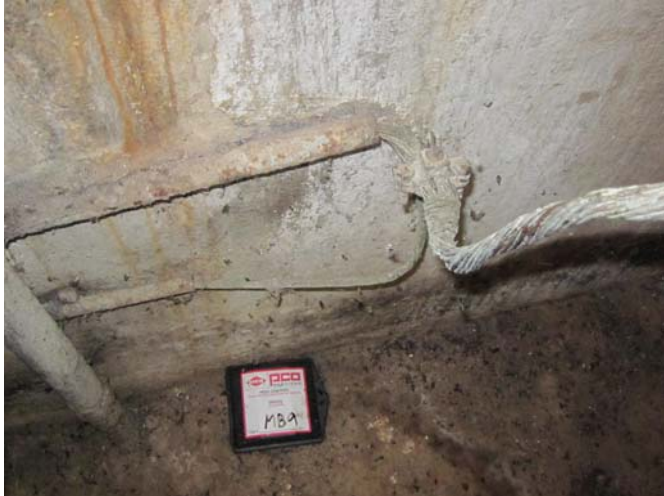
EL-005 – Corroded main facility electrical system grounding.

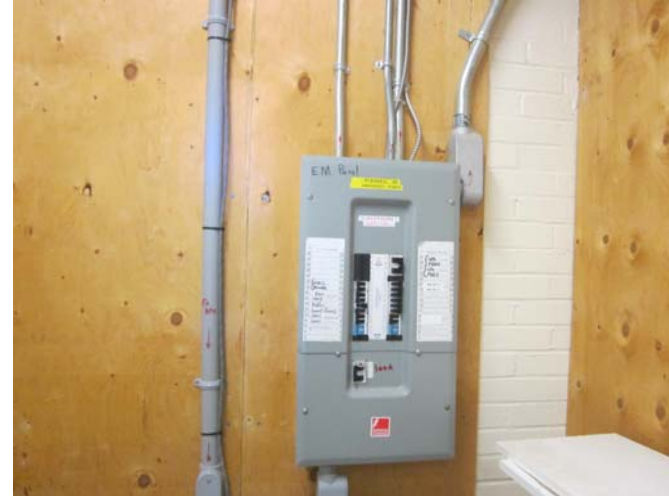
EL-006 – Overloaded emergency power panel.

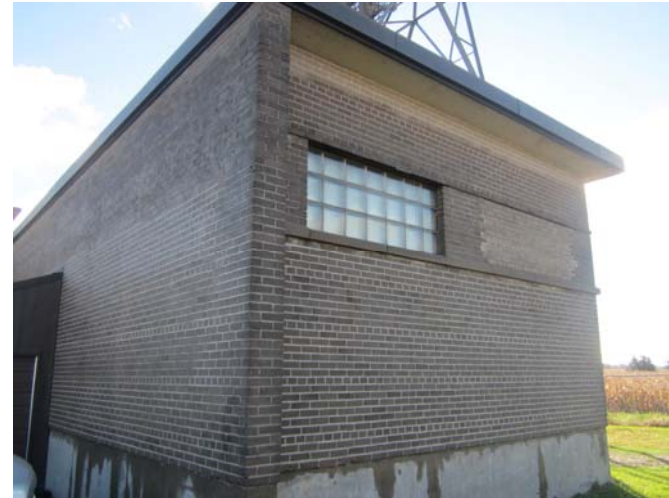
EL-014 – Example of no exterior lighting around facility.

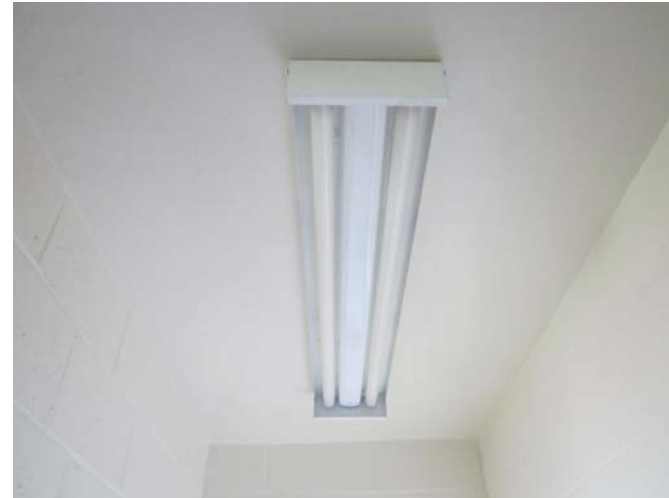
EL-018 – Typical older type lamps/no lens.

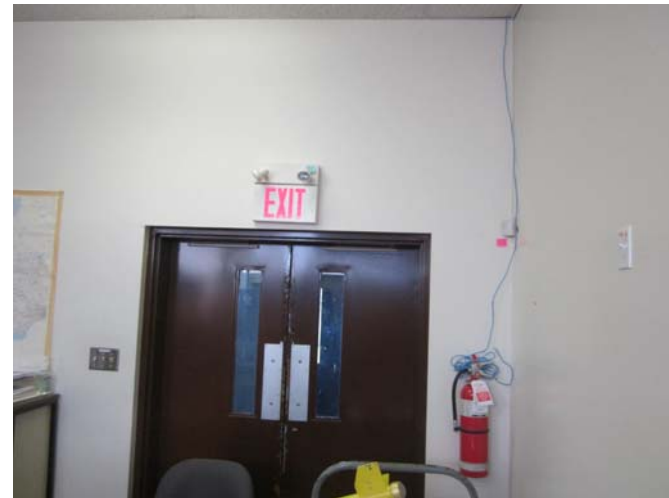
EL-020 – Minimal exit light (not code compliant).
