# **Waterton Lakes National Park Hazard Tree Assessment and Abatement**

**Prepared By: TDB Consultants Inc.**

**Prepared For: Parks Canada**

**April 2019**

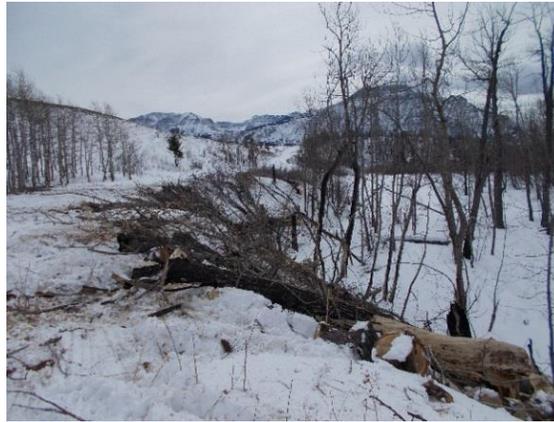
Site RR1 is comprised entirely of cottonwood with a stand of large diameter stems on the low side of the road and smaller diameter, shorter stems on the upper side of the road. The treatment area extends approximately 20 meters, from the road centerline, below the road and 12 meters above the road. 53 trees were felled, totaling 53.10 cubic meters.

Tree debris disposal recommendations are to leave, all stems located below the road and limb and buck to lay flat all smaller diameter stems on uphill side, disperse pieces in adjacent stand if required.

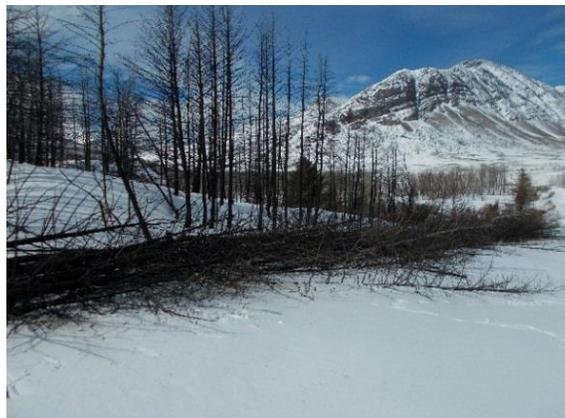
Site RR2 is primarily comprised of Douglas fir with a few scattered aspen. Tree felling occurred on a strip approximately 15 meters wide on both sides of the road. 87 trees were felled totaling 22.99 cubic meters.

The recommended debris disposal method is to remove the trees with a rubber tracked mini excavator capable of processing the stems. Processed logs and limbs will be piled at the roadside to facilitate later removal through chipping and hauling offsite or loading debris into bins for removal.

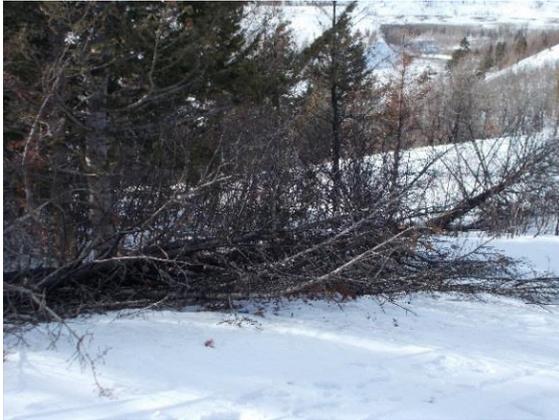
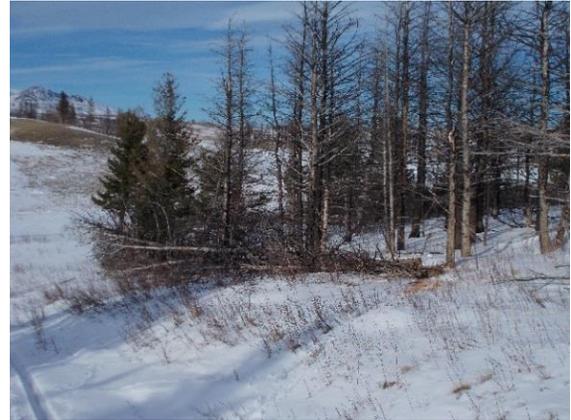
Site RR3 is comprised entirely of Douglas fir located on both sides of the road, approximately 15 meters from the road centerline. 19 trees were felled, totaling 6.06 cubic meters.

The recommended debris disposal method is to remove the trees with a rubber tracked mini excavator capable of processing the stems. Processed logs and limbs will be piled at the roadside to facilitate later removal through chipping and hauling offsite or loading debris into bins for removal.

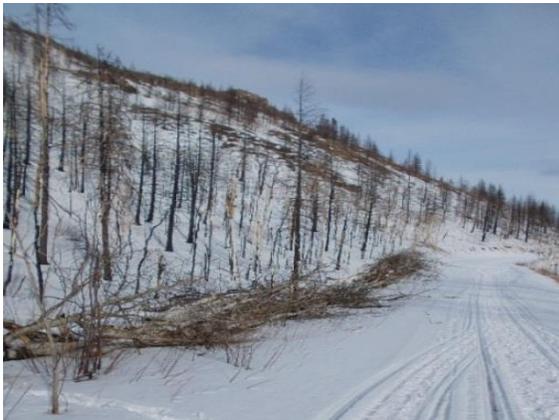
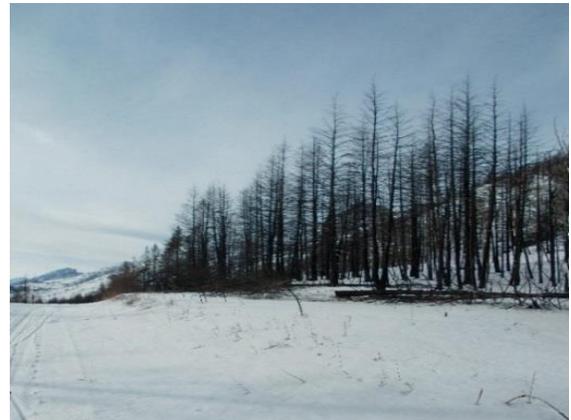
Site RR4 is comprised of mixed Douglas fir and aspen approximately 15 meters wide on the uphill side of the road. 58 trees were felled, totaling 12.57 cubic meters.

The recommended debris disposal method is to remove the trees with a rubber tracked mini excavator capable of processing the stems. Processed logs and limbs will be piled at the roadside to facilitate later removal through chipping and hauling offsite or loading debris into bins for removal.

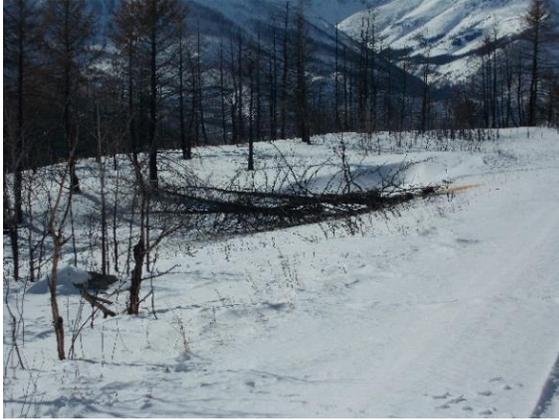
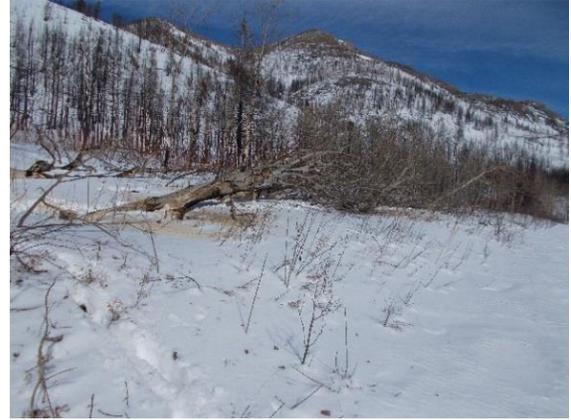
Site RR5 is primarily comprised of aspen with a few scattered Douglas fir located within 15 meters of the road centerline on both sides of the road. 42 trees were felled, totaling 17.70 cubic meters.

Tree debris disposal recommendations include collecting the Douglas fir for use as firewood or buck to lay flat all stems and leave on site as per the BMPs for Watershed-Scale Danger Tree Removal.

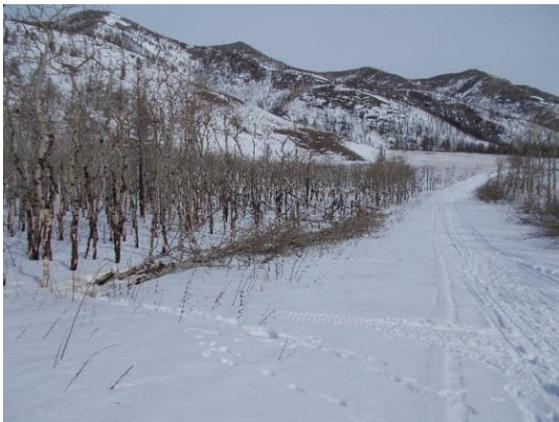
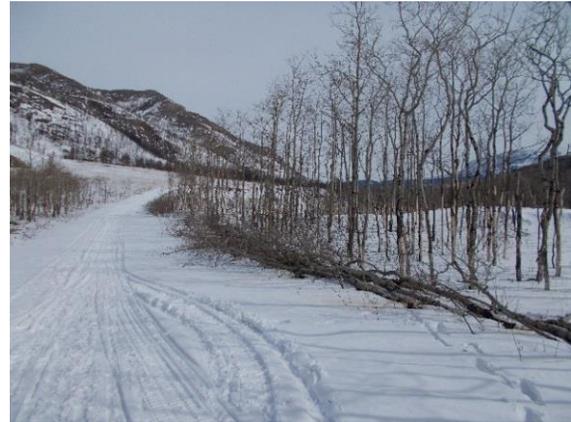
Site RR6 is comprised entirely of aspen located on both sides of the road approximately 12m from the road centerline. 93 trees were felled, totaling 8.37 cubic meters.

The recommended debris disposal method is to remove the trees with a rubber tracked mini excavator capable of processing the stems. Processed logs and limbs will be piled at the roadside to facilitate later removal through chipping and hauling offsite or loading debris into bins for removal.

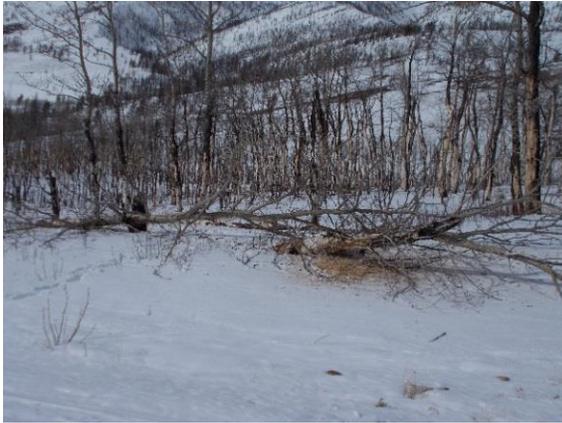
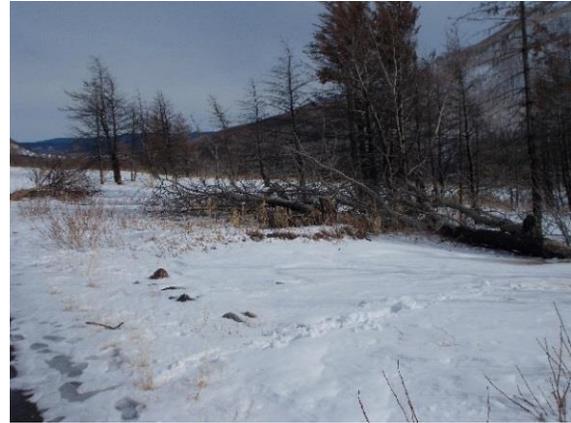
Site RR7 is comprised entirely of aspen located on both sides of the road, approximately 15 meters from the centerline. 10 trees were felled, totaling 3.53 cubic meters.

The recommended debris disposal method is to remove the trees with a rubber tracked mini excavator capable of processing the stems. Processed logs and limbs will be piled at the roadside to facilitate later removal through chipping and hauling offsite or loading debris into bins for removal.

Alternatively, buck to lay flat and leave on site as per the BMPs for Watershed-Scale Danger Tree Removal.

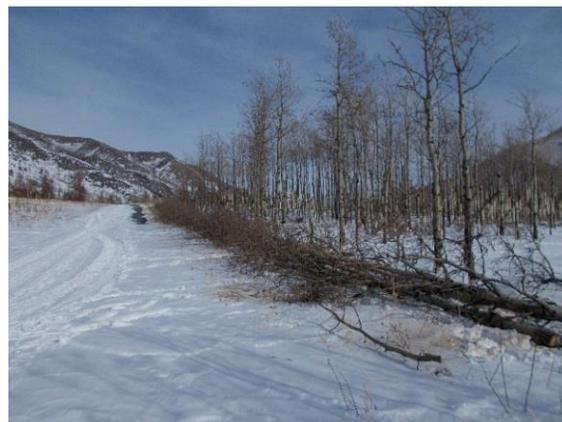
Site RR8 is comprised entirely of aspen located in a strip approximately 12 meters wide on one side of the road. 195 trees were felled, totaling 13.46 cubic meters.

The recommended debris disposal method is to remove the trees with a rubber tracked mini excavator capable of processing the stems. Processed logs and limbs will be piled at the roadside to facilitate later removal through chipping and hauling offsite or loading debris into bins for removal.

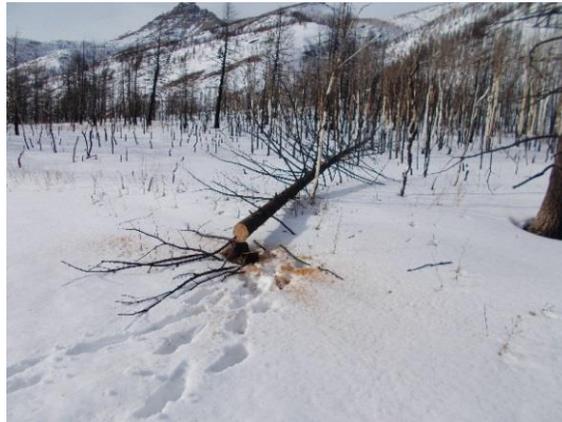
Site RR9 is comprised of a single Douglas fir tree totaling 0.29 cubic meters.

No debris disposal is recommended. Leave tree as is on site, no ladder fuel risk exists.

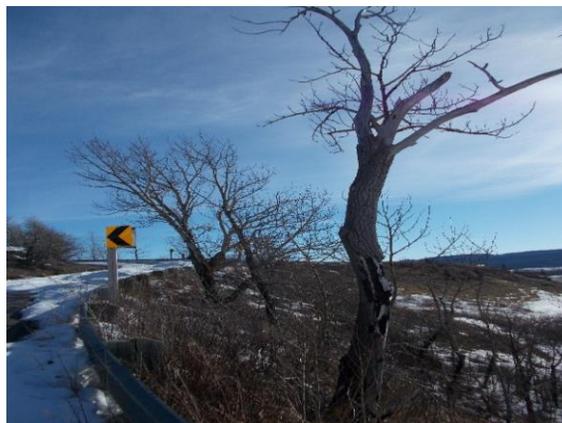
Site RR10 is comprised entirely of scattered cottonwood located on the downhill side of the road. 5 trees were felled, totaling 1.45 cubic meters.

No debris disposal is recommended. Leave trees as is on site, no ladder fuel risk exists.

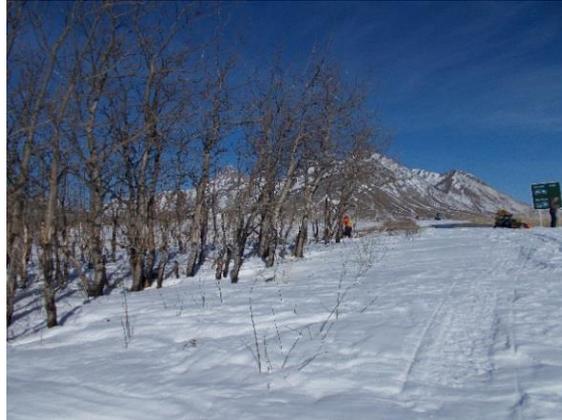
Site RR11 is comprised entirely of aspen located on one side of the road, approximately 12 meters from the road centerline. 26 trees were felled, totaling 2.08 cubic meters.

The recommended debris disposal method is to remove the trees with a rubber tracked mini excavator capable of processing the stems. Processed logs and limbs will be piled at the roadside to facilitate later removal through chipping and hauling offsite or loading debris into bins for removal. Alternatively, buck to lay flat and leave on site.

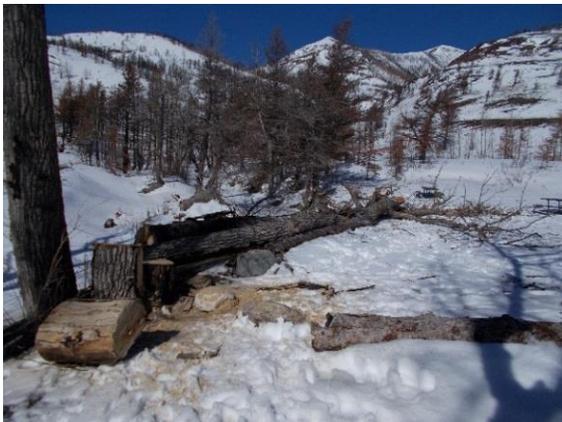
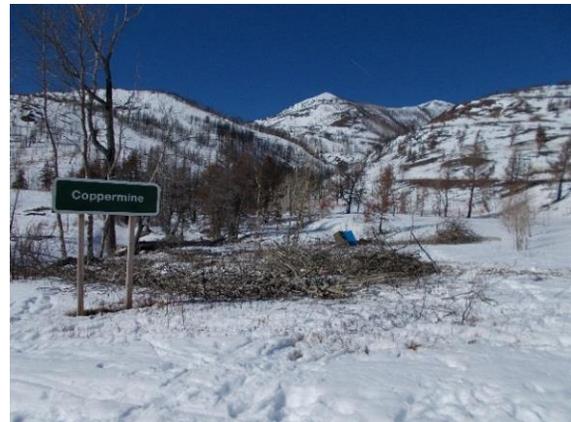
Site RR12 is comprised entirely of cottonwood located on both sides of the road at the entrance to the Coppermine day use area. The treatment area extends approximately 20 meters to the uphill side of the road and 15 meters below the road. 28 trees were felled, totaling 13.38 cubic meters. One telegraph insulator was found on a cottonwood tree located across the creek from the day use area. The tree was retained, GPS'd and photographed with the resulting data provided to Parks Canada.

Tree debris disposal recommendations include leaving, all large diameter cottonwood stems located adjacent to the creek. Remove the remaining felled trees with a rubber tracked mini excavator capable of processing the stems. Processed logs and limbs will be piled to facilitate later removal through chipping and hauling offsite or loading debris into bins for removal.

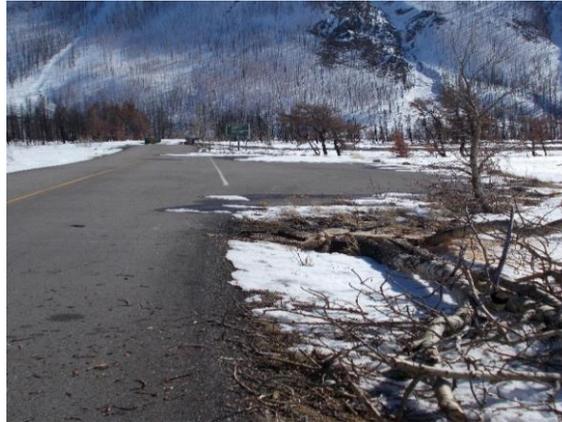
Site RR13 is comprised of scattered cottonwood located at either end of a pullout area. 4 trees were felled, totaling 0.62 cubic meters.

The recommended debris disposal method is to remove the trees with a rubber tracked mini excavator capable of processing the stems. Processed logs and limbs will be piled at the roadside to facilitate later removal through chipping and hauling offsite or loading debris into bins for removal.

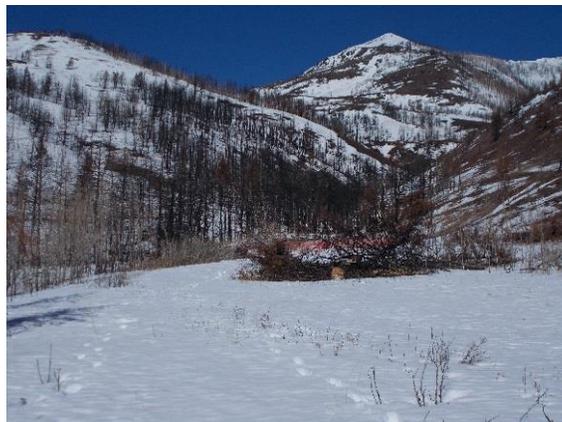
Site RR14 is primarily comprised of aspen with a few scattered Douglas fir located within the Coppermine day use area. 32 trees were felled, totaling 5.89 cubic meters.

The recommended debris disposal method is to remove the trees with a rubber tracked mini excavator capable of processing the stems. Processed logs and limbs will be piled to facilitate later removal through chipping and hauling offsite or loading debris into bins for removal.

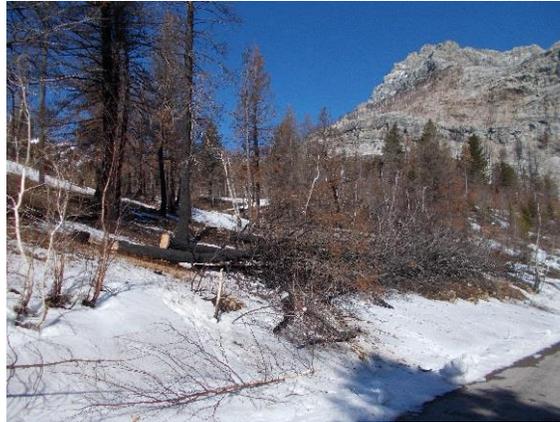
Site AK1 is comprised entirely of Douglas fir located on uphill side of the road, approximately 25 meters from the road centerline. 13 trees were felled, totaling 15.21 cubic meters.

The recommended debris disposal method is to remove the trees with a rubber tracked mini excavator capable of processing the stems. Processed logs and limbs will be piled at the roadside to facilitate later removal through chipping and hauling offsite or loading debris into bins for removal.

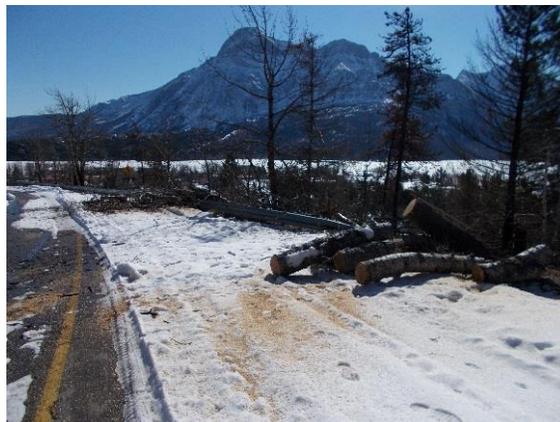
Site AK2 is comprised entirely of cottonwood located approximately 12 meters from the centerline on the downhill side of the road. 5 trees were felled, totaling 5.22 cubic meters.

The recommended debris disposal method is to remove the trees with a rubber tracked mini excavator capable of processing the stems. Processed logs and limbs will be piled at the roadside to facilitate later removal through chipping and hauling offsite or loading debris into bins for removal.

Alternatively, buck to lay flat, leave on site, dispersing in the adjacent stand as required.

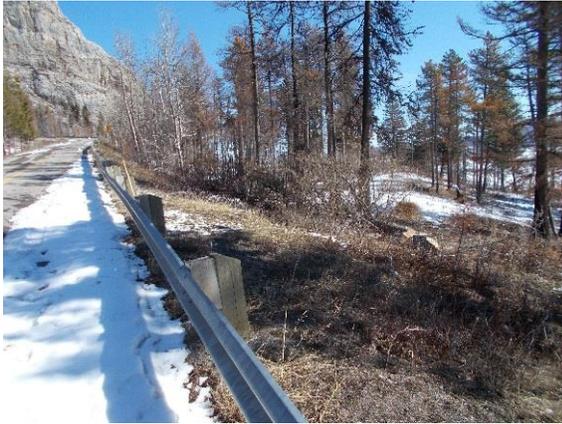
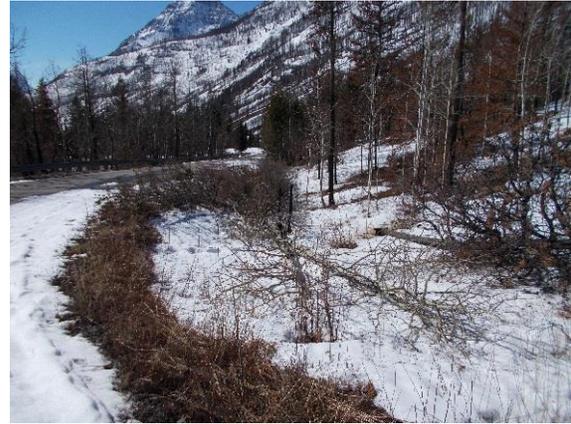
Site AK3 is comprised of a mix of species, Douglas fir, pine, spruce, aspen and birch located 15 meters from the road centerline on both sides of the road. 84 trees were felled, totaling 29.07 cubic meters.

The recommended debris disposal method is to remove the trees with a rubber tracked mini excavator capable of processing the stems. Processed logs and limbs will be piled at the roadside to facilitate later removal through chipping and hauling offsite or loading debris into bins for removal.

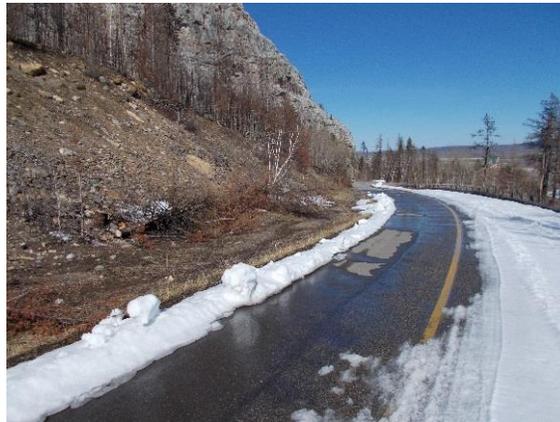
Site AK4 is primarily comprised of Douglas fir with a few scattered aspen and birch located on the uphill side of the road, approximately 15 meters from the road centerline. 37 trees were felled, totaling 5.14 cubic meters.

The recommended debris disposal method is to remove the trees with a rubber tracked mini excavator capable of processing the stems. Processed logs and limbs will be piled at the roadside to facilitate later removal through chipping and hauling offsite or loading debris into bins for removal.

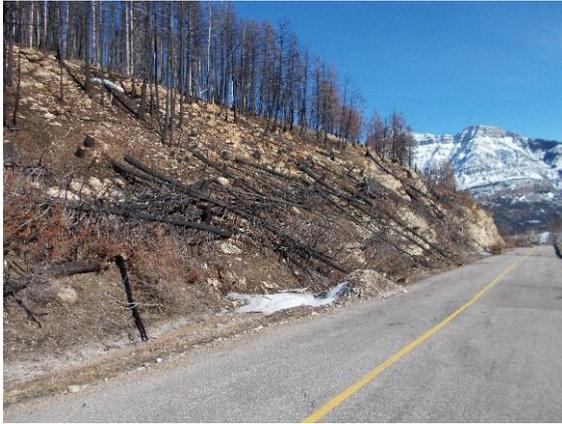
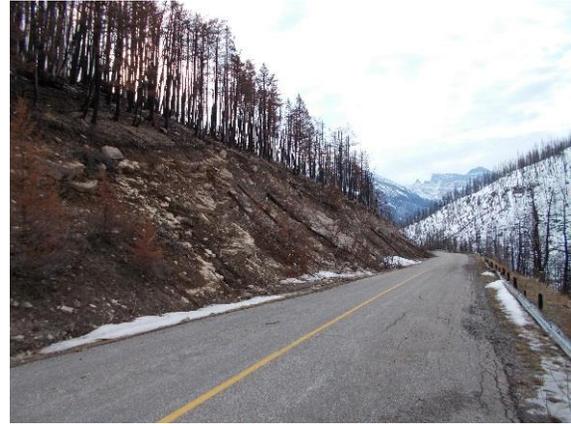
Site AK5 is primarily comprised of Douglas fir with a few scattered pine located within 15 meters of the road centerline on the uphill side of the road. 79 trees were felled, totaling 17.85 cubic meters.

The recommended debris disposal method is to remove the trees with a rubber tracked mini excavator capable of processing the stems. Processed logs and limbs will be piled at the roadside to facilitate later removal through chipping and hauling offsite or loading debris into bins for removal.

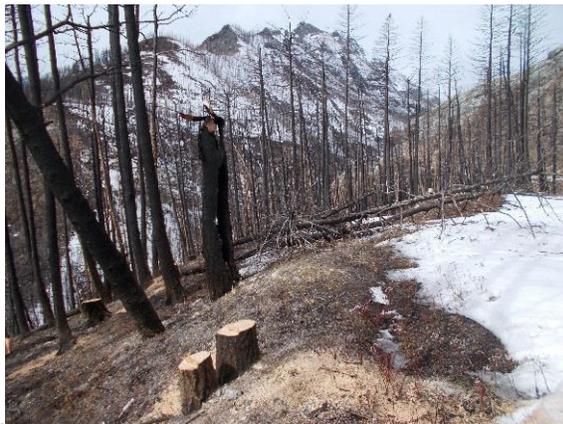
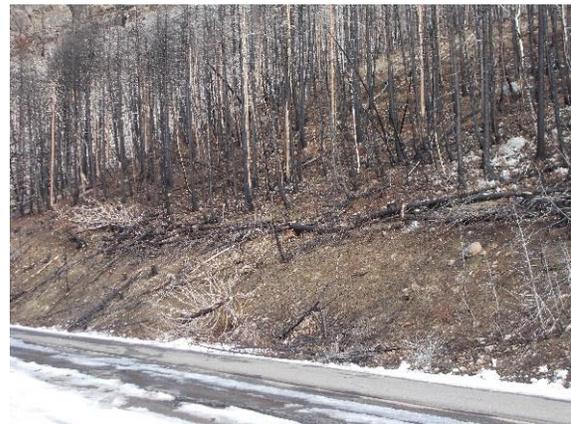
Site AK6 is comprised primarily of Douglas fir with scattered spruce, pine and aspen. The treatment area extended approximately 20 meters from the road centerline along both sides of the road. 213 trees were felled, totaling 77.96 cubic meters.

Tree debris disposal recommendations include leaving well anchored stems oriented parallel to the road on the uphill side as well as all stems located below the road on the downhill side. Remove the remaining trees with a rubber tracked mini excavator capable of processing the stems. Processed logs and limbs will be piled at the roadside to facilitate later removal through chipping and hauling offsite or loading debris into bins for removal.

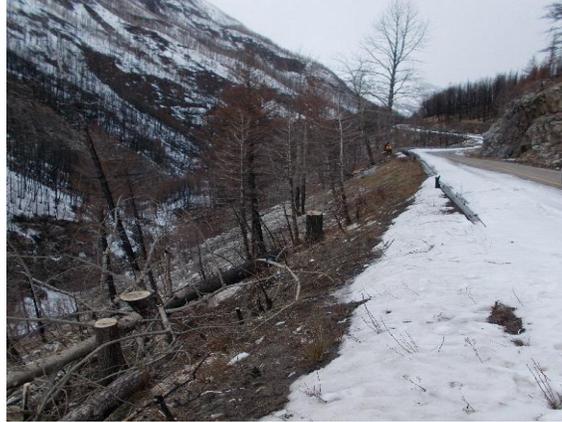
Site AK7 is comprised entirely of aspen located below the road. 4 trees were felled, totaling 2.61 cubic meters.

No debris disposal is recommended. Leave trees on site, no ladder fuel risk exists.

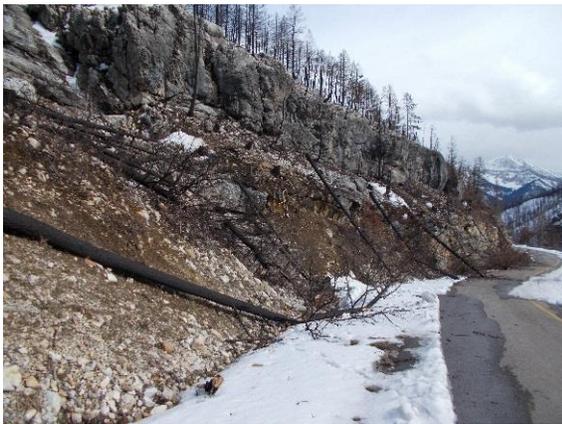
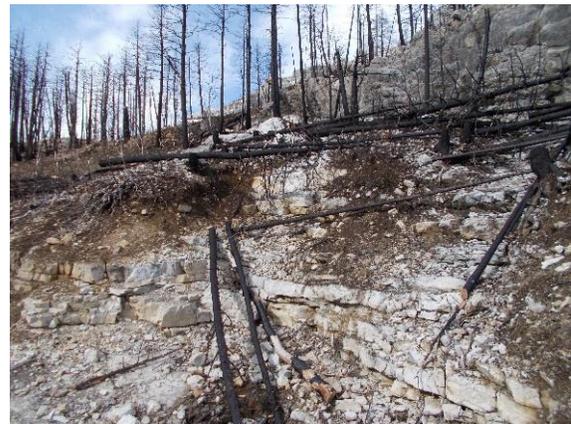
Site AK8 is comprised entirely of Douglas fir located approximately 20 meters from the road centerline above the road. 164 trees were felled, totaling 56.49 cubic meters.

Tree debris disposal recommendations include leaving well anchored stems oriented parallel to the road on the uphill side. Remove the remaining trees with a rubber tracked mini excavator capable of processing the stems. Processed logs and limbs will be piled at the roadside to facilitate later removal through chipping and hauling offsite or loading debris into bins for removal.

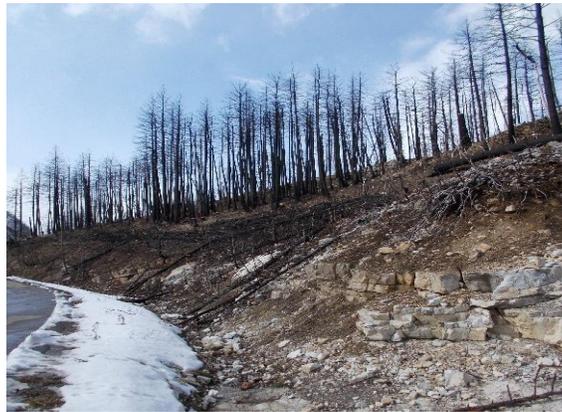
Site AK9 is comprised primarily of Douglas fir with scattered aspen located within 15 meters of the road centerline along both sides of the road. 136 trees were felled, totaling 39.59 cubic meters.

Tree debris disposal recommendations include leaving well anchored stems oriented parallel to the road on the uphill side as well as all stems located below the road on the downhill side. Remove the remaining trees with a rubber tracked mini excavator capable of processing the stems. Processed logs and limbs will be piled at the roadside to facilitate later removal through chipping and hauling offsite or loading debris into bins for removal.

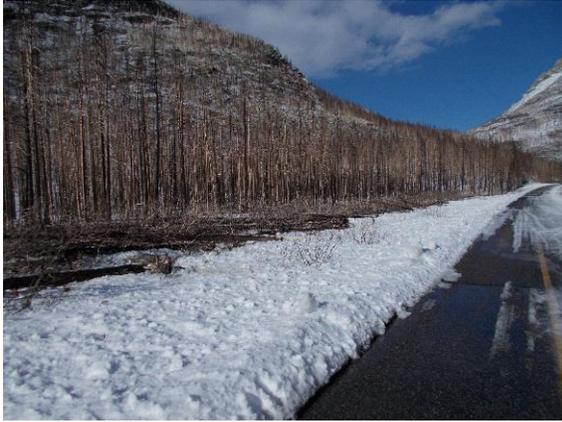
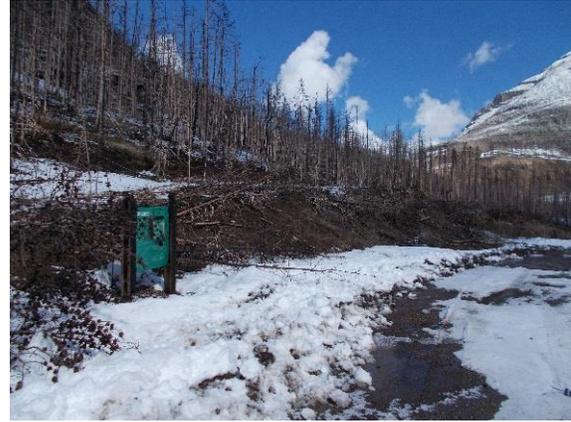
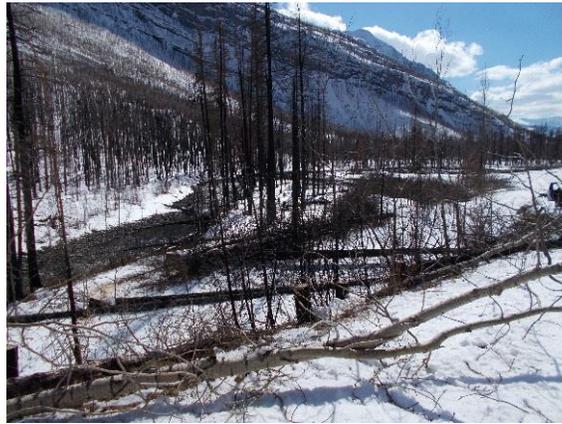
Site AK10 is an extensive site comprised primarily of pine with spruce, Douglas fir, balsam, cottonwood and aspen located along both sides of the road and the area surrounding McNeilly's Camp Site day use area. The treatment area extends approximately 15 meters from the road centerline above the road and 20 meters below the road. 1385 trees were felled, totaling 308.77 cubic meters. Three aspen wildlife trees were identified and retained on site.

Tree debris disposal recommendations include leaving on site, all cottonwood and aspen stems located adjacent to Cameron Creek, ensuring they are bucked to lay flat. Limb and buck to lay flat conifer stems located at the start of the Crandell Mountain Trail and leave on site to deter the development of further social trail leading to the parking area. Remove the remaining trees with a rubber tracked mini excavator capable of processing the stems. Processed logs and limbs will be piled at the roadside to facilitate later removal through chipping and hauling offsite or loading debris into bins for removal.

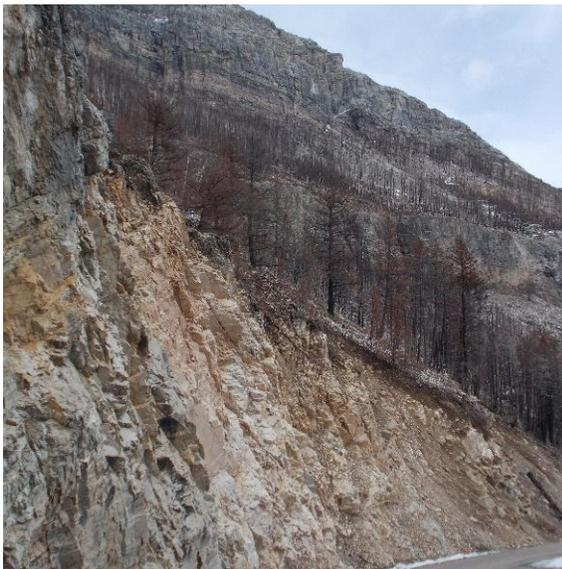
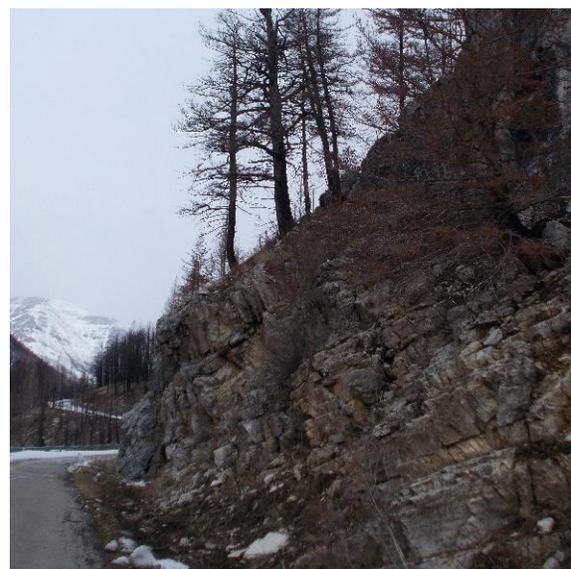
A small portion of the start of the Akamina Parkway was left untreated due to hazardous falling conditions. This area was a cliff face with fire killed Douglas fir above, located between site AK6 and AK7.
