PRE-RENOVATION HAZARDOUS MATERIALS BUILDING SURVEY - REVISED TECHNICAL SERVICES BUILDING

OCTOBER 4, 2018

PROJECT NO.: 181-00998-00 & 181-13191-00
DATE: OCTOBER 4, 2018

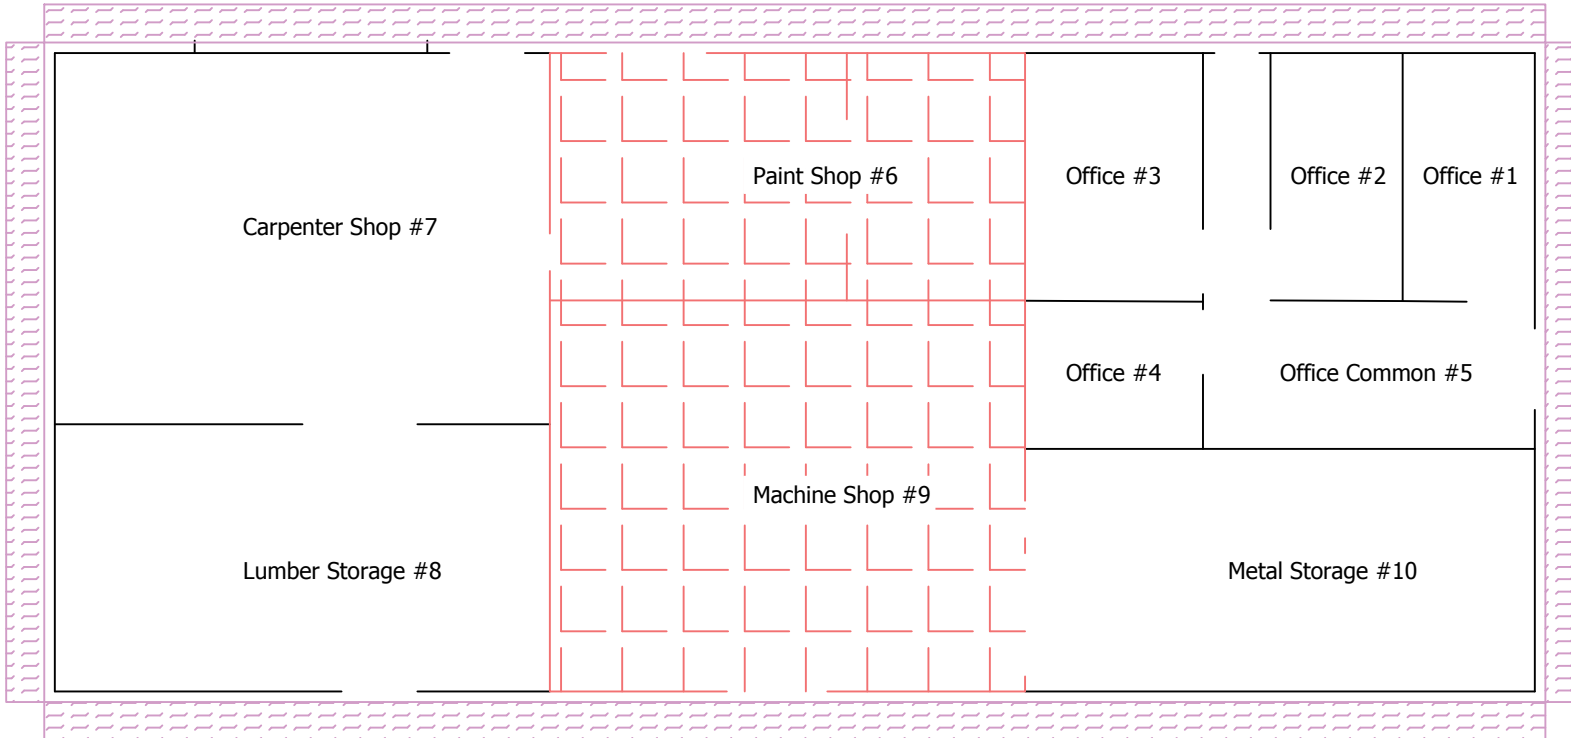
TITLE: Asbestos-Containing Composite Fibre Cement Board Paneling Plan
Pre Renovation Hazardous Building Materials Survey
Technical Services Building
3190 Hammond Bay Road, Nanaimo, BC
Fisheries and Oceans Canada

– Hard Fireproof Composite Fibre Cement Board Paneling (Transite Panel) lining the exterior sub-grade perimeter of the foundation floor slab (10 % Chrysotile). The outer slab perimeter covering of hard fireproof composite fibre cement board panelling extends in a vertical orientation downward from the top side of the base sill plate approximately 18” into the ground (not horizontally as indicated).

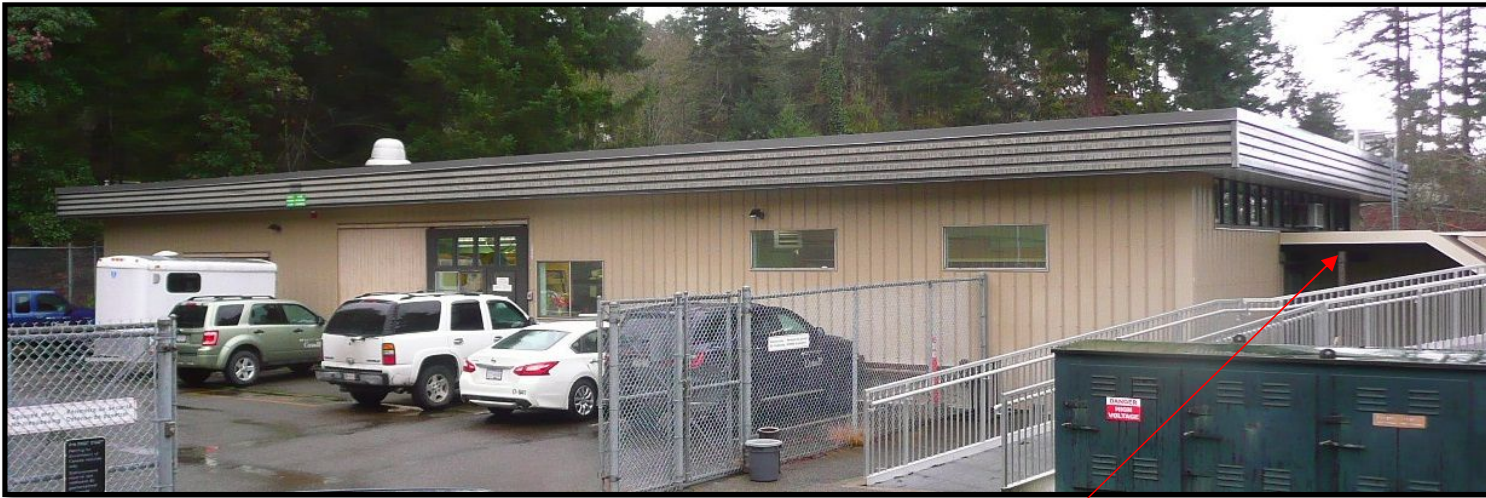
Technical Services Building west and south elevations with south staircase canopy (looking northeast).

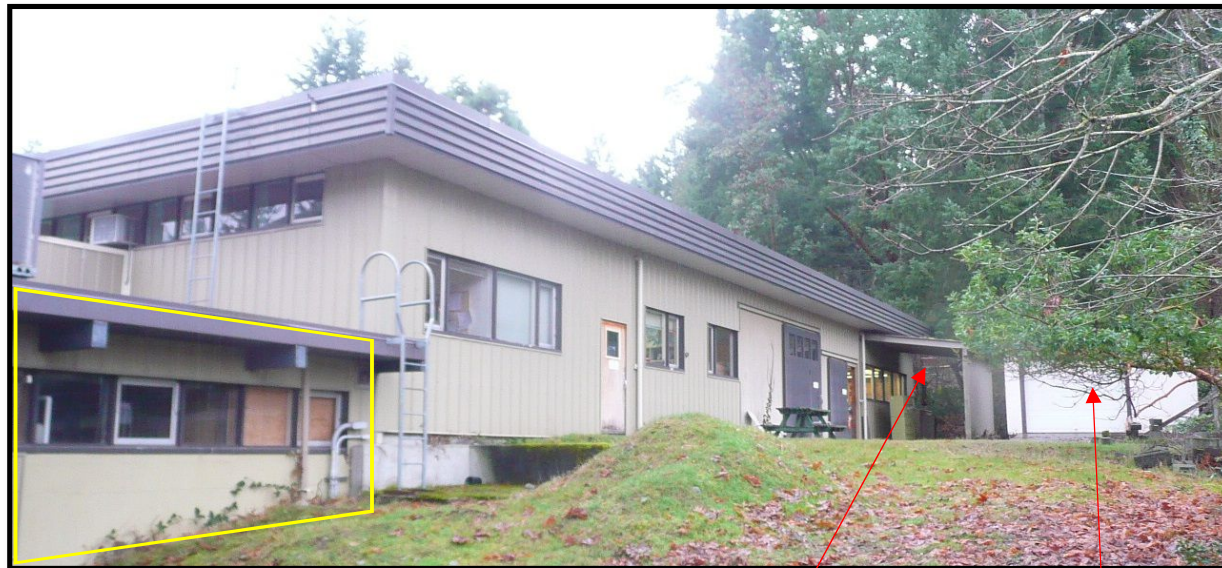
Technical Services Building south and east elevations with east attached open ended canopy, and detached storage shed (looking north-northwest).
The Furnace Breaker Building (yellow outlined lower left) was not included in the scope of this PHMS.

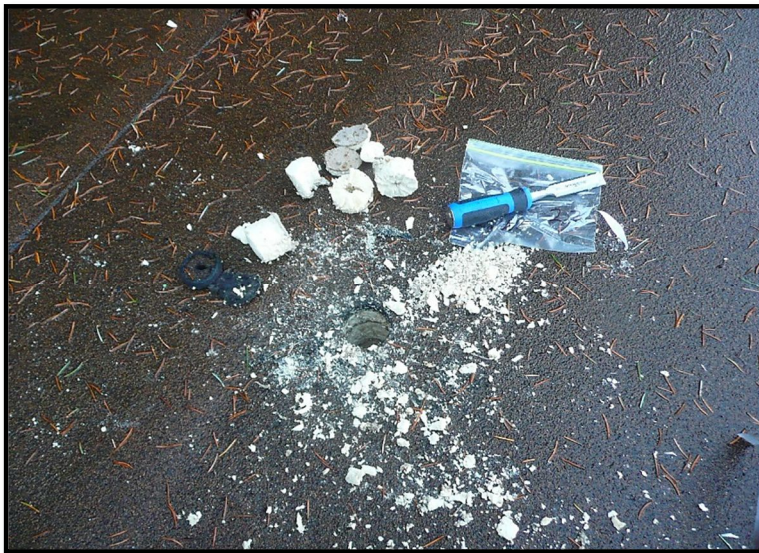
Roofing materials core layer Sample 17A-TSB-22 collected from the northeast portion of the Technical Services Building.

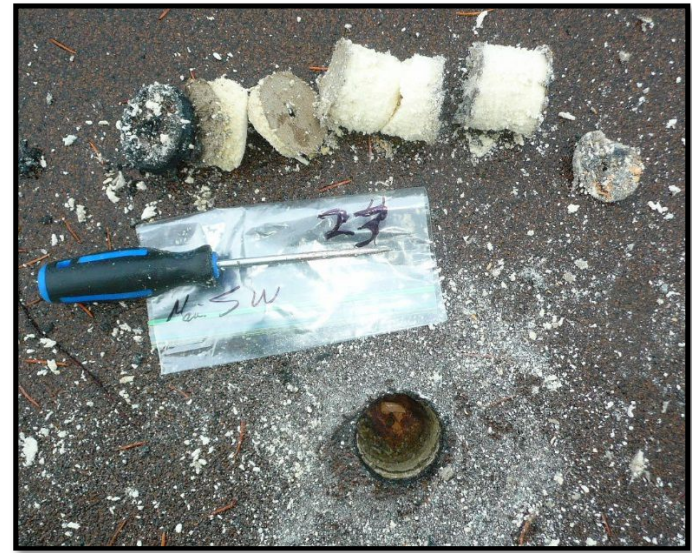
Roofing materials core layer Sample 17A-TSB-23 collected from the southwest portion of the Technical Services Building.

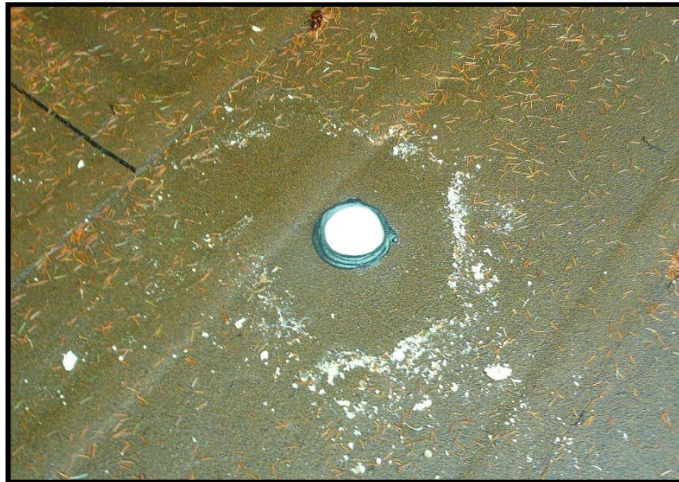
Post-core-sampling temporary fill and patch with flashing cap on the northeast portion of the Technical Services Building (not warranted).

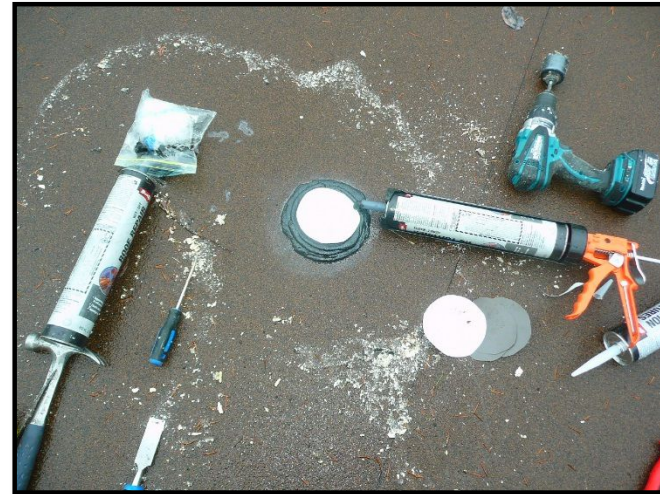
Post-core-sampling temporary fill and patch with flashing cap on the southwest portion of the Technical Services Building (not warranted).

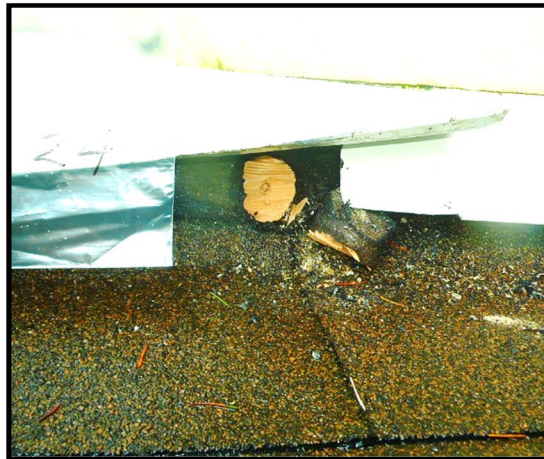
Roofing materials core layer Sample 17A-TSB-24 collected from the east cant strip under the flashing of the south staircase canopy. Subsequently filled and patched with flashing cap (not warranted).

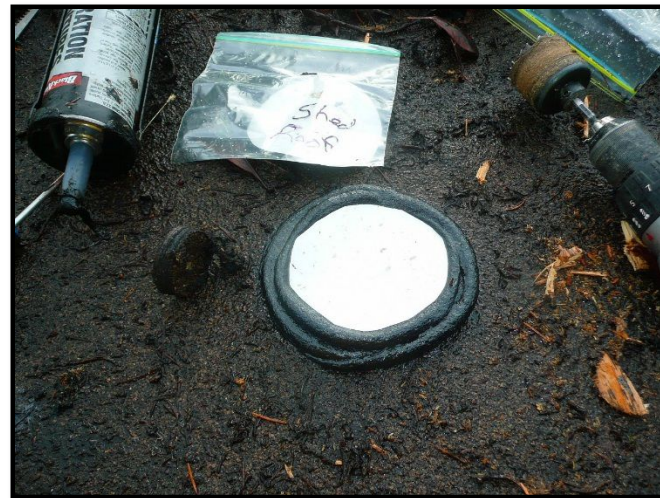
Post-core Sample 17A-TSB-25 temporary fill and patch with flashing cap on the detached storage shed (not warranted).

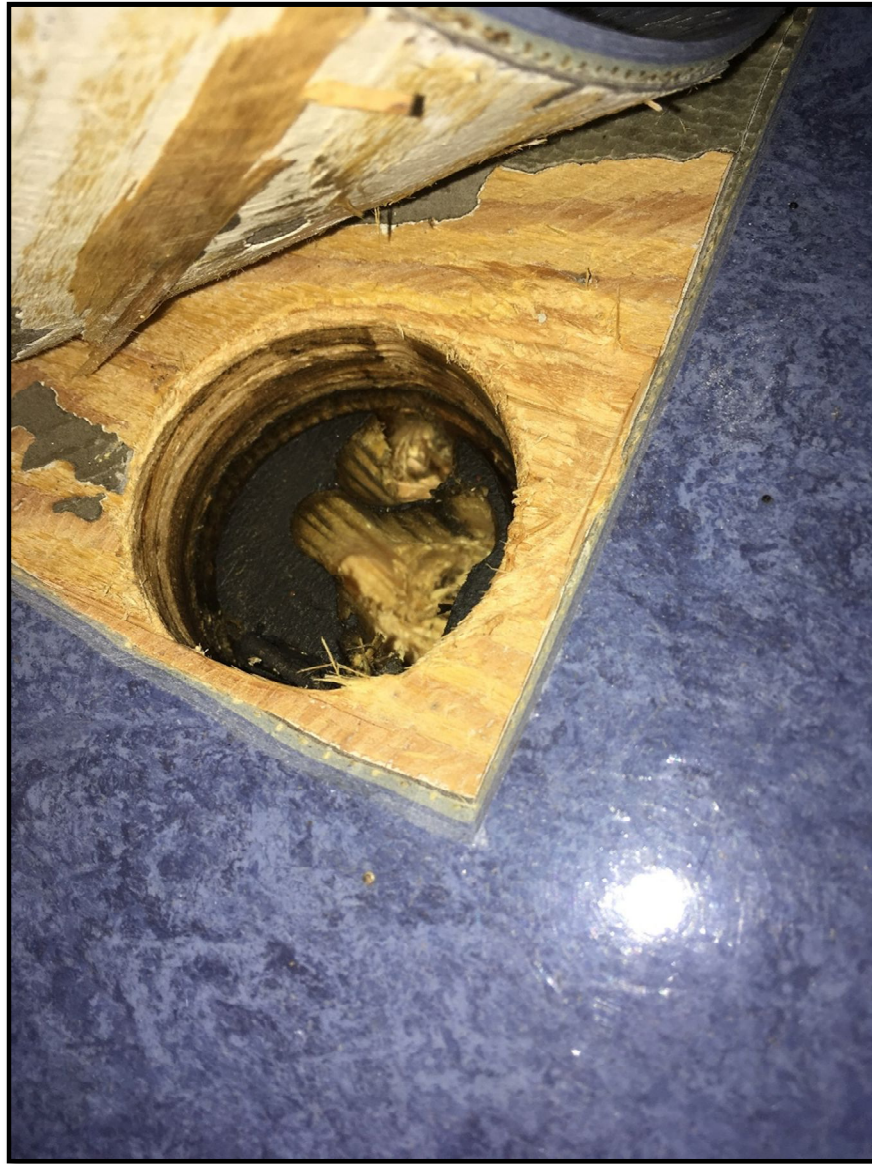
Close-up of exploratory review of modern vinyl sheet flooring and underlying plywood and wood blocking within southwest corner of office area.
