Pacific Biological Station – Taylor Building Window Replacement

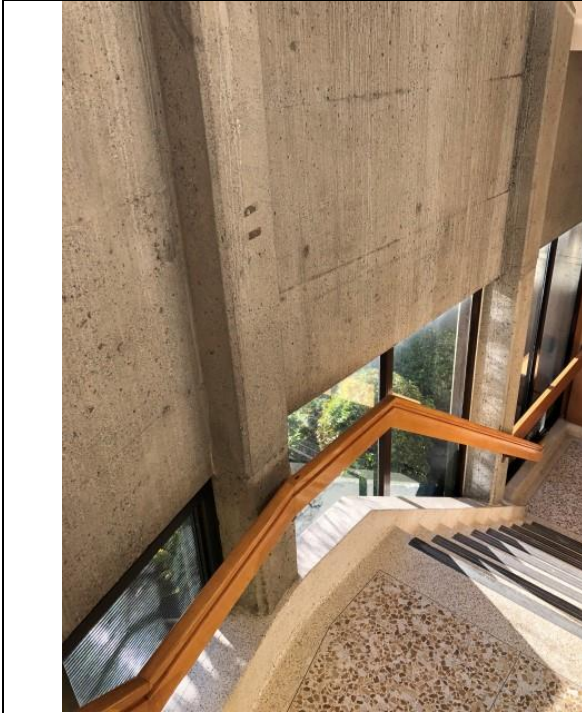
**Photo 2 – Typical Interior Condition
Showing Existing Windows, Stairs, and Stair
Curb**

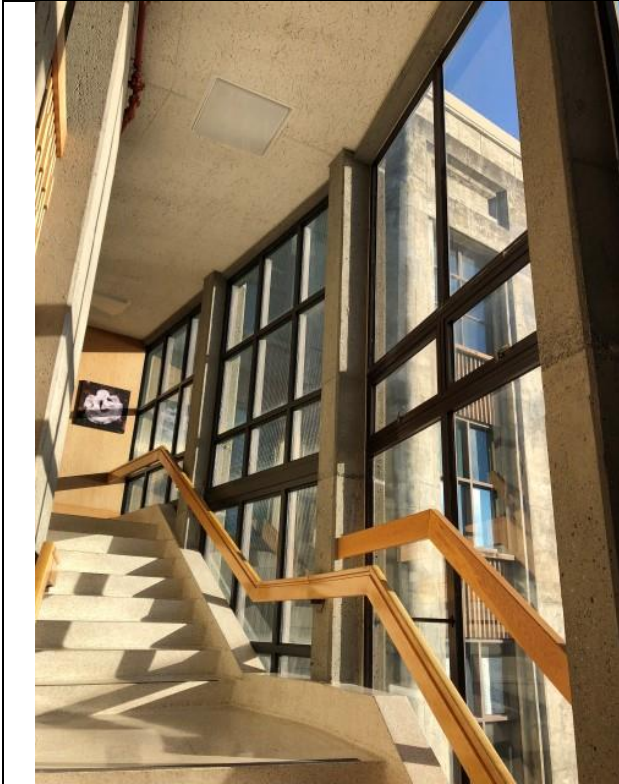
**Photo 3 – Typical Interior Condition
Showing Existing Windows, Stairs, and Stair
Curb**

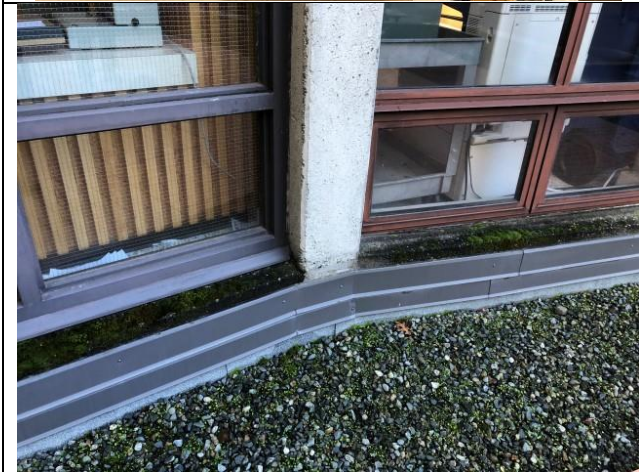
Photo 4 – Sample of Base of Wall Conditions

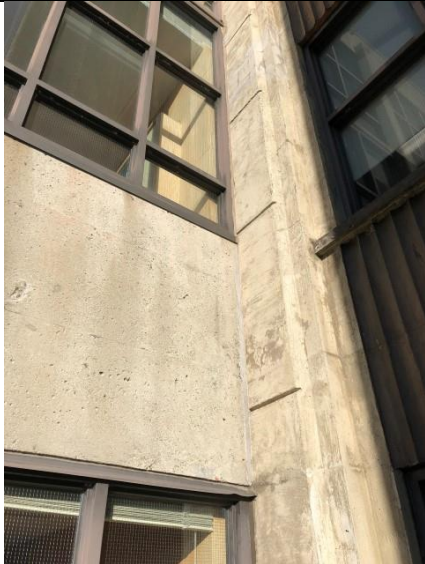
Photo 5 – Sample of Jamb Conditions
