January 11, 2017

1059BB-16-001

**RE: HAZARDOUS MATERIALS ASSESSMENT RADIUM HOT POOLS LOCKER ROOMS**

Further to your request, EHS Partnerships Ltd. (EHS<sup>P</sup>) has completed a hazardous material assessment of the Women's Locker Rooms and the rooms adjacent to the cold pool access at the Radium Hot Pools (Project Area). The Project Area consists of the women's locker room (room ~~100 to 105~~) and the rooms adjacent to the cold pool entrance (rooms 107 – 116). The assessment was conducted on December 19, 2016, by Jon Ernst, B.Sc., B.A., Project Manager for EHS Partnerships Ltd. 105-107

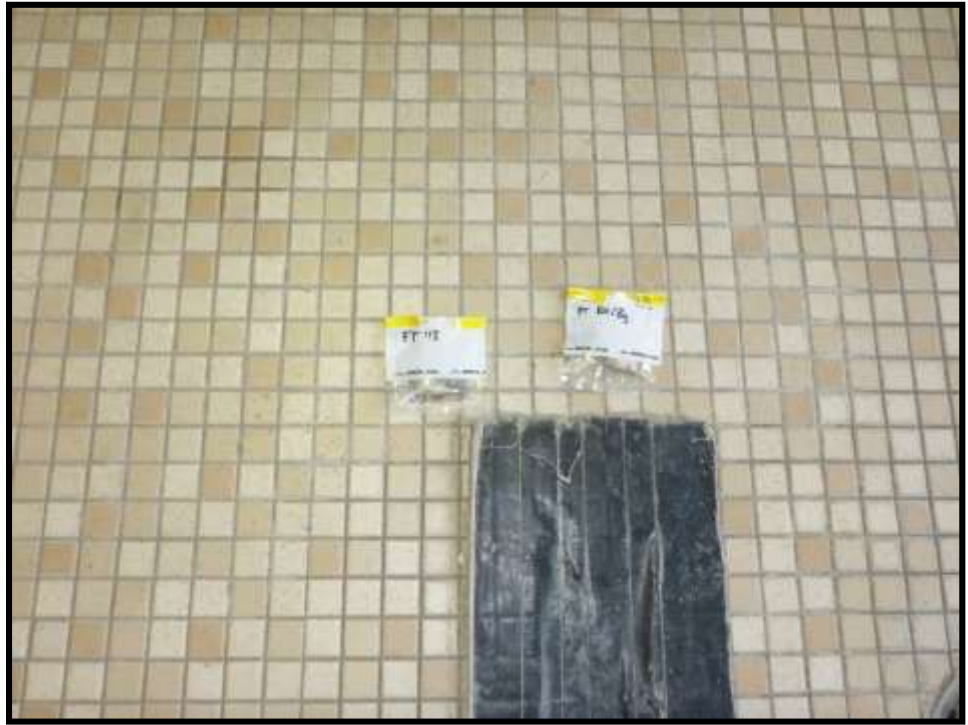
Two (2) samples of floor tile thin set mortar were collected and one (1) was found to contain asbestos. The floor tile thin set mortar present under the beige and brown 1”x1” tiles in rooms ~~100~~, and 108-114 should be treated as asbestos-containing. 107

**Photograph #1 – Asbestos-Containing Tile Thin Set Mortar under Brown & Beige Tiles – Room 113 (Sample A8b)**

- Moderate-risk procedures must be followed to remove the asbestos-containing floor tile thin set mortar, plaster, and window putty in the Project Area as per WorkSafeBC's Safe Work Practices for Handling Asbestos, 2012.

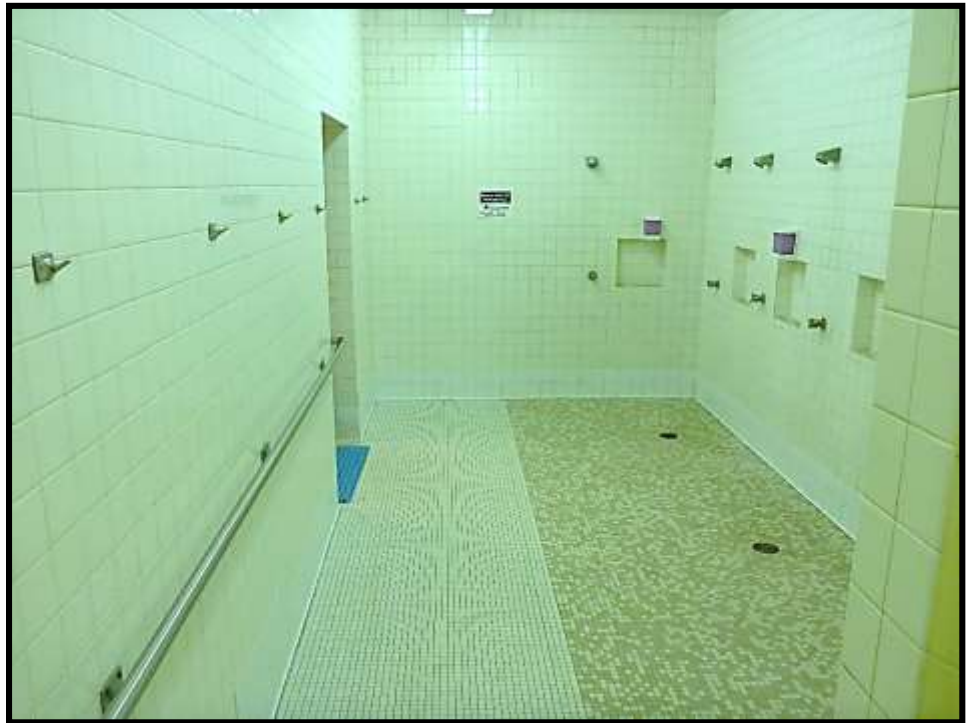
**Photograph #2 – Asbestos-Containing Tile Thin Set Mortar under Brown & Beige Tiles – Room 100 107 (Reference Sample A8b)**

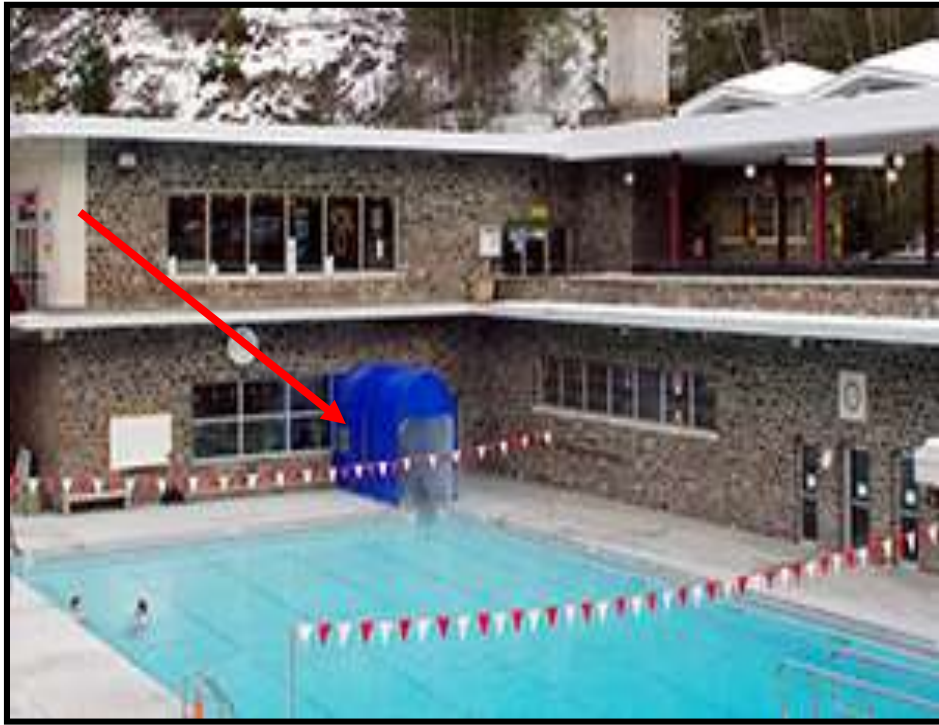
One (1) sample of grey window putty was collected and found to contain asbestos. The grey window putty identified around exterior doors and windows in Room 116 should be treated as asbestos-containing.

**Photograph #3 – Asbestos-Containing Grey Window Putty – Exterior Door Room 116 (Sample A11).**

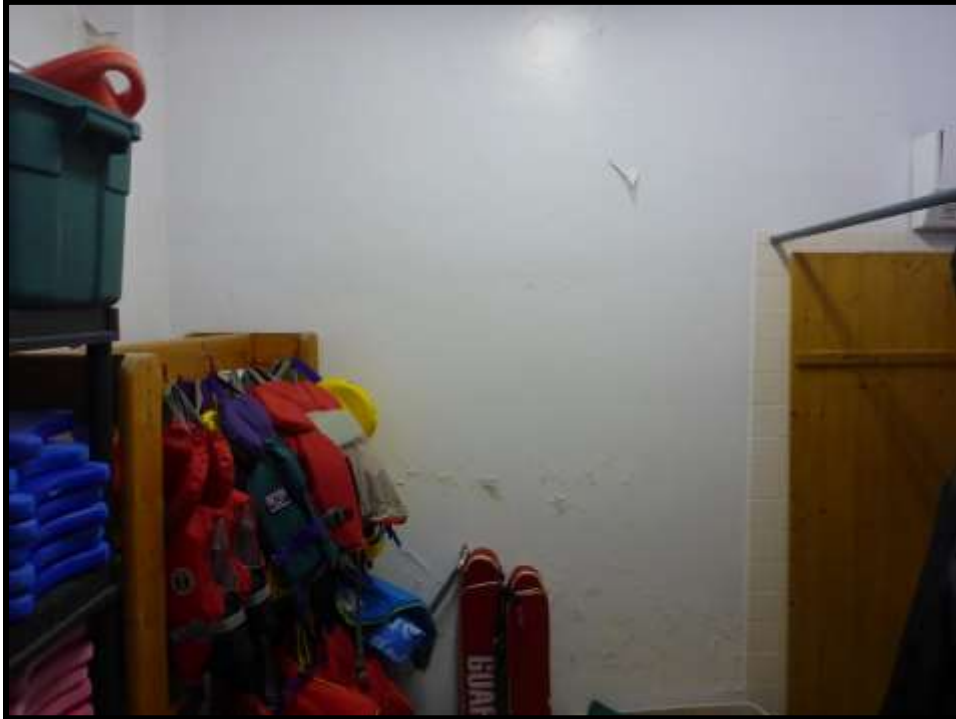
Three (3) composite samples of plaster were collected and two (2) were found to contain asbestos. The plaster throughout the Project Area should be treated as asbestos containing.

**Photograph #4 – Asbestos-Containing Plaster Skim Coat – Room 115 (Sample A13a).**

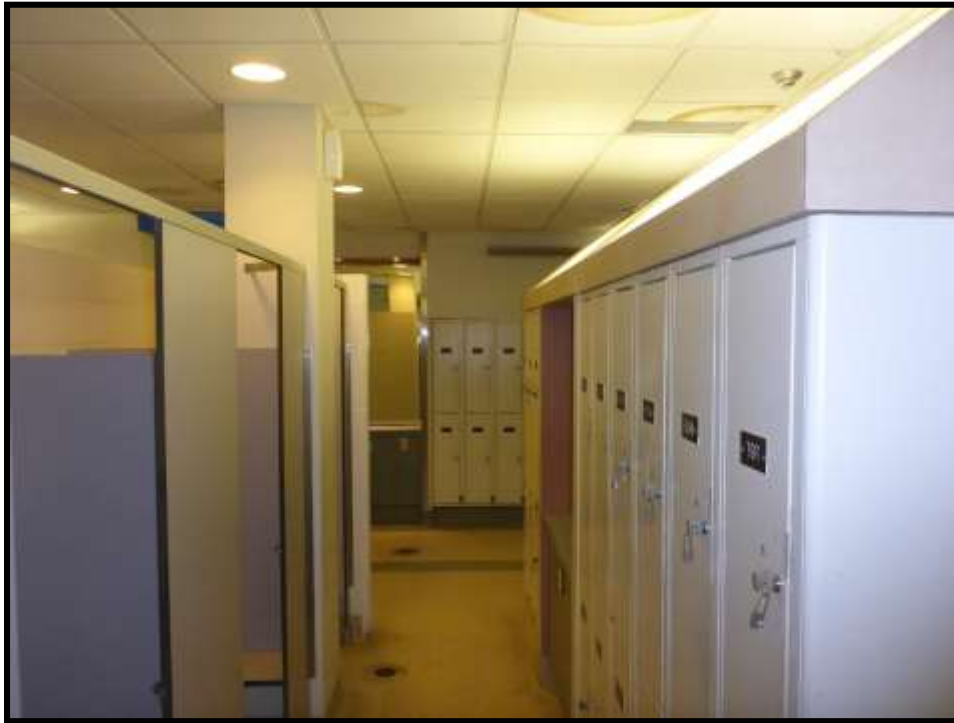
Photograph #5 – Asbestos-Containing Plaster Base Coat – Column Room ~~104~~<sup>105</sup> (Sample A24b).

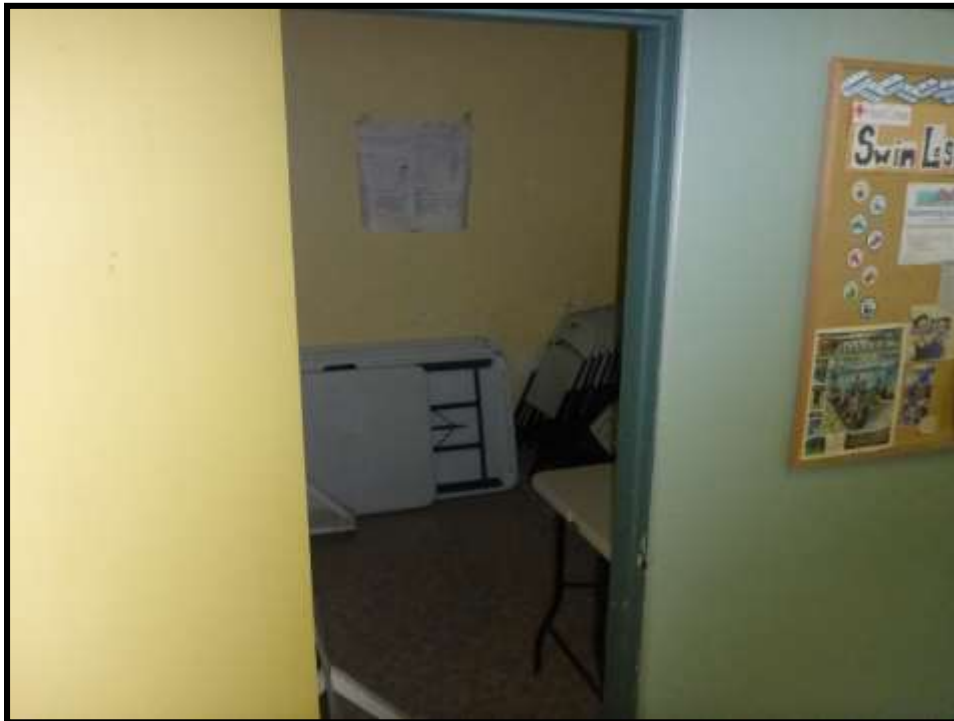
One (1) of the six (6) lead samples were found to contain lead above 600 ppm. The following painted surfaces should be treated lead based:

- Green plaster walls throughout rooms 108 – 115

Photograph #6 – Lead-Based Green Paint on Plaster Wall (Sample Pb17).

2. Building material containing lead based paint must be properly disposed of as per the Hazardous Waste Regulation (HWR). If the paint is to be removed and segregated from the waste stream, exposure control plans must be developed and followed to keep worker exposure as low as reasonably achievable by following the guidelines presented in WorkSafeBC's Lead-Containing Paints and Coatings Guideline, 2011.

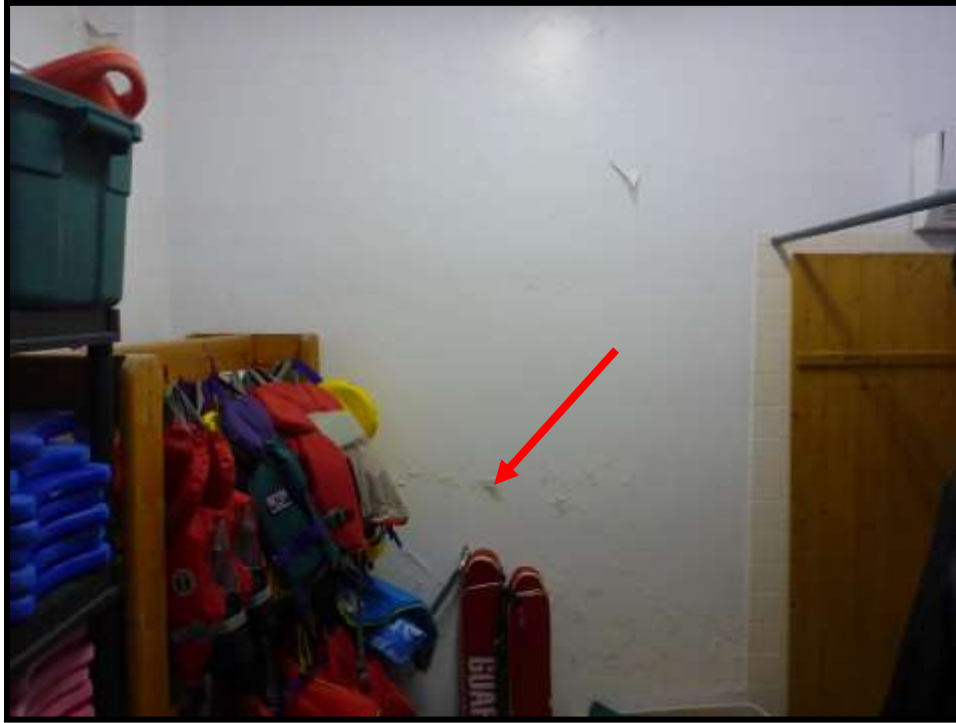
Note that several walls in rooms 108 – 115 showed evidence of being previously painted green.

**Photograph #7 – Example of Lead-Based Green Paint Under Other Layers – Room 115**
