PWGSC Moosonee Buildings Demolition

SPECIFICATIONS

DESIGNATED SUBSTANCES & HAZARDOUS MATERIALS SURVEY

FOUR BUILDINGS NATIONAL DEFENCE RADAR BASE MOOSONEE, ONTARIO

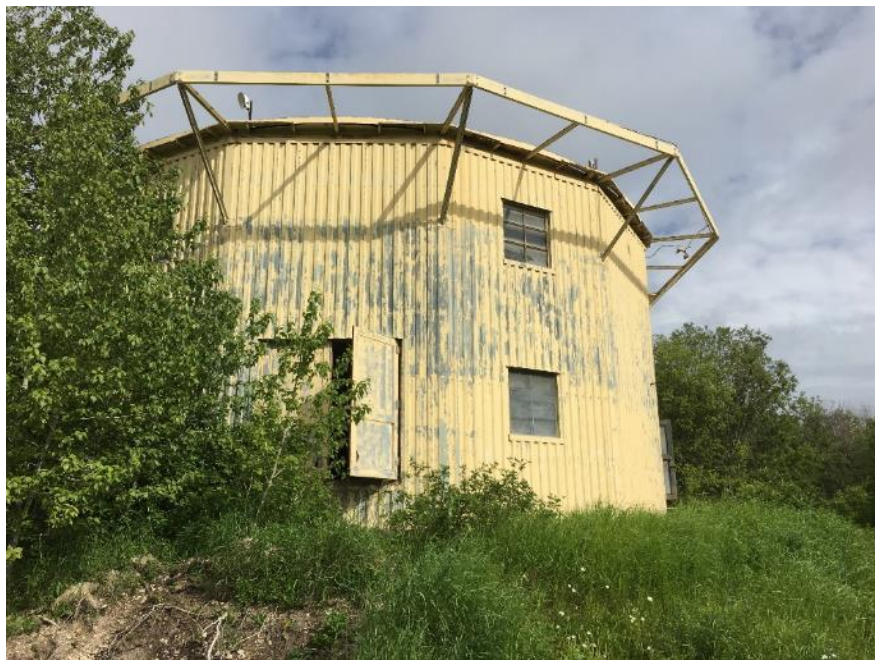
Photo 1 : Exterior view of Building 1 with yellow/grey paint on metal cladding (DST 2006, 353-01-LP-01). This paint was not identified as leachate hazardous with respect to lead.

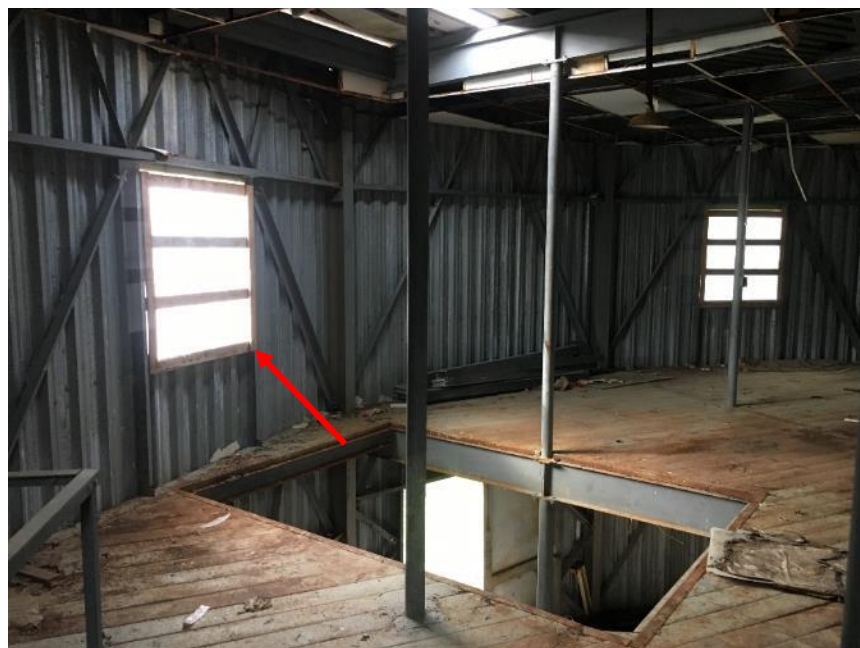
Photo 2: View of 2nd floor of Building 1. Asbestos-containing grey caulking located around all windows (DST Sample 29911-1-01A) and grey floor paint (DST Sample 29911-1-LP-02).

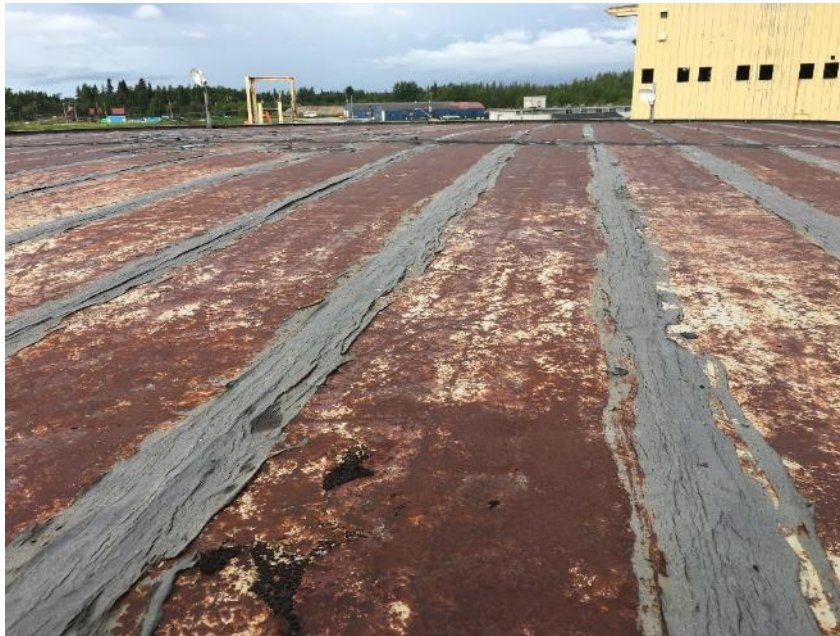
Photo 3: View of asbestos-containing black tar located on roof top of Building 1 (DST Sample 29911-1-03A).

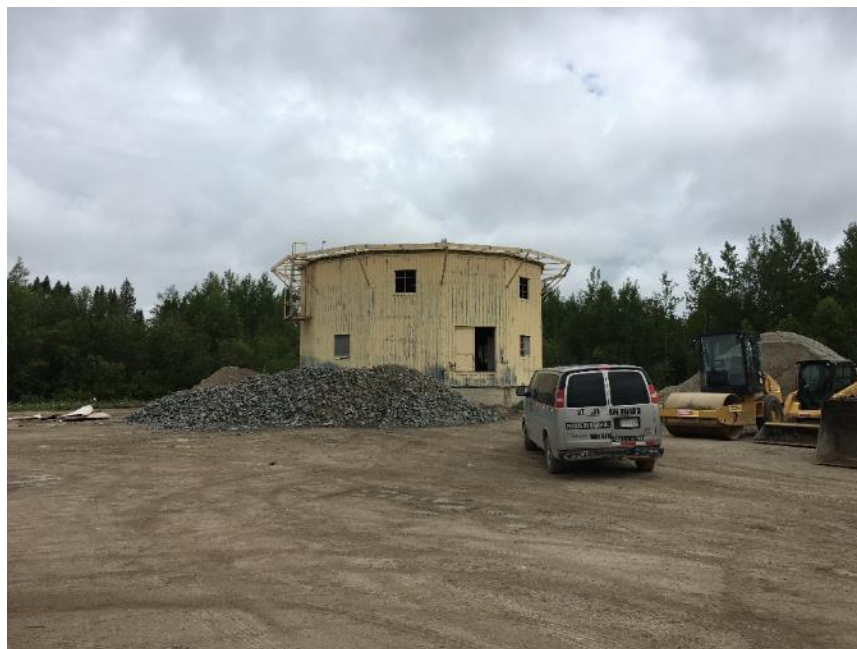
Photo 4: View of Building 1A with lead-containing yellow paint on metal cladding (DST 2006, 353-1A-LP-01). This paint has been identified as leachate hazardous with respect to lead.

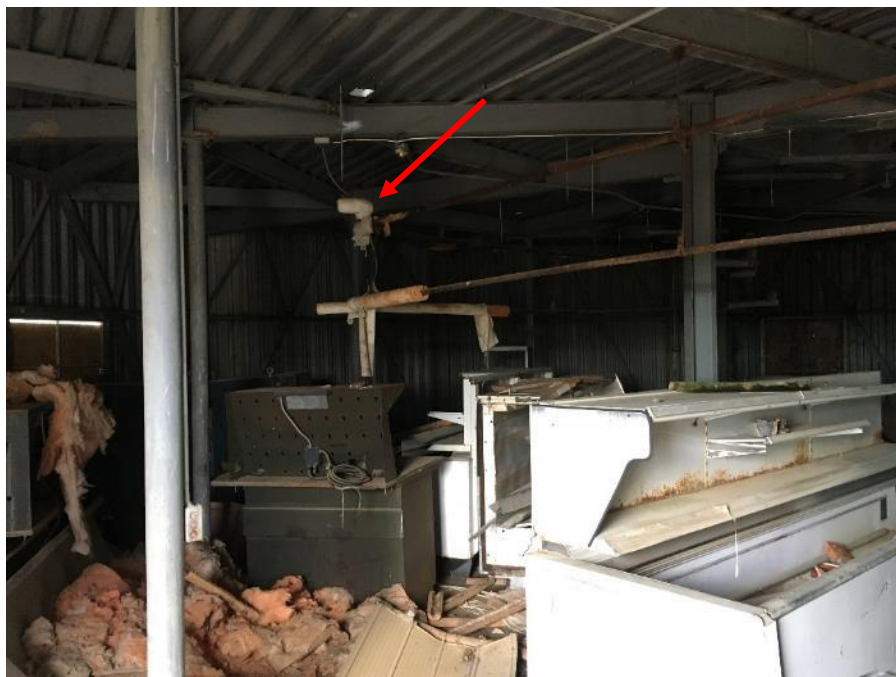
Photo 5: View of asbestos-containing grey cement compound on pipe fittings (DST Sample 29911-1A-01A) and old grocery display refrigeration units, located in Building 1A.

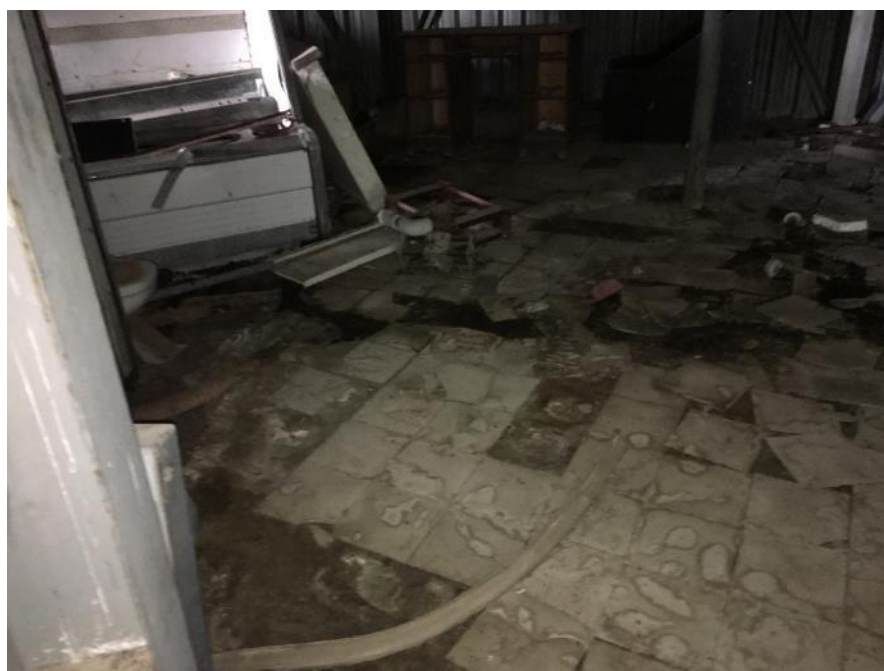
Photo 6: Asbestos-containing beige 9"x9" vinyl floor tiles (DST Sample 29911-1A-02A), observed on the main floor of Building 1A). The associated mastic was found to not contain asbestos.

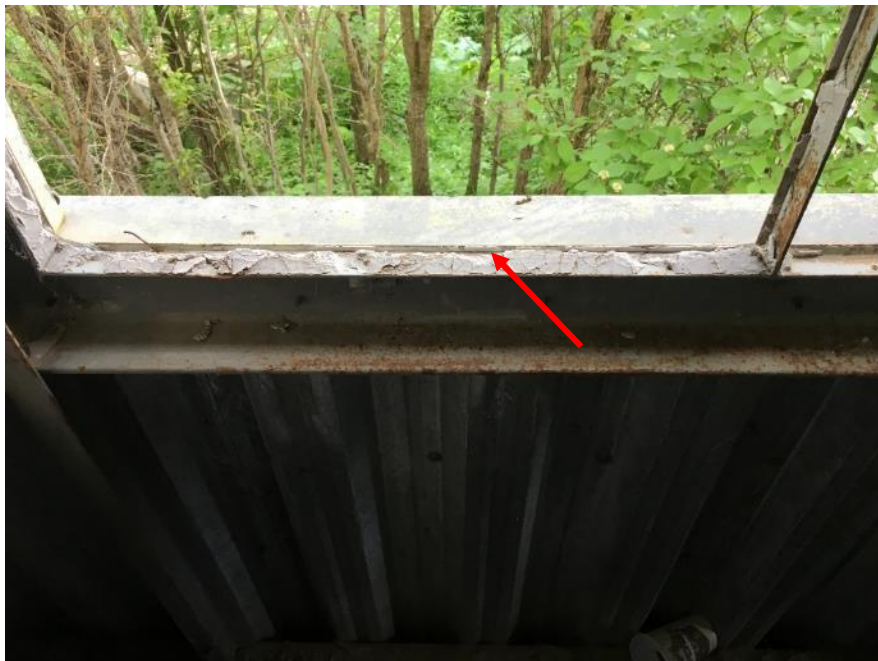
Photo 7: View of asbestos-containing grey window caulking (DST Sample 29911-1A-03A) observed around all windows throughout Building 1A.

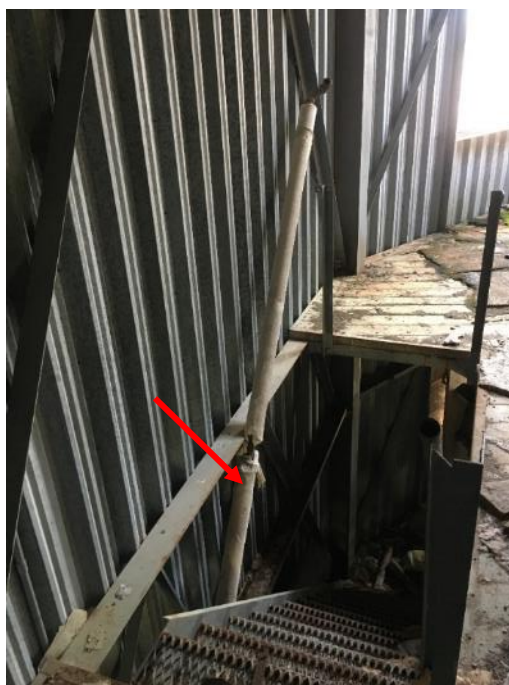
Photo 8: Asbestos-containing white pre-formed pipe insulation (Magblock) (DST Sample 29911-1A-04A), observed in stairwell of Building 1A.

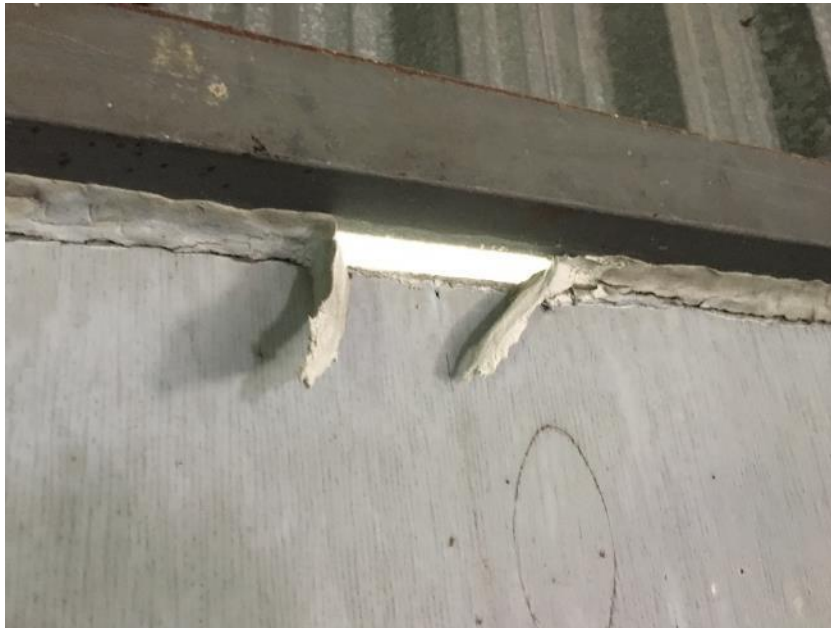
Photo 9: Asbestos-containing grey caulking (DST Sample 29911-1A-05A), noted between wood panels and the metal wall, on the 2nd floor of Building 1A.

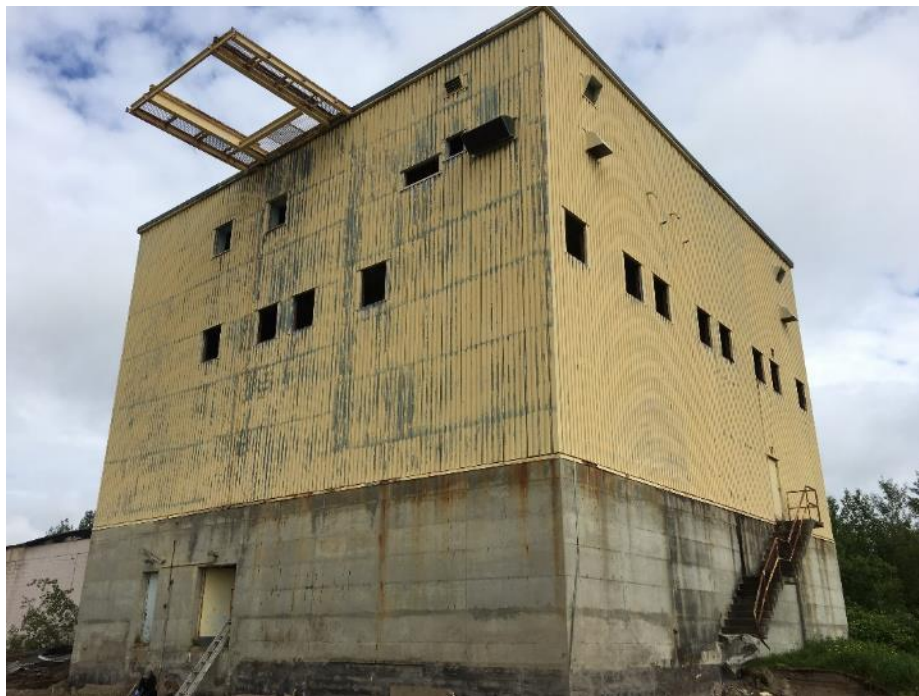
Photo 10: View of Building 3 with lead-containing yellow/Off-White paint on metal cladding (DST 2006, 353-3-LP-01). This paint has been identified as leachate hazardous with respect to lead.

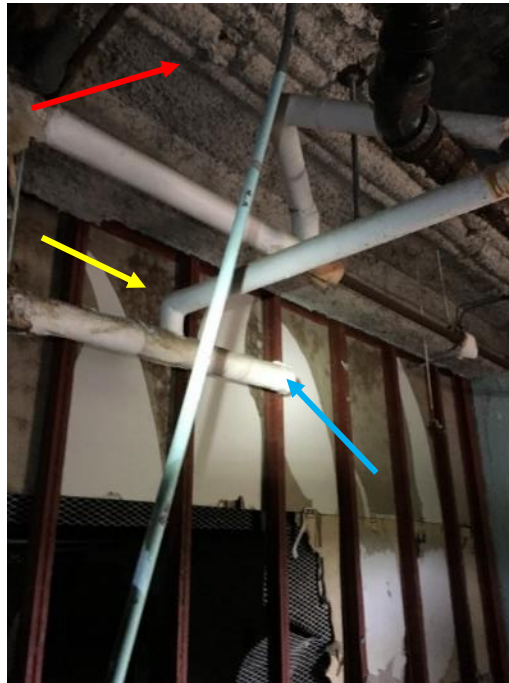
Photo 11: View of asbestos-containing fireproofing (red arrow, DST Sample 29911-3-02A), pipe fittings (blue arrow, DST Sample 29911-3-03A), and mould-impacted drywall (yellow arrow) on the main floor at Building 3.

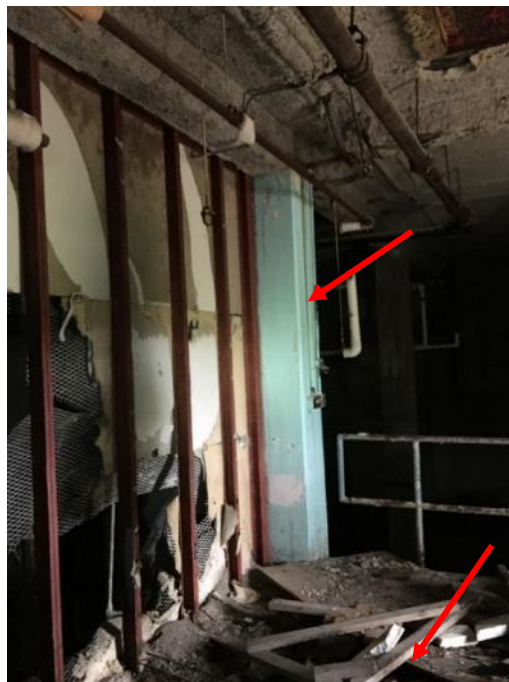
Photo 12: View of lead-containing blue paint (DST Sample 29911-3-LP-01, non-hazardous for disposal) and asbestos-containing fireproofing debris, observed on the Ground Floor of Building 3.

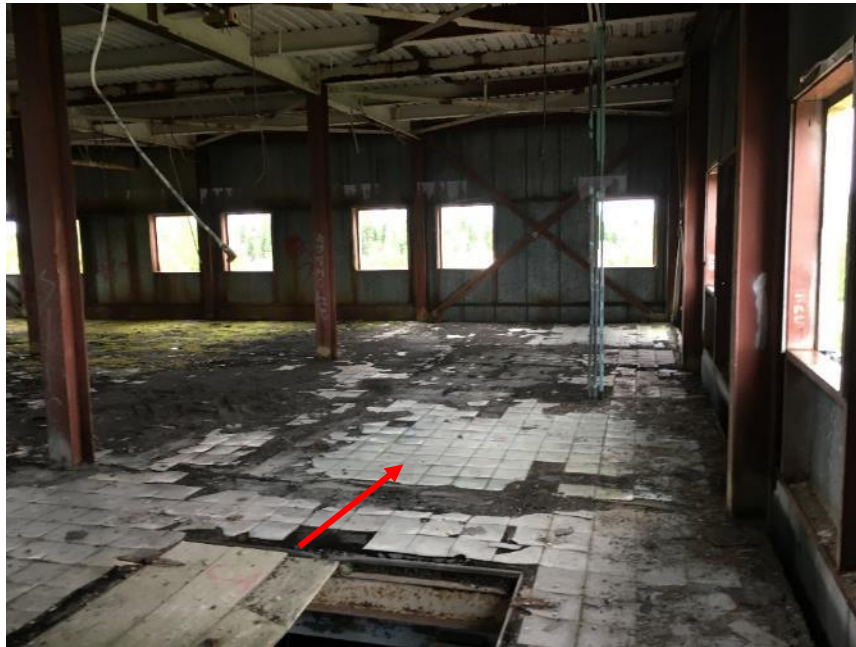
Photo 13: View of asbestos-containing blue 9"x9" vinyl floor tiles (DST Sample 29911-3-01A), observed throughout Building 3.

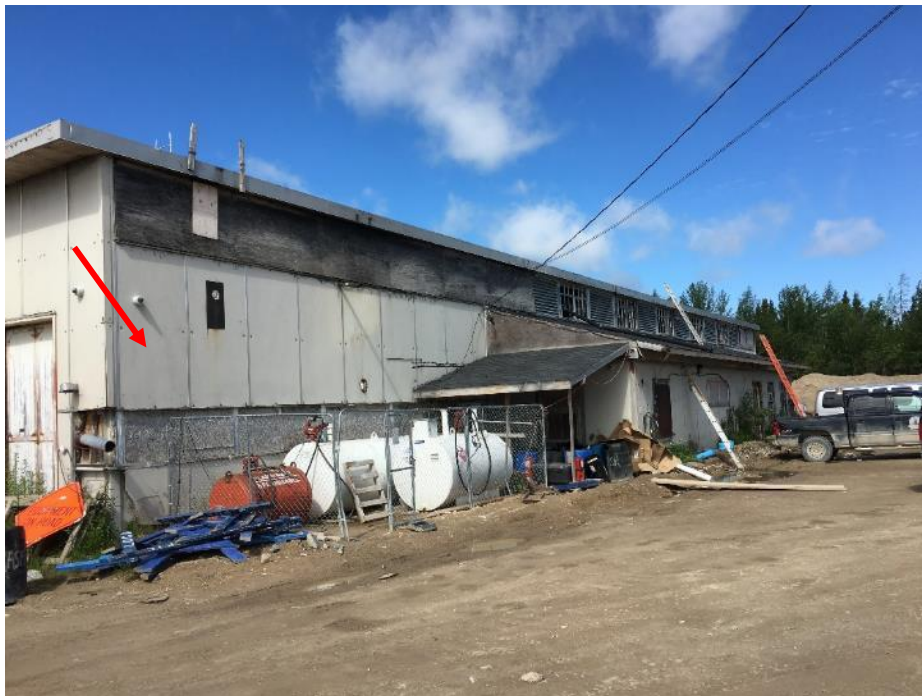
Photo 14: View of Building 4 with asbestos-containing Transite exterior wall paneling (DST Sample 29911-4-01A). One (1) 1,000-gallon diesel, one (1) 500-gallon gasoline and one (1) 250-gallon red re-fueling tank are present at the building's exterior.

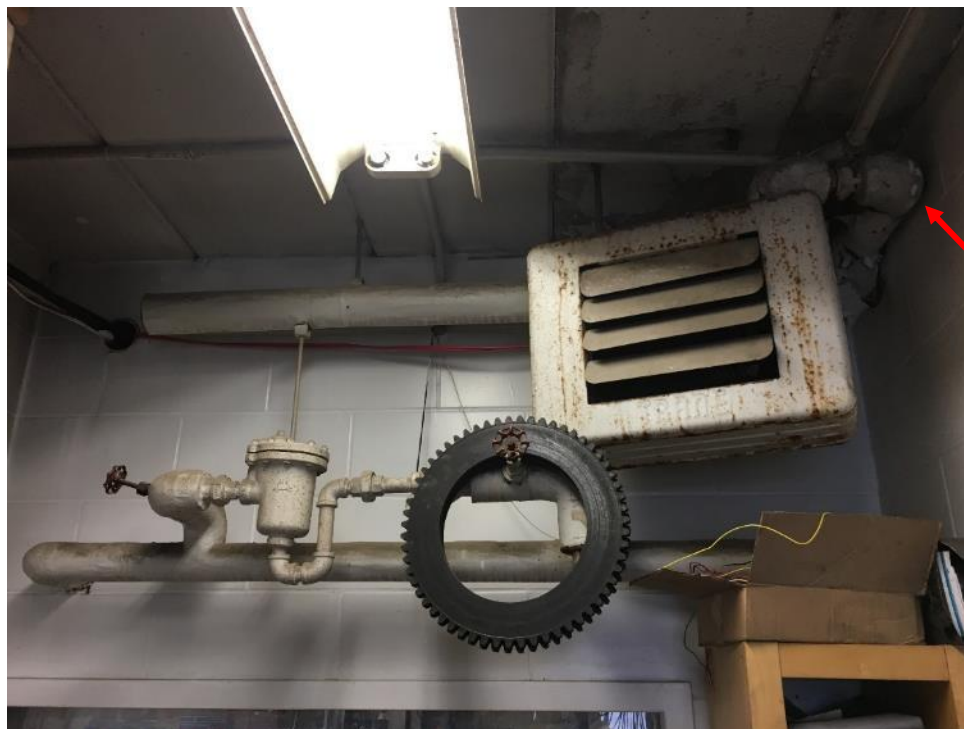
Photo 15: View of asbestos-containing grey cement compound on pipe fittings (DST 2006 Sample 353-04-MI-01) in a small workshop, observed throughout Building 4.

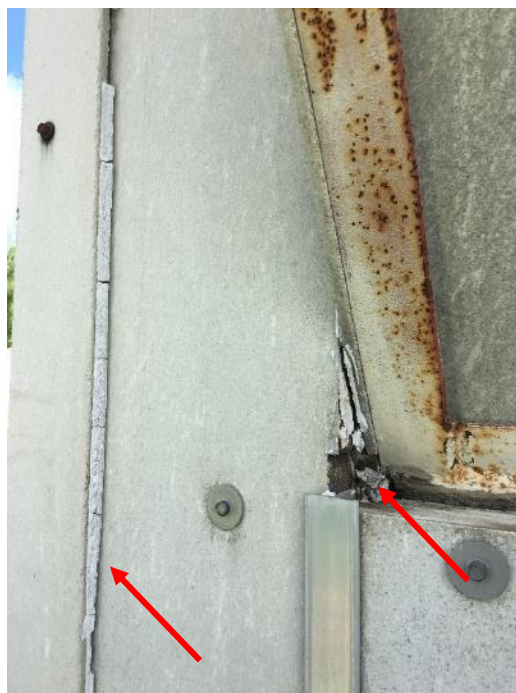
Photo 16: Asbestos-containing caulking (DST Sample 29911-4-04A) observed throughout the exterior of Building 4, between Transite paneling.

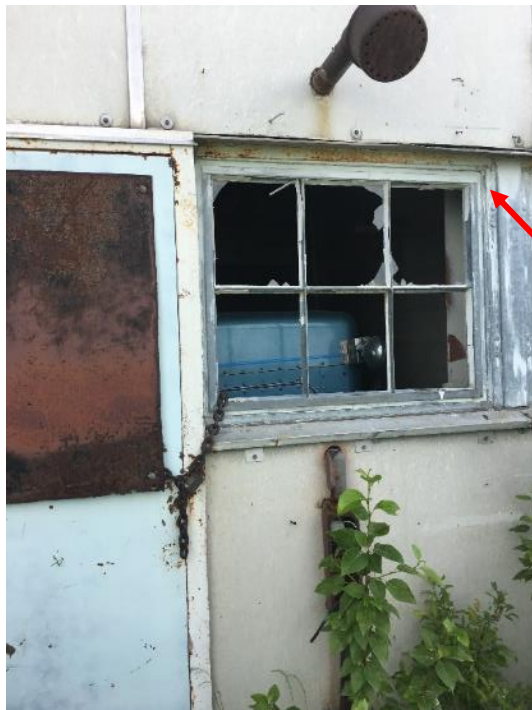
Photo 17: Asbestos-containing grey caulking (DST Sample 29911-4-05A) observed on the exterior windows throughout Building 4.

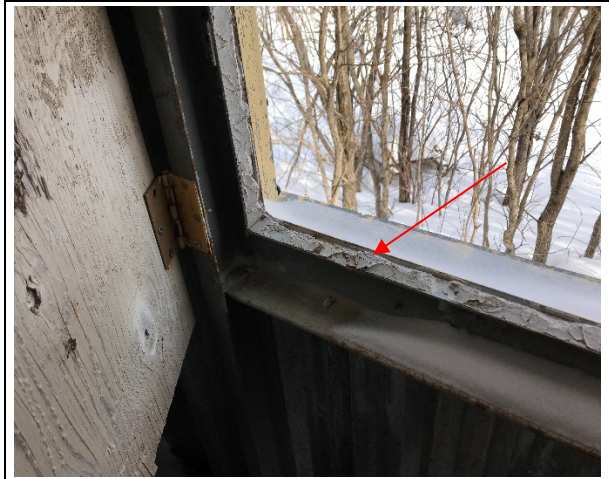
Photo 2: Building 1 – asbestos-containing (2% chrysotile) interior window glaze compound – grey observed to be in poor condition (cracking)

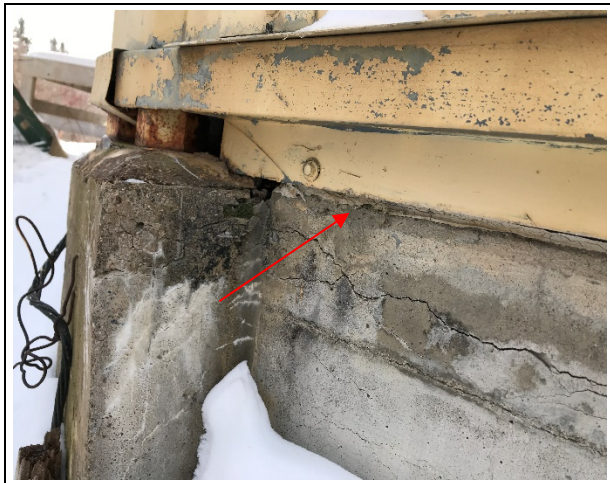
Photo 3: Building 1 – asbestos-containing (5% chrysotile) exterior caulking – grey

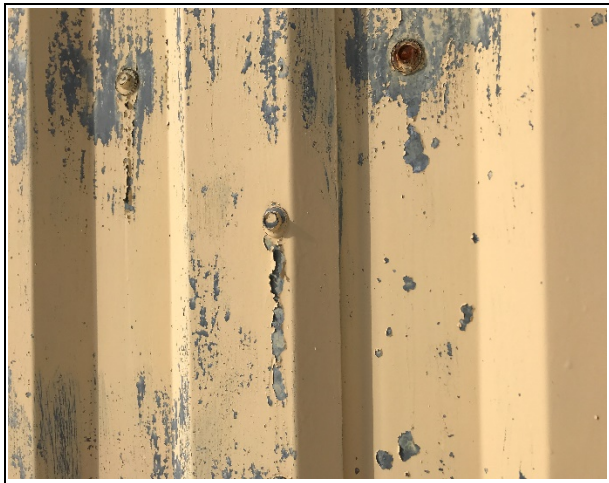
Photo 4: building 1 – lead-containing (350 ppm) yellow/grey coloured paint on the exterior metal cladding

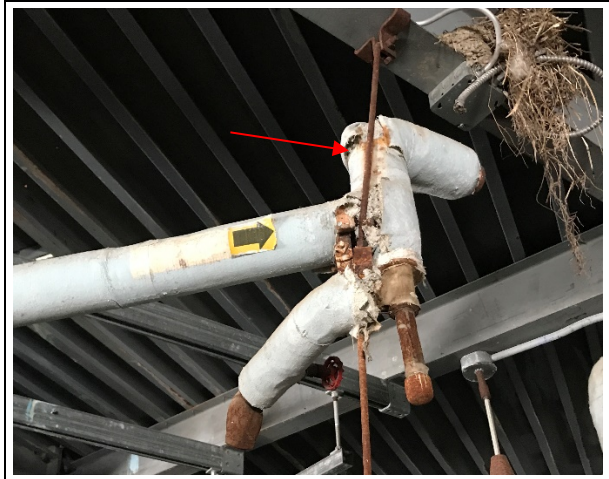
Photo 6: Building 1A – asbestos-containing (65% chrysotile) insulating cement on pipe fittings

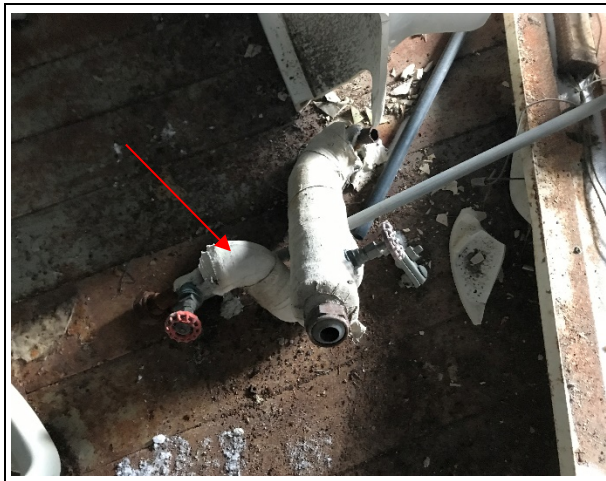
Photo 7: Building 1A – asbestos-containing (65% chrysotile) insulating cement on pipe fittings observed debris on floor

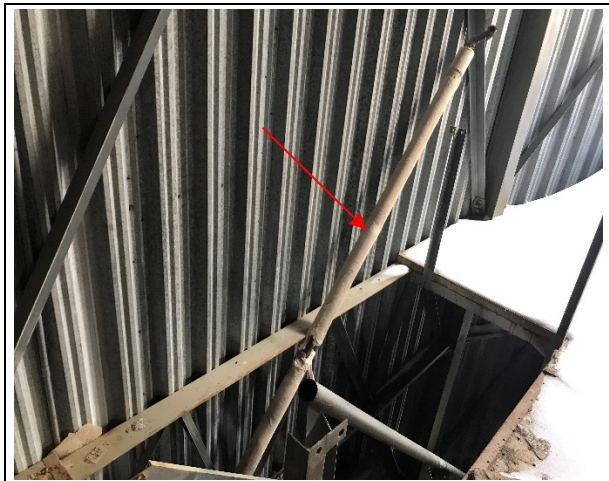
Photo 8: Building 1A – asbestos-containing (30% chrysotile) pre-formed pipe straight insulation

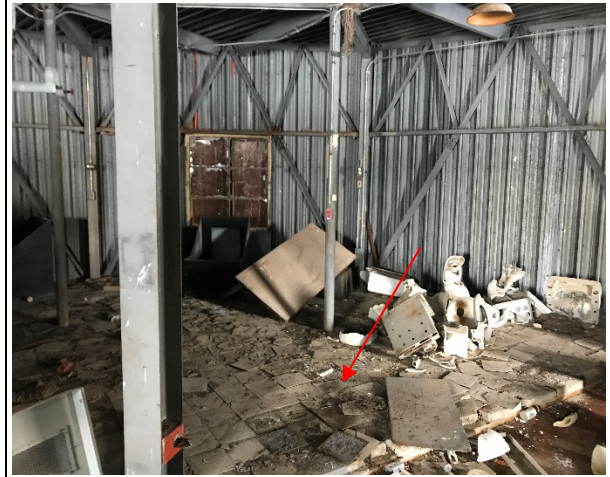
Photo 10: Building 1A – asbestos-containing (1% chrysotile) 9"x9" vinyl floor tile – grey

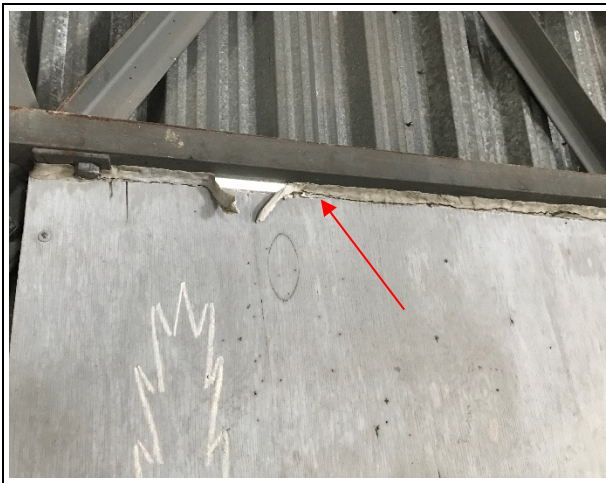
Photo 11: Building 1A – asbestos-containing (15% chrysotile) interior joint caulking – grey

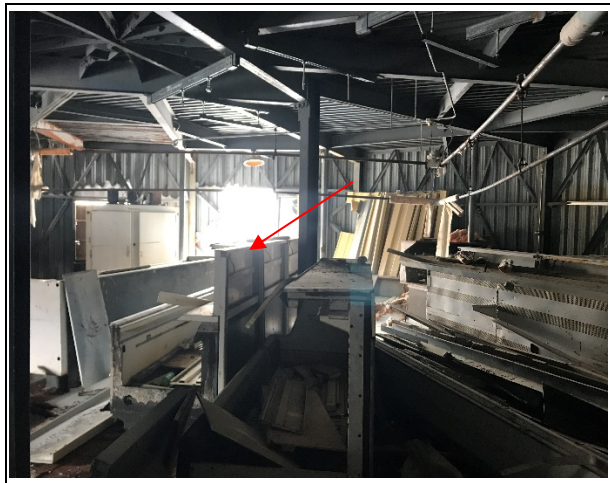
Photo 12: Building 1A – suspect ODS-containing refrigerator display units

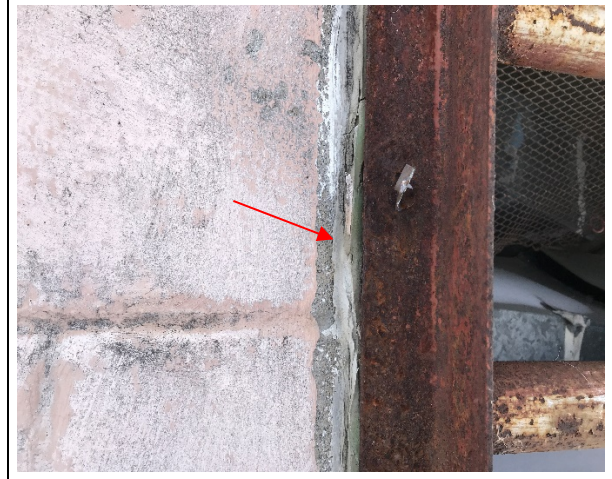
Photo 14: Building 2 – asbestos-containing (1.7% chrysotile) exterior caulk – grey located on the exterior of the building (north vent)

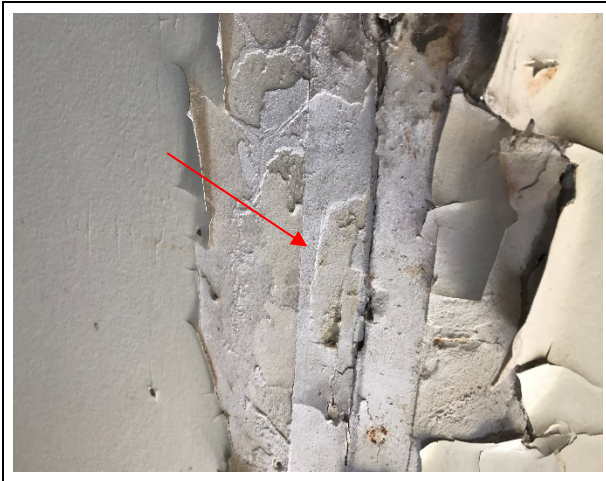
Photo 15: Building 2 – asbestos-containing (3% chrysotile) drywall joint-fill compound located in room 2

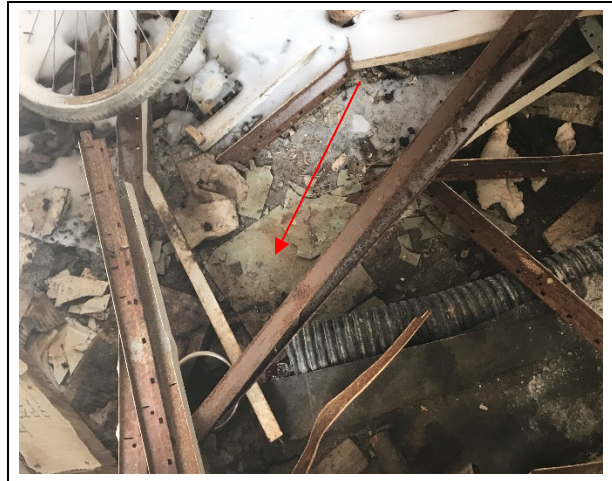
Photo 16: Building 2 – asbestos-containing (1.2% chrysotile) mastic associated with 9"x9" vinyl floor tile – green located in room 2

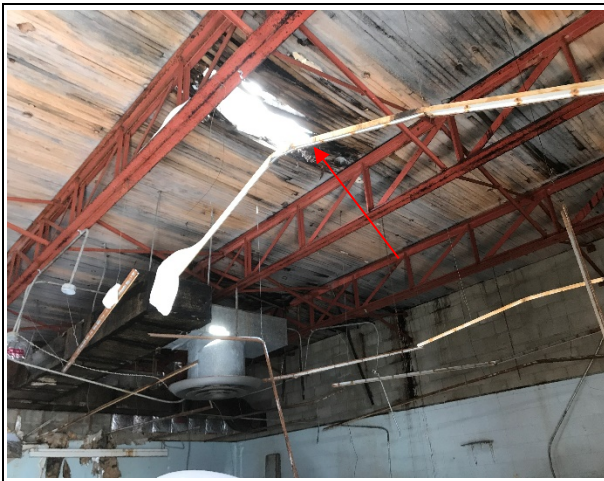
Photo 19: Building 2 – presumed asbestos containing roof insulation, roof caulking and roofing materials

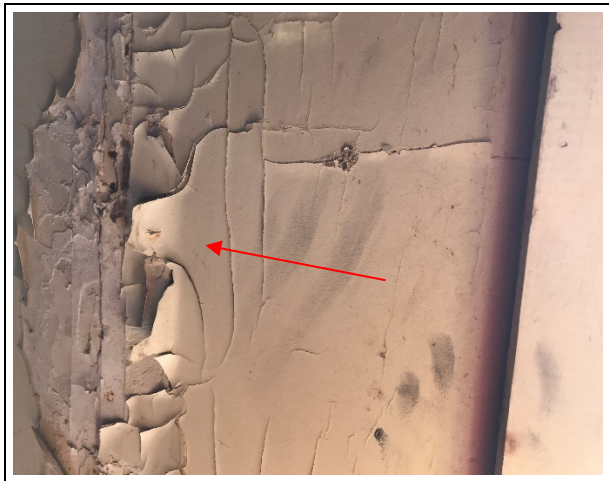
Photo 20: Building 2 – lead-containing (1,200 ppm) cream coloured paint located on the drywall walls in room 2

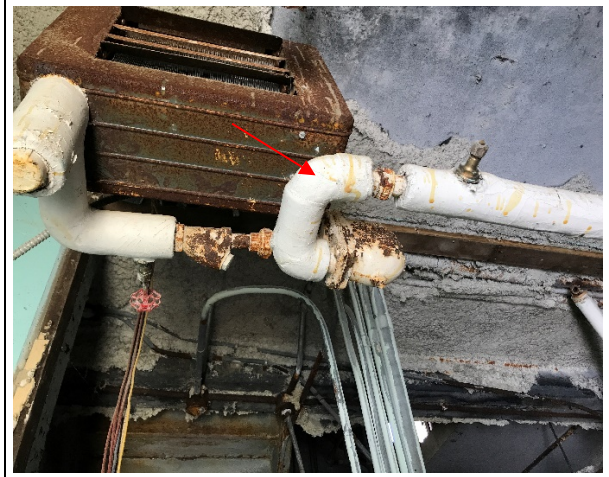
Photo 22: Building 3 – asbestos-containing (65% chrysotile) insulating cement on pipe fittings located in the entrance

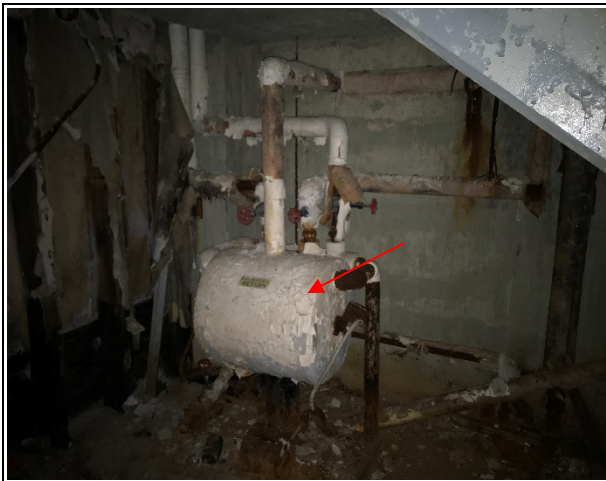
Photo 23: Building 3 – asbestos-containing (75% chrysotile) pre-formed tank/body insulation on the condensate return tank located in the storage room

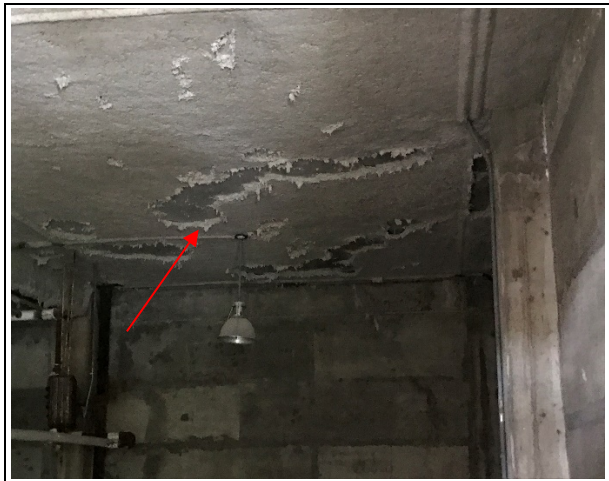
Photo 24: Building 3 – asbestos-containing (10% chrysotile) sprayed fireproofing located in the storage room

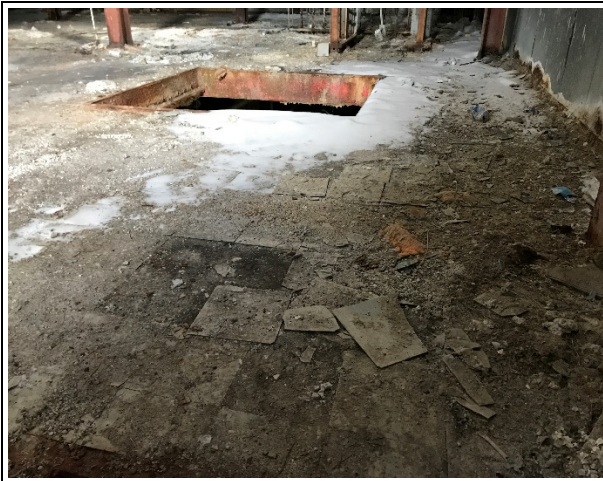
Photo 27: Building 3 – asbestos-containing (2% chrysotile) 9"x9" vinyl floor tile – grey located on the second floor

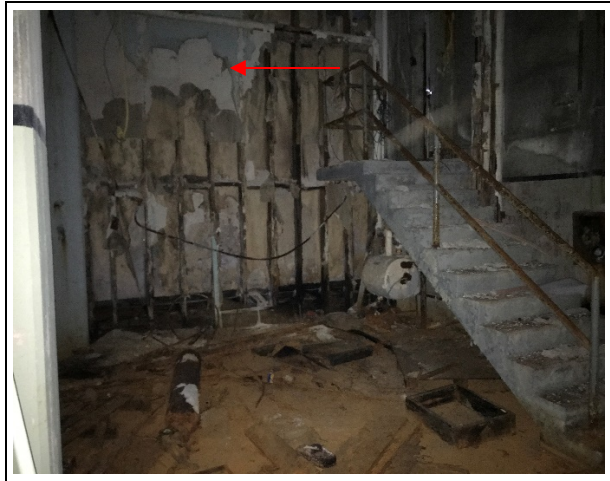
Photo 28: Building 3 – asbestos-containing (2% chrysotile) drywall joint-fill compound located in the storage room

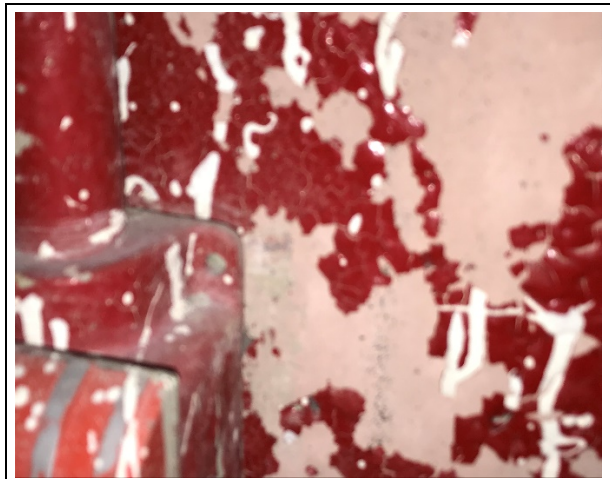
Photo 32: Building 3 – lead-containing (4,800 ppm) red coloured paint located on the interior walls of the storage room

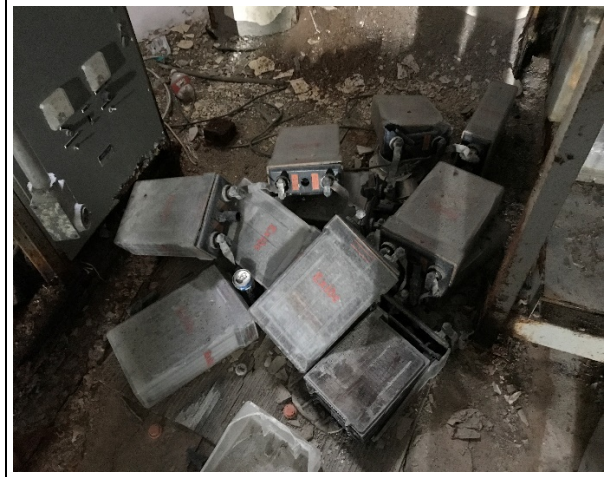
Photo 34: Building 3 – suspect mercury containing batteries located in the communications room

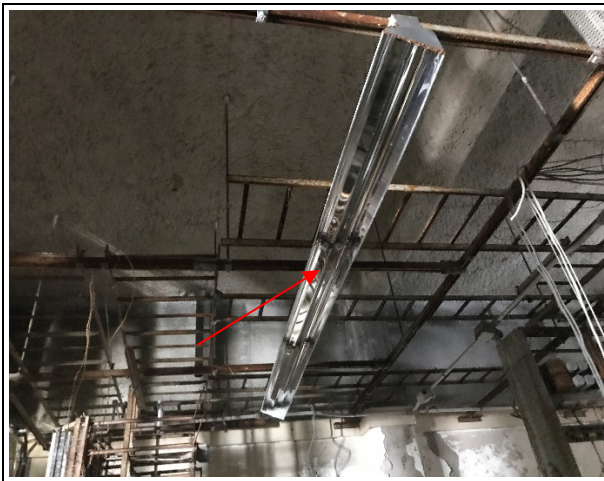
Photo 35: Building 3 – suspect PCB-containing ballasts associated with light fixtures

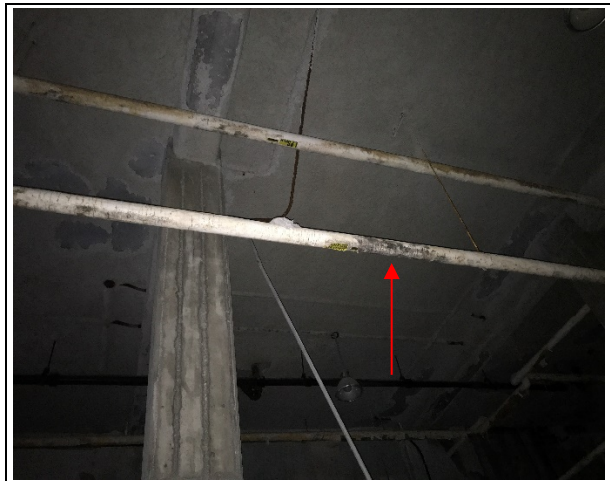
Photo 36: Building 3 – suspect mould located on the pipe insulation within the storage room

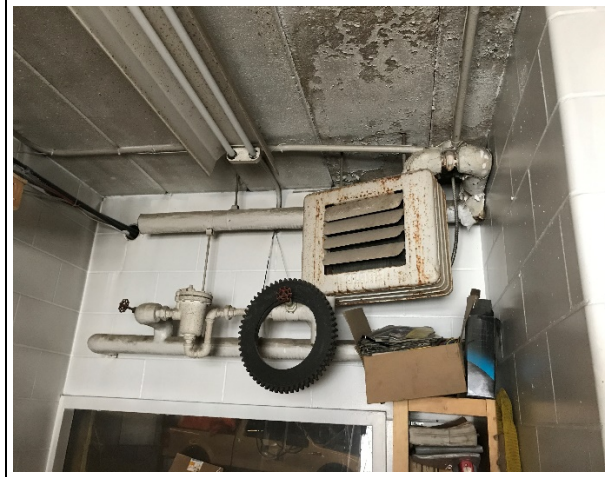
Photo 38: Building 4 – asbestos-containing (65% chrysotile) insulating cement on pipe fittings located in the storage room

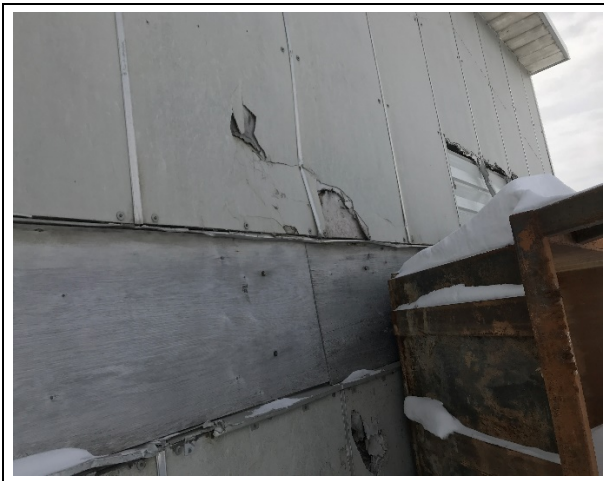
Photo 39: Building 4 – asbestos-containing (20% chrysotile) cement board panels located on the exterior of the building (north wall)

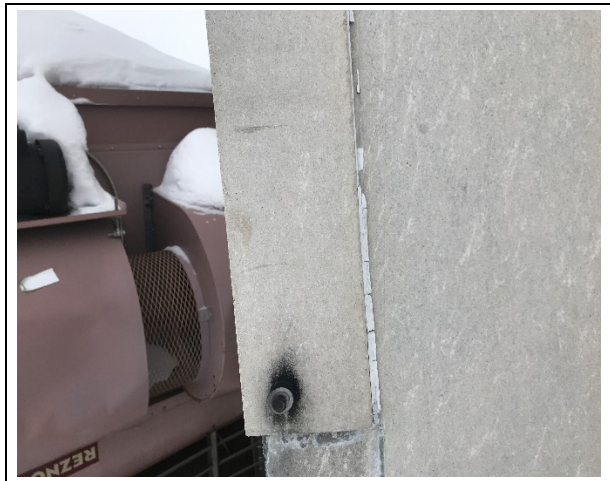
Photo 40: Building 4 – asbestos-containing (5% chrysotile) exterior caulking – grey located on the exterior walls

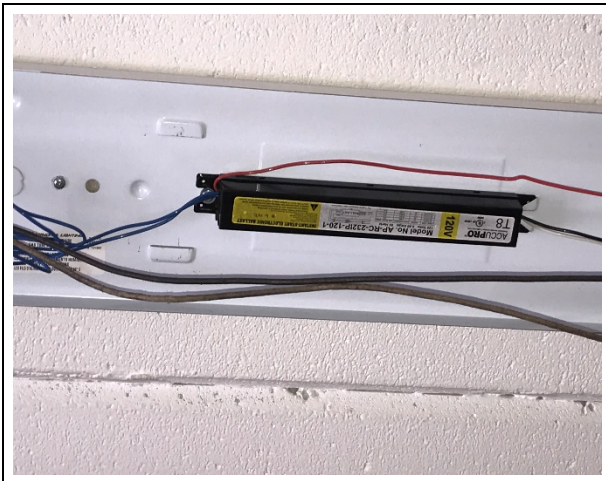
Photo 43: Building 4 – non-PCB-containing electric ballast associated with the light fixture in office 1

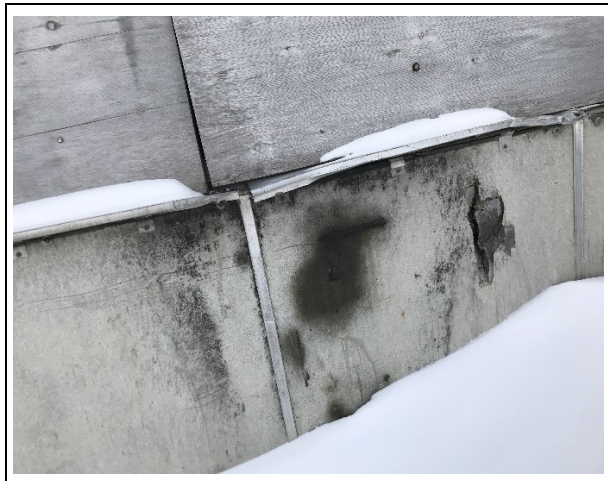
Photo 44: Building 4 – suspect mould located on the exterior north wall

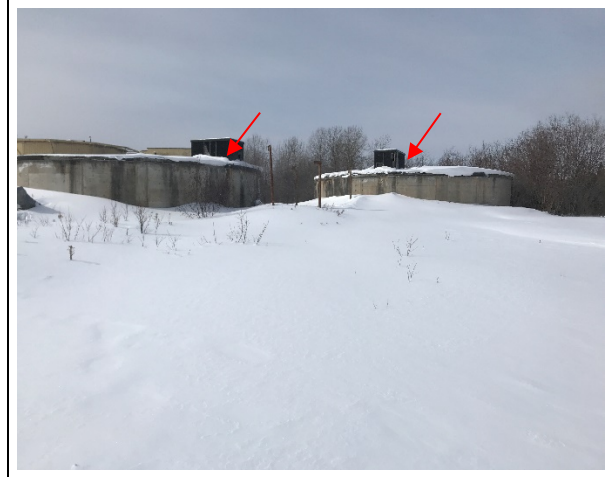
Photo 46: Building 5&6 – presumed asbestos-containing roofing materials and roof caulking

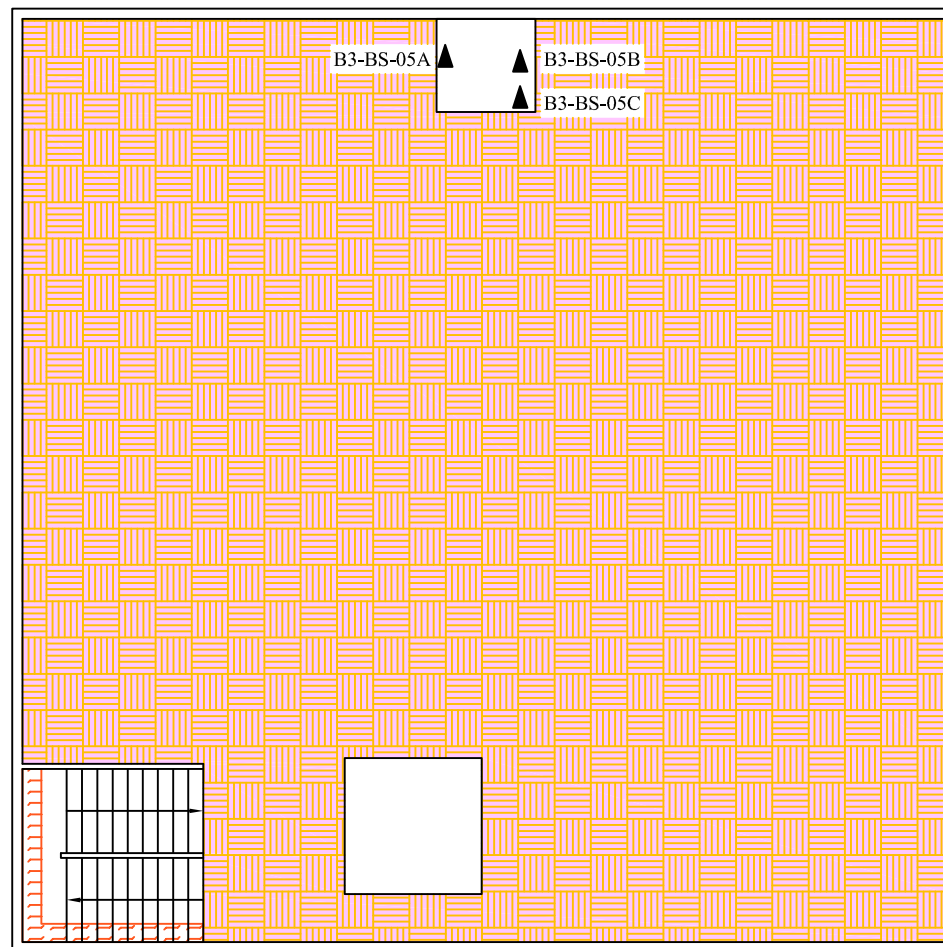
BUILDING 3 - SECOND FLOOR

NOTES: 1. CAULKING MATERIALS ON CAST IRON DRAIN PIPES ARE PRESUMED TO BE ASBESTOS-CONTAINING.
 2. GASKET MATERIALS ON MECHANICAL PIPING IS PRESUMED TO BE ASBESTOS-CONTAINING.
 3. THIS DRAWING ILLUSTRATES SUPPORTING INFORMATION SPECIFIC TO A STANTEC CONSULTING LTD. REPORT AND MUST NOT BE USED FOR OTHER PURPOSES.
