Addendum No.1

Description: F1700-184013 CCG Workshops Maintenance Building HVAC Refurbishment

HAZARDOUS BUILDING MATERIALS ASSESSMENTS

Stantec Consulting Ltd. (Stantec) was retained by Public Services and Procurement Canada (PSPC) on behalf of Fisheries and Oceans Canada (DFO) to conduct hazardous building materials assessments within 6 buildings at the Victoria Coast Guard Base located at 25 Huron Street, Victoria, British Columbia (BC).

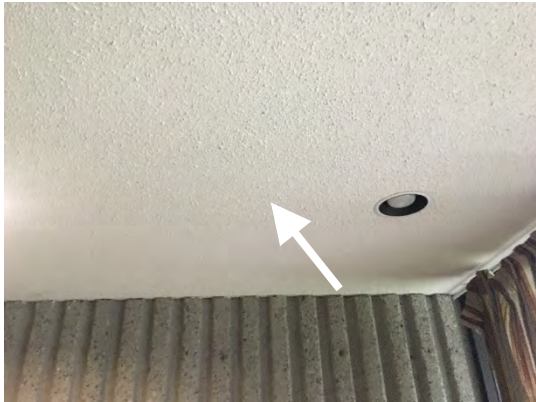
Identified ACM Description and Condition Information		Photo
Texture coat applied to drywall ceiling in the front entrance vestibule, which is continuous with the exterior soffit in this area.

Friability	Non-friable in situ—may become friable if disturbed.	
Condition	Good	
Total Quantity	Approximately 20 m ²	
Content	1% Chrysotile	
Black electrical penetration putty on the floor penetration in the Electrical/Telephone room.

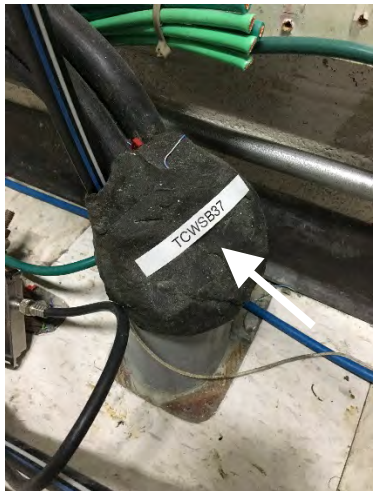
Friability	Non-friable	
Condition	Good	
Total Quantity	One penetration	
Content	12.1% Chrysotile

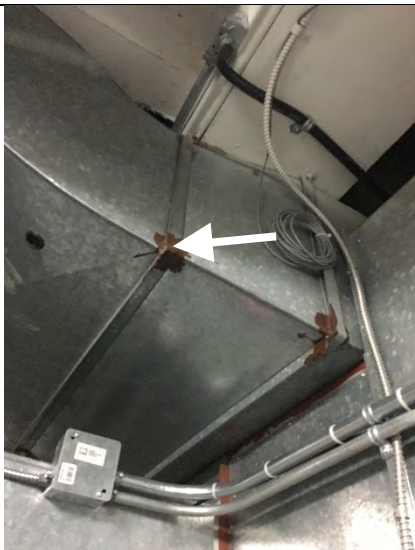
Identified ACM Description and Condition Information		Photo
Red mastic applied to seams of HVAC ducting throughout.

Friability	Non-friable	
Condition	Good	
Total Quantity	HVAC seams throughout	
Content	1.2% Chrysotile (current assessment) 5.7% Chrysotile (WSP Admin Report, 2018) 10–25% Chrysotile (Golder Report, 2004)	
Beige pebble patterned vinyl sheet flooring in the Janitor Room and Female Washroom.

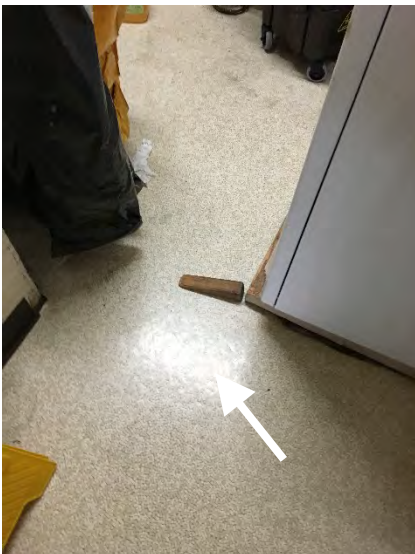
Friability	Non-friable	
Condition	Good	
Total Quantity	Approximately 25 m ²	
Content	15.0% Chrysotile (current assessment) 10–25% Chrysotile (Golder Report, 2004)

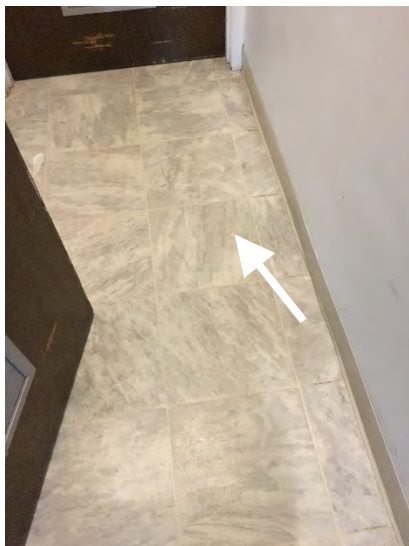
Identified ACM Description and Condition Information		Photo
Tan vinyl sheet flooring beneath cream 12"x12" patterned vinyl sheet flooring in the Male Washroom.

Friability	Non-friable	
Condition	Good	
Total Quantity	Approximately 15 m ²	
Content	10.2% Chrysotile	
12"x12" cream vinyl floor tile with beige smudges in the Electrical/Telephone room and west portion of the Mail/Files room.

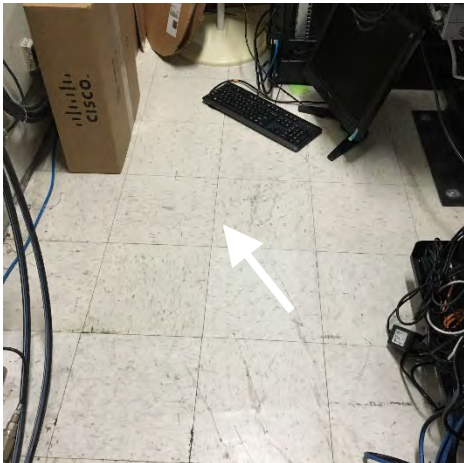
Friability	Non-friable	
Condition	Good	
Total Quantity	Approximate 25 m ²	
Content	1.3% Chrysotile (current assessment) 1-10% Chrysotile (Golder Report, 2004)

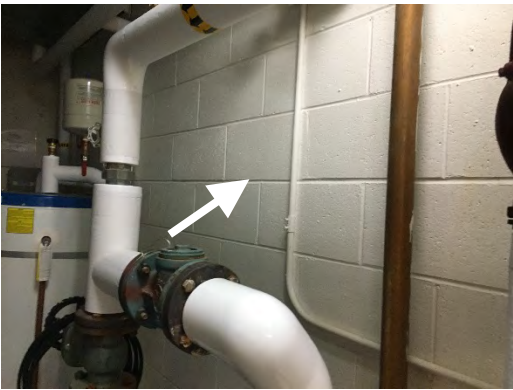
Identified LCP Description		Photo
Paint colour	White

Substrate	Concrete	
Location/approx. extent	Interior walls	
Lead content	800 ppm	
Condition	Good	
Paint colour	Grey

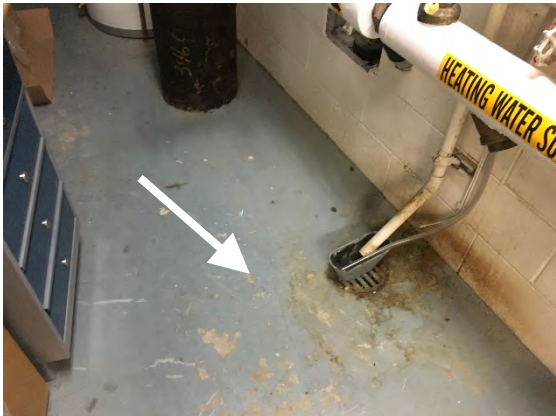
Substrate	Concrete	
Location/approx. extent	Mechanical room floor	
Lead content	3,600 ppm	
Condition	Good in general, worn from surface in localized areas

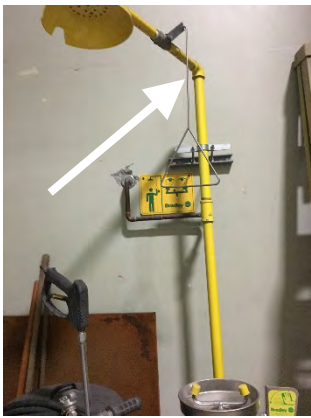
Identified ACM Description and Condition Information		Photo
Blue pipe sealant applied to threads of the wash station pipes.

Friability	Non-friable	
Condition	Good	
Total Quantity	Wash station pipe fittings	
Content	1% Chrysotile	
Cream pipe sealant applied to threads of compressed air lines throughout. See section 5.2.1.1

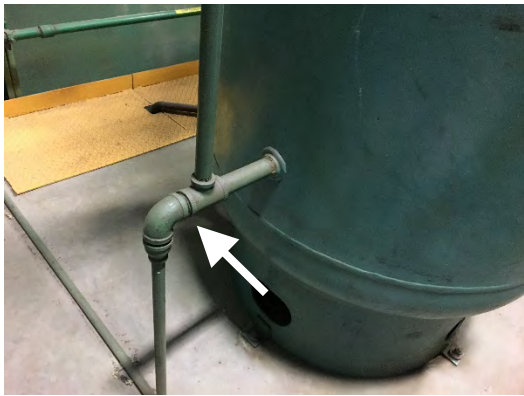
Friability	Non-friable	
Condition	Good	
Total Quantity	Compressed air line fittings throughout	
Content	<0.36—<1% Chrysotile

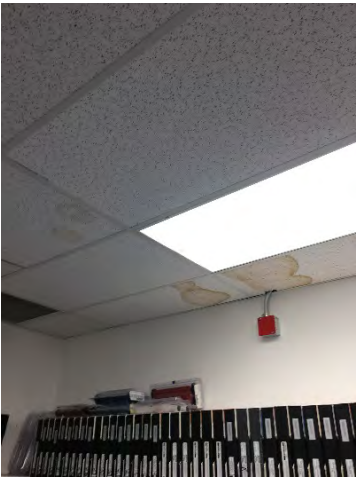
Building Area	Observation	Suspected Source of Moisture	Photo
Office and Paint Shop	Moisture stained ceiling tiles	Pipe leaks, condensation tray overflow

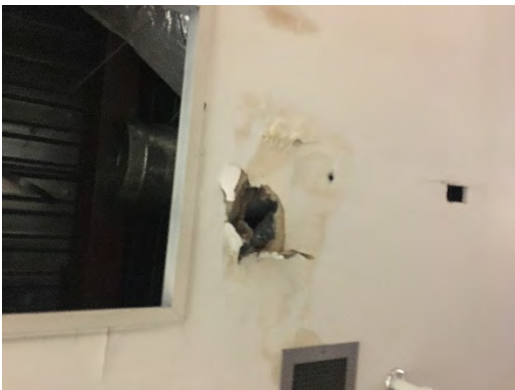
Envir. Crew Storage	Moisture impacted drywall ceiling	Pipe leaks, condensation tray overflow, roof leaks

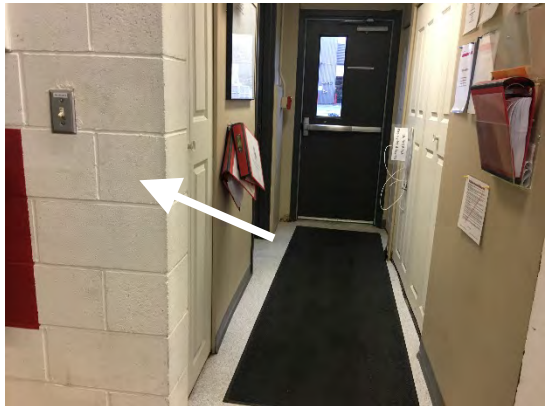
Identified LCP Description		Photo
Paint colour	White

Substrate	Concrete	
Location/approx. extent	Interior walls	
Lead content	710 ppm	
Condition	Good

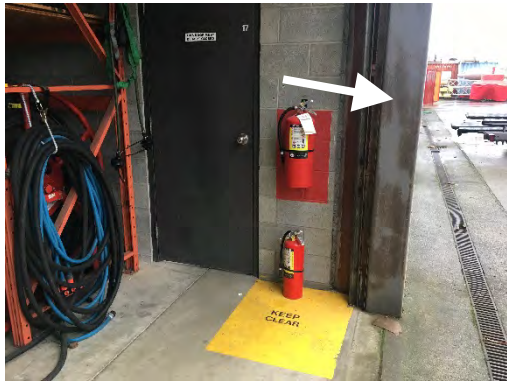
Identified LCP Description		Photo
Paint colour	Brown

Substrate	Metal	
Location/approx. extent	Exterior door frames	
Lead content	39,000 ppm	
Condition	Good	
Paint colour	Blue

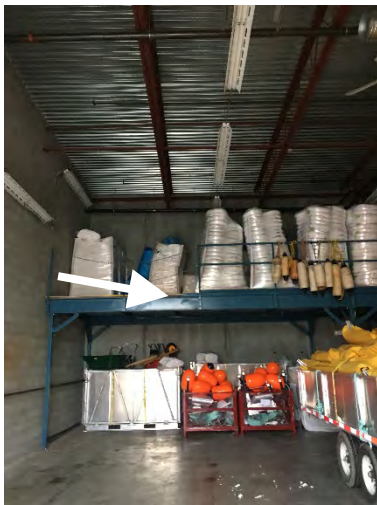
Substrate	Metal	
Location/approx. extent	Mezzanine structure	
Lead content	3,100 ppm	
Condition	Good

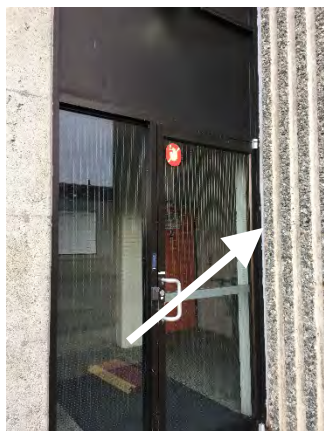
Identified ACM Description and Condition Information		Photo
Grey wall sealant applied to exterior concrete vertical seams.

Friability	Non-friable	
Condition	Good	
Total Quantity	Vertical seams throughout exterior	
Content	1.5% Chrysotile	
Black window pane caulking applied to windows throughout.

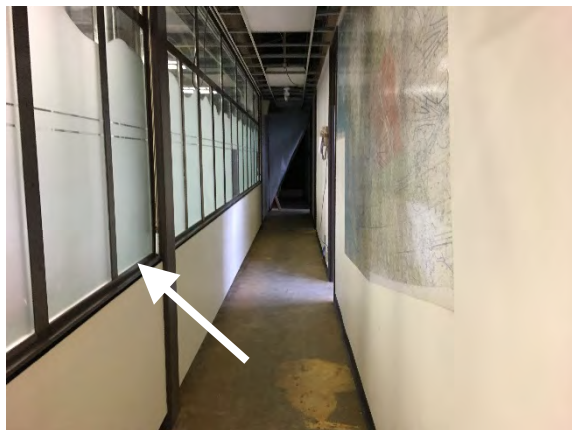
Friability	Non-friable	
Condition	Good	
Total Quantity	Windows throughout	
Content	1.4% Chrysotile

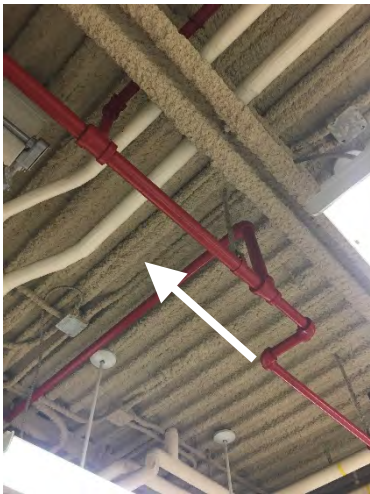
Identified ACM Description and Condition Information		Photo
Spray on insulation/fireproofing applied to ceilings and structural steel (observed to have been removed from the mezzanine area). See section 5.4.1.1

Friability	Friable	
Condition	Good	
Total Quantity	NICAD electrical shop, stock room, workshop, workshop stores, SNR. HEL. ENGR. Office, technical library, electrical room and boiler room	
Content	0.5% Actinolite (North West Bulk Sample 2016 Report) <0.5% Actinolite (North West Bulk Sample 2017 Report) Vermiculite detected (BC Hazmat 2017 Report)

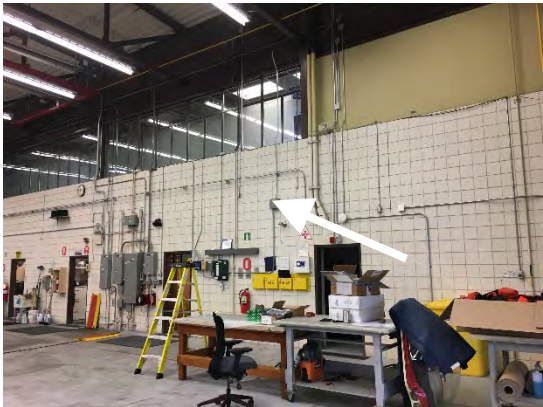
Identified LCP Description		Photo
Paint colour	White

Substrate	Concrete	
Location/approx. extent	Interior walls	
Lead content	780 ppm	
Condition	Good	
Paint colour	Orange

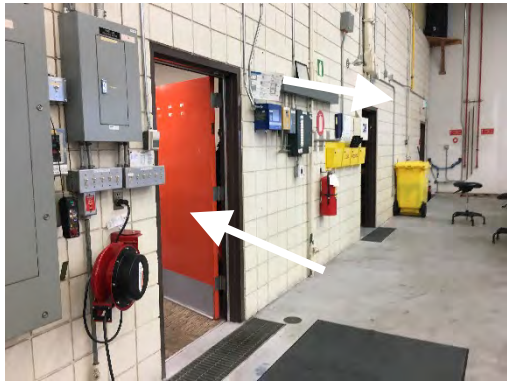
Substrate	Metal	
Location/approx. extent	Doors	
Lead content	20,000 ppm	
Condition	Good	
Paint colour	Brown

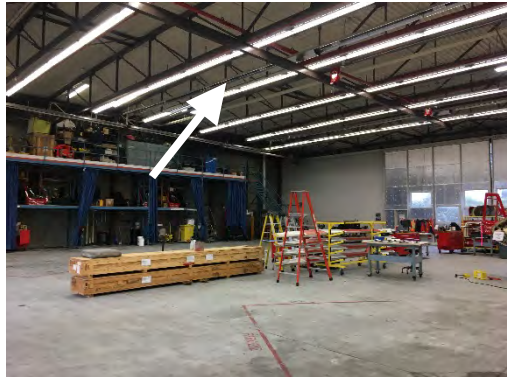
Substrate	Metal	
Location/approx. extent	Structural steel	
Lead content	7,300 ppm	
Condition	Good

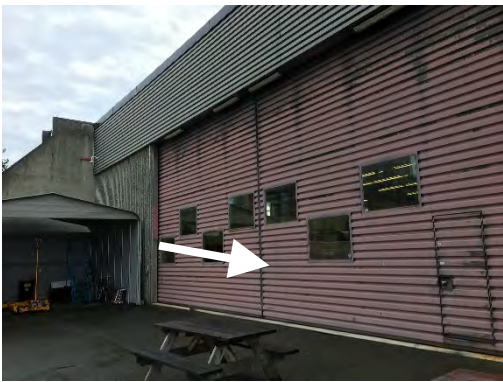
Identified LCP Description		Photo
Paint colour	Pink

Substrate	Metal	
Location/approx. extent	Exterior bay doors	
Lead content	2,800 ppm	
Condition	Good

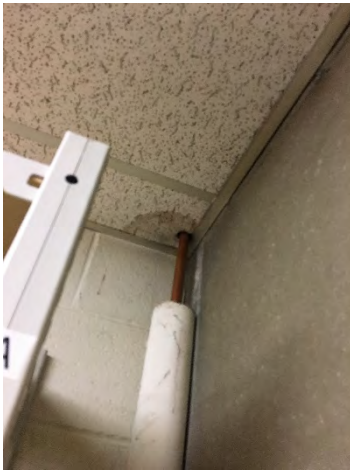
Building Area	Observation	Suspected Source of Moisture	Photo
Workshop, workshop stores and SNR. HEL. ENGR office	Moisture stained ceiling tiles	Pipe leaks, condensation tray overflow, roof leaks

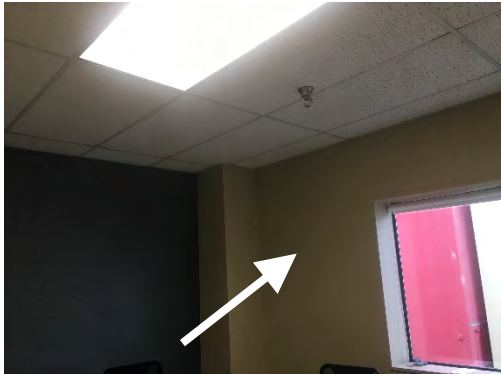
Identified ACM Description and Condition Information		Photo
Drywall joint compound applied to walls and ceilings throughout.

Friability	Non-friable in situ, can be made friable if disturbed	
Condition	Good	
Total Quantity	Approximately 1,000 m ²	
Content	1–2% Chrysotile

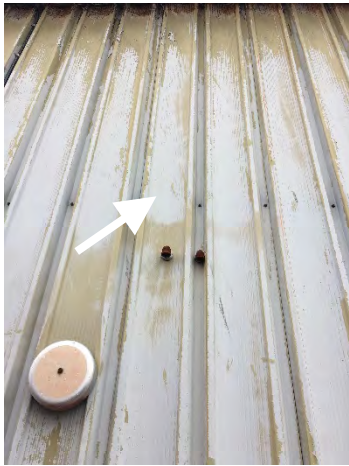
Identified LCP Description		Photo
Paint colour	Light blue/grey

Substrate	Metal	
Location/approx. extent	Exterior siding	
Lead content	3,500 ppm	
Condition	Good

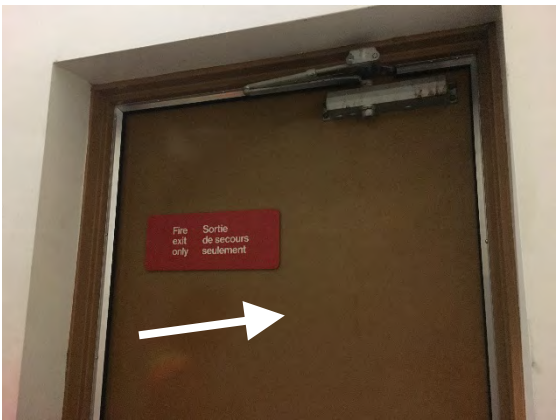
Identified LCP Description		Photo
Paint colour	Light brown

Substrate	Metal	
Location/approx. extent	Stairwell, door and frame	
Lead content	2,000 ppm	
Condition	Good	
Paint colour	Orange

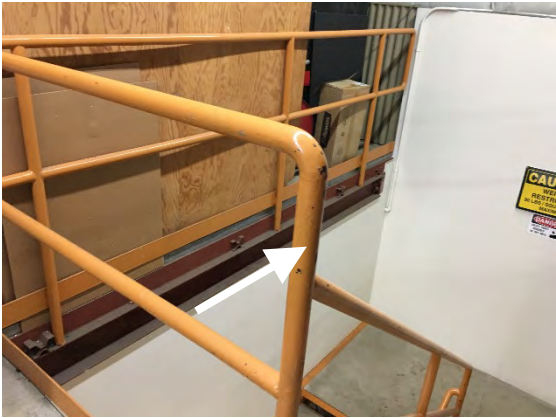
Substrate	Metal	
Location/approx. extent	Mezzanine storage, stairs and railing	
Lead content	3,200 ppm	
Condition	Good	
Paint colour	Purple	No photo
Substrate	Metal	
Location/approx. extent	Exterior walls	
Lead content	2,000 ppm	
Condition	Good

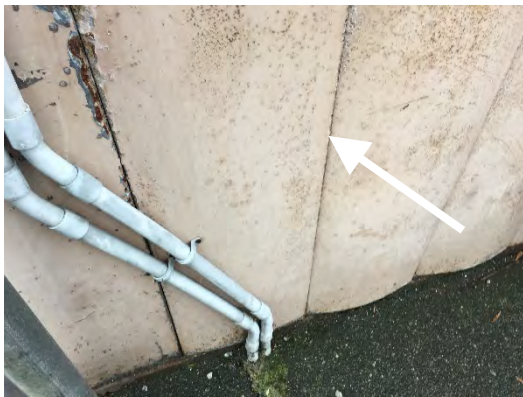
Identified LCP Description		Photo
Paint colour	Pink/peach

Substrate	Metal	
Location/approx. extent	Exterior walls	
Lead content	32,000 ppm	
Condition	Good in general, some localized damage

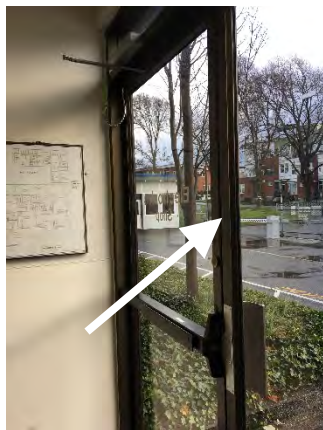
Identified ACM Description and Condition Information		Photo
Grey window pane caulking applied to windows throughout.

Friability	Non-friable	
Condition	Good	
Total Quantity	Windows throughout	
Content	3.2% Chrysotile (current assessment) 1–10% Chrysotile (Golder Report, 2004)	
Black mechanical gaskets in pipe flanges.

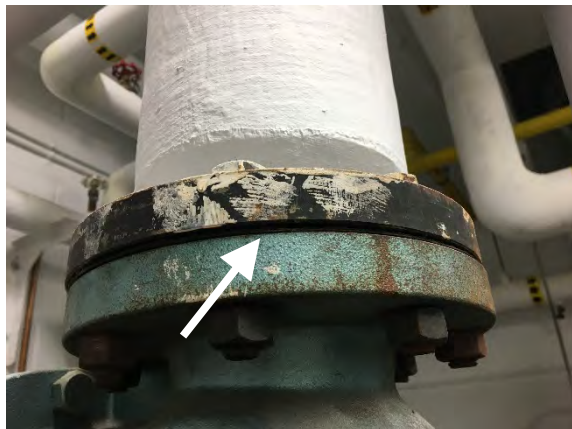
Friability	Non-friable	
Condition	Good	
Total Quantity	Flanges throughout	
Content	45% Chrysotile	
12"x12" beige vinyl floor tile with brown streaks in the Carpentry Shop mezzanine and shop foreman (concealed beneath linoleum), Maintenance Garage equipment and systems storage.

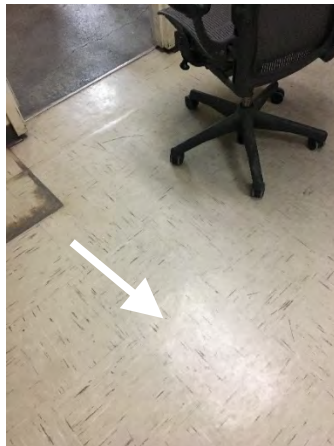
Friability	Non-friable	
Condition	Good	
Total Quantity	Approximately 35 m ²	
Content	1.3% Chrysotile (current assessment) 2.5% Chrysotile (WSP Workshop Report, 2018) 1–10% Chrysotile (Golder Report, 2004)

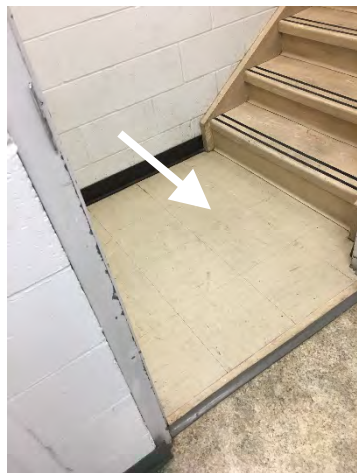
Identified ACM Description and Condition Information		Photo
12"x12" white with grey floor tile at the base of the stairwell in the electrical shop and open storage.

Friability	Non-friable	
Condition	Good	
Total Quantity	Approximately 5 m ²	
Content	1–10% Chrysotile (Golder Report, 2004)

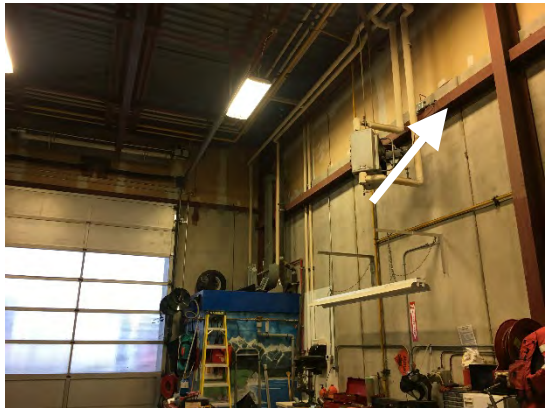
Identified LCP Description		Photo
Paint colour	Red

Substrate	Metal	
Location/approx. extent	Structural steel	
Lead content	2,300 ppm	
Condition	Good	
Paint colour	Red

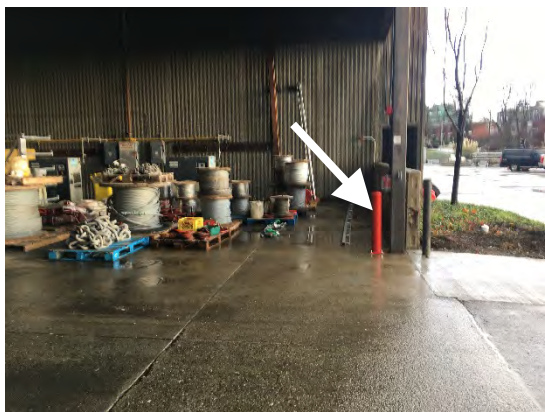
Substrate	Metal	
Location/approx. extent	Exterior bollards	
Lead content	1,300 ppm	
Condition	Good

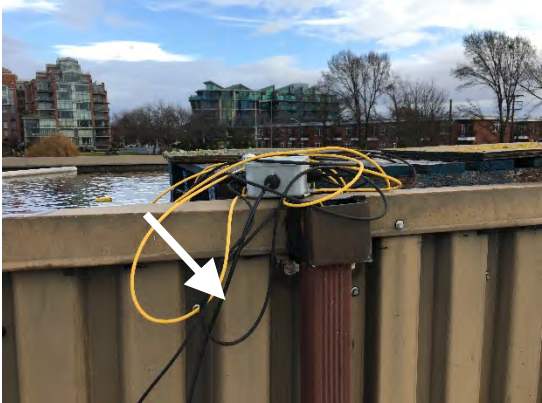
Identified LCP Description		Photo
Paint colour	Brown

Substrate	Metal	
Location/approx. extent	Exterior walls	
Lead content	700 ppm	
Condition	Good	
Paint colour	Cream (red underneath)

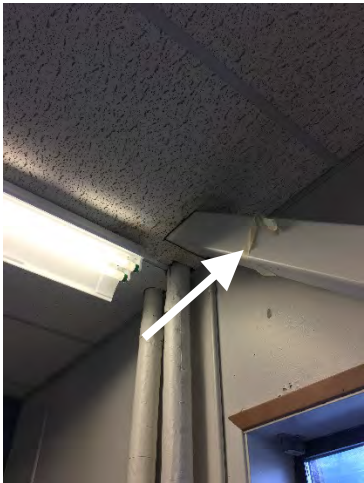
Substrate	Metal	
Location/approx. extent	Vertical columns	
Lead content	1,200 ppm (WSP Workshop Report, 2018)	
Condition	Good

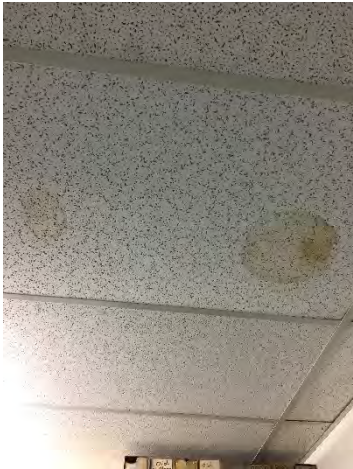
Building Area	Observation	Suspected Source of Moisture	Photo
Electrical shop, machine shop office, lamp room and lunch room	Moisture stained ceiling tiles	Pipe leaks, condensation tray overflow, roof leaks

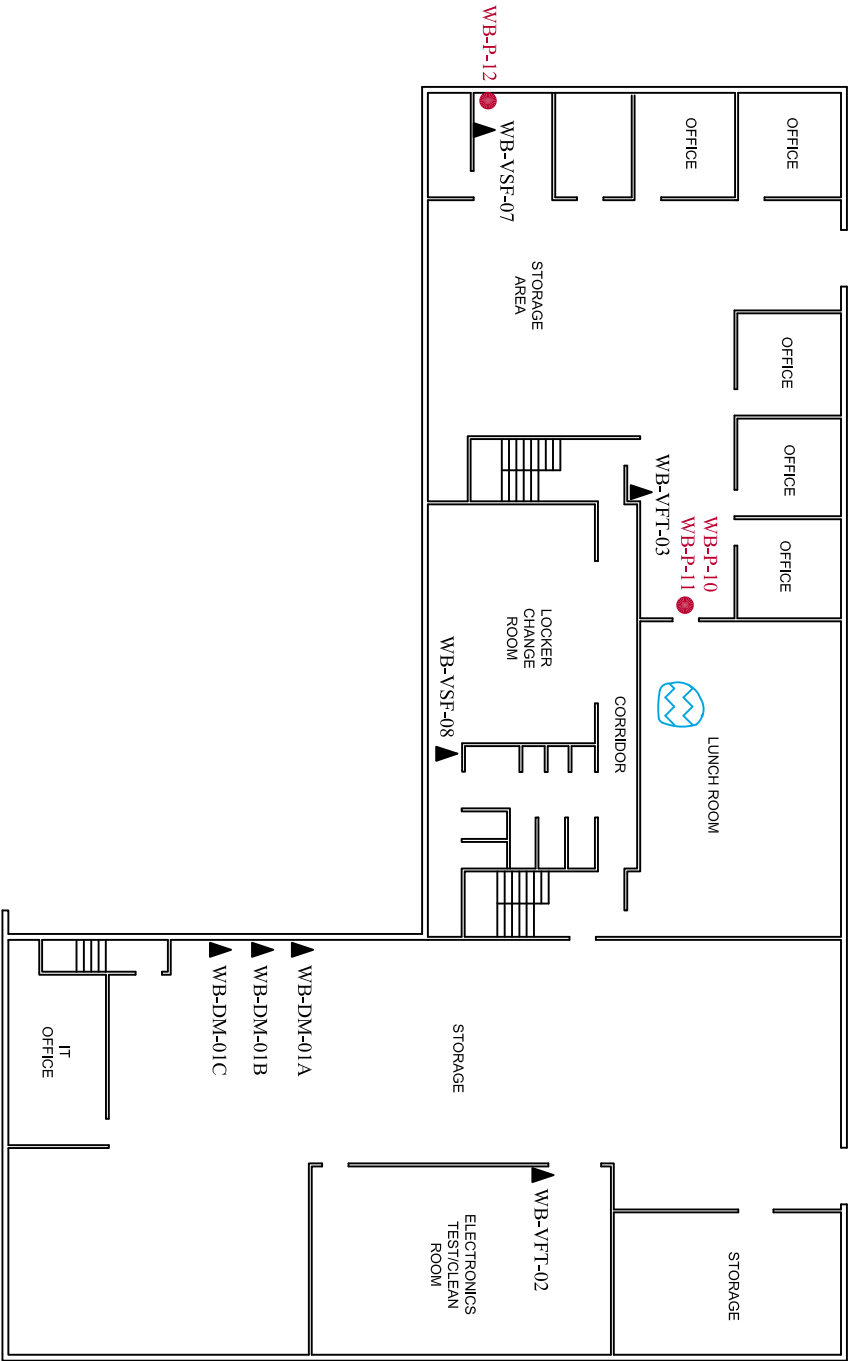
MEZZANINE WORKSHOP BUILDING

- NOTES:**
1. GREY WINDOW PANE CAULKING APPLIED TO WINDOWS THROUGHOUT IS ASBESTOS-CONTAINING.
 2. BLACK MECHANICAL GASKETS ON PIPE FLANGES THROUGHOUT IS ASBESTOS-CONTAINING.
 3. THIS DRAWING ILLUSTRATES SUPPORTING INFORMATION SPECIFIC TO A STANTEC CONSULTING LTD. REPORT AND MUST NOT BE USED FOR OTHER PURPOSES.
