Hazardous Building Materials Assessments

6 Buildings/Structures at the Victoria
Coast Guard Base, 25 Huron Street,
Victoria, BC

March 18, 2019

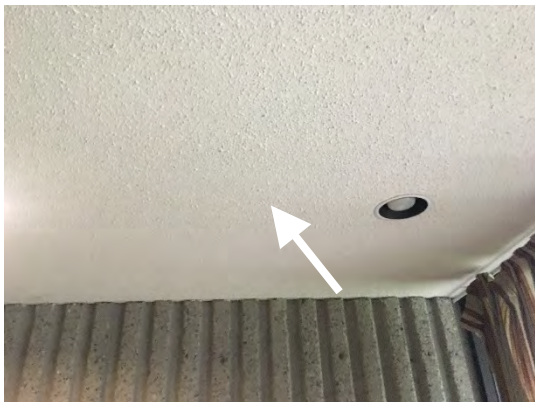
Identified ACM Description and Condition Information		Photo
Texture coat applied to drywall ceiling in the front entrance vestibule, which is continuous with the exterior soffit in this area.

Friability	Non-friable in situ—may become friable if disturbed.	
Condition	Good	
Total Quantity	Approximately 20 m ²	
Content	1% Chrysotile	
Black electrical penetration putty on the floor penetration in the Electrical/Telephone room.

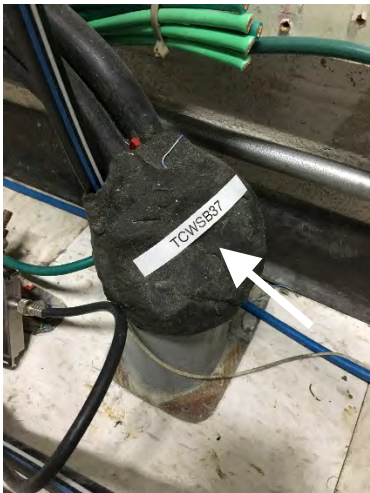
Friability	Non-friable	
Condition	Good	
Total Quantity	One penetration	
Content	12.1% Chrysotile

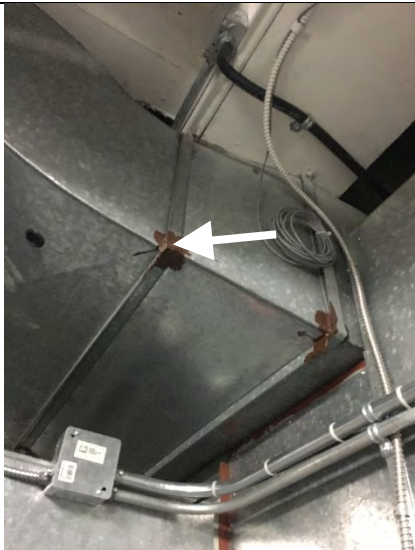
Identified ACM Description and Condition Information		Photo
Red mastic applied to seams of HVAC ducting throughout.

Friability	Non-friable	
Condition	Good	
Total Quantity	HVAC seams throughout	
Content	1.2% Chrysotile (current assessment) 5.7% Chrysotile (WSP Admin Report, 2018) 10–25% Chrysotile (Golder Report, 2004)	
Beige pebble patterned vinyl sheet flooring in the Janitor Room and Female Washroom.

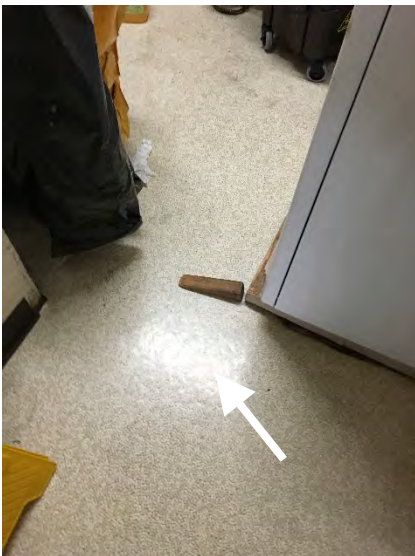
Friability	Non-friable	
Condition	Good	
Total Quantity	Approximately 25 m ²	
Content	15.0% Chrysotile (current assessment) 10–25% Chrysotile (Golder Report, 2004)

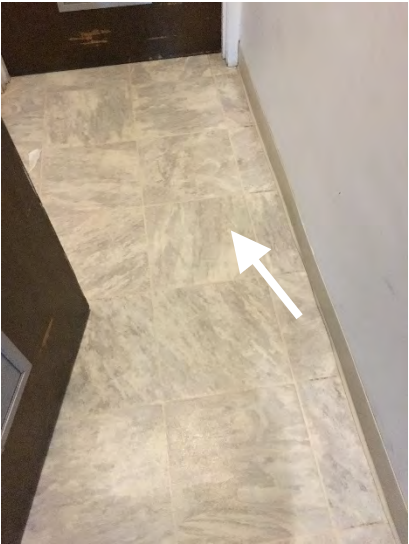
Identified ACM Description and Condition Information		Photo
Tan vinyl sheet flooring beneath cream 12"x12" patterned vinyl sheet flooring in the Male Washroom.

Friability	Non-friable	
Condition	Good	
Total Quantity	Approximately 15 m ²	
Content	10.2% Chrysotile	
12"x12" cream vinyl floor tile with beige smudges in the Electrical/Telephone room and west portion of the Mail/Files room.

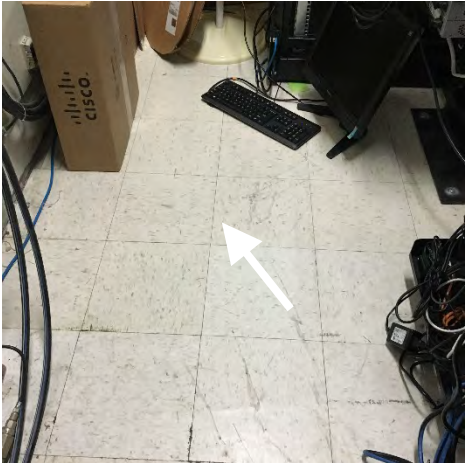
Friability	Non-friable	
Condition	Good	
Total Quantity	Approximate 25 m ²	
Content	1.3% Chrysotile (current assessment) 1-10% Chrysotile (Golder Report, 2004)

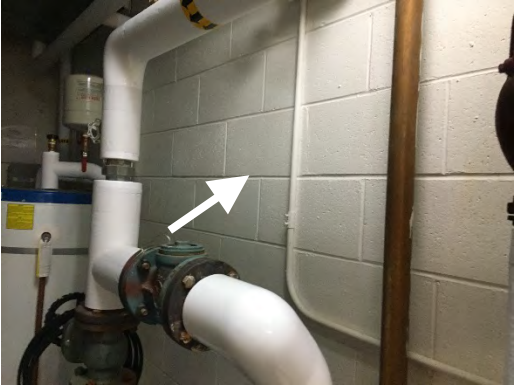
Identified LCP Description		Photo
Paint colour	White

Substrate	Concrete	
Location/approx. extent	Interior walls	
Lead content	800 ppm	
Condition	Good	
Paint colour	Grey

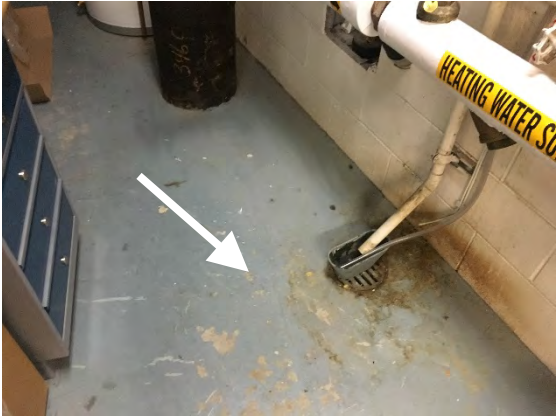
Substrate	Concrete	
Location/approx. extent	Mechanical room floor	
Lead content	3,600 ppm	
Condition	Good in general, worn from surface in localized areas

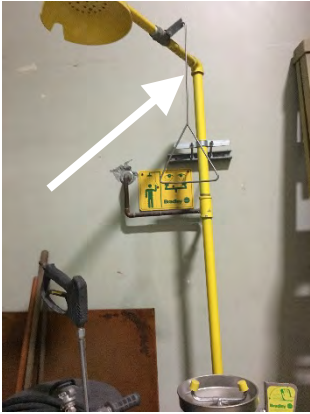
Identified ACM Description and Condition Information		Photo
Blue pipe sealant applied to threads of the wash station pipes.

Friability	Non-friable	
Condition	Good	
Total Quantity	Wash station pipe fittings	
Content	1% Chrysotile	
Cream pipe sealant applied to threads of compressed air lines throughout. See section 5.2.1.1

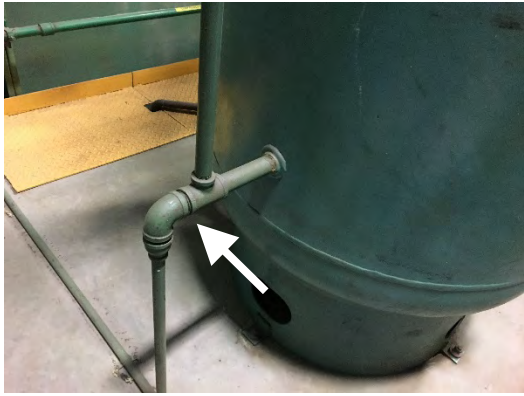
Friability	Non-friable	
Condition	Good	
Total Quantity	Compressed air line fittings throughout	
Content	<0.36—<1% Chrysotile

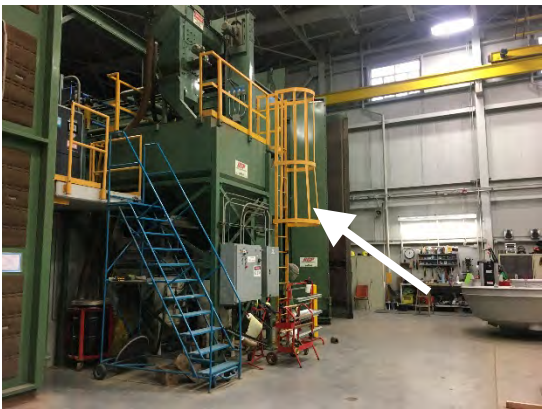
Identified LCP Description		Photo
Paint colour	Yellow

Substrate	Metal	
Location/approx. extent	Mezzanine railings and ladder	
Lead content	690 ppm	
Condition	Good

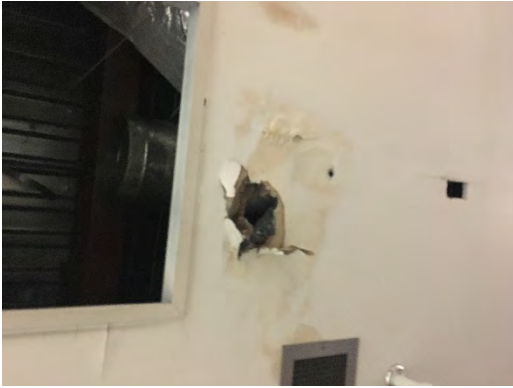
Envir. Crew Storage	Moisture impacted drywall ceiling	Pipe leaks, condensation tray overflow, roof leaks

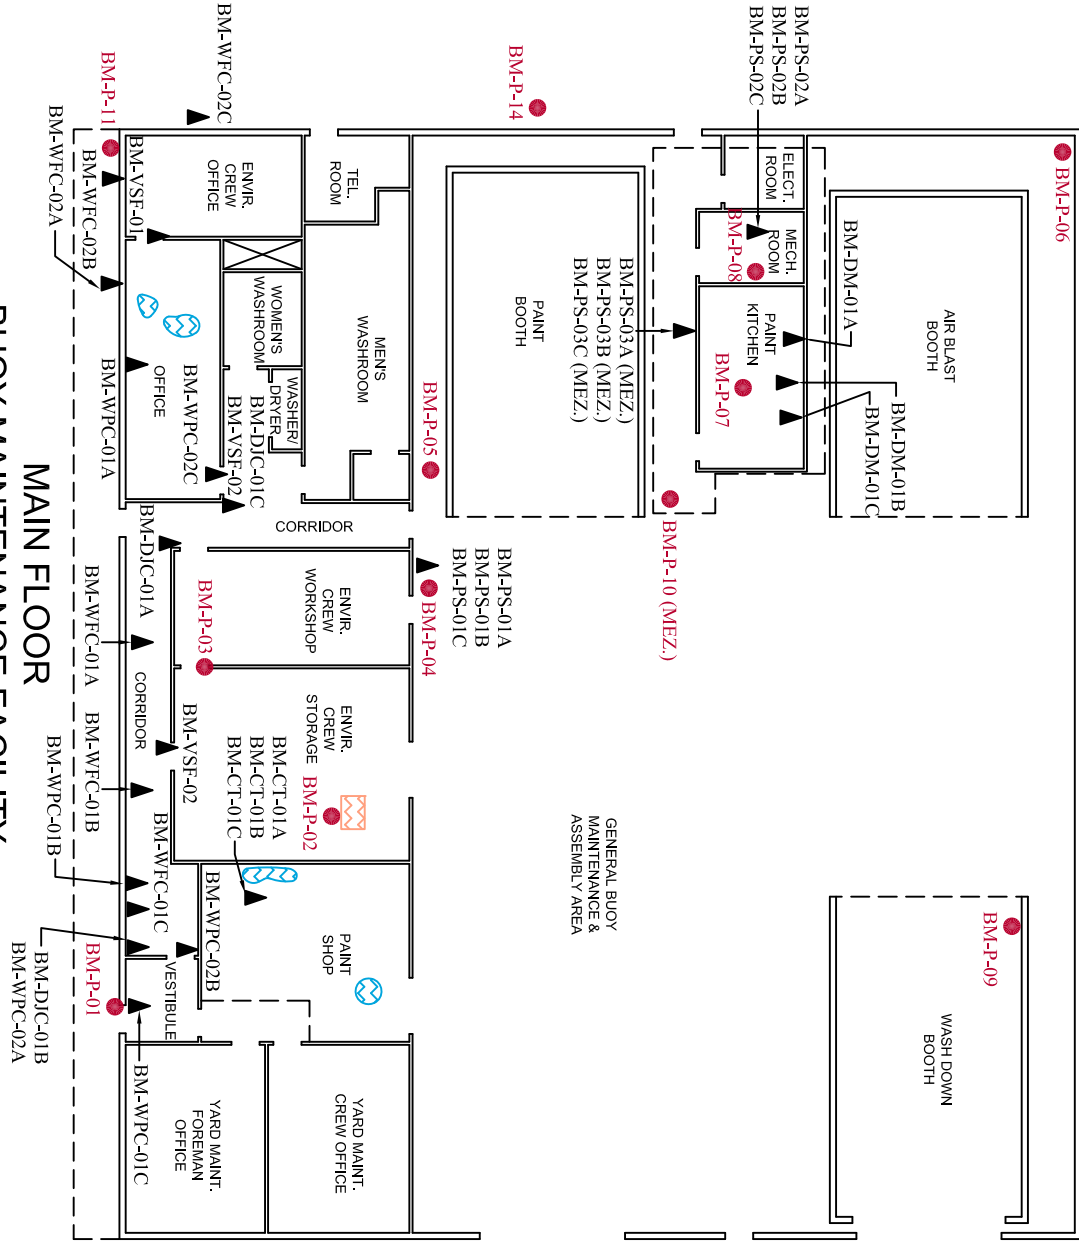
NOTES: 1. BLUE PIPE SEALANT APPLIED TO THREADS OF EYEWASH STATION LINES IS ASBESTOS-CONTAINING.
 2. CREAM PIPE SEALANT APPLIED TO THREADS OF COMPRESSED AIR LINES IS ASBESTOS-CONTAINING.
 3. THIS DRAWING ILLUSTRATES SUPPORTING INFORMATION SPECIFIC TO A STANTEC CONSULTING LTD. REPORT AND MUST NOT BE USED FOR OTHER PURPOSES.

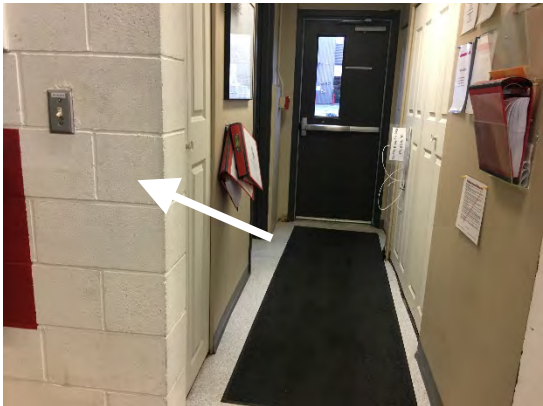
Identified LCP Description		Photo
Paint colour	White

Substrate	Concrete	
Location/approx. extent	Interior walls	
Lead content	710 ppm	
Condition	Good

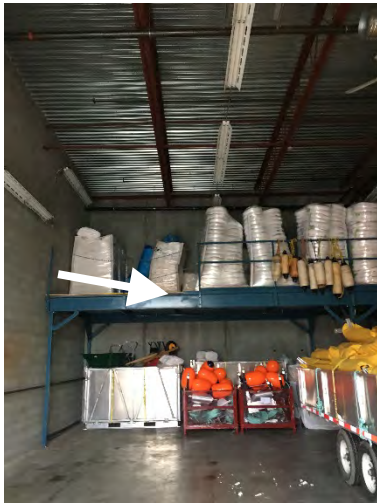
Substrate	Metal	
Location/approx. extent	Exterior door frames	
Lead content	39,000 ppm	
Condition	Good	
Paint colour	Blue

Substrate	Metal	
Location/approx. extent	Mezzanine structure	
Lead content	3,100 ppm	
Condition	Good

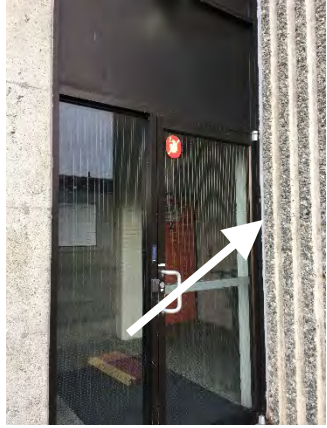
Identified ACM Description and Condition Information		Photo
Grey wall sealant applied to exterior concrete vertical seams.

Friability	Non-friable	
Condition	Good	
Total Quantity	Vertical seams throughout exterior	
Content	1.5% Chrysotile	
Black window pane caulking applied to windows throughout.

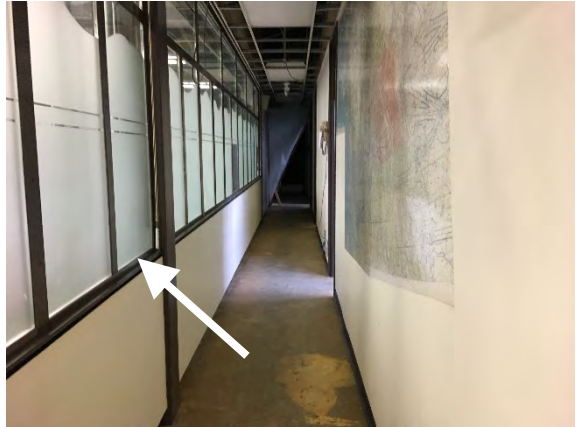
Friability	Non-friable	
Condition	Good	
Total Quantity	Windows throughout	
Content	1.4% Chrysotile

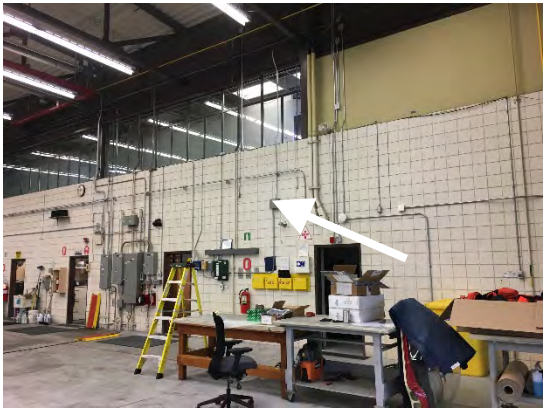
Identified LCP Description		Photo
Paint colour	White

Substrate	Concrete	
Location/approx. extent	Interior walls	
Lead content	780 ppm	
Condition	Good	
Paint colour	Orange

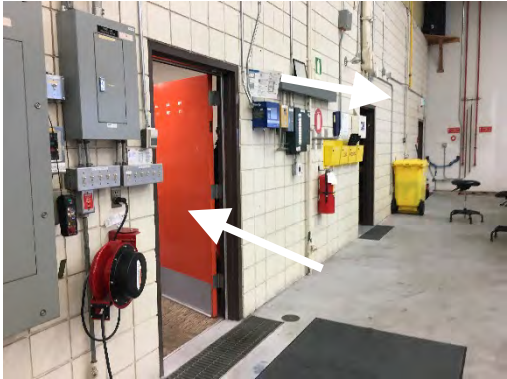
Substrate	Metal	
Location/approx. extent	Doors	
Lead content	20,000 ppm	
Condition	Good	
Paint colour	Brown

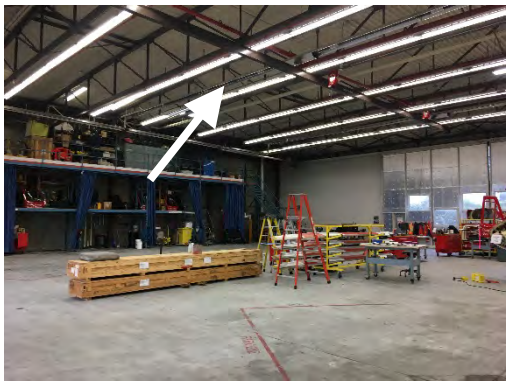
Substrate	Metal	
Location/approx. extent	Structural steel	
Lead content	7,300 ppm	
Condition	Good

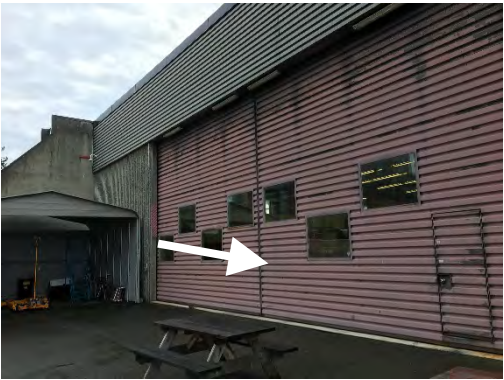
Identified LCP Description		Photo
Paint colour	Pink

Substrate	Metal	
Location/approx. extent	Exterior bay doors	
Lead content	2,800 ppm	
Condition	Good

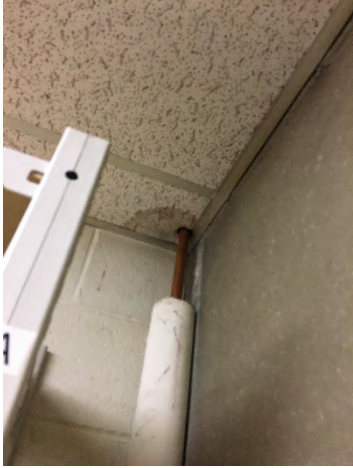
Building Area	Observation	Suspected Source of Moisture	Photo
Workshop, workshop stores and SNR. HEL. ENGR office	Moisture stained ceiling tiles	Pipe leaks, condensation tray overflow, roof leaks

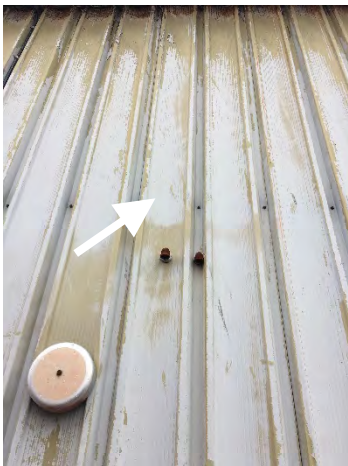
Identified LCP Description		Photo
Paint colour	Light blue/grey

Substrate	Metal	
Location/approx. extent	Exterior siding	
Lead content	3,500 ppm	
Condition	Good

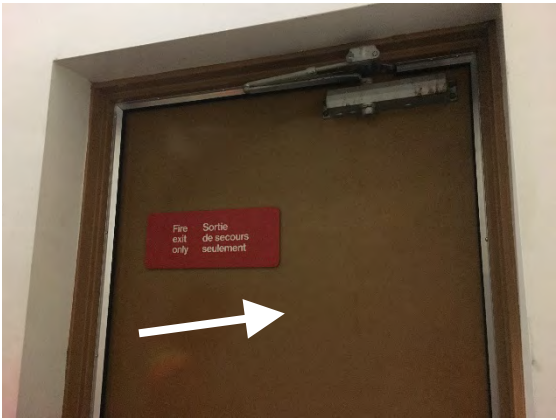
Identified LCP Description		Photo
Paint colour	Light brown

Substrate	Metal	
Location/approx. extent	Stairwell, door and frame	
Lead content	2,000 ppm	
Condition	Good	
Paint colour	Orange

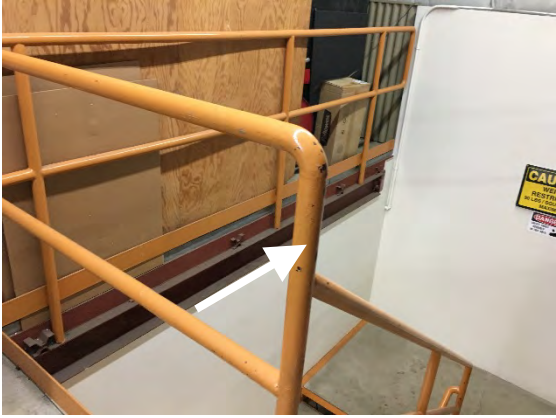
Substrate	Metal	
Location/approx. extent	Mezzanine storage, stairs and railing	
Lead content	3,200 ppm	
Condition	Good	
Paint colour	Purple	No photo
Substrate	Metal	
Location/approx. extent	Exterior walls	
Lead content	2,000 ppm	
Condition	Good

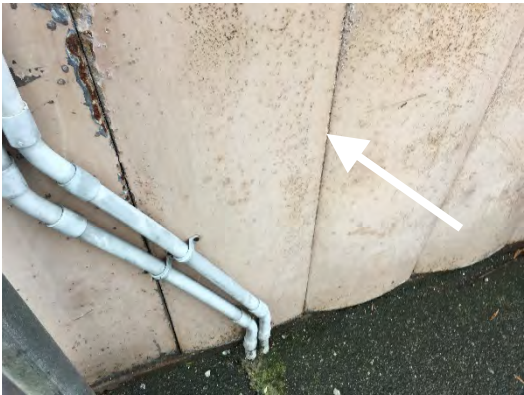
Identified LCP Description		Photo
Paint colour	Pink/peach

Substrate	Metal	
Location/approx. extent	Exterior walls	
Lead content	32,000 ppm	
Condition	Good in general, some localized damage

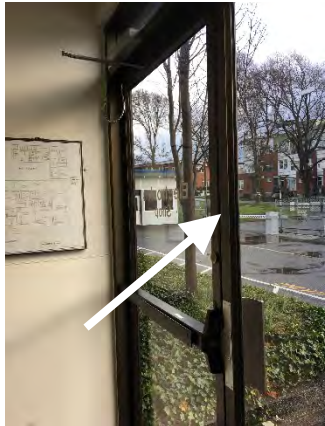
Identified ACM Description and Condition Information		Photo
Grey window pane caulking applied to windows throughout.

Friability	Non-friable	
Condition	Good	
Total Quantity	Windows throughout	
Content	3.2% Chrysotile (current assessment) 1–10% Chrysotile (Golder Report, 2004)	
Black mechanical gaskets in pipe flanges.

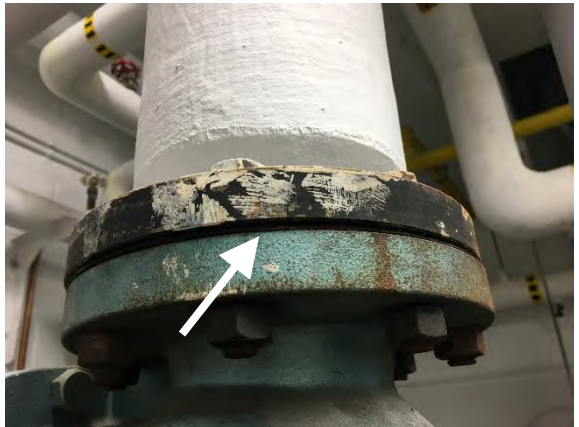
Friability	Non-friable	
Condition	Good	
Total Quantity	Flanges throughout	
Content	45% Chrysotile	
12" x 12" beige vinyl floor tile with brown streaks in the Carpentry Shop mezzanine and shop foreman (concealed beneath linoleum), Maintenance Garage equipment and systems storage.

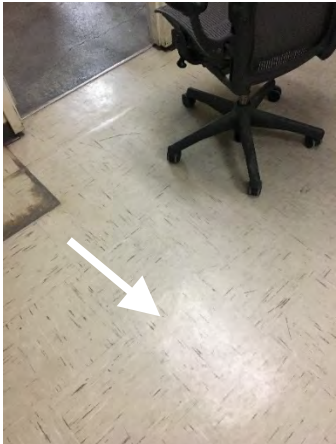
Friability	Non-friable	
Condition	Good	
Total Quantity	Approximately 35 m ²	
Content	1.3% Chrysotile (current assessment) 2.5% Chrysotile (WSP Workshop Report, 2018) 1–10% Chrysotile (Golder Report, 2004)

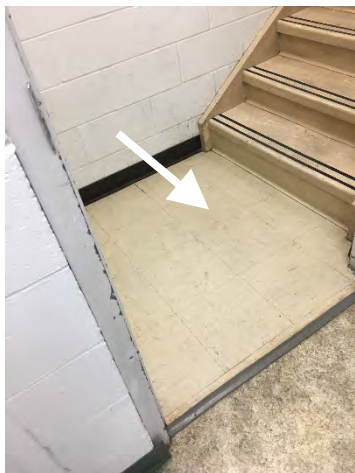
Identified ACM Description and Condition Information		Photo
12"x12" white with grey floor tile at the base of the stairwell in the electrical shop and open storage.

Friability	Non-friable	
Condition	Good	
Total Quantity	Approximately 5 m ²	
Content	1–10% Chrysotile (Golder Report, 2004)

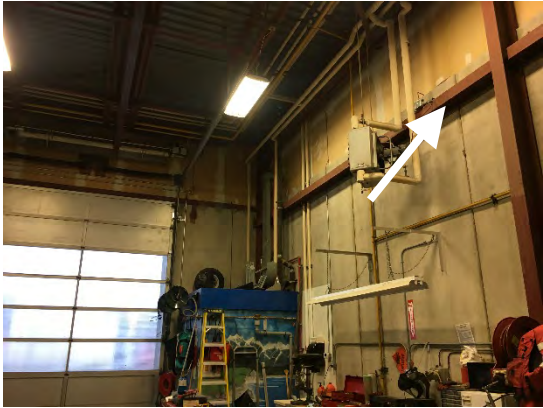
Identified LCP Description		Photo
Paint colour	Red

Substrate	Metal	
Location/approx. extent	Structural steel	
Lead content	2,300 ppm	
Condition	Good	
Paint colour	Red

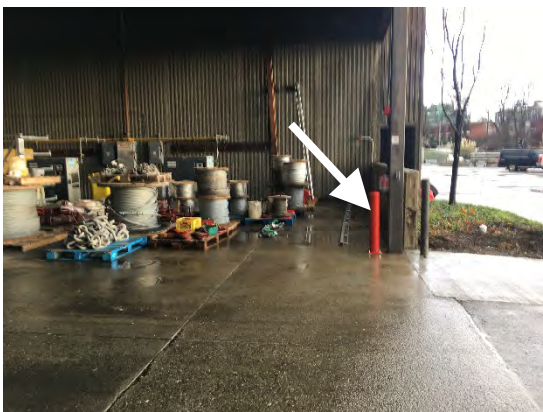
Substrate	Metal	
Location/approx. extent	Exterior bollards	
Lead content	1,300 ppm	
Condition	Good

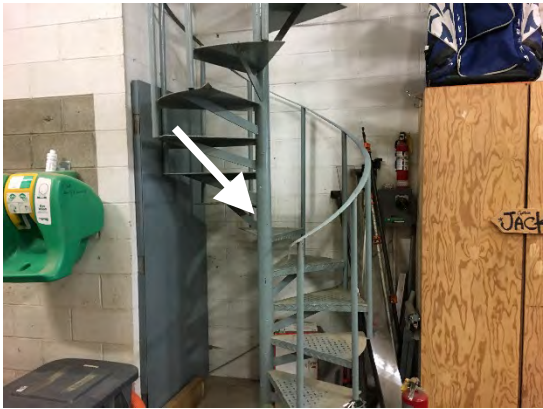
Identified LCP Description		Photo
Paint colour	Grey

Substrate	Metal	
Location/approx. extent	Carpentry shop stairwell	
Lead content	44,000 ppm	
Condition	Good	
Paint colour	White	 
Substrate	Metal	
Location/approx. extent	Doors and frames	
Lead content	1,100 ppm (current assessment) 2,100 ppm (WSP Workshop Report, 2018)	
Condition	Good	
Paint colour	Orange

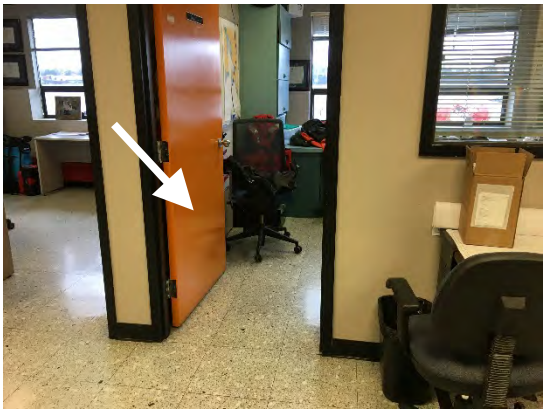
Substrate	Metal	
Location/approx. extent	Doors	
Lead content	120,000 ppm	
Condition	Good

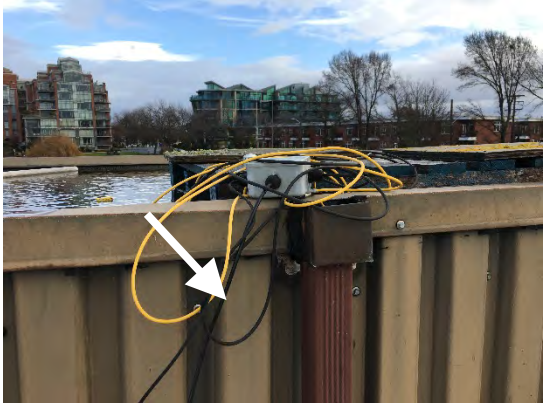
Identified LCP Description		Photo
Paint colour	Brown

Substrate	Metal	
Location/approx. extent	Exterior walls	
Lead content	700 ppm	
Condition	Good	
Paint colour	Cream (red underneath)

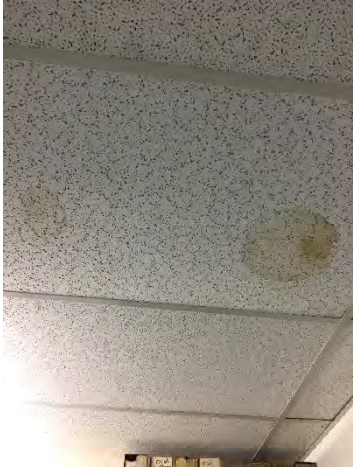
Building Area	Observation	Suspected Source of Moisture	Photo
Electrical shop, machine shop office, lamp room and lunch room	Moisture stained ceiling tiles	Pipe leaks, condensation tray overflow, roof leaks
