Reference: CLIENT SUPPLIED PDF FILE 295218-V1	Job No.: 121416161	Client: PUBLIC SERVICES AND PROCUREMENT CANADA	Project: CCGC ASBESTOS AND LEAD CONTAINING MATERIALS SURVEY	Drawing Title: CG1 CABOT BUILDING LEVEL 300 BLOCK A ACM LOCATIONS

Dwg. No.: CG1-A7
	Scale: N.T.S.				
	Date: 2019/11/01	Site Address CANADIAN COAST GUARD COLLEGE SYDNEY, NS			
	Dwn. By: bsp				
	App'd By:

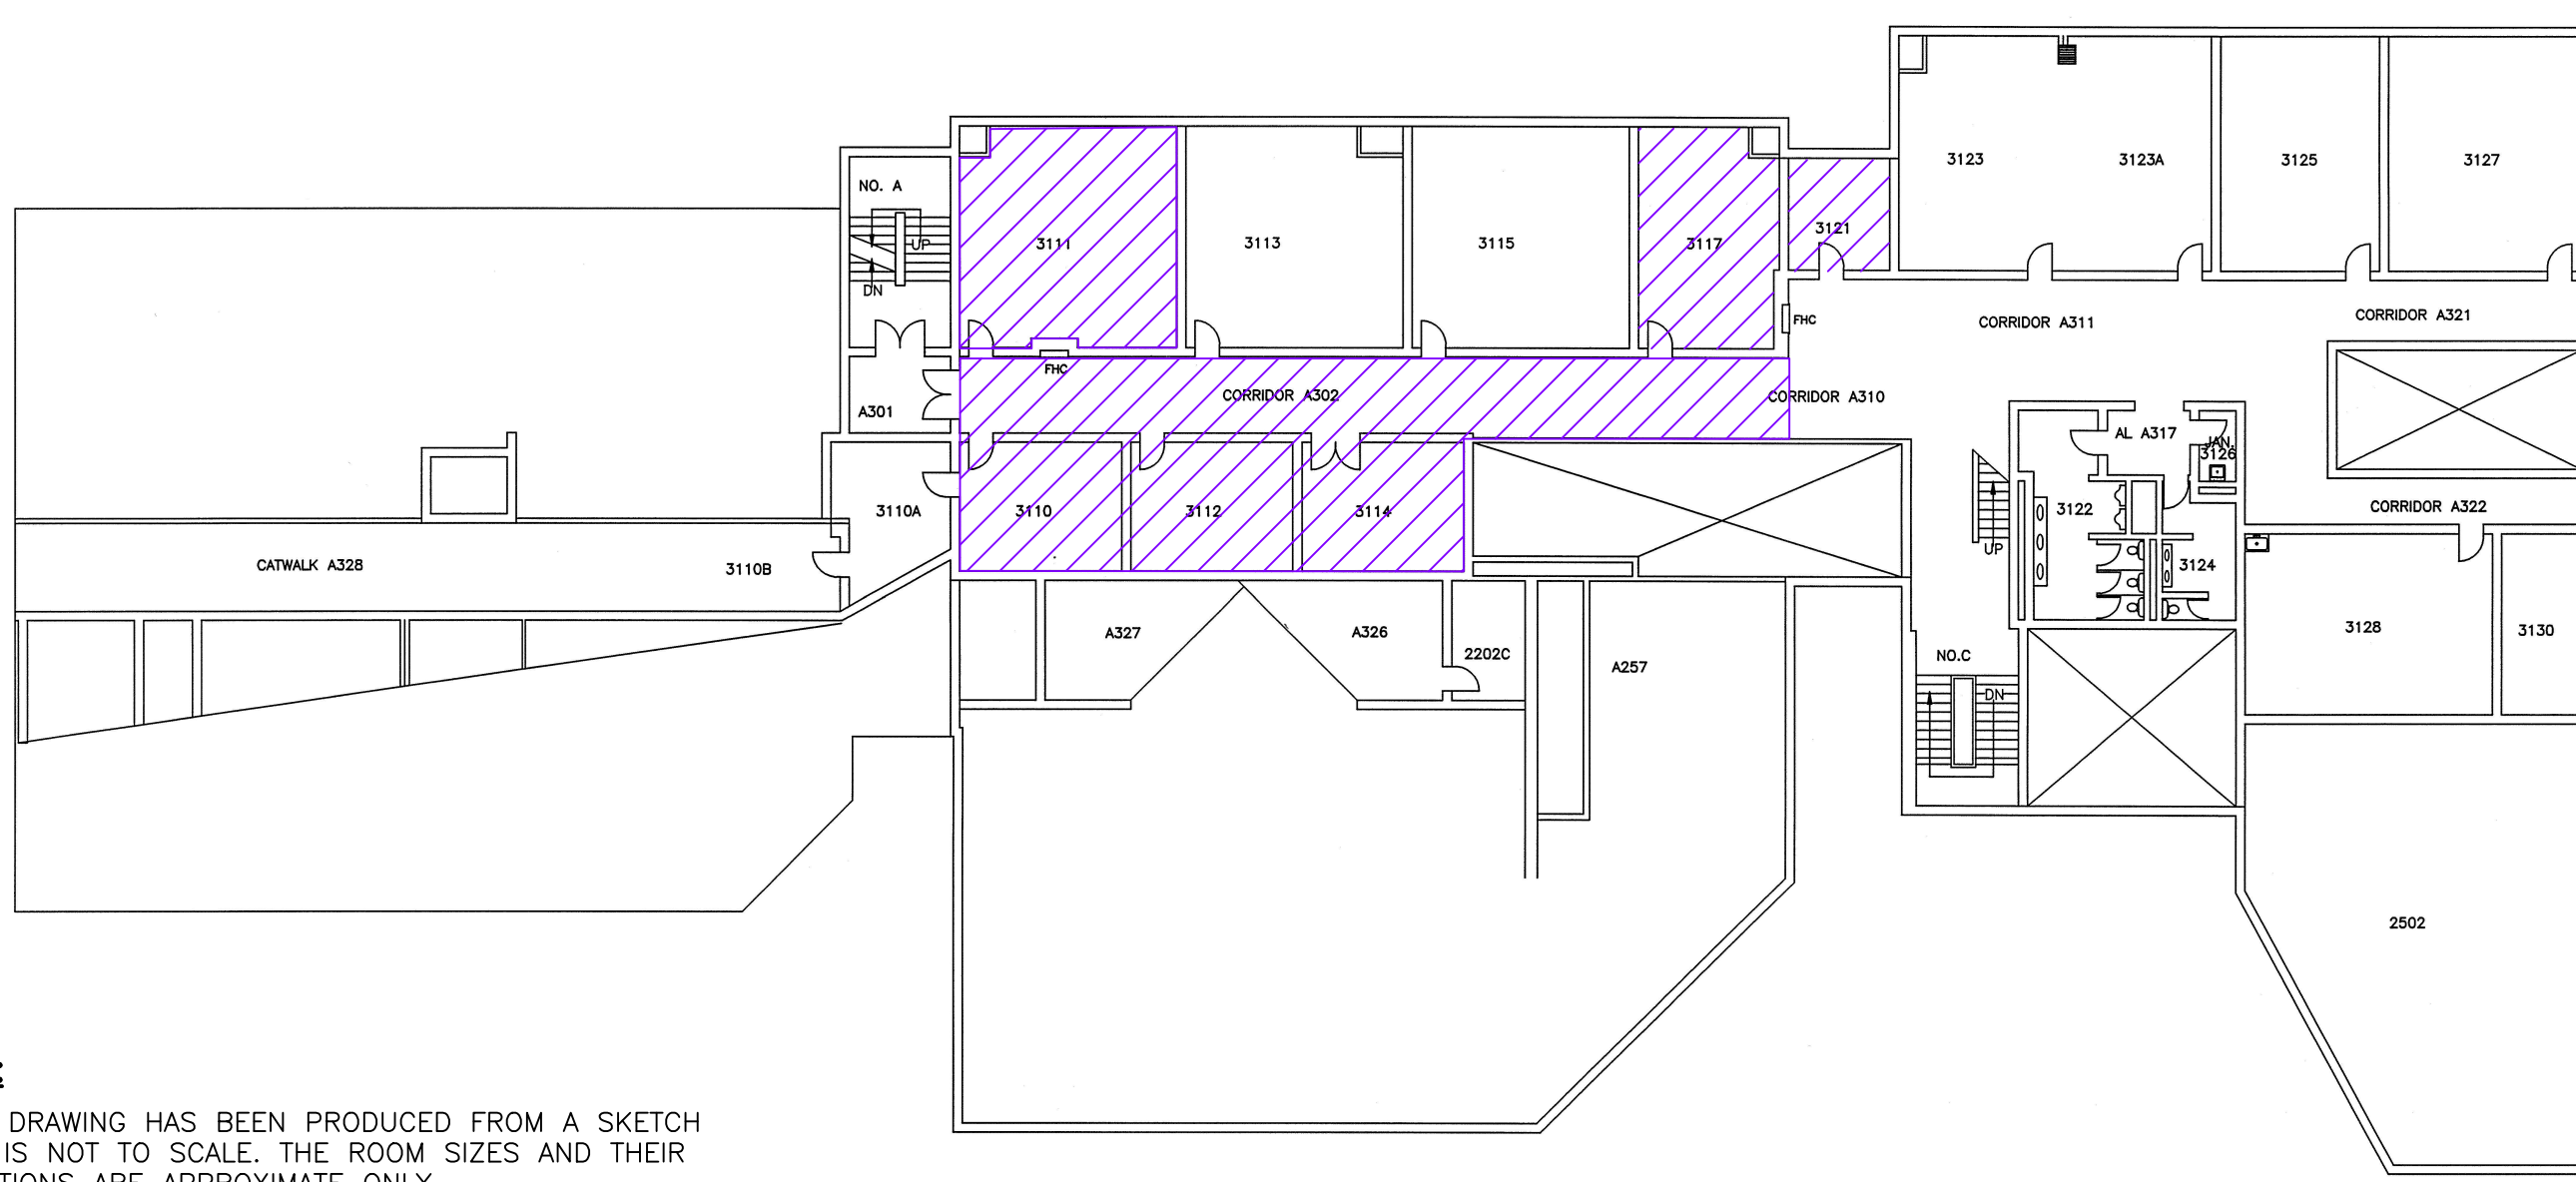
ASBESTOS-CONTAINING CEILING TILE TO BE REMOVED
