## **DRAFT HAZARDOUS BUILDING MATERIALS ASSESSMENT**

**FUNDY BATHHOUSE AND SALTWATER POOL, FUNDY NATIONAL PARK,  
ALMA, NEW BRUNSWICK**

**PUBLIC WORKS AND GOVERNMENT SERVICES CANADA  
ON BEHALF OF PARKS CANADA**

**FEBRUARY 5, 2016**

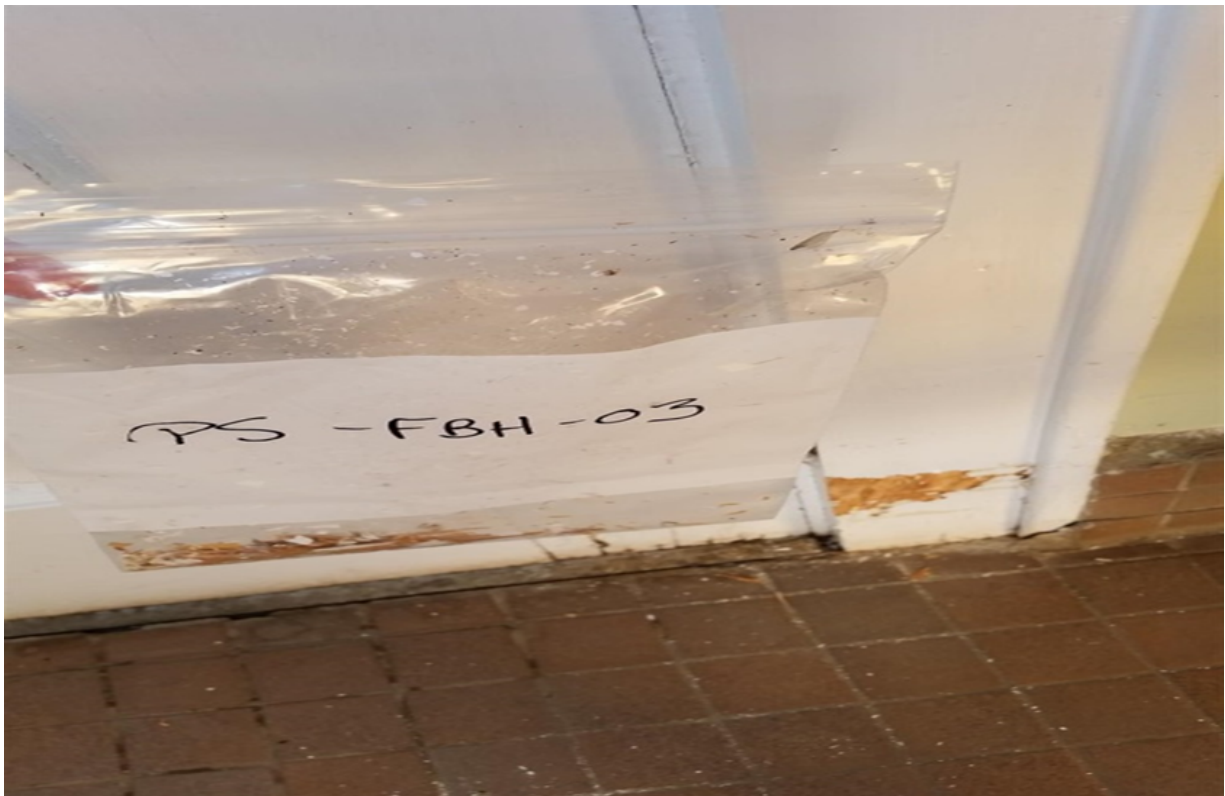
- White paint chips (PS-FBH-03) - interior window and door trim. This white paint was sampled from the wood trim around the doors found on the north and south walls of the interior finishes, where it was observed to be in GOOD to FAIR condition. Paint chips alone contain a lead leachate toxic concentration (greater than 5 mg/L). However, when the paint is attached to wood substrate, the paint application has a lead leachate toxic concentration of (less than 5 mg/L).

PHOTO 2: View of interior wood door and trim located in Area 2 of the First Floor, sample location of paint sample PS-FBH-03 (White paint on wood substrate), which was determined by laboratory analysis to be lead leachate toxic when in paint chip form

Based on laboratory analysis, the white paint chips (PS-FBH-03 and PS-FBH-05) observed on the wood window and door trim of the interior and exterior of the building, were identified to be lead leachate toxic ( $> 5$  mg/L) and cannot be disposed of at a Regional Solid Waste Landfill. If samples PS-FBH-03 and PS-FBH-05, are well adhered to the wood substrates, these painted materials can be disposed of at a Regional Solid Waste Landfill. However, loose and flaking lead-leachate toxic paint chips should be removed by a certified abatement contractor, shipped as hazardous waste, and disposed of at an approved hazardous waste disposal facility out of province, capable of handling leachate toxic waste.

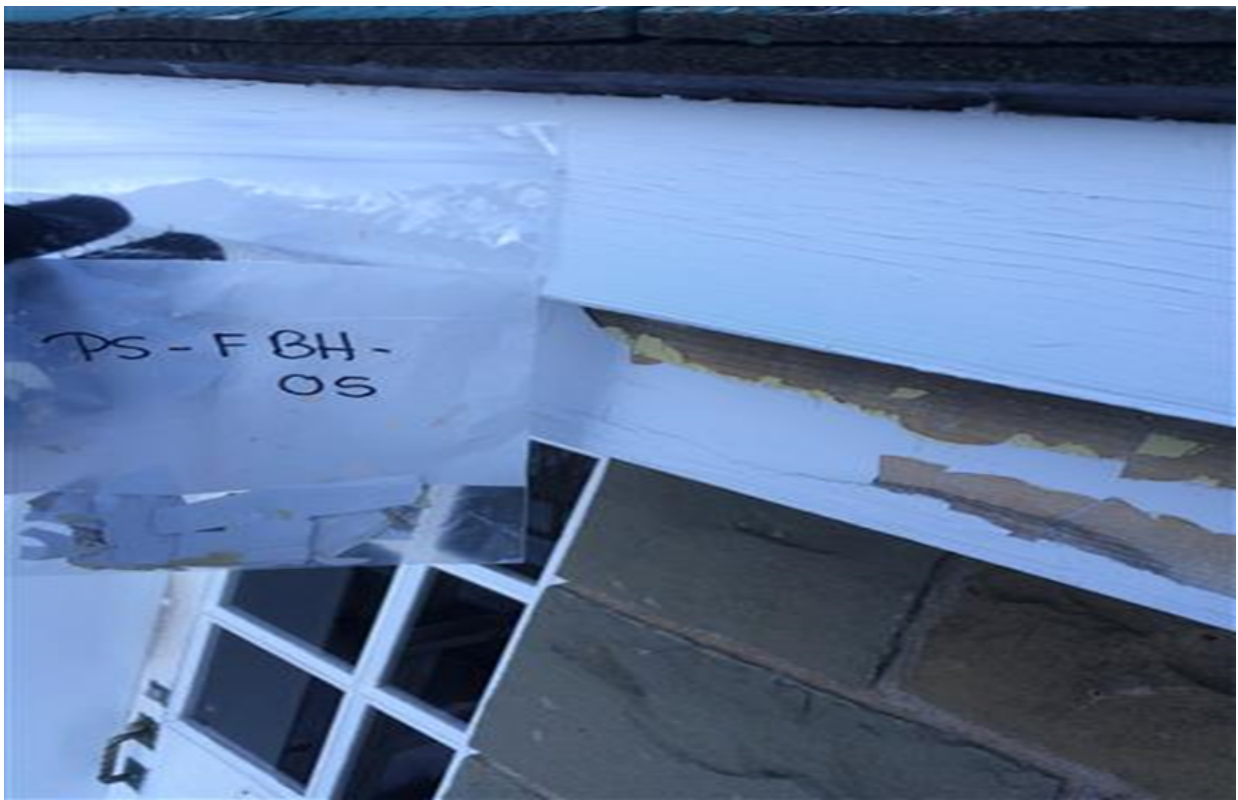
- White paint chips (PS-FBH-05) – exterior door and door trim. This white paint was sampled from the wood trim and door found located on the south wall of Area 2. Two doors are present on the south wall; the paint was collected from the door that resides on the eastern portion of the south wall, where it was observed to be in GOOD to FAIR condition. Paint chips contain a lead leachate toxic concentration (greater than 5 mg/L). No paint and substrate sample was collected for this sample, to ensure the integrity of the building's exterior. However, based on the results of the paint and wood substrate sample (PS-FBH-03), it is assumed that the well adhered paint on wood substrate trim on the exterior of the building meets the applicable guideline.

PHOTO 3: View of exterior wood door and frame located outside of Area 2 of the First Floor, sample location of paint sample PS-FBH-05 (White paint chips), which was determined by laboratory analysis to be lead leachate toxic.

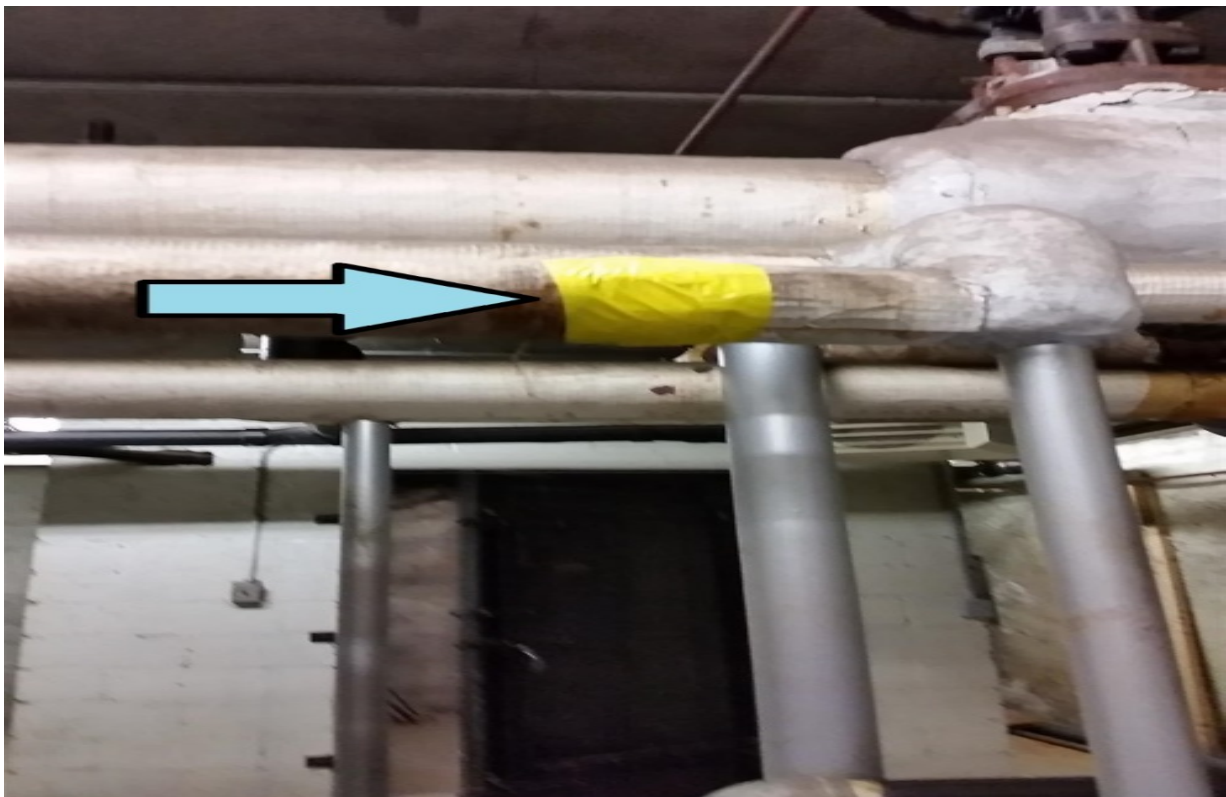
The thermal insulating parging cement on the steam pipe fittings located in the northwest corner of the Basement were observed to be in GOOD to POOR condition.

PHOTO 4: View of sample location of thermal insulating padding cement (grey colour) on steam pipe fitting, in the Basement of the subject building. A bulk sample (BS-FBH-07A) of this material was found to contain 35 % Chrysotile asbestos.

- Damaged asbestos-containing materials (recommended corrective action), should be repaired or removed by a certified asbestos abatement contractor.
- If materials containing trace amounts of asbestos are removed for disposal at a Construction and Demolition (C&D) site, the C&D site should be notified that this material contains <1% asbestos, prior to disposal.

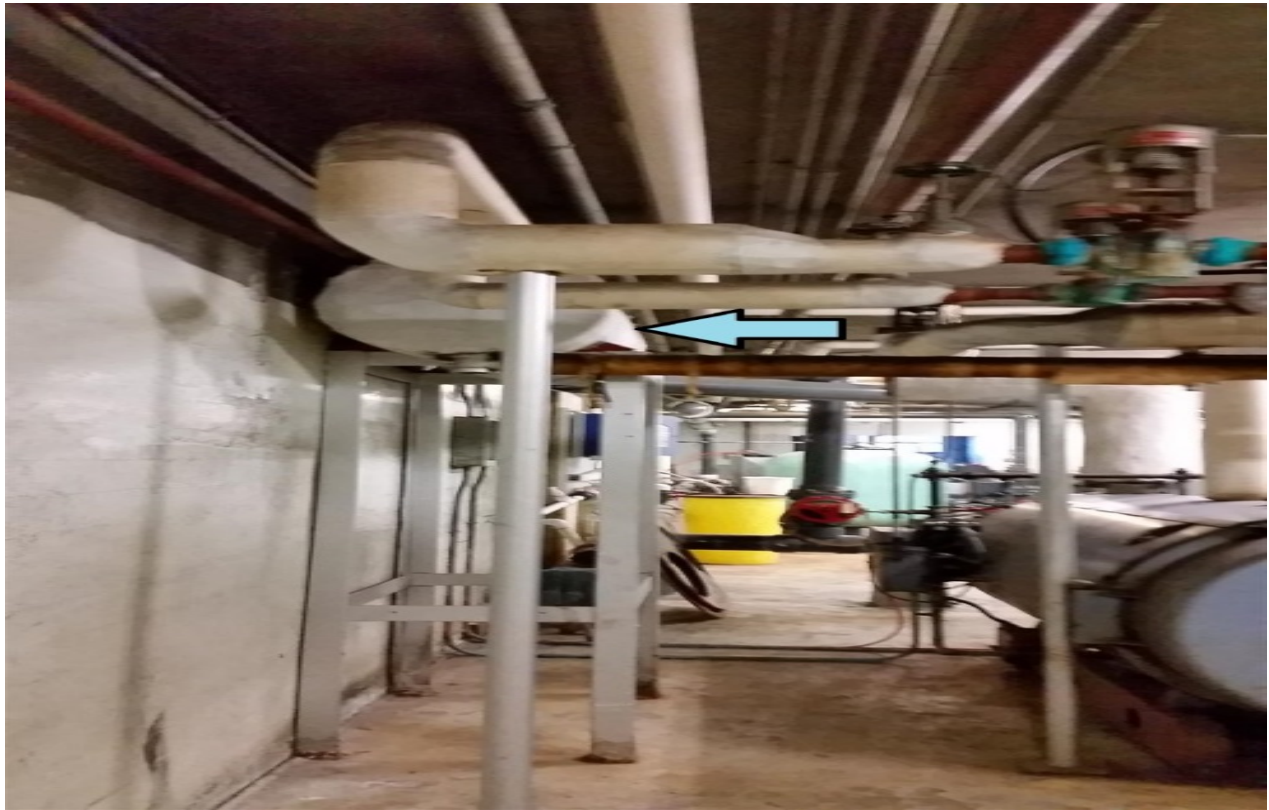
The thermal insulating parging cement present on the heat exchange cylinder located in the northwest corner of the Basement was observed to be in GOOD to POOR condition.

PHOTO 5: View of sample location of thermal insulating parging cement over diamond mesh, over fibre glass on the heat exchange cylinder, (grey and off-white colour) located in the Basement of the subject building. A bulk sample (BS-FBH-12A) of this material was found to contain 40 % Chrysotile .

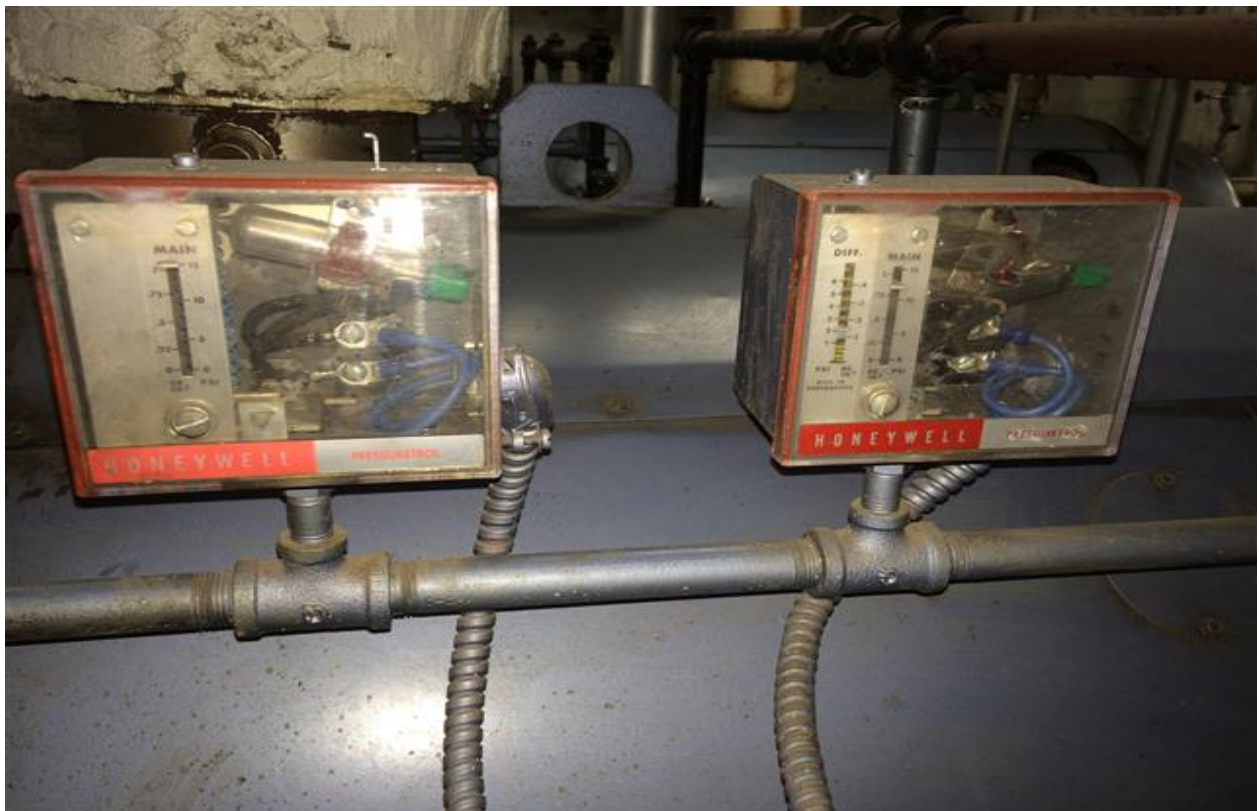
PHOTO 6: Two of four mercury thermostats that were observed to be connected to the two boiler units in the Basement of the subject building.

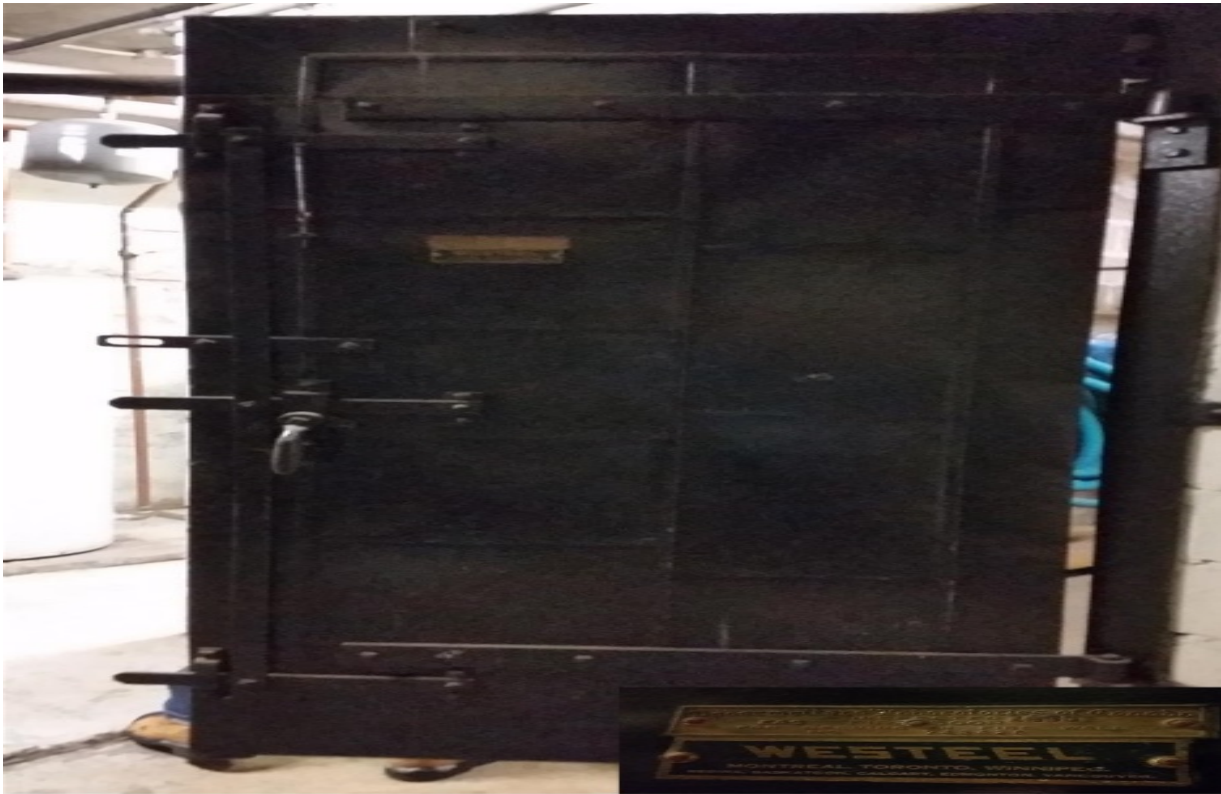
PHOTO 7: View of fire rated door found in the Basement of the subject building. Fire rated doors are known to have been manufactured with asbestos, they should be presumed to be asbestos-containing unless proven otherwise by laboratory analysis.

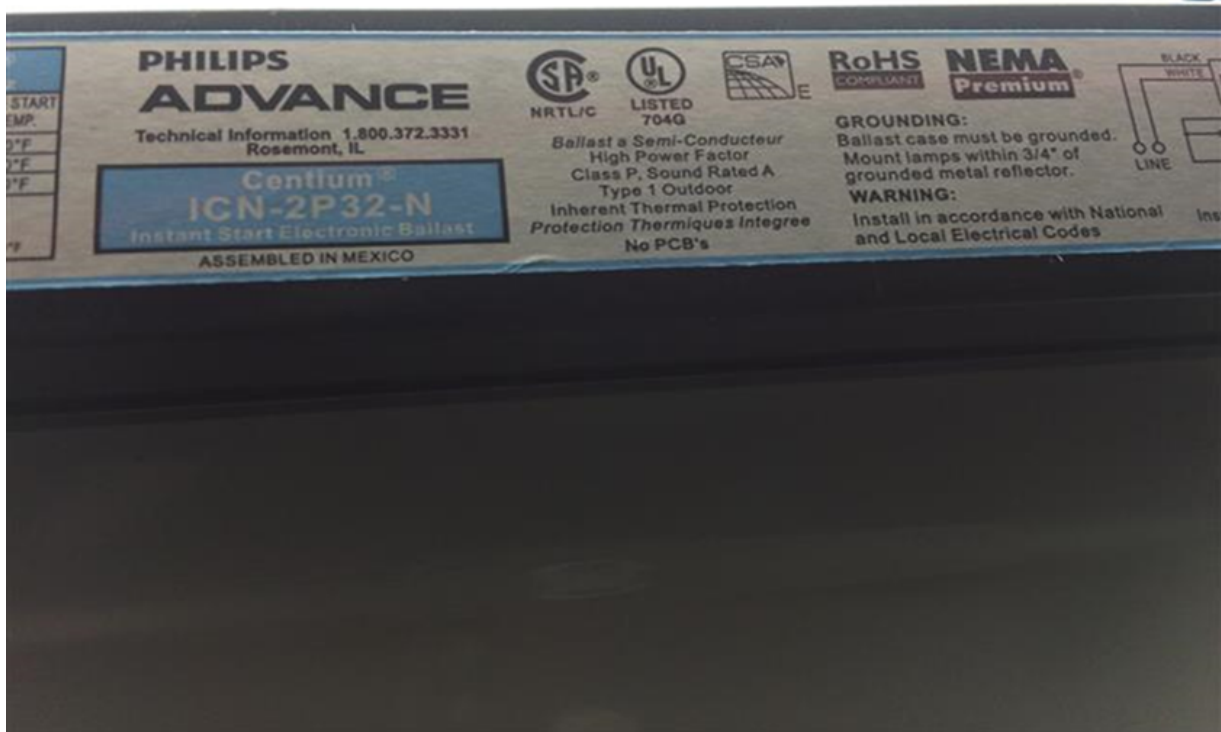
Based on the age of the building (*i.e.* constructed between 1949 and 1950), PCBs may be present in the fluorescent light ballasts of the approximately thirteen (13) light fixtures observed throughout the Basement of the building. Ten percent (10%) of these fixtures were examined for PCBs and were found to contain no PCBs based on "NO PCBs" label markings or date code and stamps.

PHOTO 8: View of lamp ballasts found in Basement of subject building. The ballasts checked in the subject building were found to contain no PCBs based on "No PCB" label markings.

Fluorescent lamp ballasts that may contain PCBs can be managed in place, where these items are operating and in good condition. No further action is currently required until such time that renovation or demolition activities are to be conducted, or until 2025, when PCB-containing ballasts will require removal and disposal.
