**DESIGNATED SUBSTANCES SURVEY
BUILDING S-77
OTTAWA, ONTARIO**

August 2007

PR-06-039

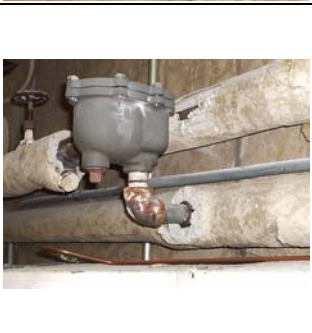
| 34 | | | | SB44 | One encapsulation is required on the damaged aircell pipe insulation on the steam system. (0.3 LM) Two encapsulations are required on the damaged mud joint compound fitting insulation on the condensate system. |

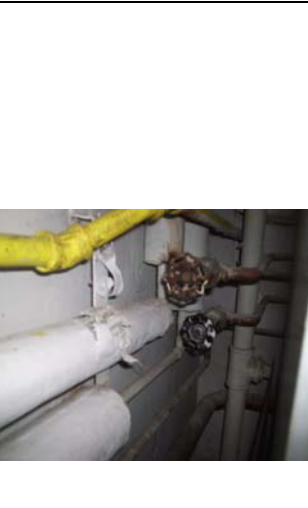
| 156 | | | 1043 | One encapsulation on the damaged mud joint compound fitting insulation and one encapsulation on the exposed end of aircell pipe insulation are required on the domestic hot water system. (0.2 LM) Two encapsulations are required on the exposed ends of mag block pipe insulation on the hot water heating system. (0.2 LM) |
