**RCMP Anahim Lake
Housing Renovations**

**Pre-Demolition Hazardous
Building Materials Assessment**

RCMP Mobile Home #4, 6665 Christensen
Road, Anahim Lake, BC

September 16, 2019

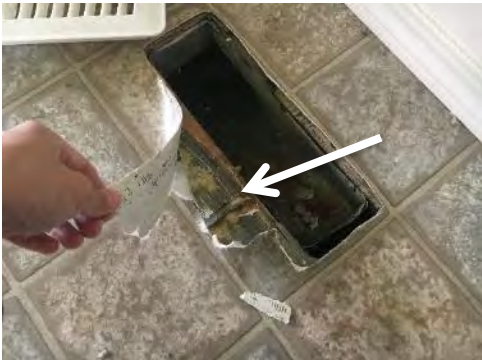
Identified ACM Description and Condition Information	
Grey vinyl sheet flooring concealed as 2nd layer (under VSF-01) in the kitchen, laundry room and washroom #2	
% Type	4.2% Chrysotile
Friability	Non-friable in situ; potentially friable during demolition
Quantity	Approximately 17 square metres
Condition	Good

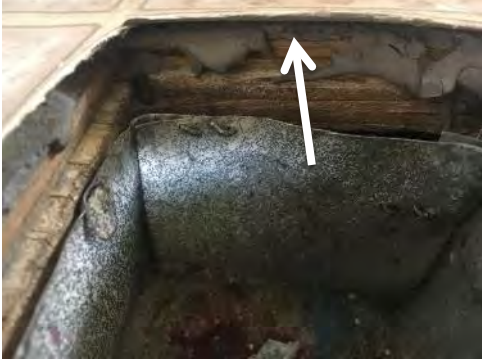
Grey vinyl sheet flooring concealed as 3rd layer (under VSF-01 and VSF-02) in washroom #2	
% Type	13.7% Chrysotile
Friability	Non-friable in situ; potentially friable during demolition
Quantity	Approximately 4 square metres
Condition	Good

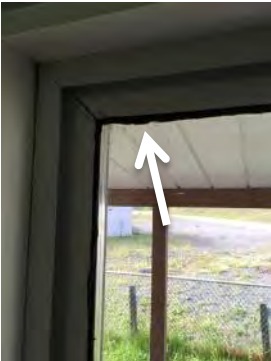
Black sticky window pane caulking applied between window glass and frames on windows throughout	
% Type	5.2% Chrysotile
Friability	Non-friable
Quantity	Approximately 20 linear metres
Condition	Good

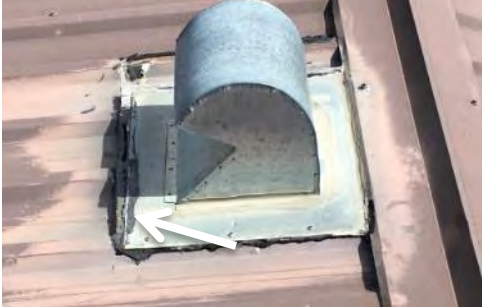
Identified ACM Description and Condition Information	
Grey mastic applied to perimeter seams of rooftop vents	
% Type	6.2% Chrysotile
Friability	Non-friable
Quantity	Approximately 6 linear metres
Condition	Good

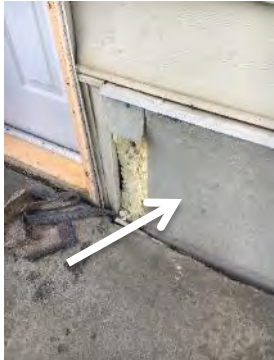
Grey cement panel applied to lower exterior walls	
% Type	15% Chrysotile
Friability	Non-friable
Quantity	Approximately 50 square metres
Condition	Good

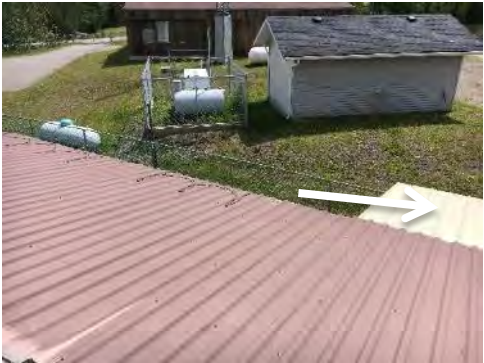
LCP Description		Photo
Paint colour	Tan

Substrate	Metal	
Location/approx. extent	Canopy roofing	
Lead content	2,200	
Condition	Good

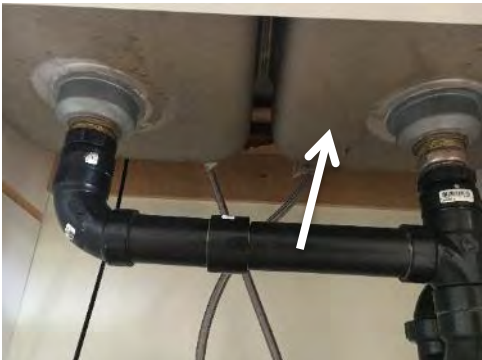
Identified ACM Description and Condition Information	
Silver sink undercoating applied to the underside of the kitchen sink	
% Type	1% Chrysotile
Friability	Non-friable
Quantity	Approximately 1 square metre
Condition	Good

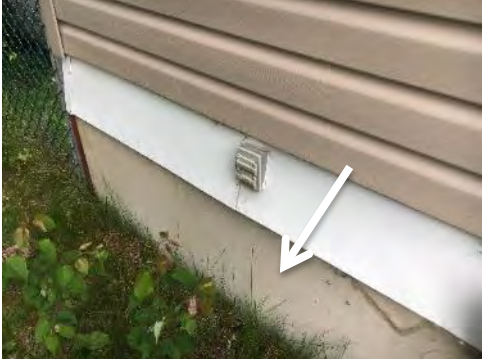
Grey cement panel applied to lower exterior walls	
% Type	15% Chrysotile
Friability	Non-friable
Quantity	Approximately 55 square metres
Condition	Good

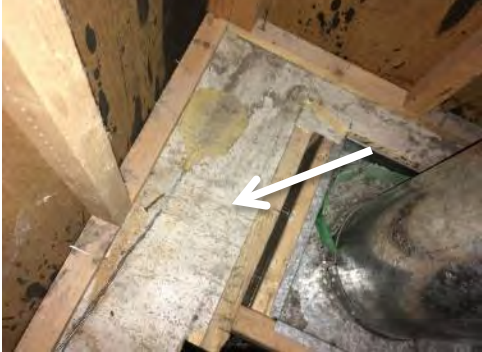
12" x 12" cream stone patter vinyl floor tile in the main floor furnace room	
% Type	0.96% Chrysotile
Friability	Non-friable
Quantity	Approximately 1 square metre
Condition	Good

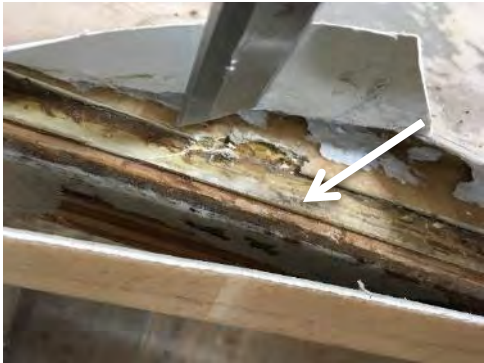
Identified ACM Description and Condition Information	
12" x 12" white vinyl floor tile concealed under two layers of sheet flooring in the entrance stairwell.	
% Type	0.60% Chrysotile
Friability	Non-friable
Quantity	Approximately 15 square metres
Condition	Good

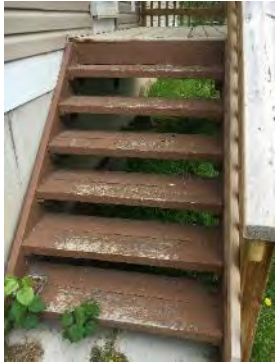
LCP Description		Photo
Paint colour	Brown

Substrate	Wood	
Location/approx. extent	Exterior wood stairs of the rear porch	
Lead content	710	
Condition	Good (partially worn from the surface in some locations)

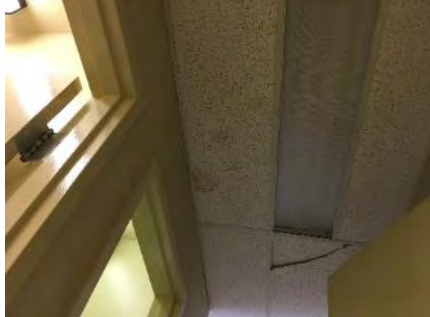
Building Area	Observation	Suspected Source of Moisture	Photo
Throughout	Moisture-stained ceiling tiles in various locations	Pipe leaks or roof leaks

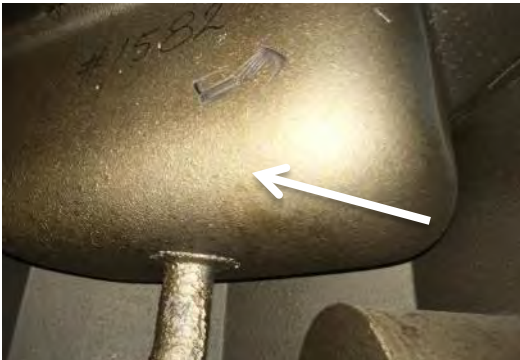
Identified ACM Description and Condition Information		
Gold sink/toilet under coating within cell #1 and cell #2

% Type	1% Chrysotile	
Friability	Non-friable	
Quantity	Approximately 3 square metres	
Condition	Good	
Brown vent mastic applied to various roof vents

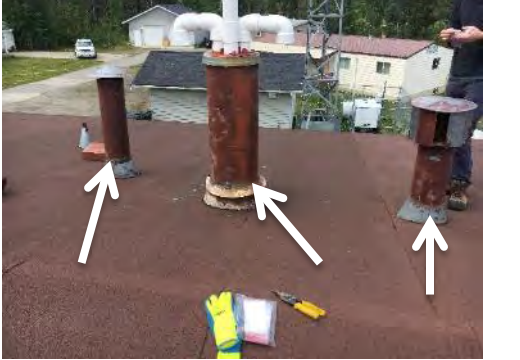
% Type	0.69% Chrysotile	
Friability	Non-friable in situ; potentially friable during demolition	
Quantity	Approximately 3 linear metres	
Condition	Good	
Black window pane caulking applied between glass and frame throughout exterior windows

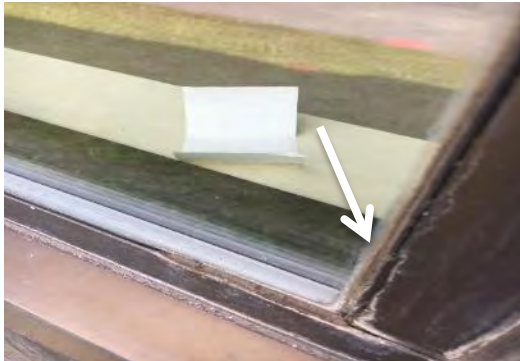
% Type	1.5% Chrysotile	
Friability	Non-friable	
Quantity	Approximately 60 linear metres	
Condition	Good

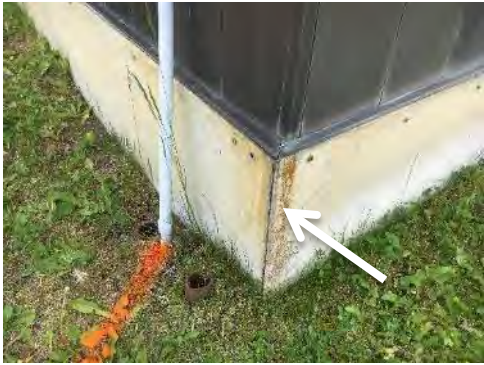
Identified ACM Description and Condition Information	
Grey cement panel applied to lower exterior walls	
% Type	20% Chrysotile
Friability	Non-friable
Quantity	Approximately 65 square metres
Condition	Good in general, with areas of localized damage

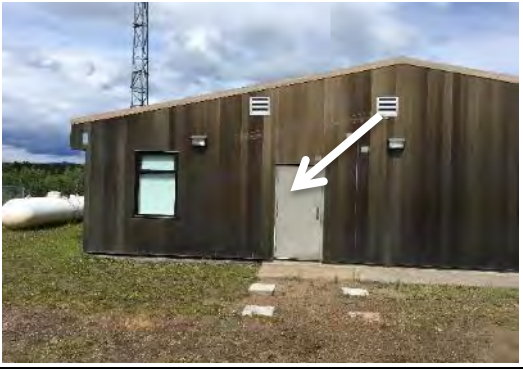
LCP Description		Photo
Paint colour	Grey

Substrate	Metal	
Location/approx. extent	Front/rear entrance door and frame	
Lead content	120,000 ppm (Pinchin Report)	
Condition	Good	
Paint colour	Light tan

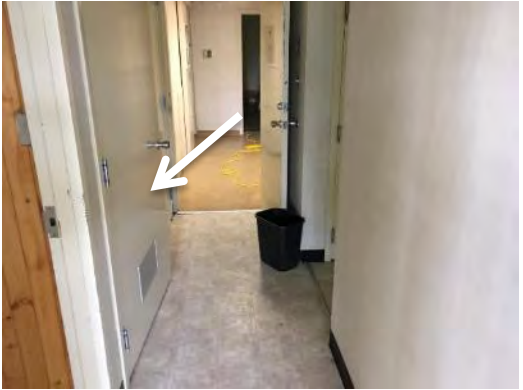
Substrate	Metal	
Location/approx. extent	Door and frame throughout	
Lead content	7,300 ppm (Pinchin Report)	
Condition	Good	
Paint colour	Off-white

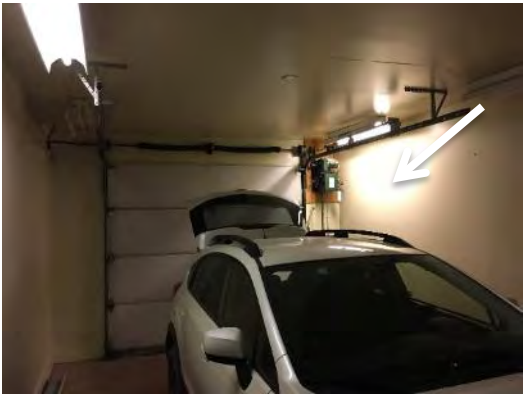
Substrate	Drywall	
Location/approx. extent	Drywall throughout	
Lead content	730 ppm (Pinchin Report)	
Condition	Good

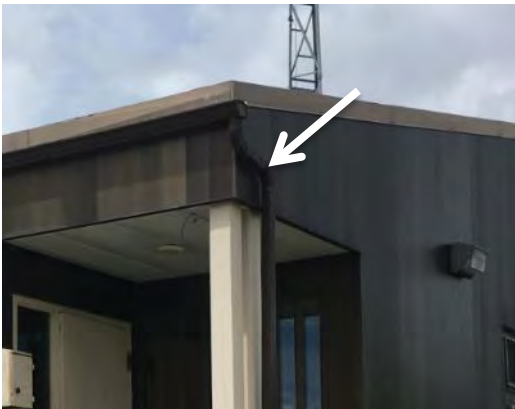
LCP Description		Photo
Paint colour	Brown

Substrate	Metal	
Location/approx. extent	Gutter and downspout throughout	
Lead content	1,110 ppm	
Condition	Good

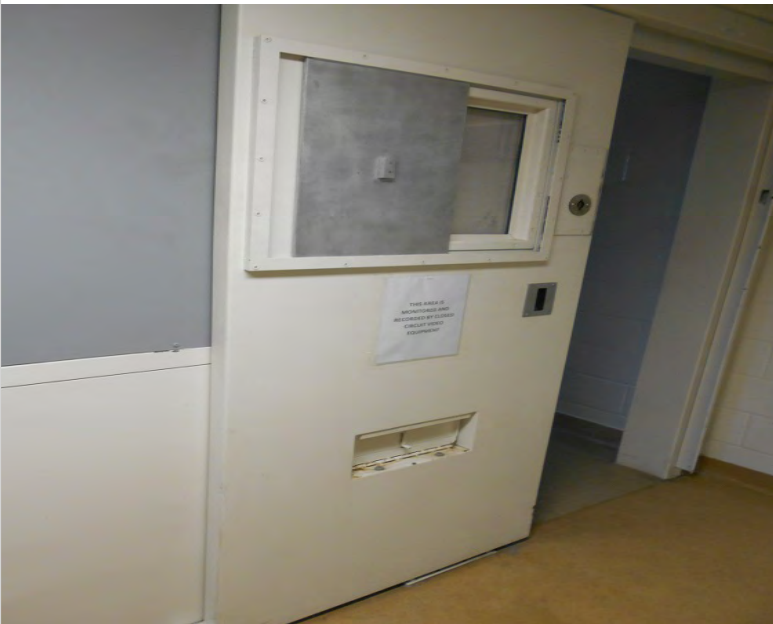
Cell Area 91270-70-628-000001 3 - Satisfactory condition-reliable N Cell walls and benches painted August 2012, doors a MEDIUM

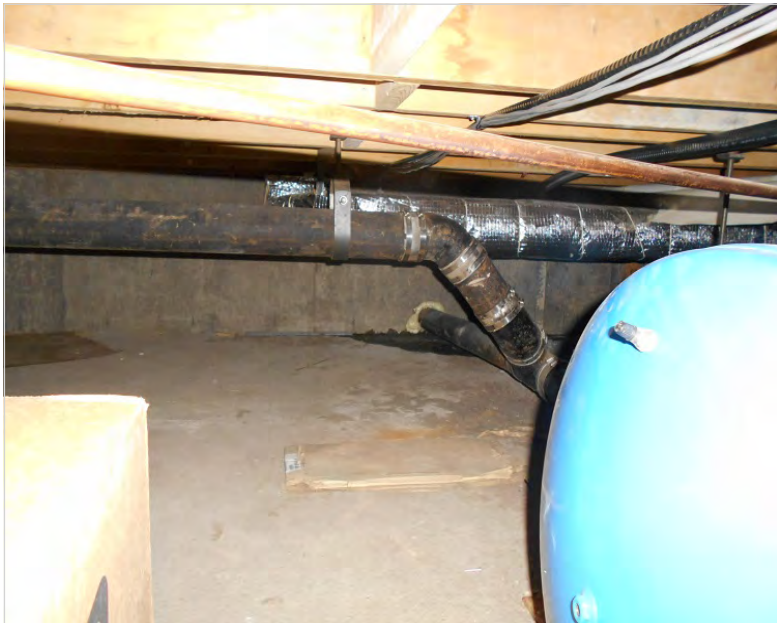
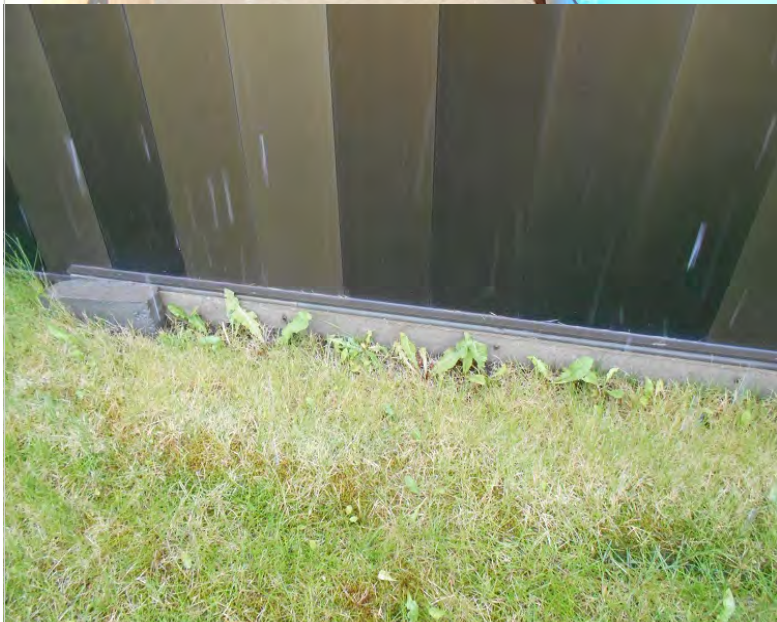
Foundation & Footings 91270-80-830-000001		3 - Satisfactory condition-reliable N	The continuous concrete foundation is covered with rigi	MEDIUM					
---	--	---------------------------------------	---	--------	--	--	--	--	--

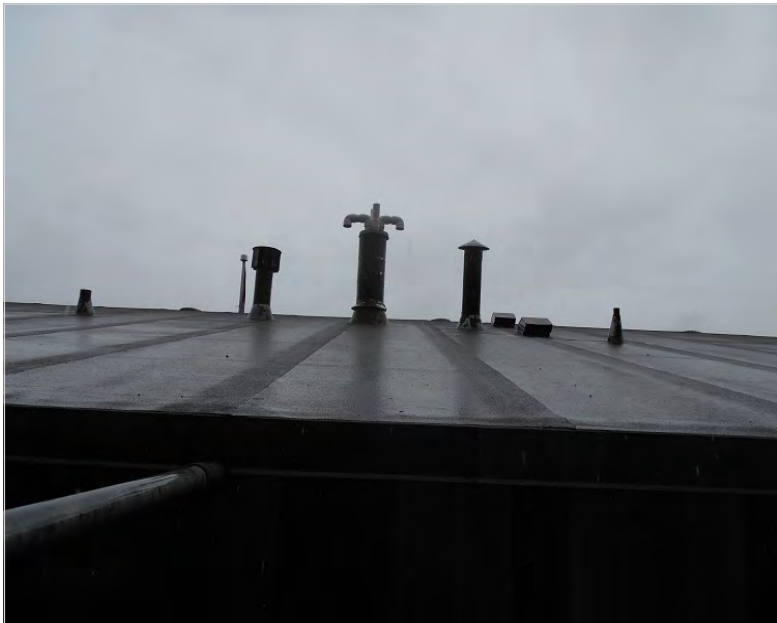
Roof 91270-80-870-000001		3 - Satisfactory condition-reliable N	The main building roof is torch down membrane which is relat	LOW					
--------------------------	--	---------------------------------------	--	-----	--	--	--	--	--

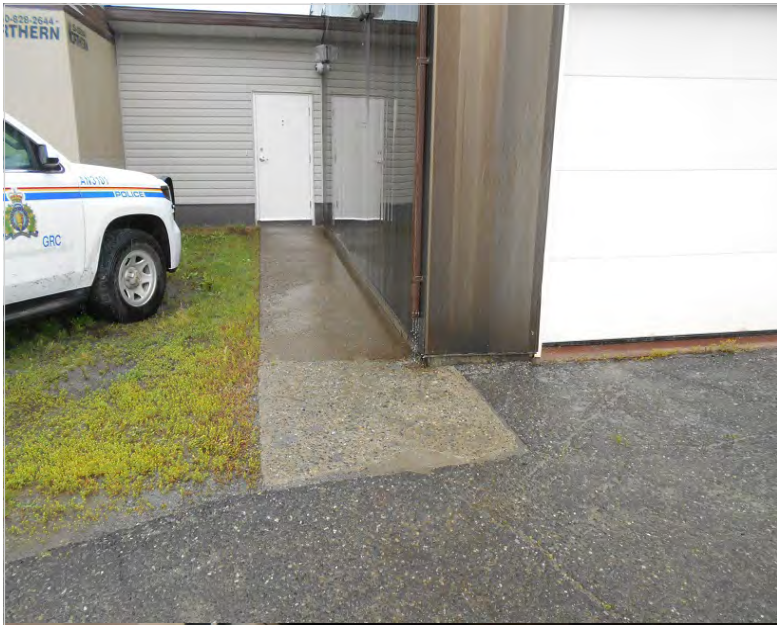
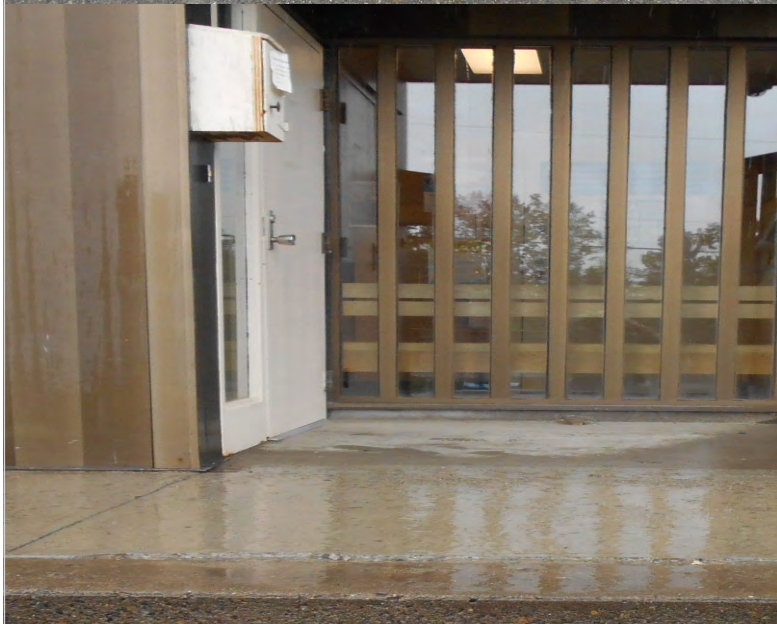
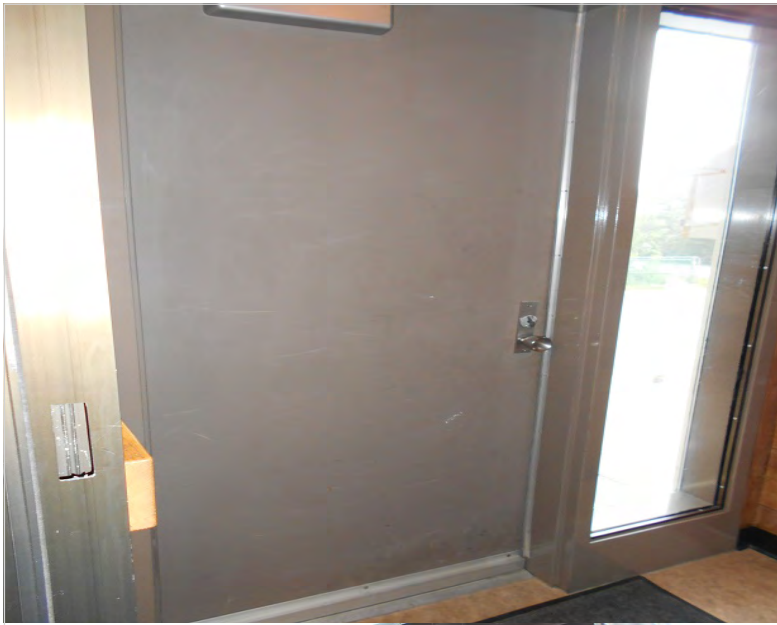
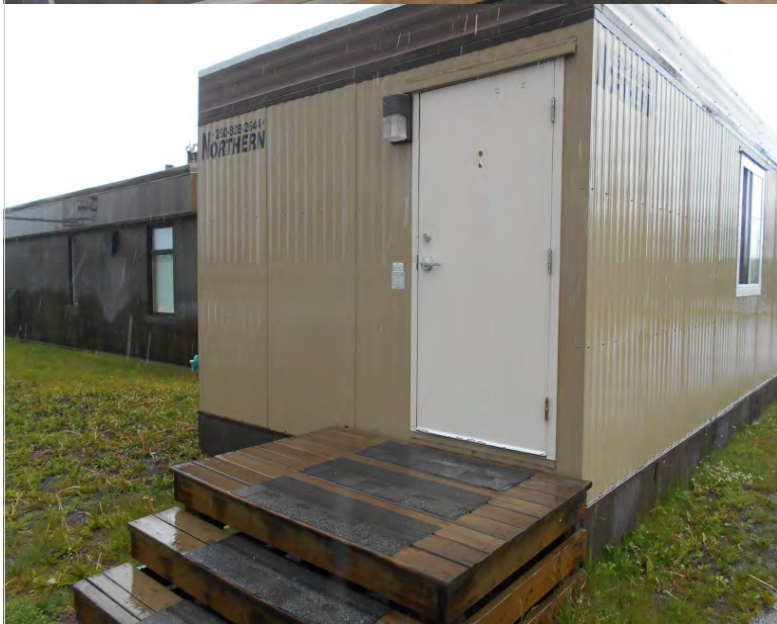
Doors Exterior 91270-80-815-000001		3 - Satisfactory condition-reliable N	Three exterior doors, all are metal with metal jambs, equip	MEDIUM					
------------------------------------	--	---------------------------------------	---	--------	--	--	--	--	--

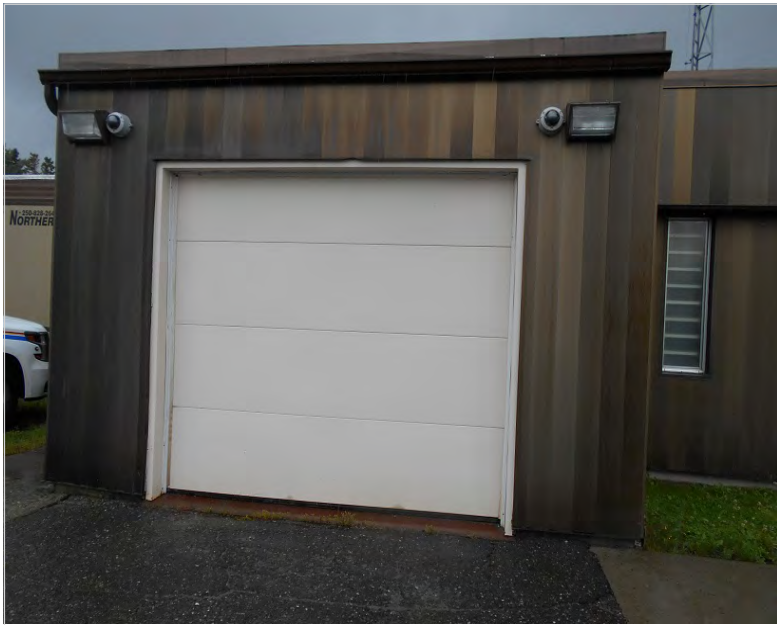
Overhead Door 91270-80-855-000001	Prisoner Unload	3 - Satisfactory condition-reliable N	Overhead door good working order, next annual service sch	MEDIUM
-----------------------------------	-----------------	---------------------------------------	---	--------

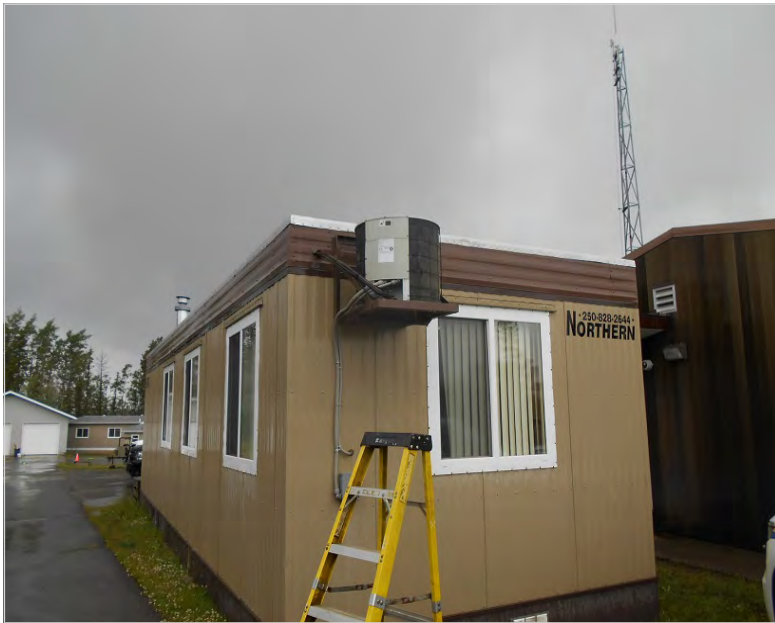
Photo Description:
screw on metal siding used on mobile
Uploaded On: 9/12/2016 1:58:37 PM

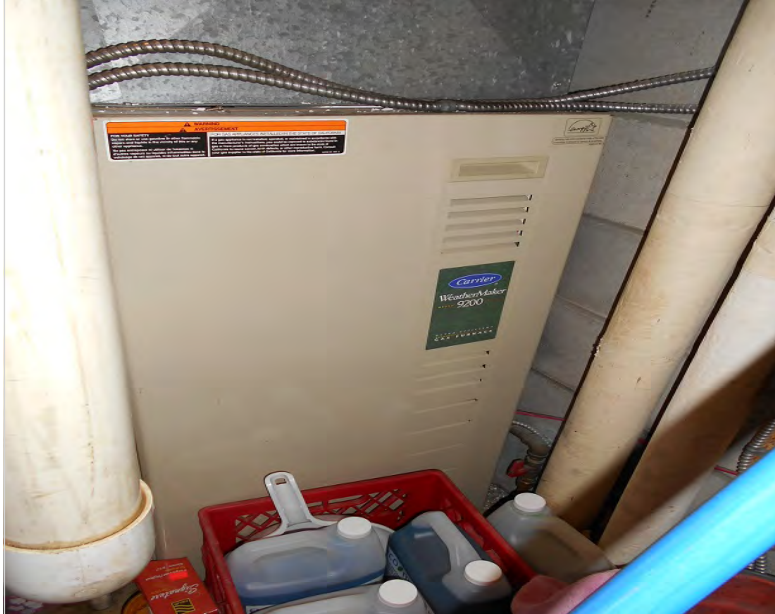
340 - Furnace - Forced Air (Gas or Oil)										
Furnace - Forced Air- PROPANE #1 (MAIN 2) 9127	OFFICE	3 - Satisfactory condition-reliable N	Annually serviced in October. High efficiency forced air prop	MEDIUM

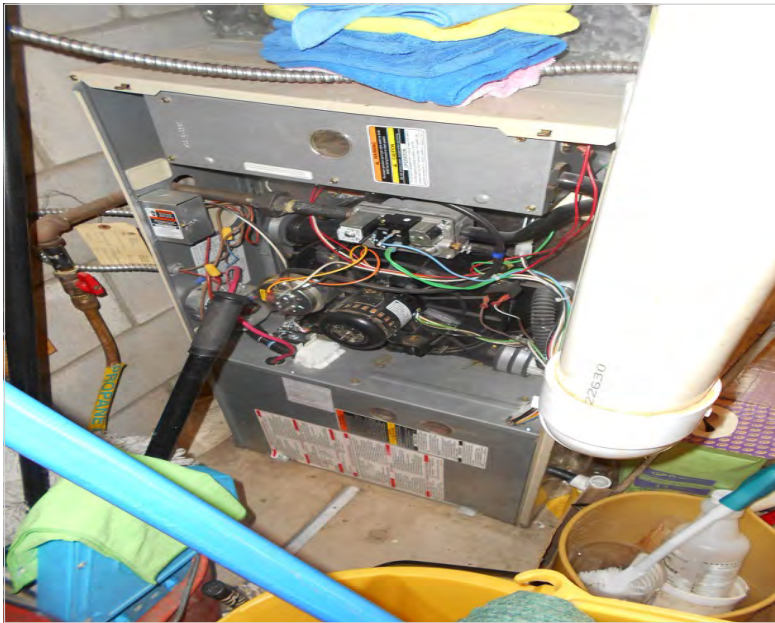
Furnace - Forced Air- PROPANE #2 91270-20-340-	CELLS	3 - Satisfactory condition-reliable N	Annually serviced in October. High efficiency forced air prop	MEDIUM						
---	-------	--	--	--------	--	--	--	--	--	--

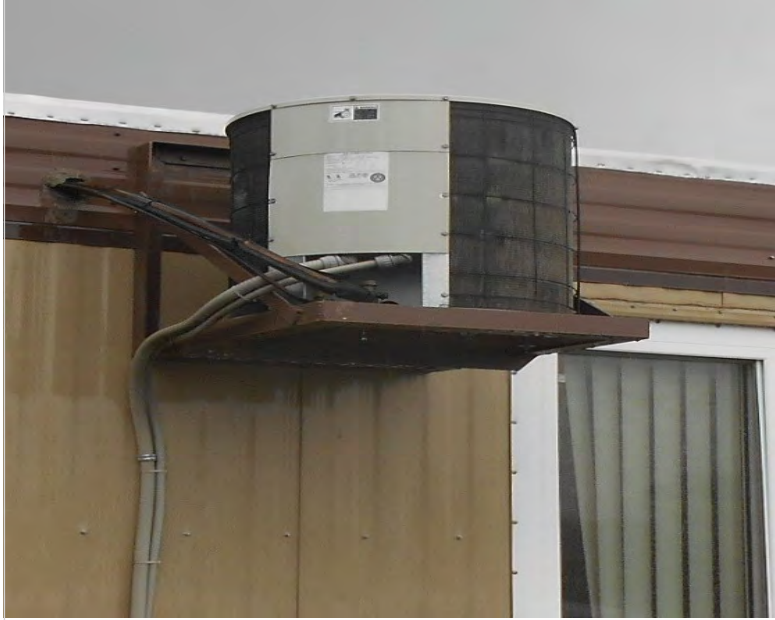
AIR CONDITION-SPLIT < 5.4T Fed 91270-25-059-0000	Trailer addition	3 - Satisfactory condition-reliable N	A/C unit located outside of attached trailer. This piece of	MEDIUM
--	------------------	---------------------------------------	---	--------

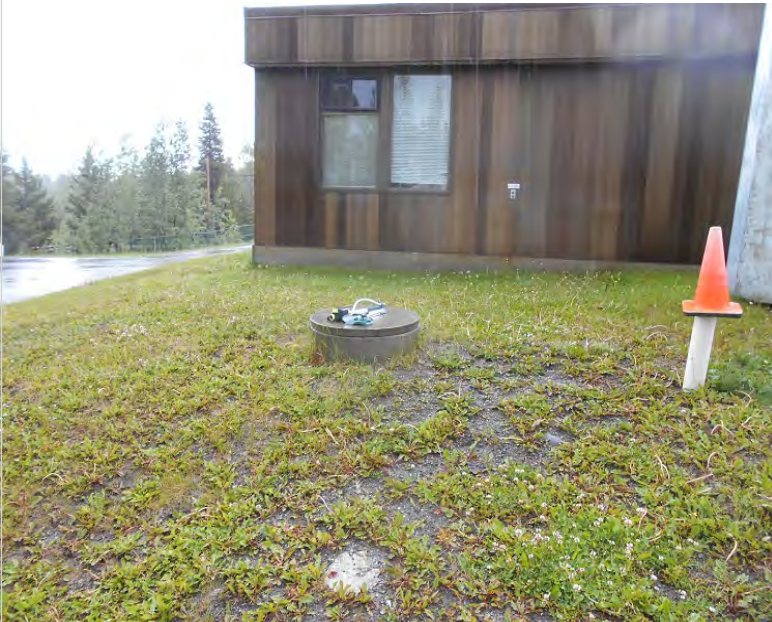
Tank, Under Ground - Septic 91270-72-482-000001 Anahim Lake RCMP 3 - Satisfactory condition-reliable N This was last pumped in June 2015. MEDIUM

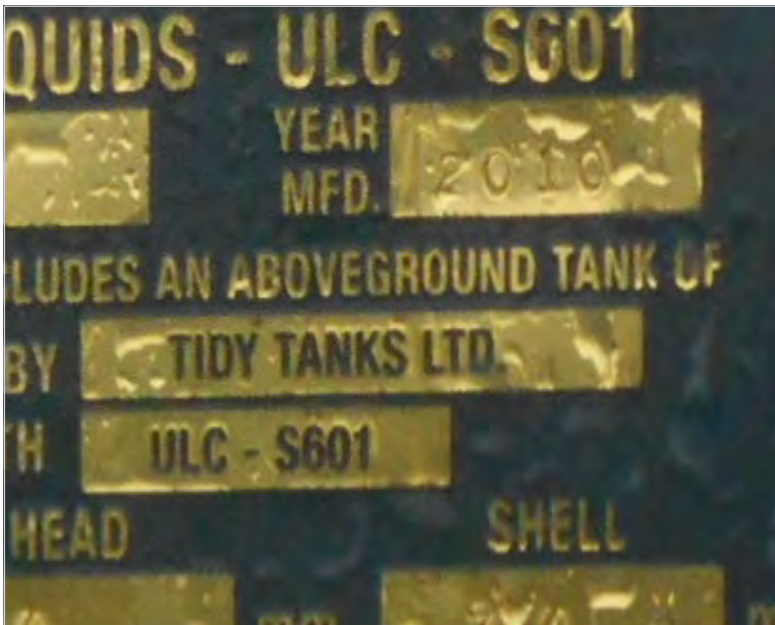
Fuel Storage System - AST - <2500L 91270-72-498-00000 inside fenced compound 3 - Satisfactory condition-reliable N Generator diesel fuel tank is an above ground "Tidy Tank" MEDIUM
