CCGS Edward Cornwallis Davit No J4373 Survey Report

Prepared By: James Morrison
 Job Title: Hydraulic Technician
 Date: 16/08/2019

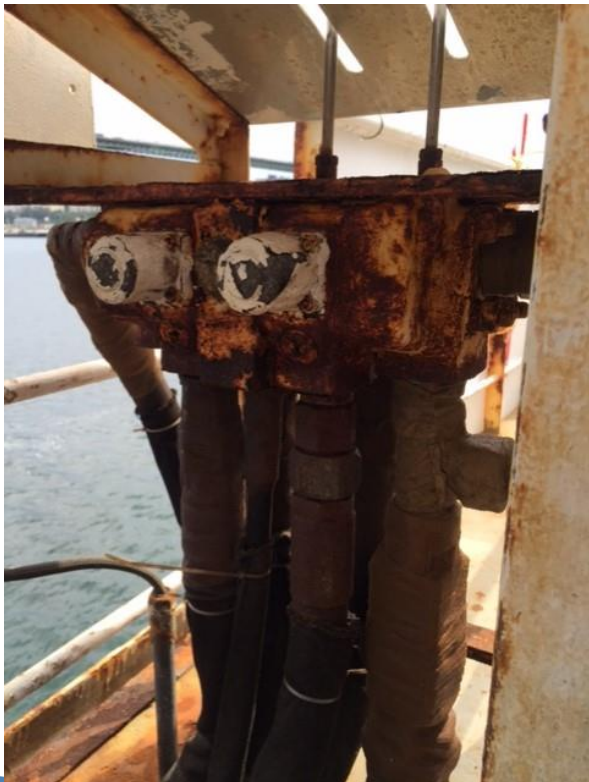
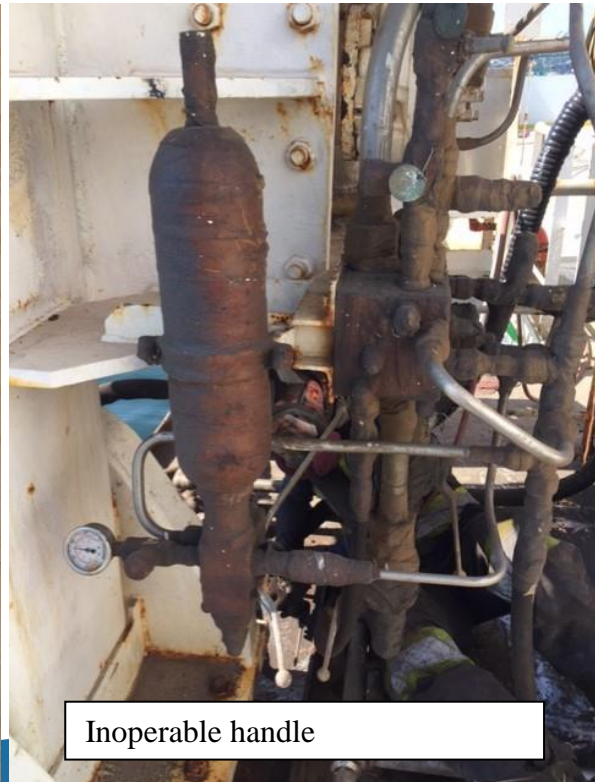
3.1 Davit General

- Initially the Davit appeared to be in a weathered condition, an carried-out operation function test was carried out with no weight / empty hook
- All Hydraulic hoses are over the 5-year life span. It is advised that these are changed out at the next maintenance period. At this point a hose register should be implemented, this will include hose ID with ID tags

- The Lever control valve is heavily corroded
- Lever control table also heavily corroded, there is an oil leak from lever control valve. The control valve will need to be stripped/replaced.

- The accumulator bottle is wrapped in denso tape, the gas was not checked as the isolation valve is seized and will not function.
- There was no certification for the accumulator or safety block, these will both need to be replaced.

- Hydraulic gauges, no visible test cert or inspection date, these should be replaced if they are being used for anything other than indication only. They have not to be used as test gauges without calibration.

- Valves at the bottom of Hydraulic tank handles are corroded, these should be replaced.
- Gasket around electrical motors are leaking due to age, the gaskets will need to be replaced gaskets, at this point the tank should be drained and inspected.

- Emergency system could not be tested as no hand pump was available and accumulator valve is seized.

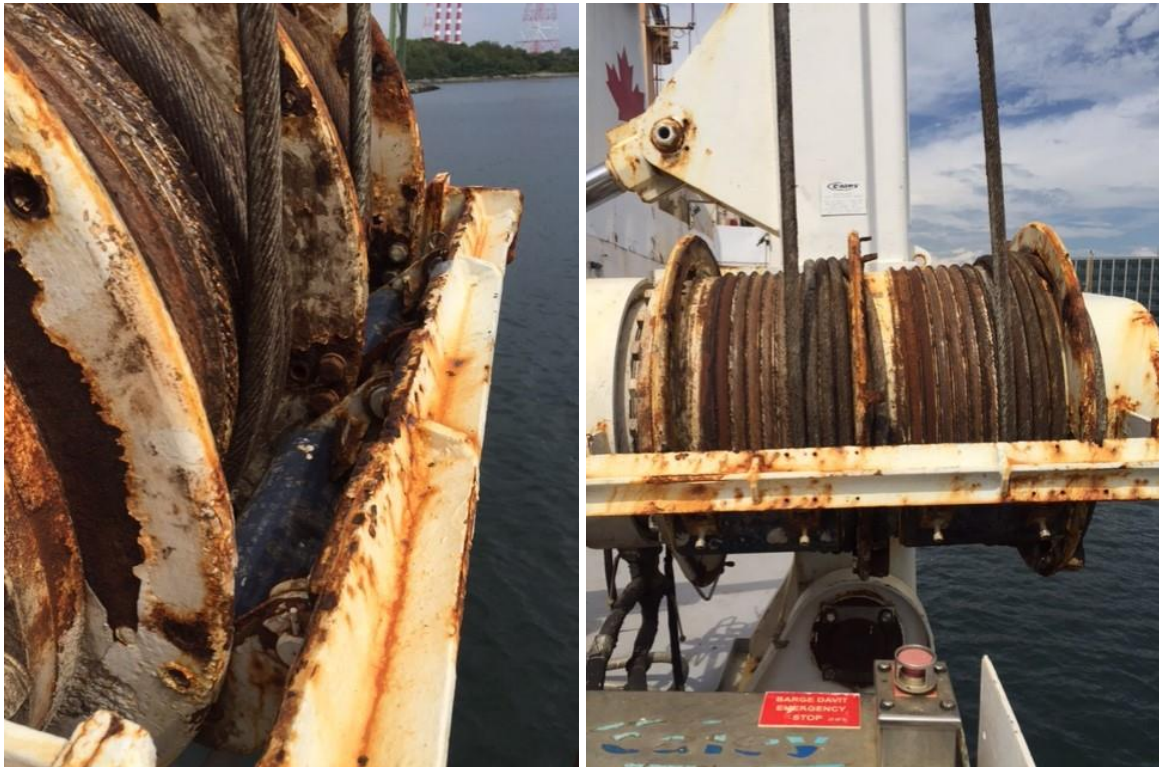
3.2 Davit Winch

- The Winch drum is in a poor condition with corrosion on all hardware, all fasteners should be replaced on next overhaul.
- At the next overhaul it is recommended that the following is done at a minimum.

- All parts should receive a full paint spec on completion.
- Side web on the winch pedestal to be repaired prior to re-coating
- Roller on the drum is heavily corroded and will not function

- Wire rope requires lubrication, the rope should be changed at the overhaul as it has a year left of certification.

- Completely dismantle winch, NDT all fabrications including drum and pedestals. Complete re-coating of the winch following NDT (any repair work should be carried out following NDT then re-tested after repair)

- Strip and inspect the brake pack replace parts as necessary
- Strip and inspect the motor, replace parts as necessary and bench test on completion
- Strip and inspect the gearbox and replace parts as necessary

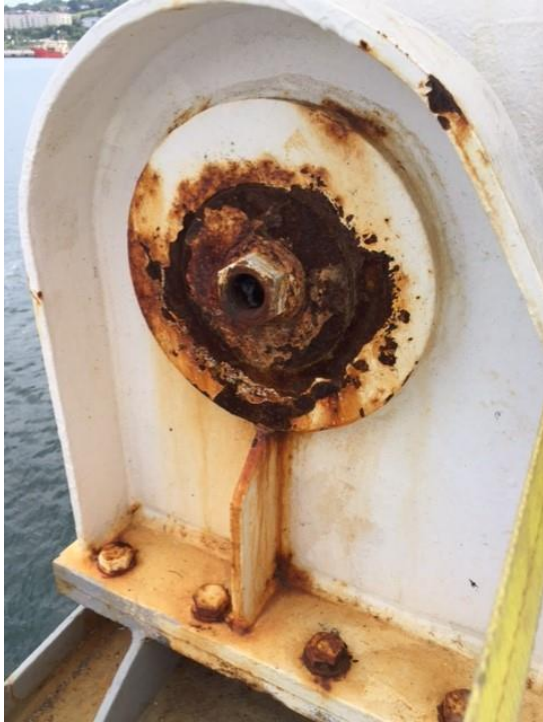
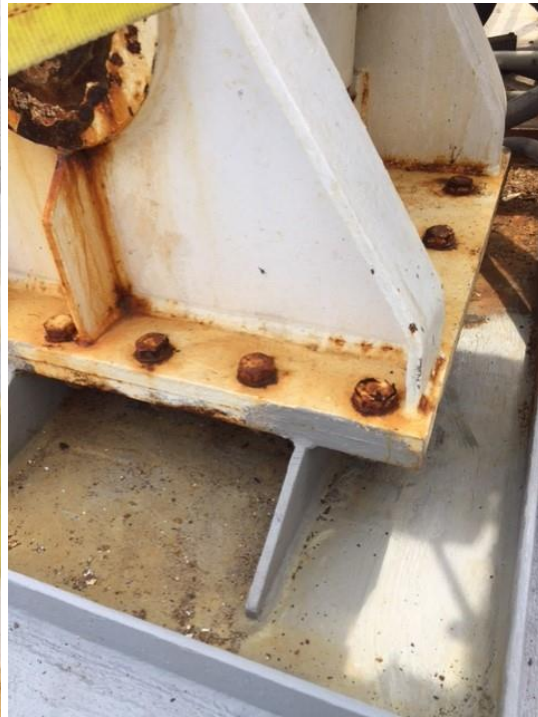
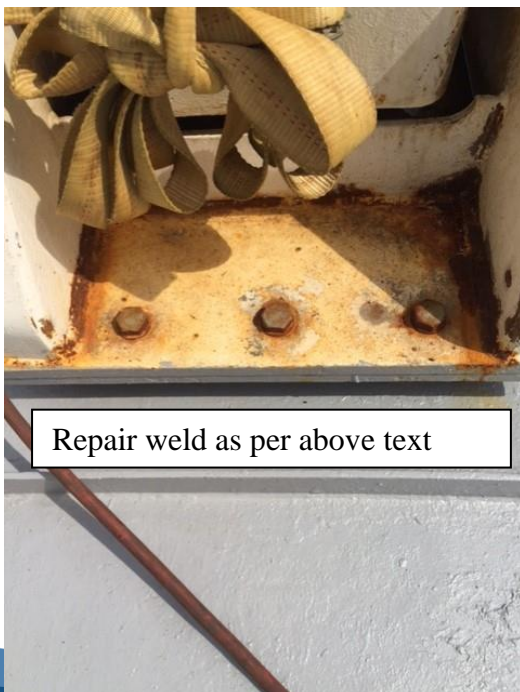
3.3 Davit strongback

- All hardware on strongback's is heavily corroded and should be replaced
- At some point forward strongback has been welded / repaired possibly had crack issue, this will have to be stripped back and have NDT carried out.
- Strongback base pins have at some point had nuts welded on to the pins to try and remove the pins. pins are corroded and should be replaced with 17/4ph pins at next overhaul.
- Please be aware that due to current condition of the pin it may need to be thermal lanced to remove.

Repair weld as per above text

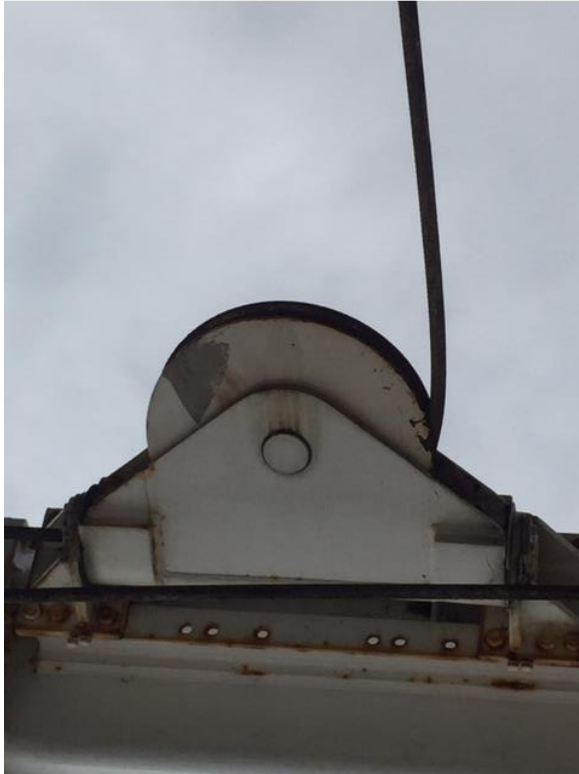
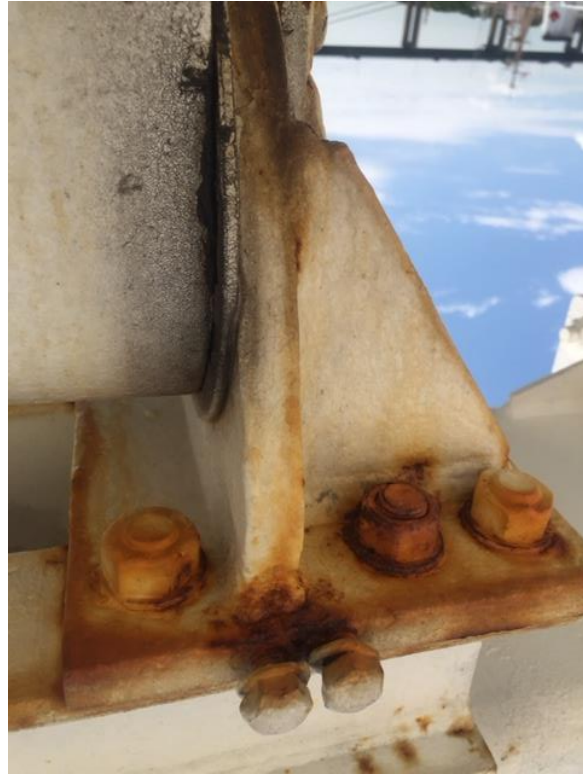
3.4 Davit crossbeam and associated equipment

- All hardware/bolts corroded, replace at next overhaul
- Sheave dolly bolts also corroded, replace at next overhaul
- Aft sheave dolly does not swing freely, strip and inspect at next overhaul and replace parts as necessary.
- For greasing sheaves, it is recommended that a central/automatic greasing system is utilised. This would negate the need to work at height for greasing routines at sea.

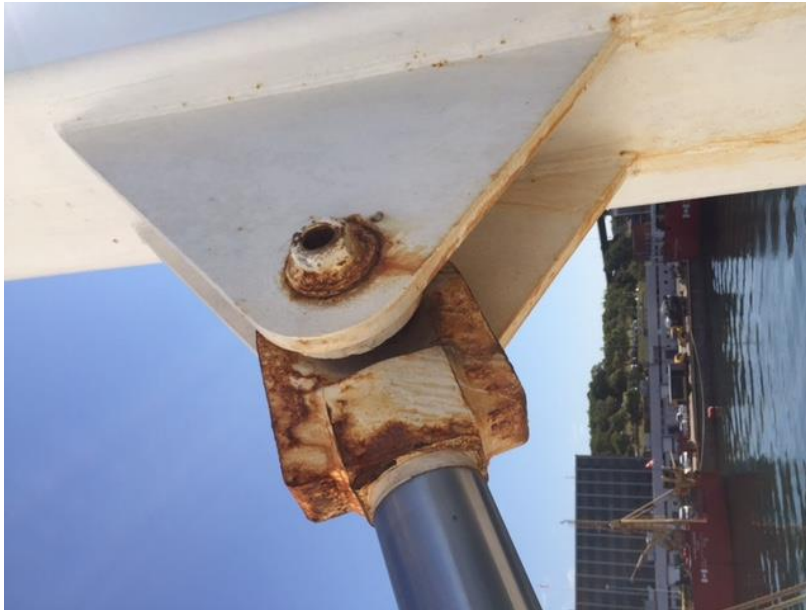
3.5 Davit Cylinders

- It appears to have nuts welded to the pin to draw pins out, pins are corroded and made of mild steel. All pins should be replaced for 17/4ph
- Please be aware that pins made need to be lanced like the strongback pins
- Cylinders to be stripped, inspected and re-sealed as part of next overhaul
