ADDENDUM # 4

Solicitation Number: 19-1107

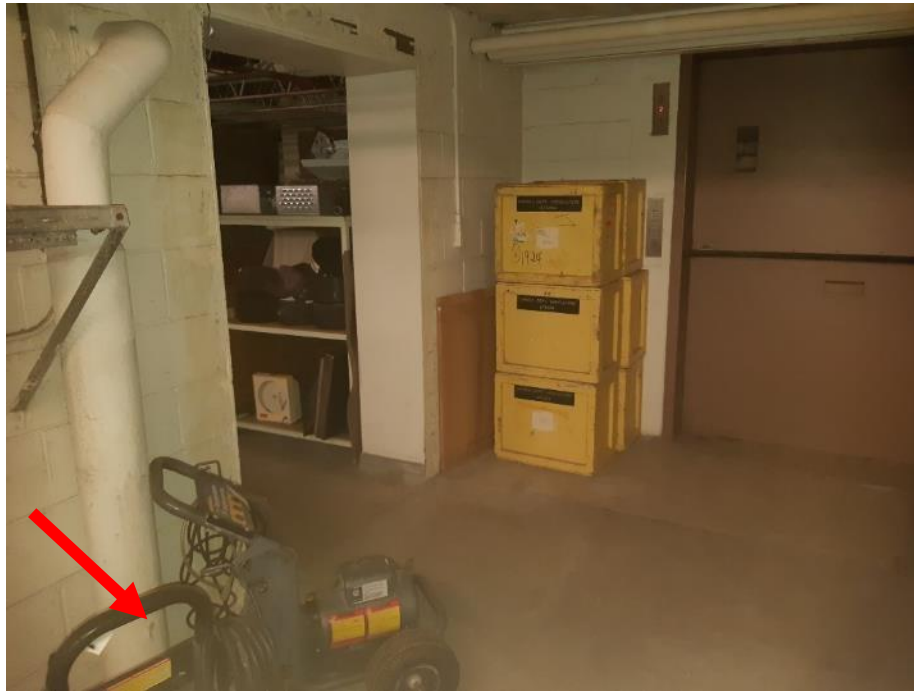
Photo 1. Second floor, mezzanine, north of freight elevator on east wall, <1 linear metre poor condition pipe insulation.

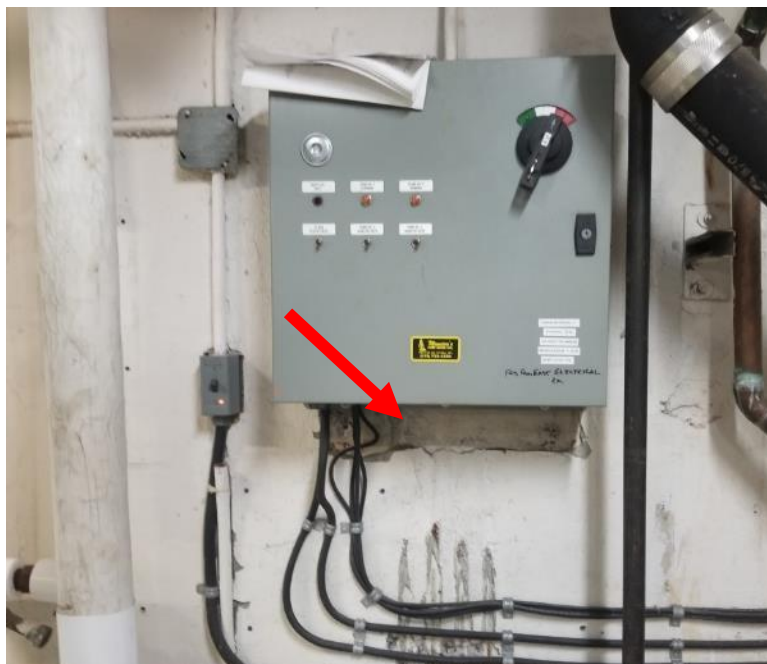
Photo 2. Basement, B-6, around emergency panel A on west wall, 1 square metre poor condition wall textured plaster.

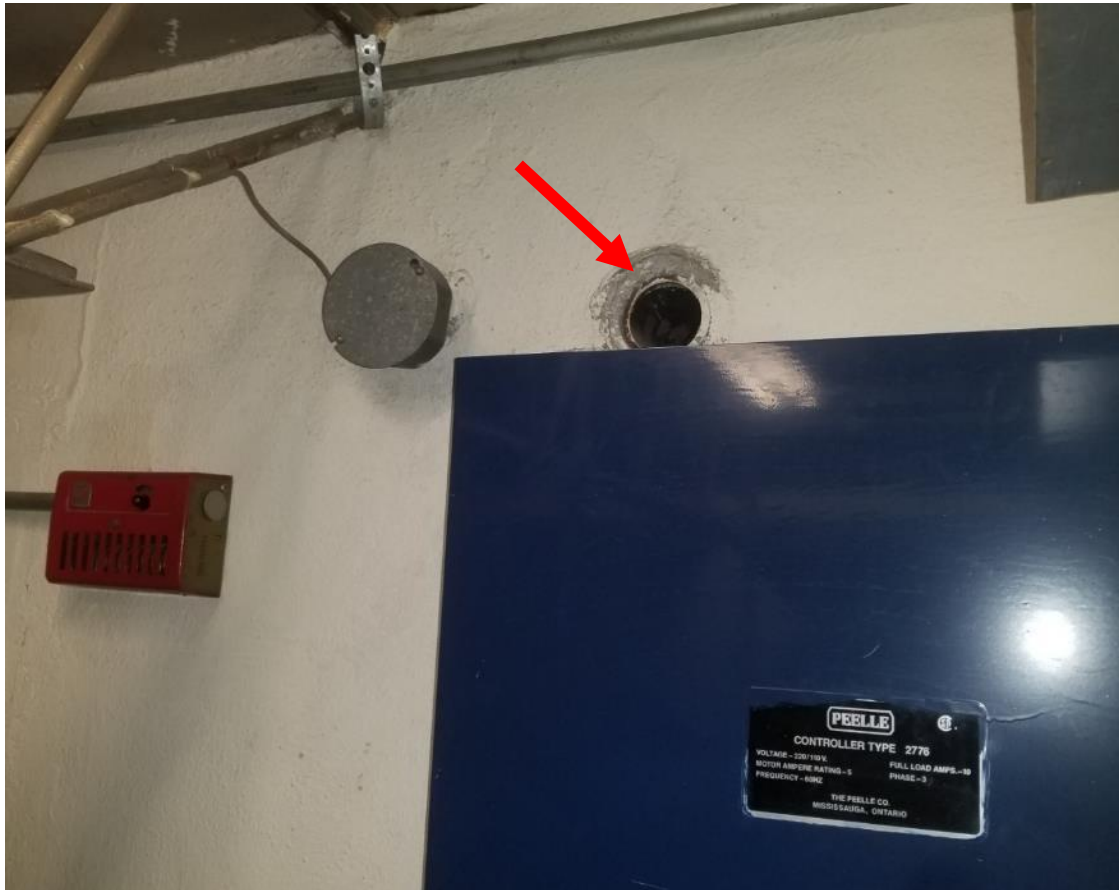
Photo 3. Second floor, west elevator control room, west wall, <1 square metre poor condition remnant pipe insulation.

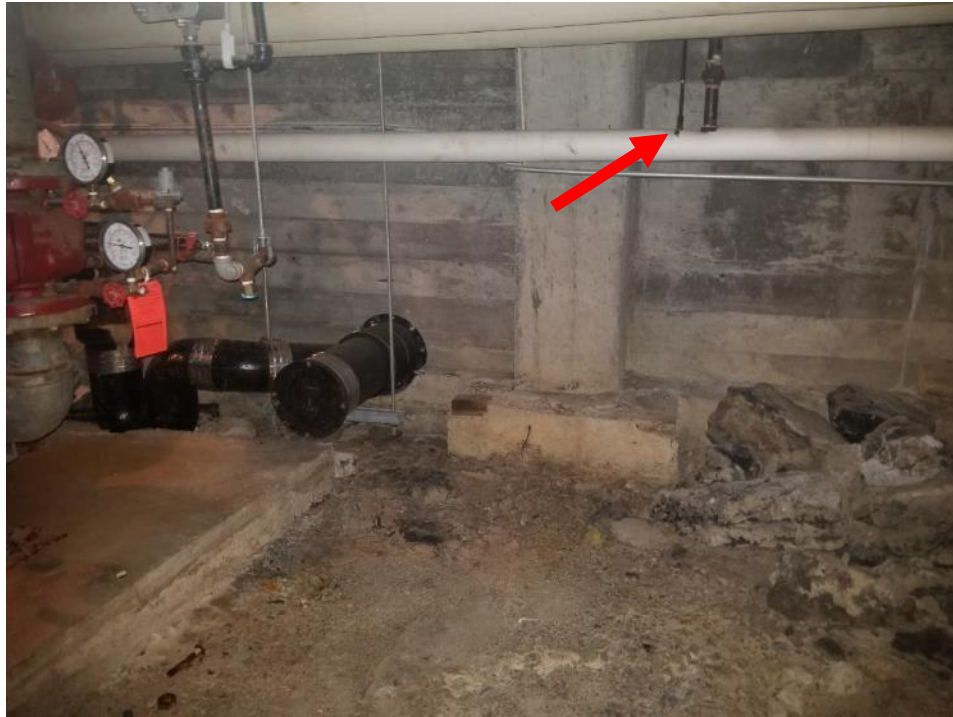
Photo 1. Basement, crawlspace, <1 square metre poor condition Aircell at hanger.

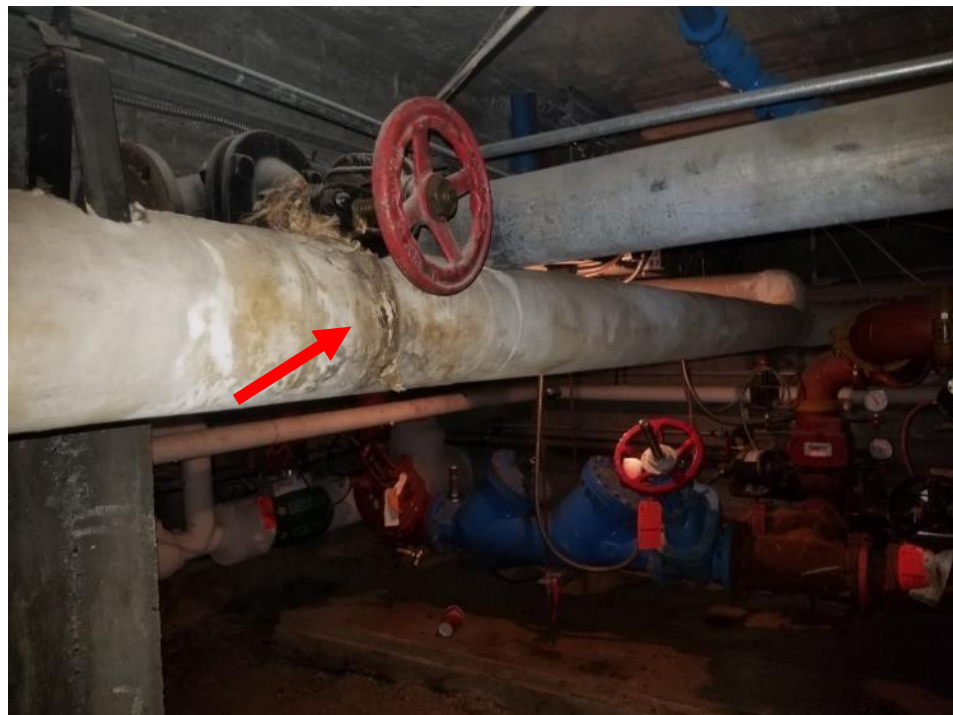
Photo 2. Basement, crawlspace, east-central, <1 square metre fair condition fitting.

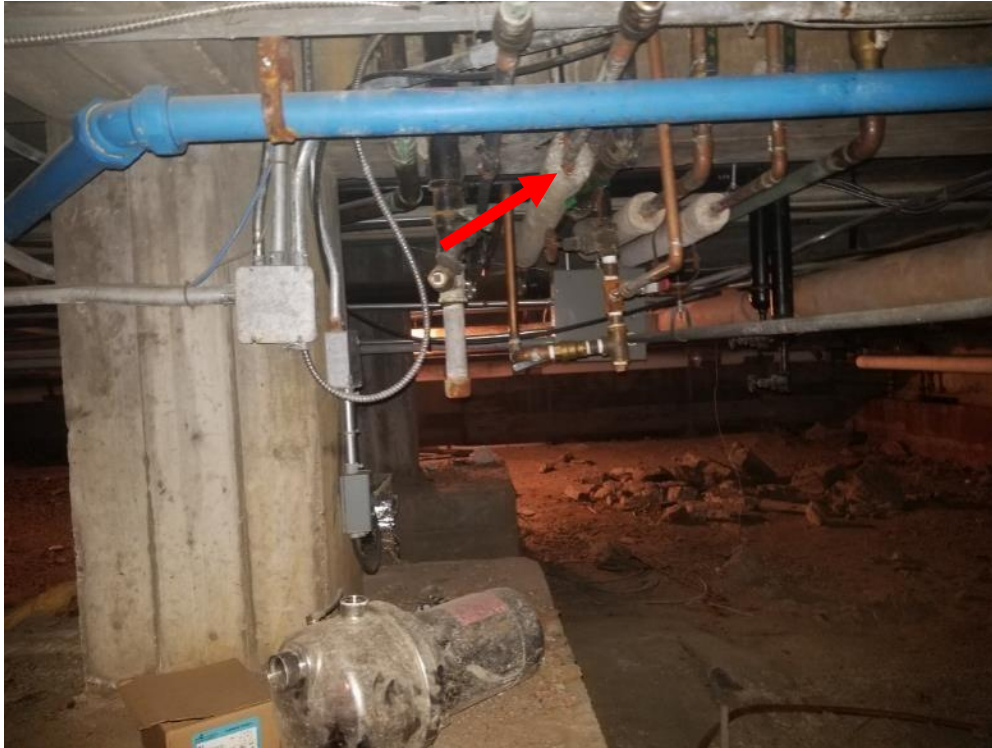
Photo 3. Basement, crawlspace, central, <1 linear metre poor condition Aircell.

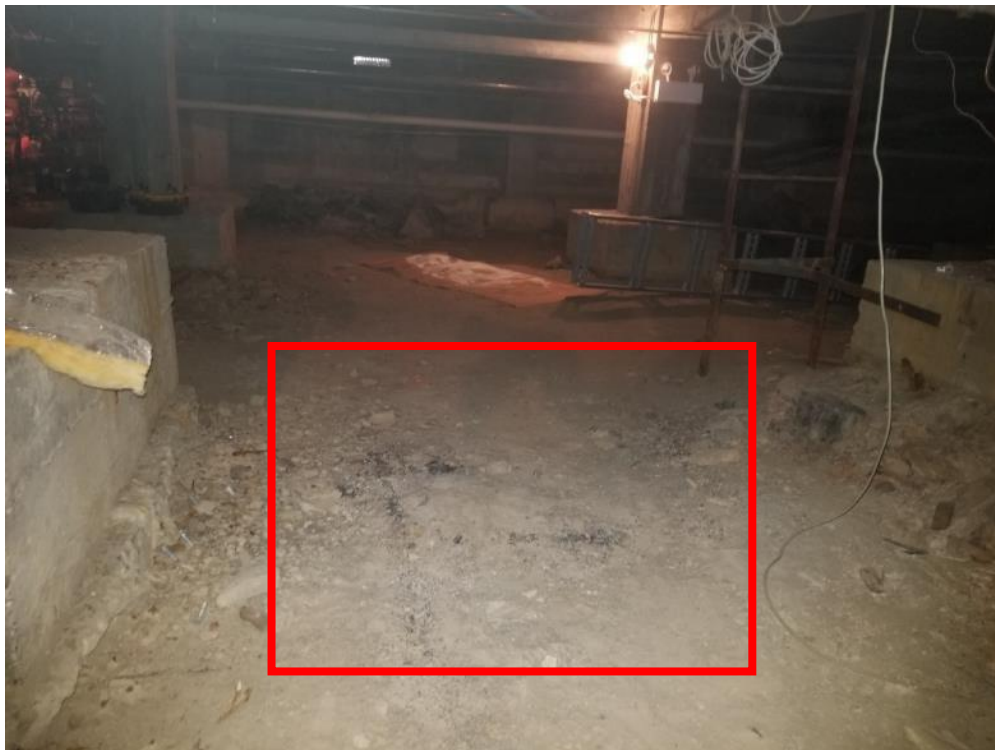
Photo 4. Basement, crawlspace, central behind ladder, 1 square metre Aircell debris on floor.

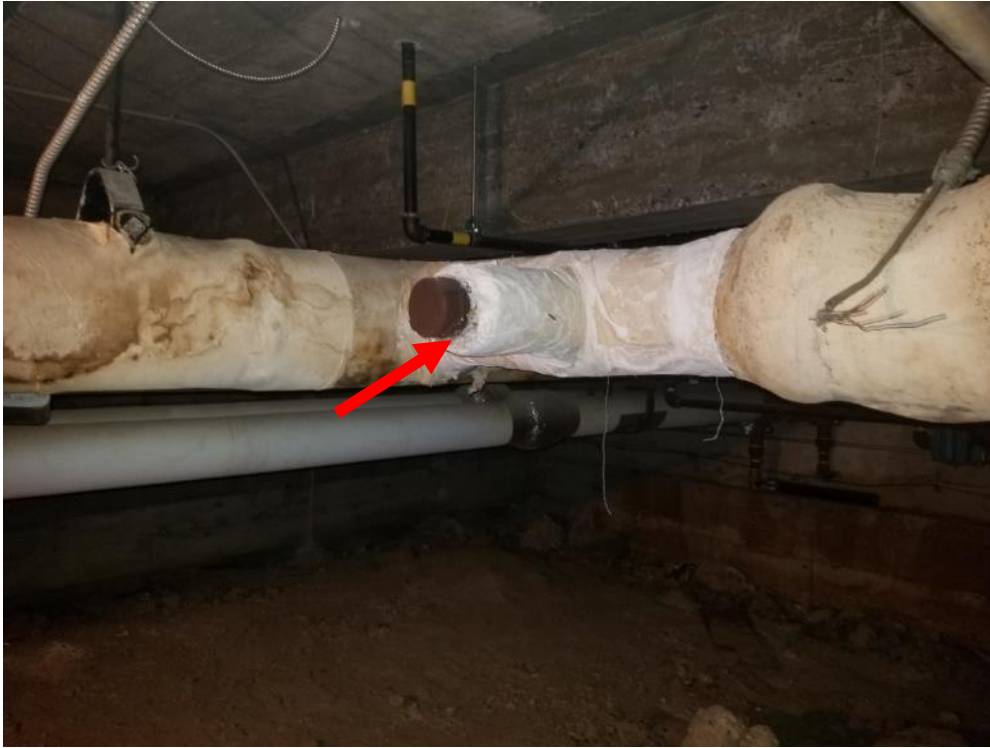
Photo 5. Basement, crawlspace, north-east corner, <1 linear metre poor condition fitting.

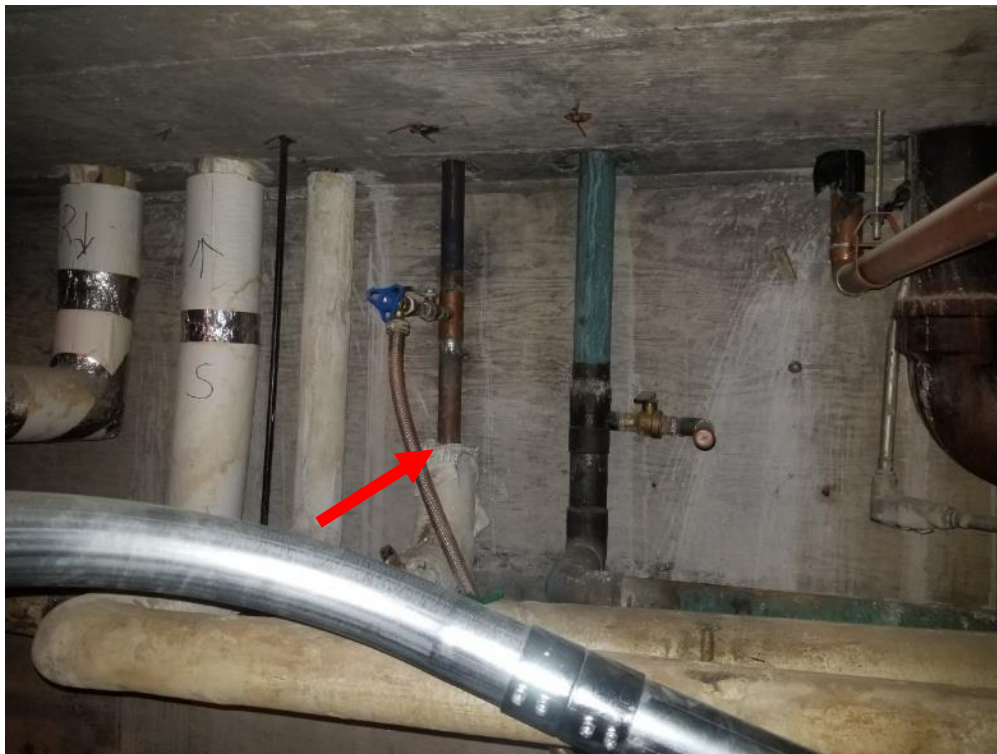
Photo 6. Basement, crawlspace, north-east corner, <1 linear metre poor condition Aircell.

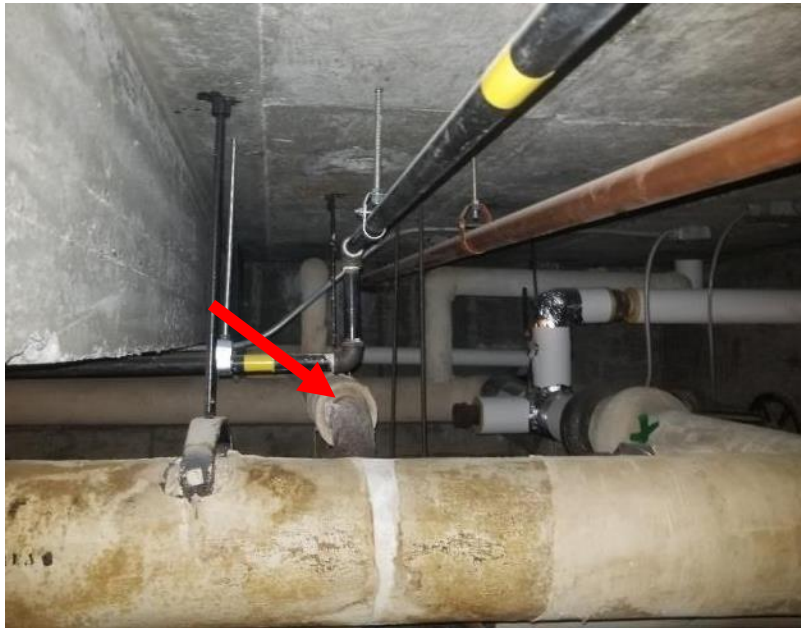
Photo 7. Basement, crawlspace, north-east corner, <1 square metre Aircell debris on cast iron pipe.

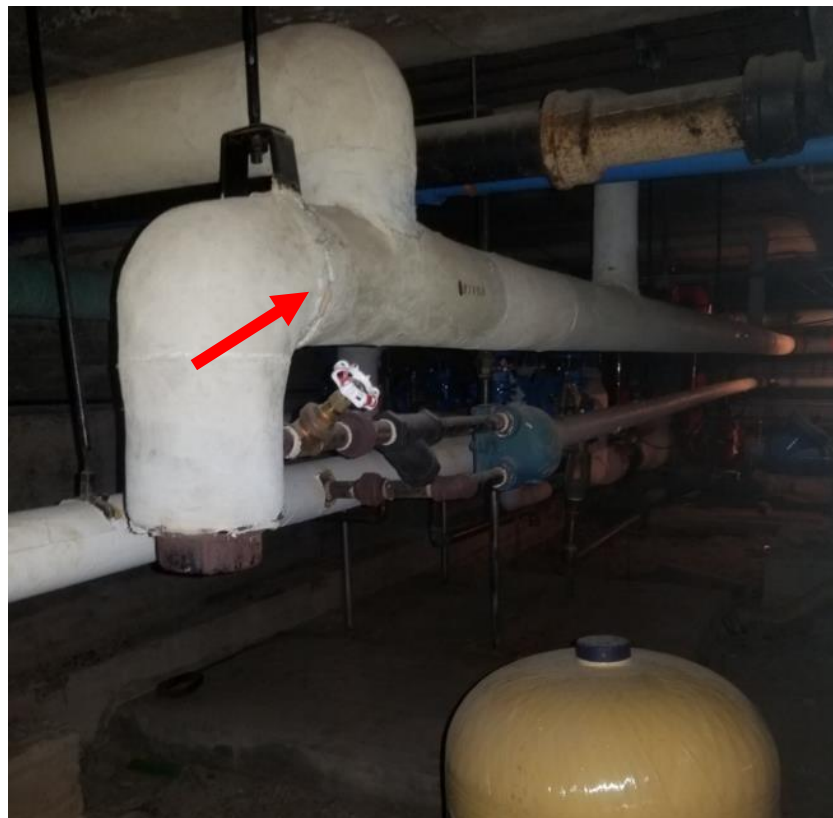
Photo 8. Basement, crawlspace, along east wall above yellow water tank, 1 poor condition fitting.

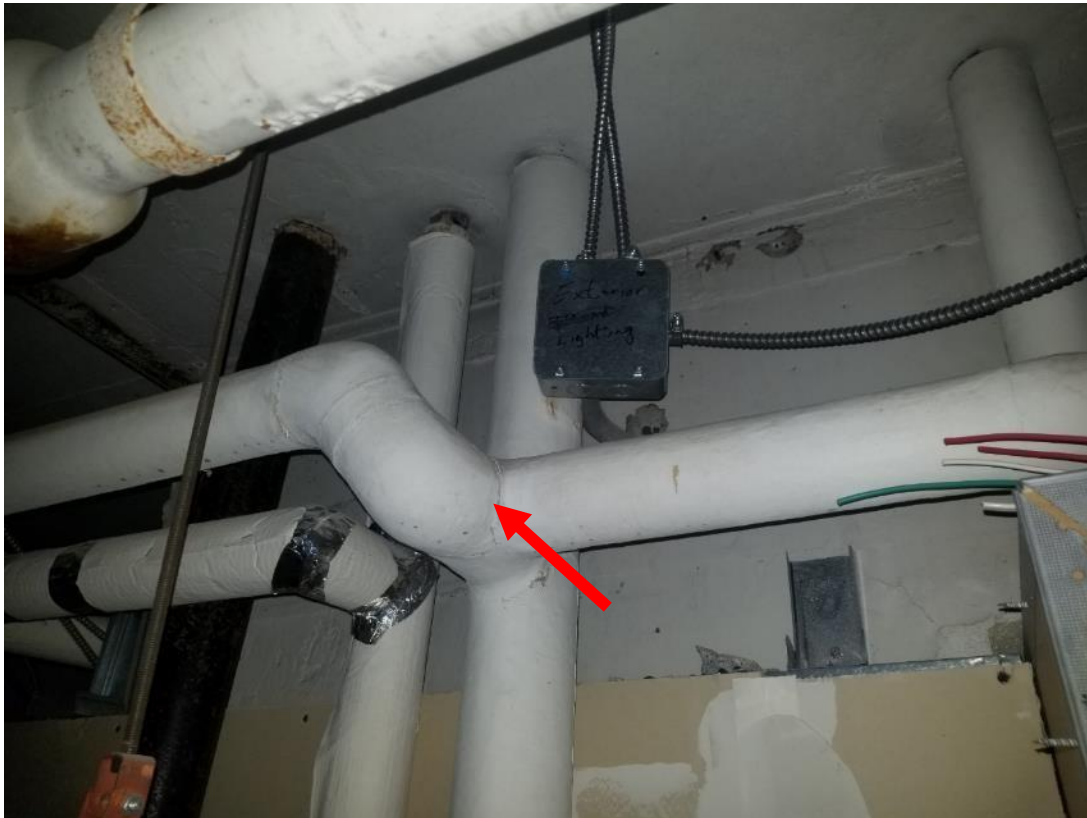
Photo 9. Basement, lab B-12, west of first window from west, 1 fair condition fitting.

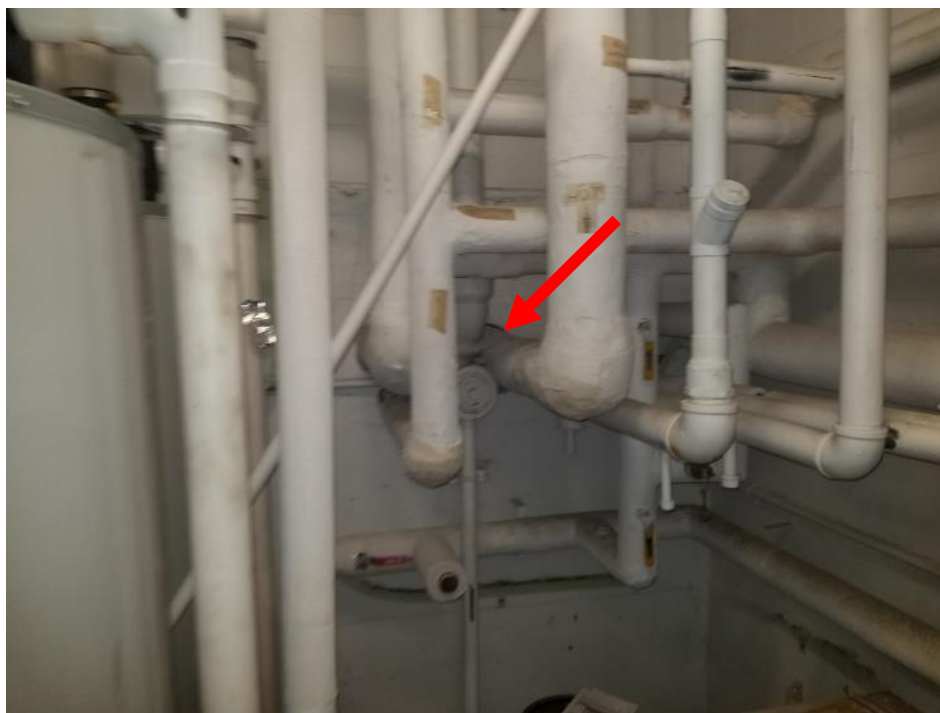
Photo 10. Basement, mechanical room B23, along north wall at bottom of stairs, <1 linear metre poor condition Aircell.

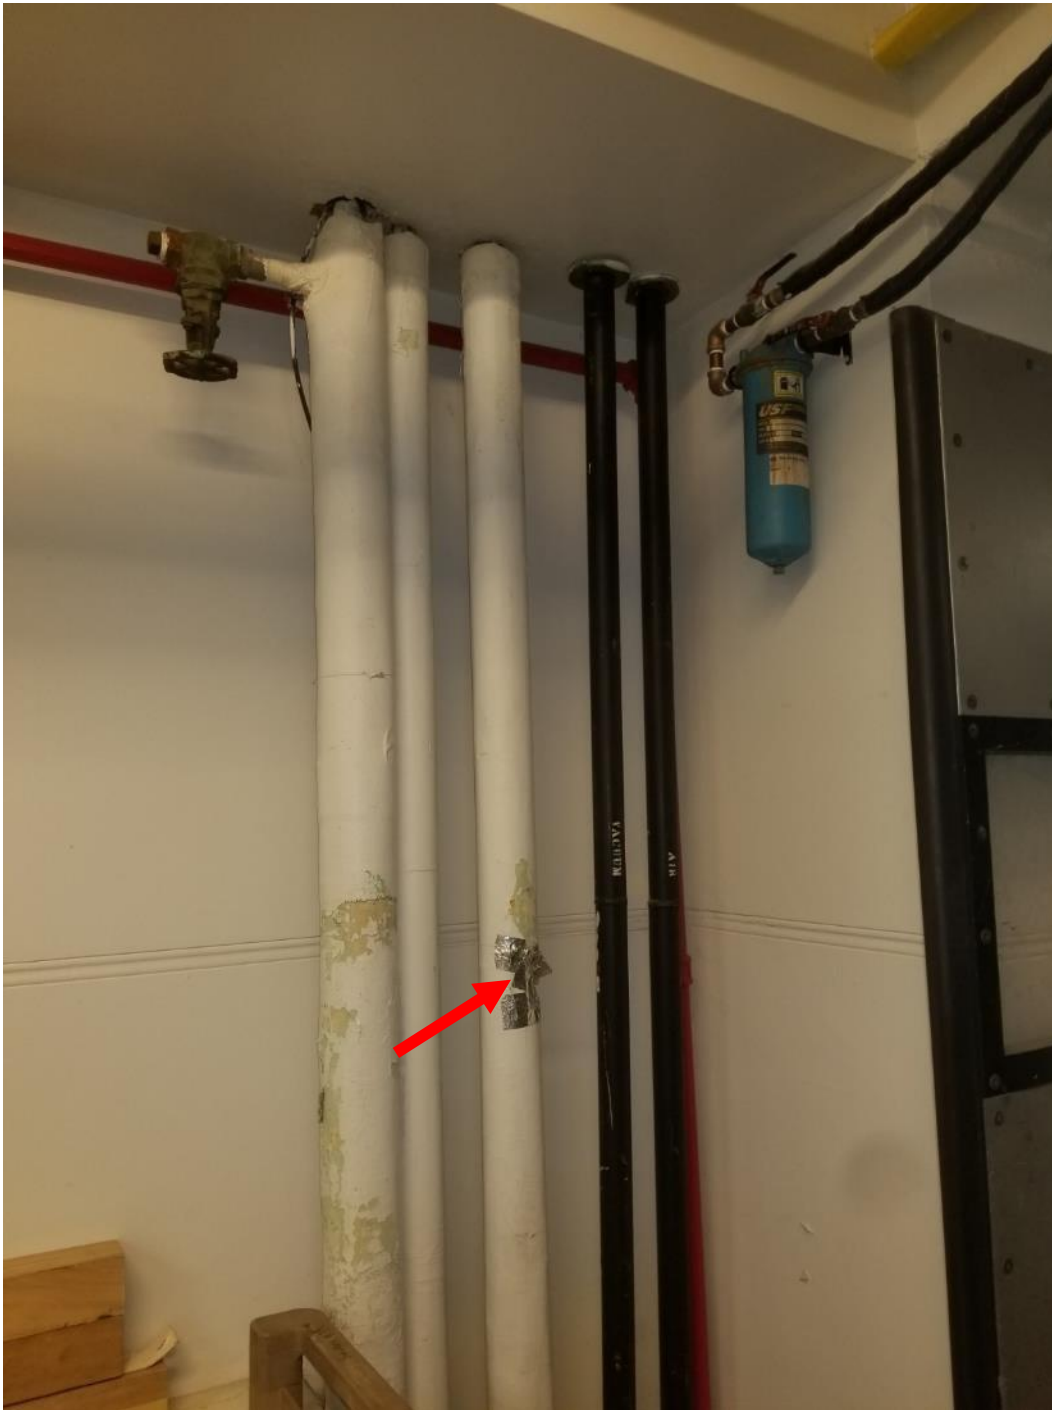
Photo 11. Basement, shipping and receiving B15, west wall, <1 linear metre poor condition
Aircell.

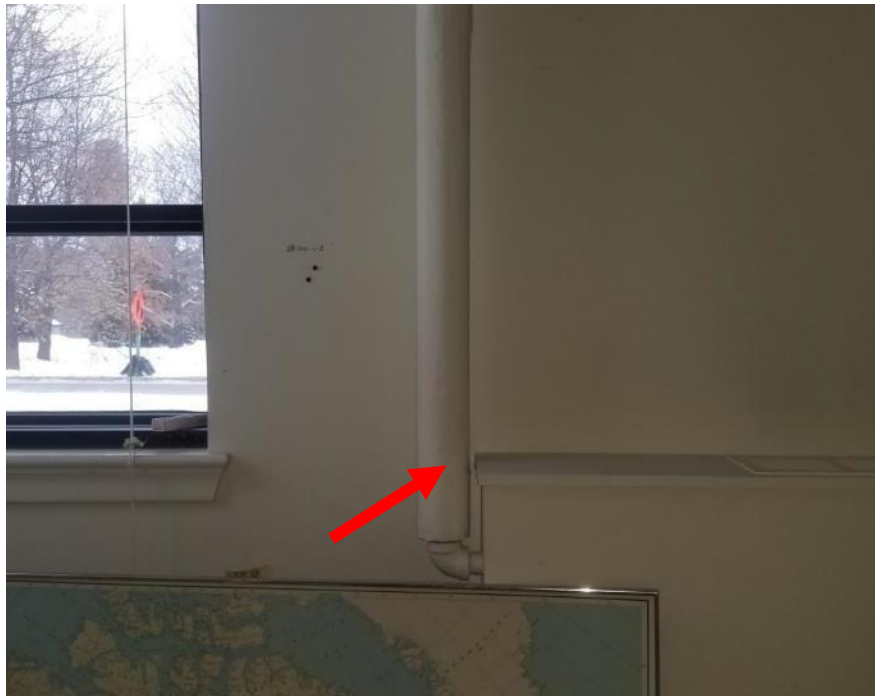
Photo 1. Ground floor, main area, along north wall, <1 square metre fair condition Aircell.

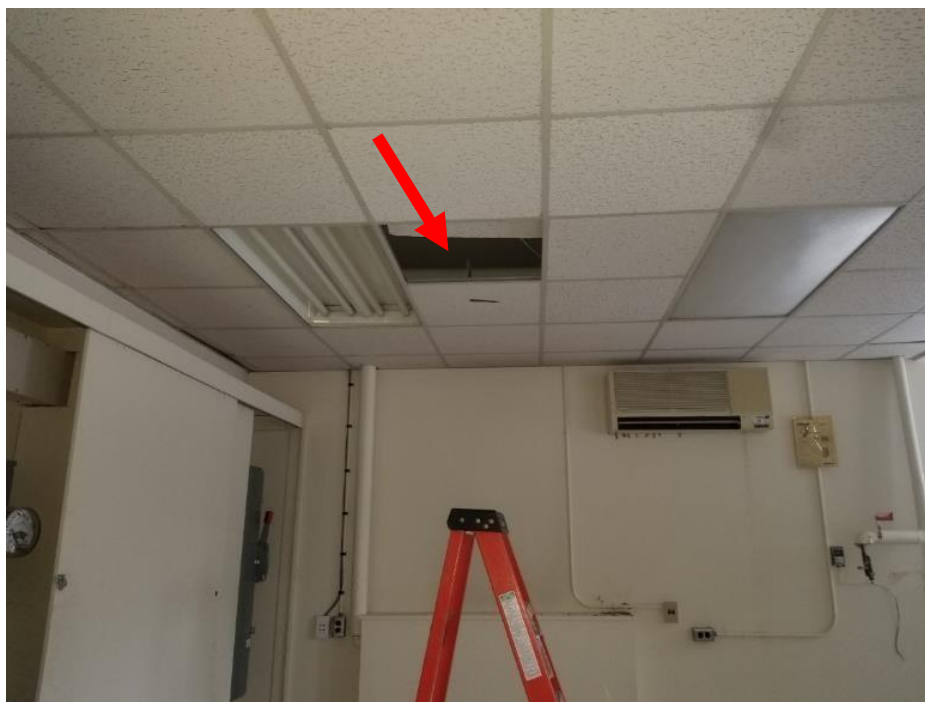
Photo 2. Ground floor, main area, south-west corner of room, <1 linear metre of poor condition Aircell.

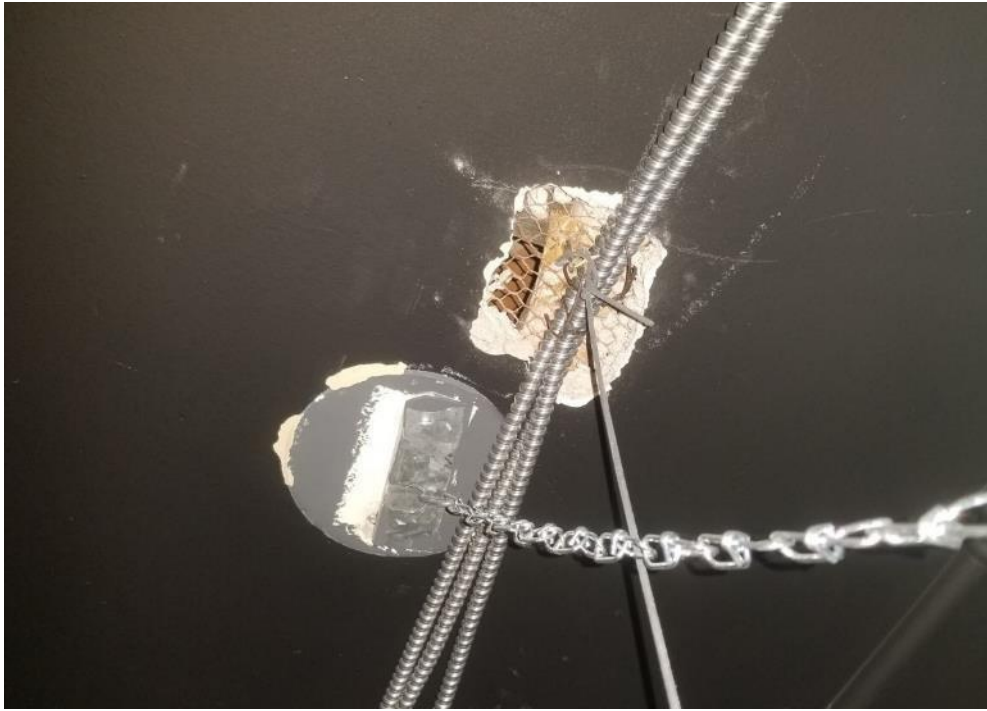
Photo 1. Basement, B-4, <1 square metre poor condition ceiling plaster at hangers throughout.

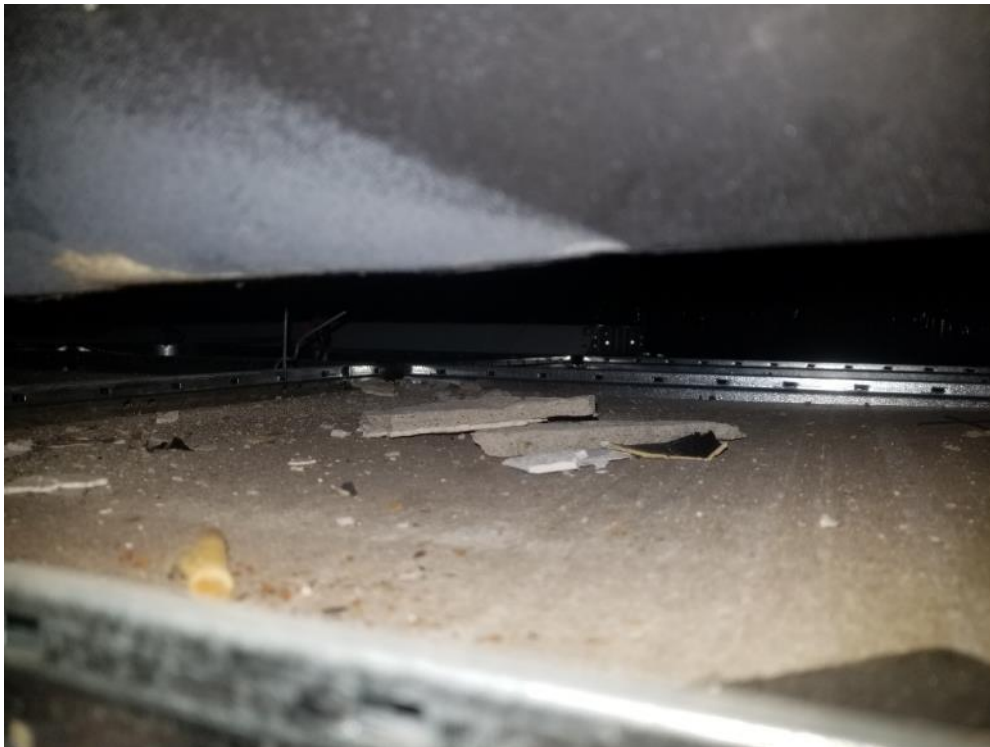
Photo 2. Basement, B-4, 200 square metres ceiling plaster debris throughout.

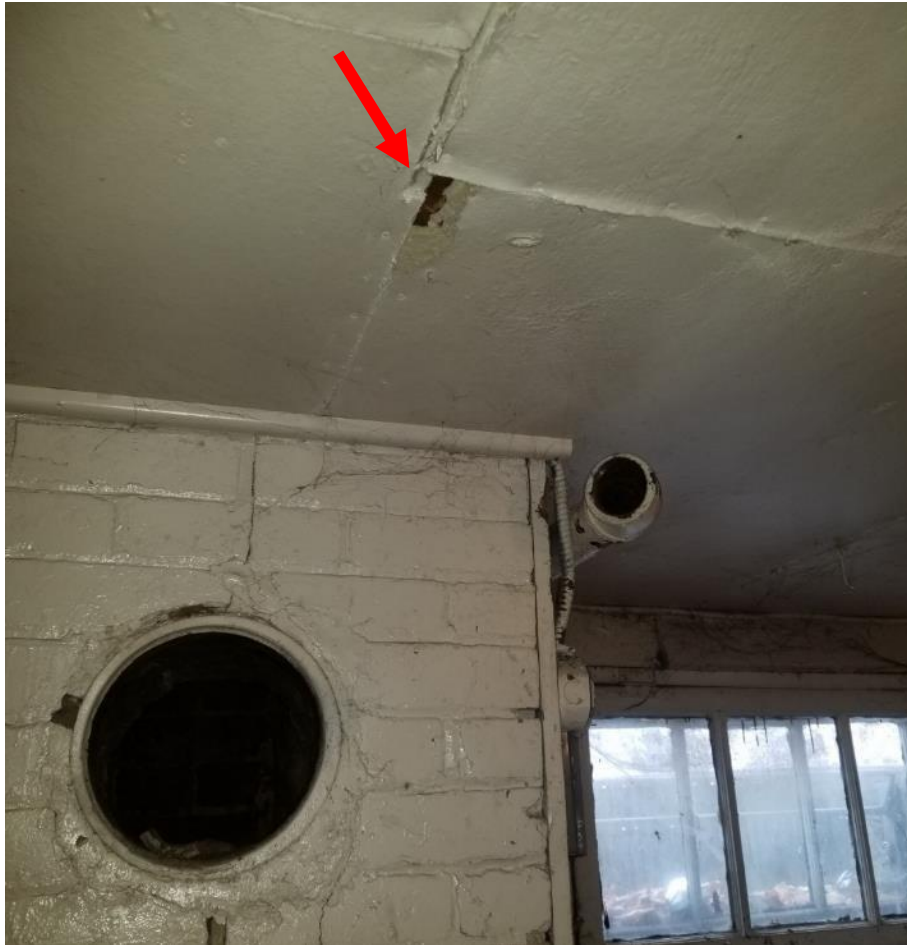
Photo 1. Basement, B-4, <1 square metre poor condition Transite on ceiling.

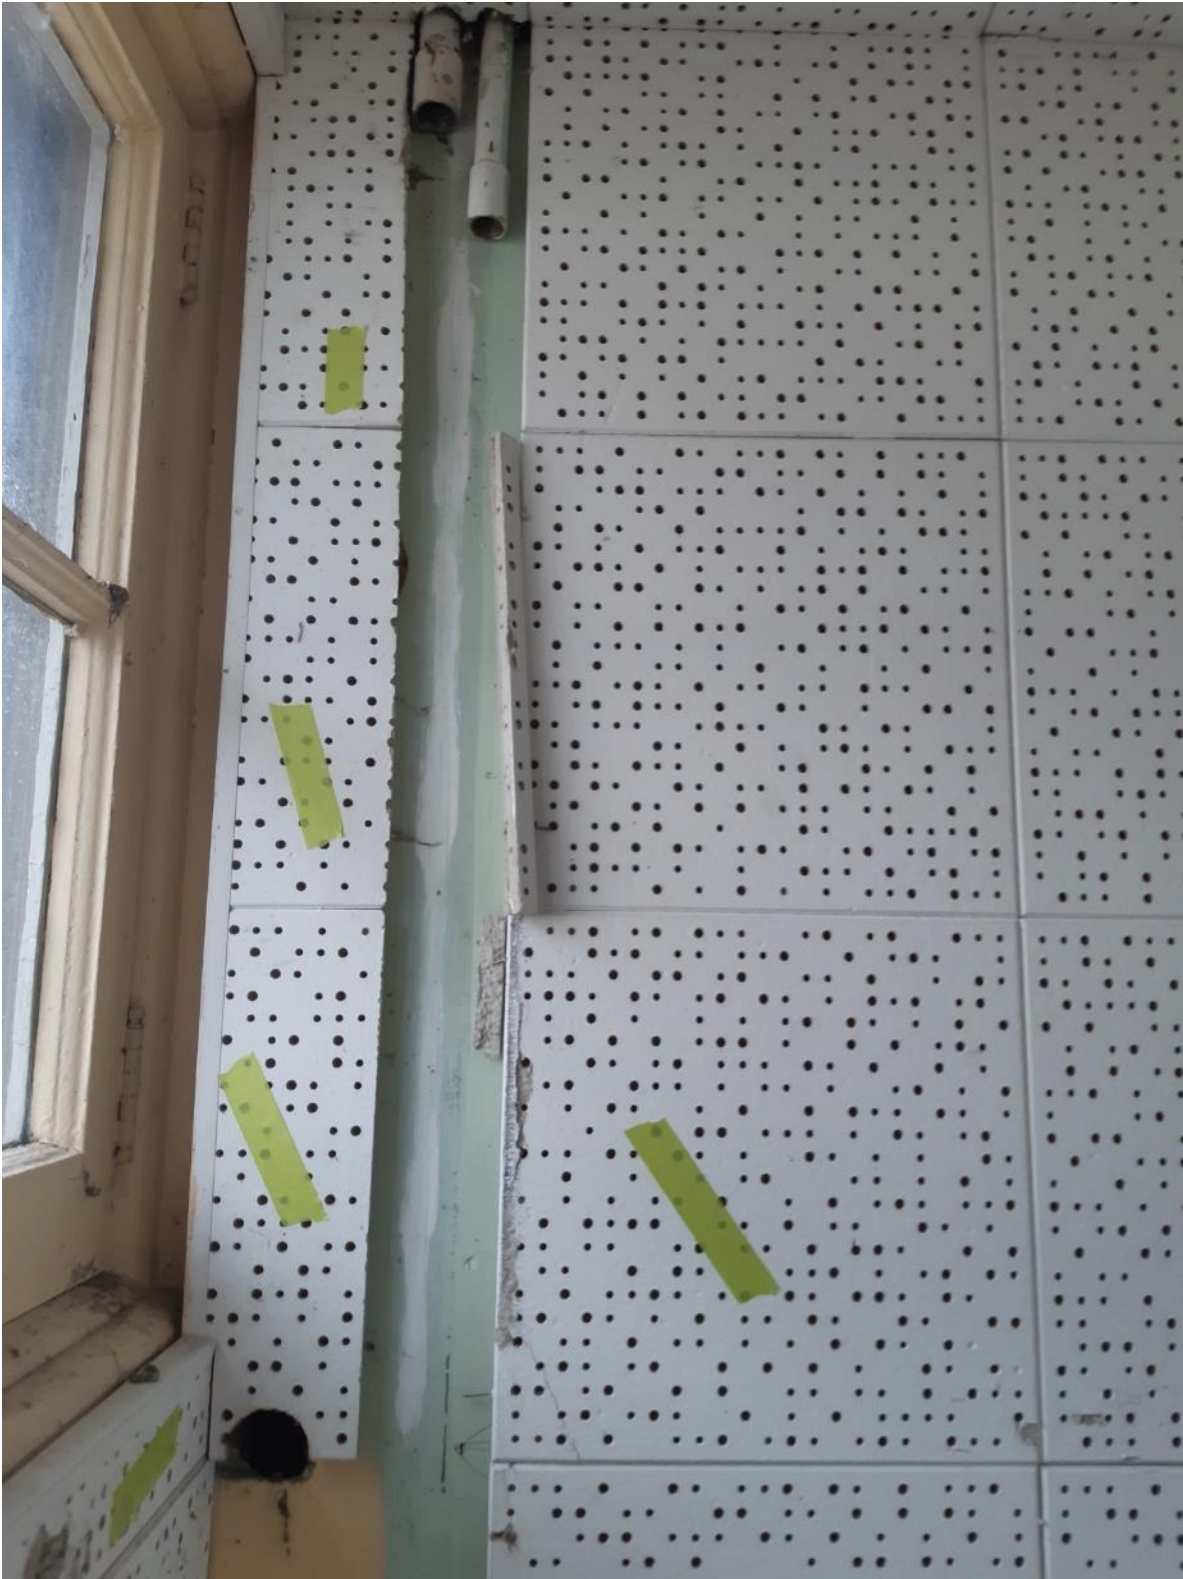
Photo 1. Ground floor, office space, poor condition 1'x1' grey acoustic tile on walls throughout.

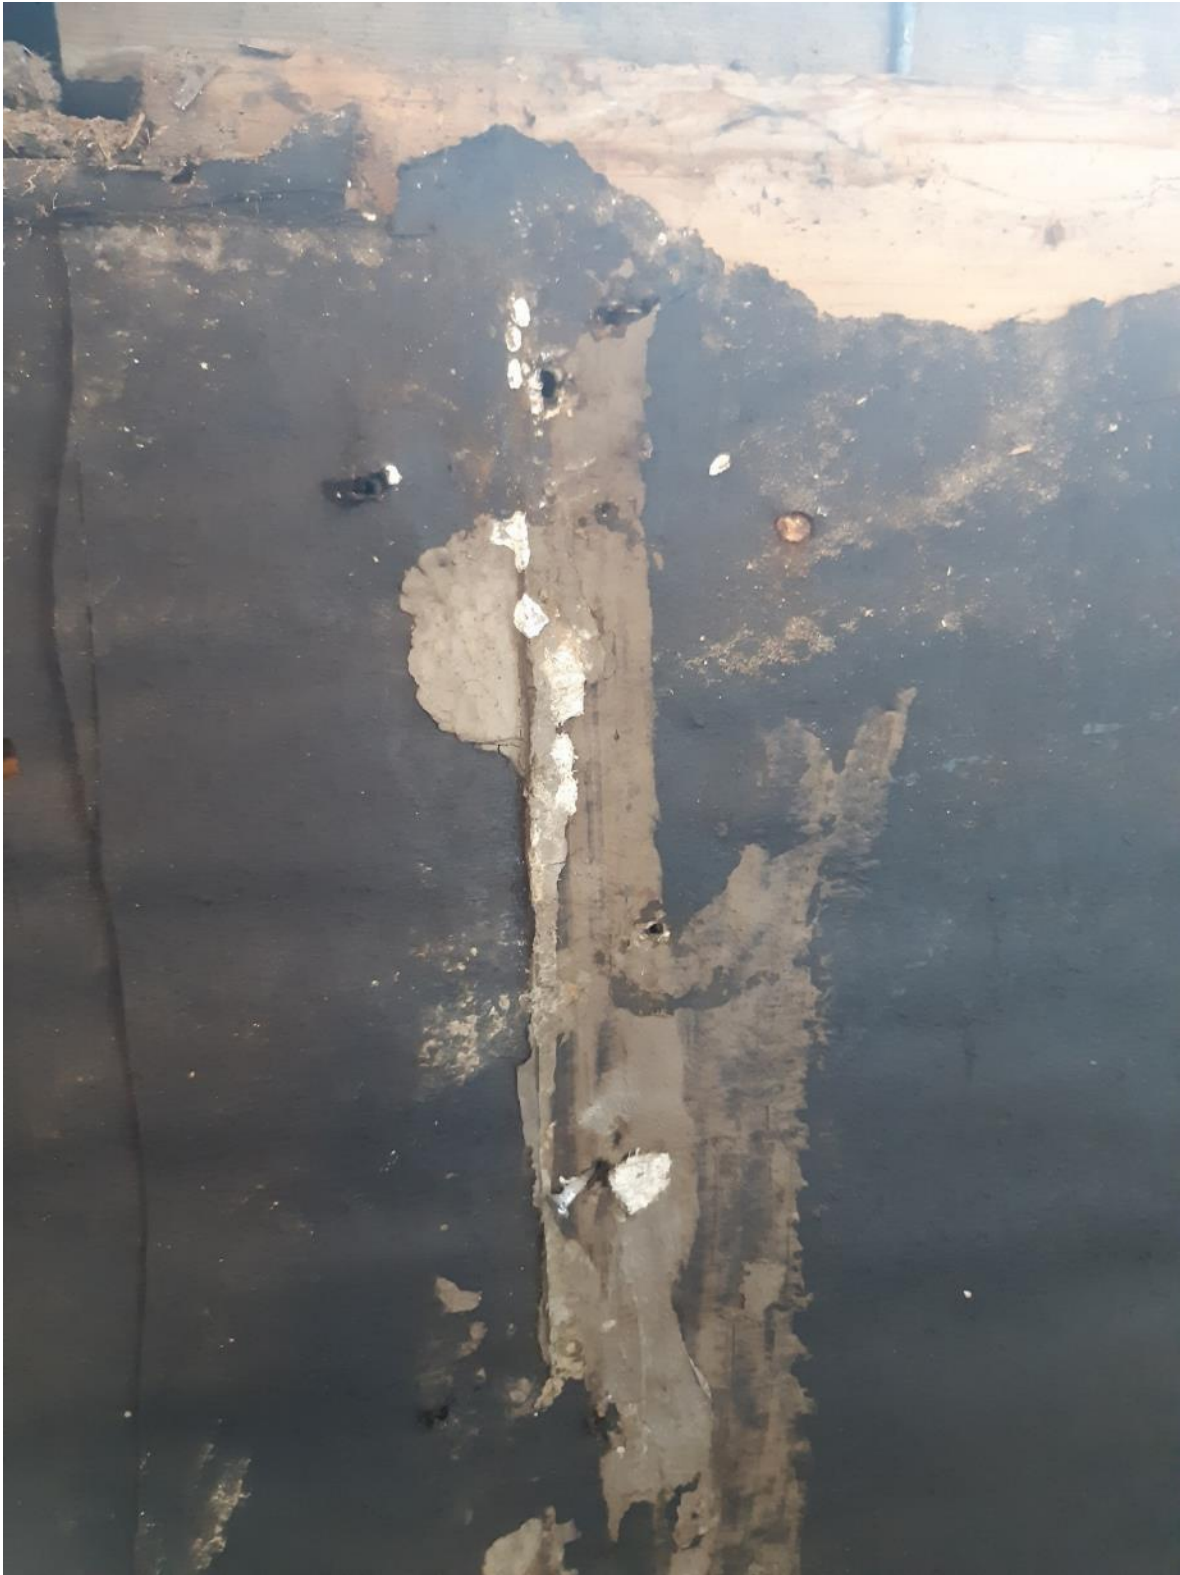
Photo 1. Ground floor, room adjacent entryway, 40 square metres of transite debris on walls.

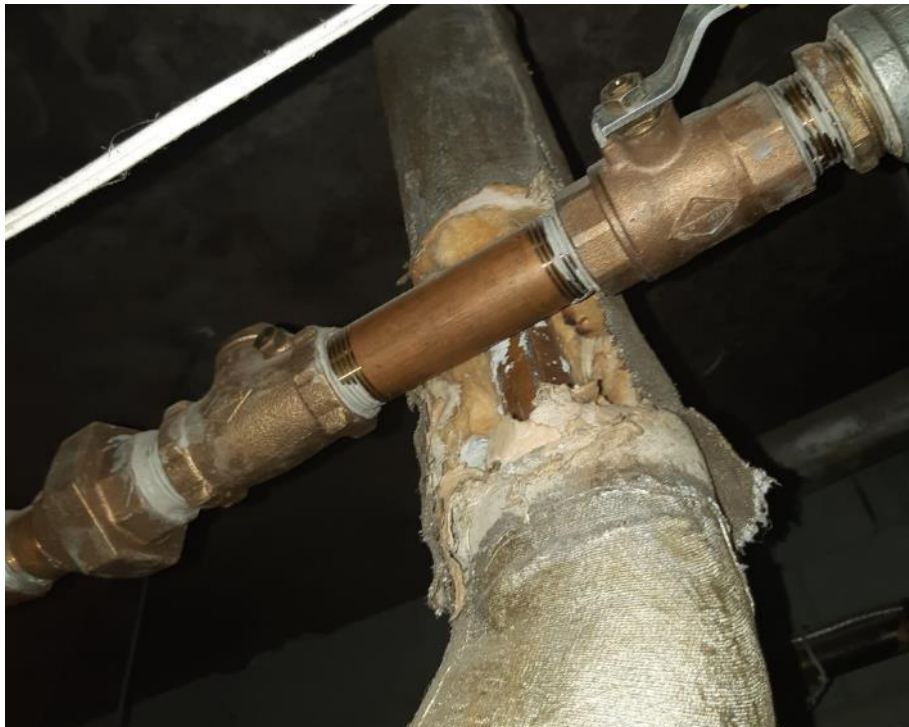
Photo 2. Basement, hallway to elevator, 1 poor condition fitting.

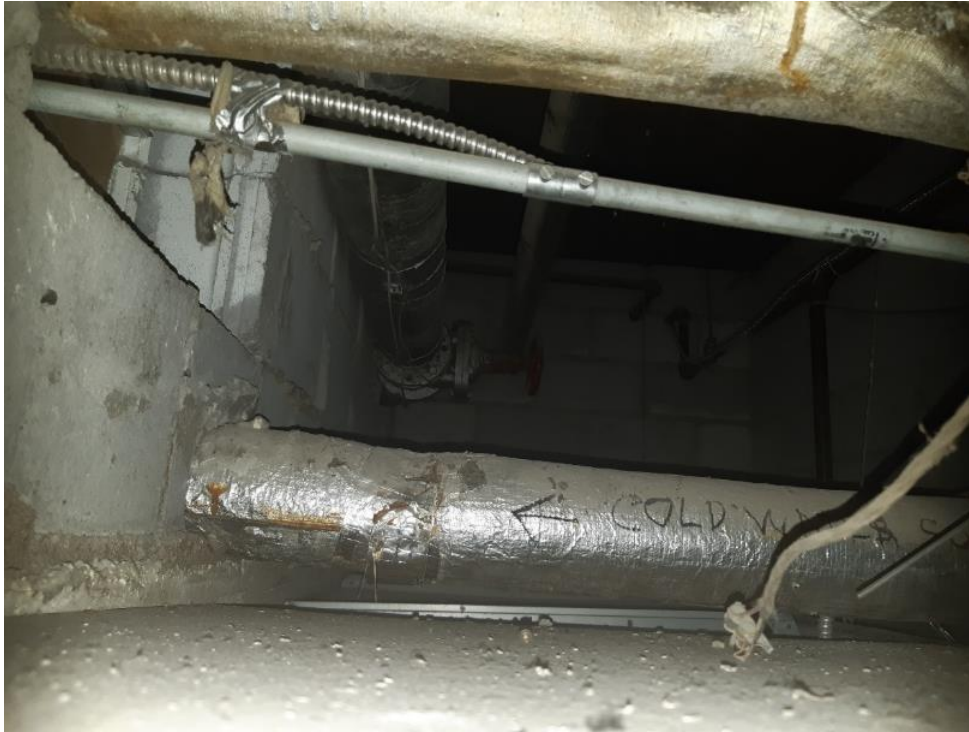
Photo 3. Basement, hallway to elevator, 4 square metres of Magblock debris on ceiling tiles.

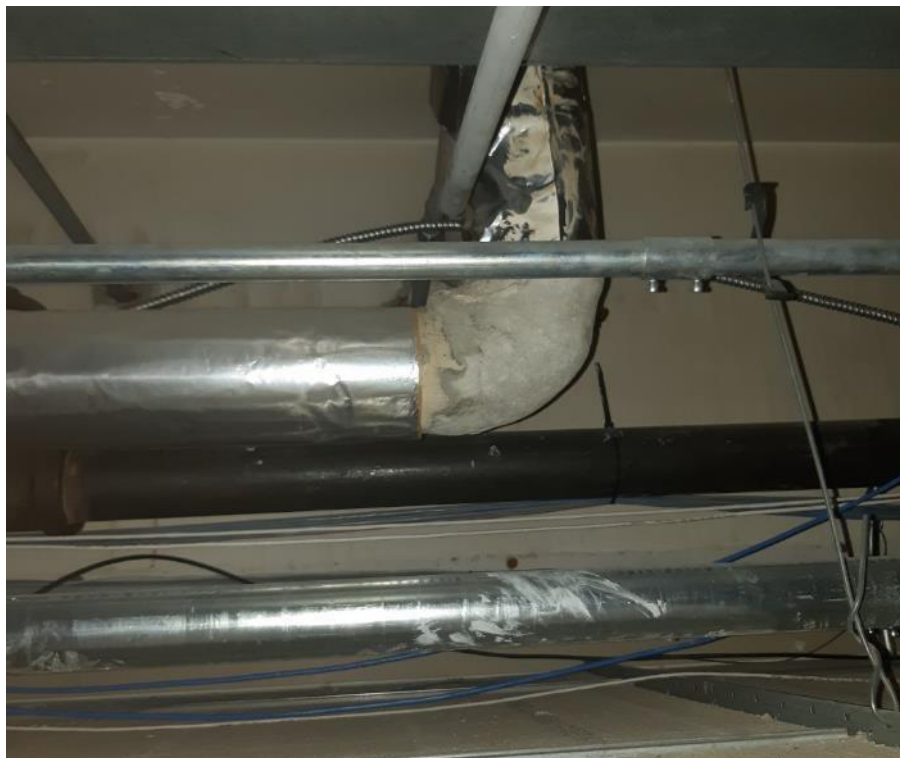
Photo 4. Basement, main hallway, in front of fire hose across from room 102, 1 fair condition pipe fitting.

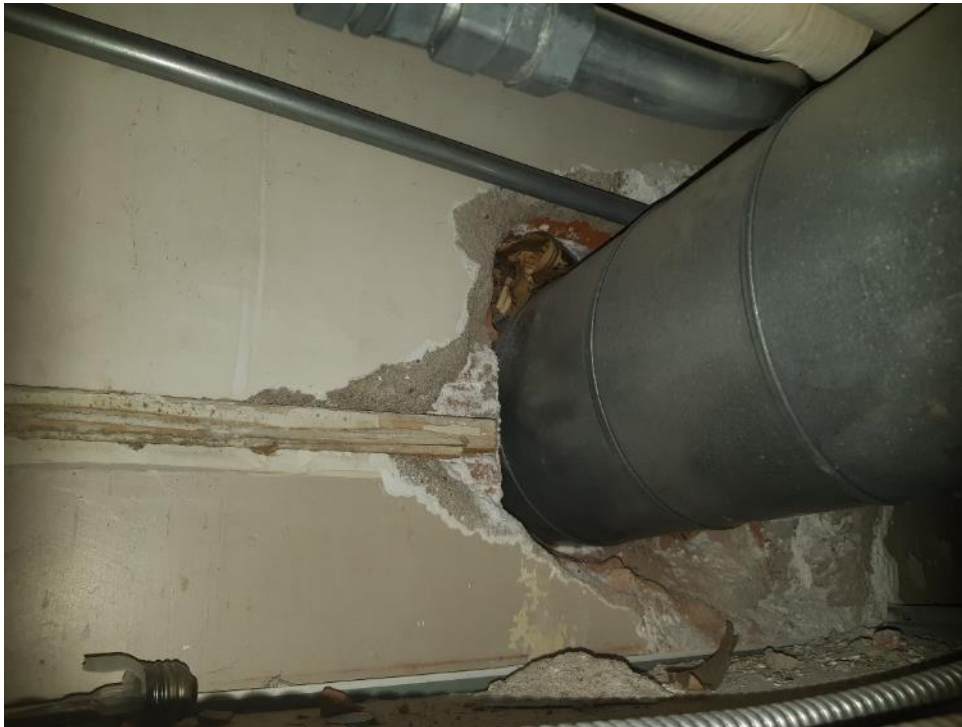
Photo 5. Basement, main hallway, 80 square metres poor condition wall plaster at pipe/duct wall penetrations.

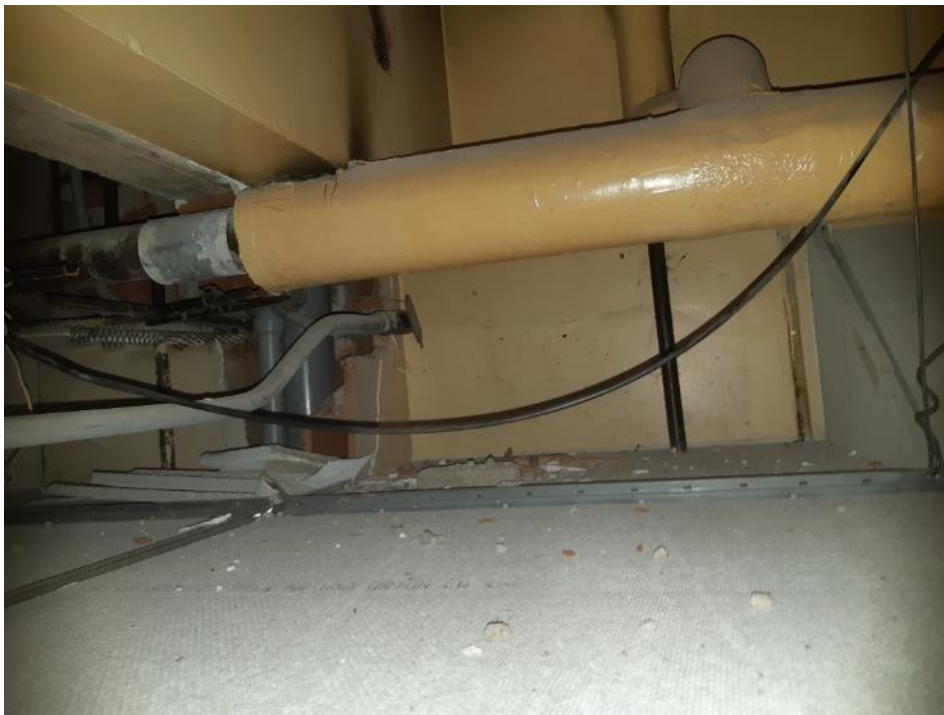
Photo 6. Basement, lab 101, above second window from east along south wall, 2 square metres debris on ceiling tile.

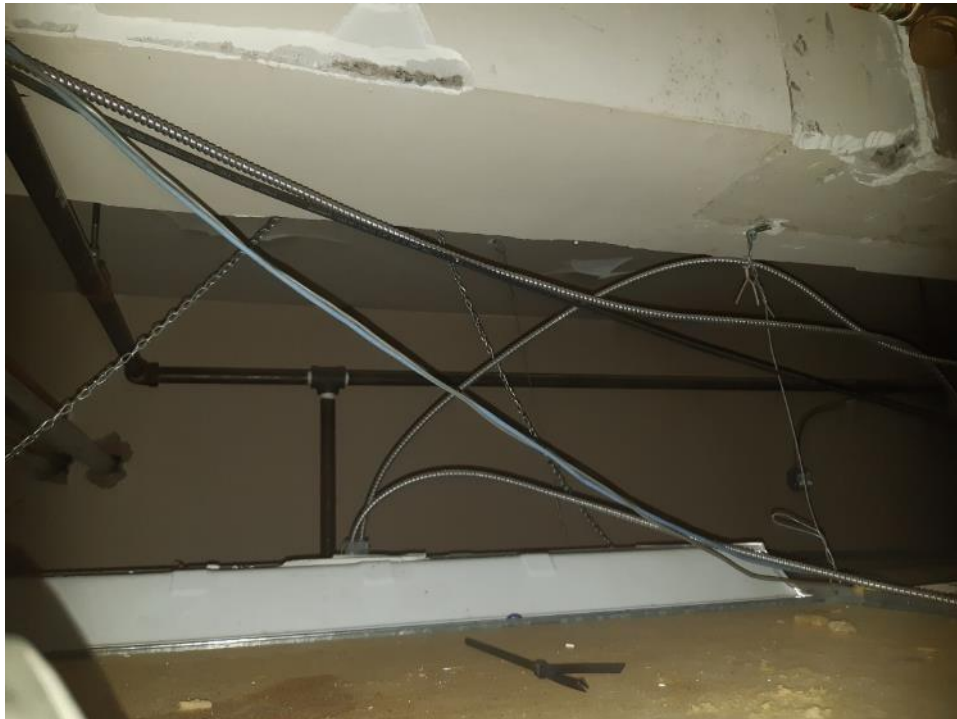
Photo 7. Basement, storage room 110, west of door, 2 square metres poor condition ceiling plaster and 4 square metres debris on ceiling tile.
