ADDENDUM # 4

Solicitation Number: 19-1107

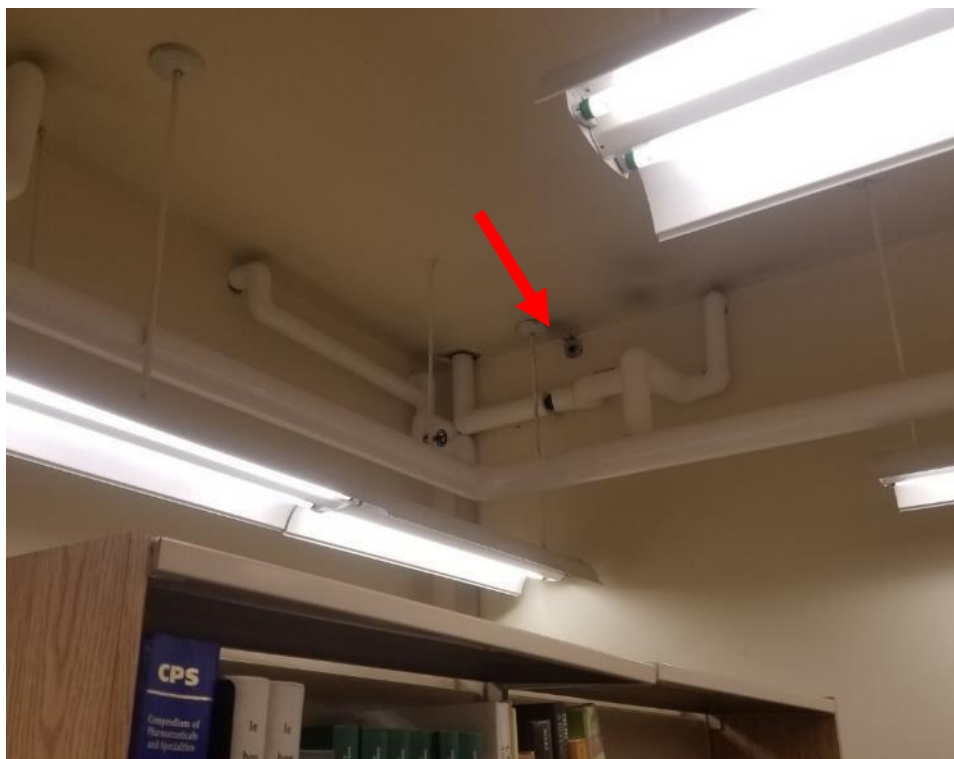
Photo 8. Basement, office 114, east wall in north-east corner, <1 square metre poor condition Aircell in wall penetration.

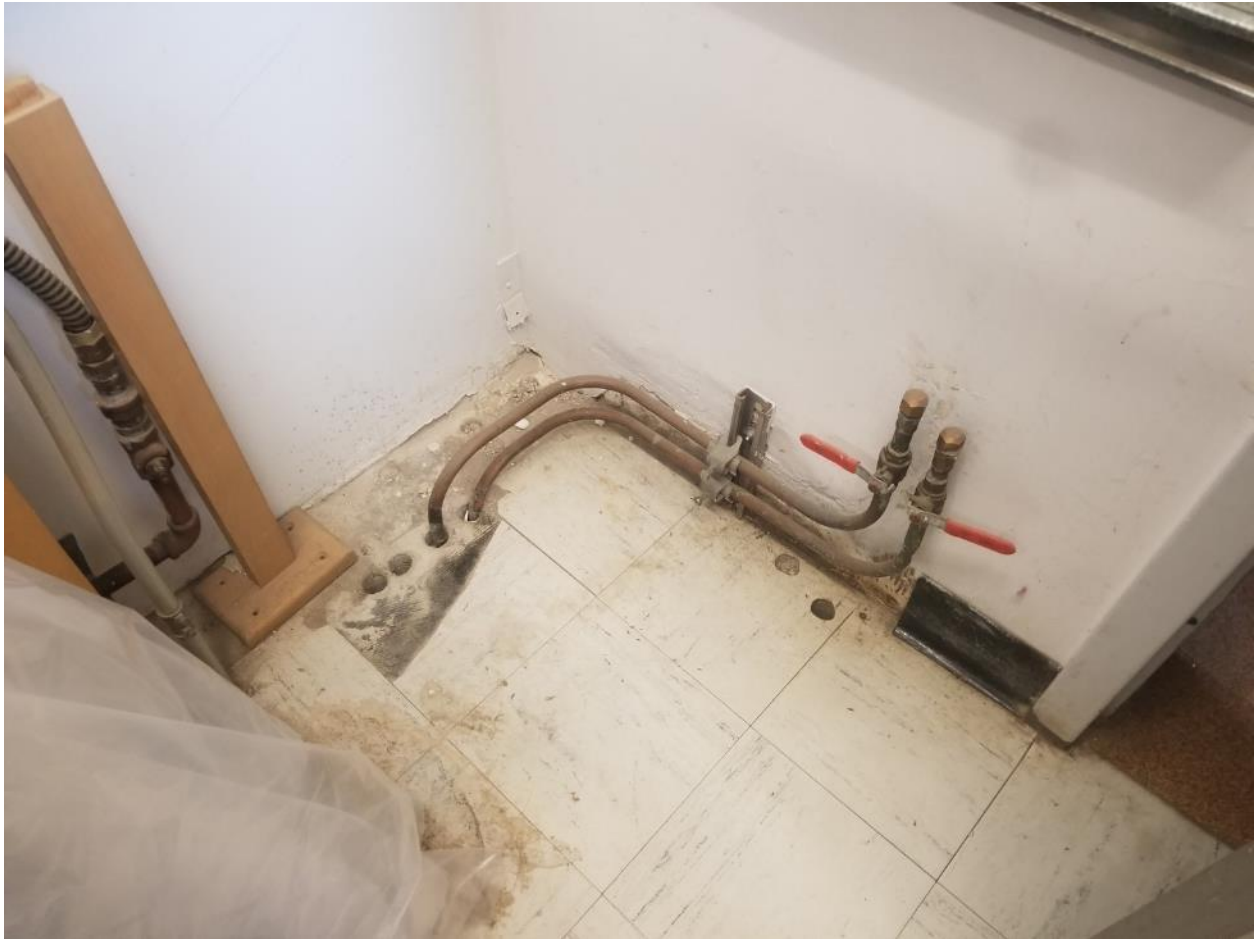
Photo 1. First floor, lab EW-06, next to door on south wall, 4 fair condition vinyl floor tiles.

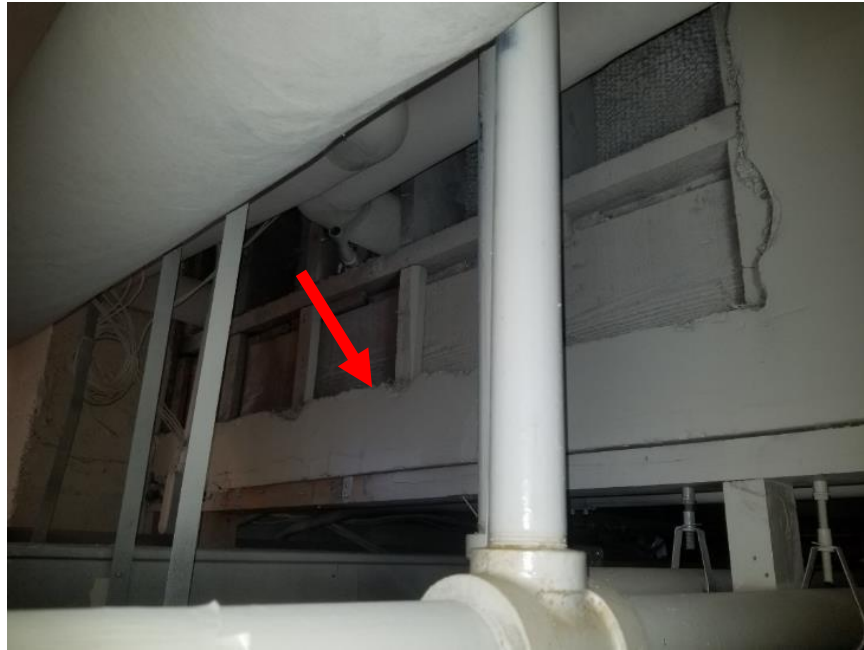
Photo 1. Basement, file secure room, south wall, 2 square metres poor condition ceiling plaster.

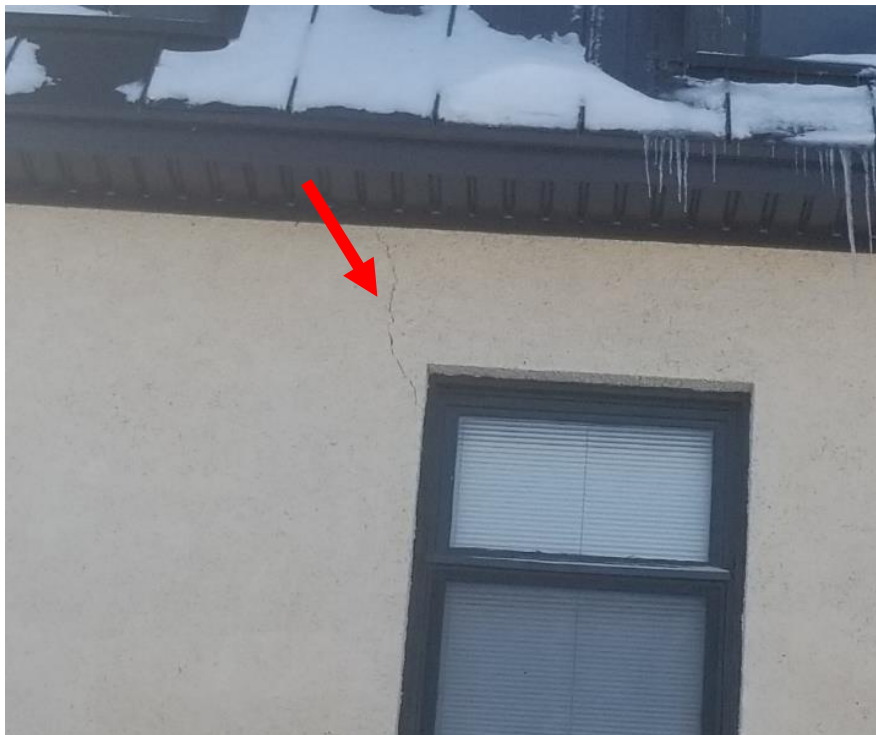
Photo 2. Exterior, north wall above fifth window from west, 1 linear metre fair condition stucco wall.

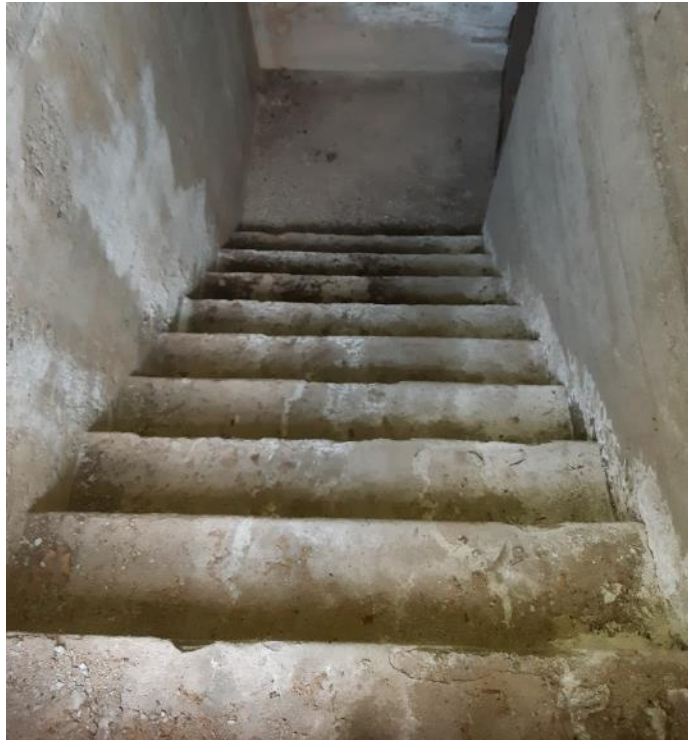
Photo 1. Basement, floor near entrance, 4 square metres debris on stairs.

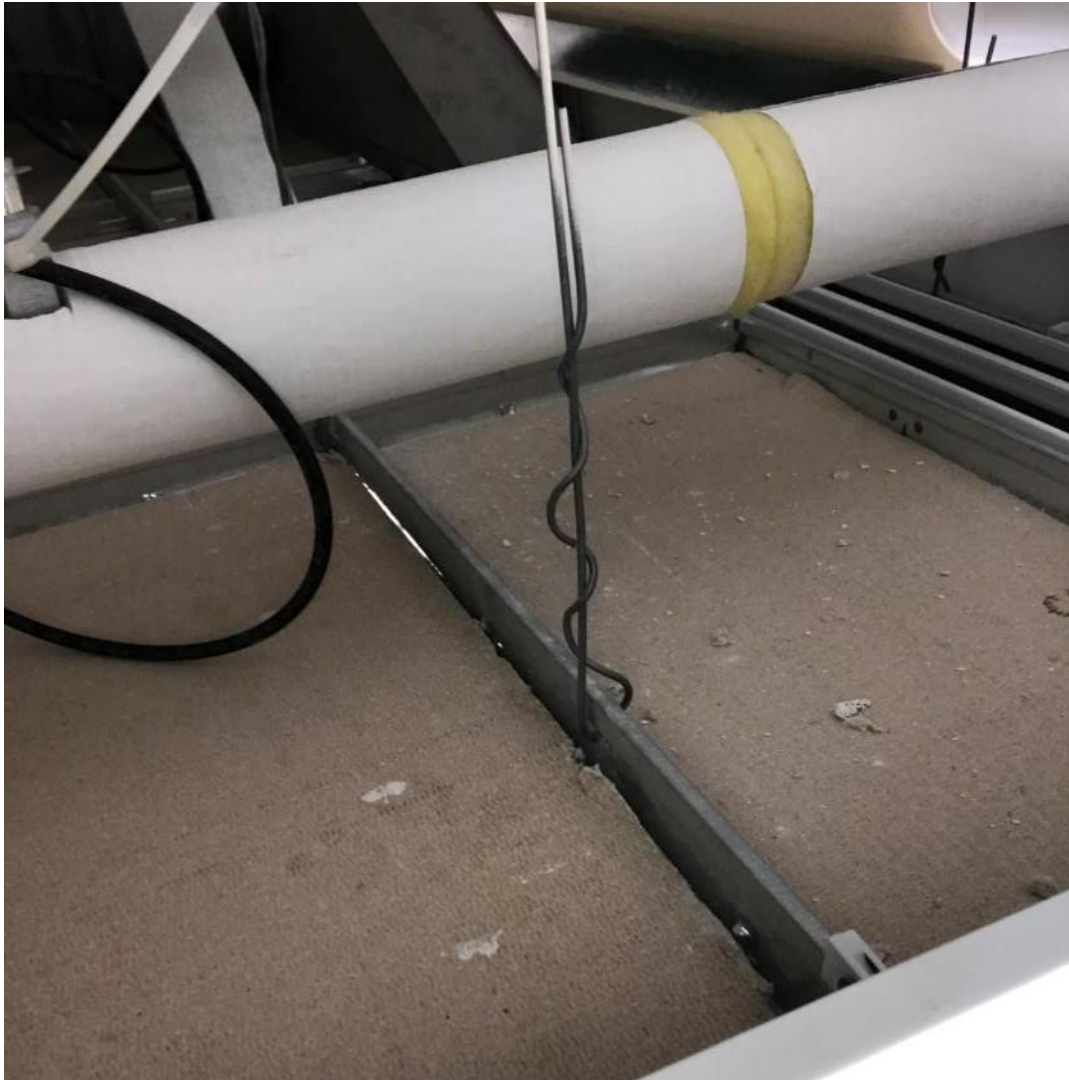
Photo 1. Ground floor, location 18 office, on south side of window, <1 square metre ceiling plaster debris on ceiling tiles.

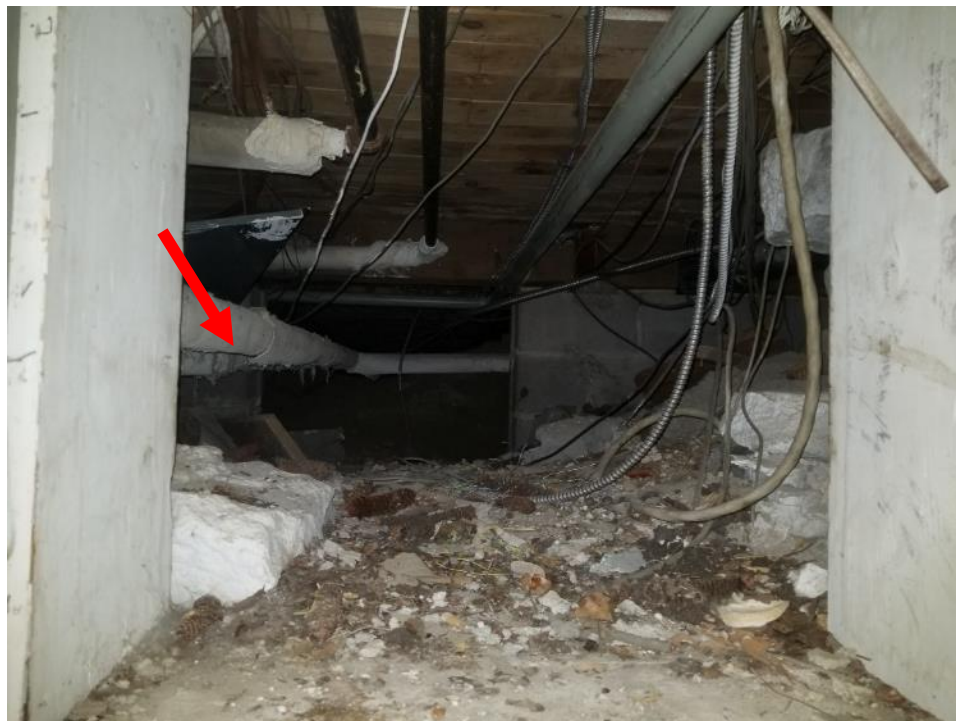
Photo 1. Basement, storage room between chimney and furnace rooms, behind panel on back wall in crawlspace, 20 linear metres poor condition Aircell.

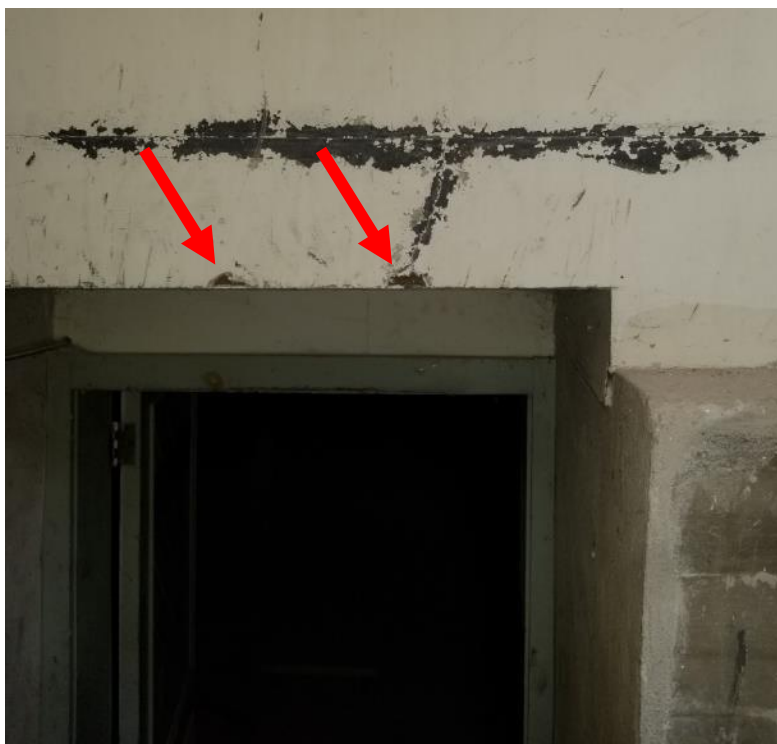
Photo 2. Basement to ground, stairwell, <1 square metre poor condition Transite wall.

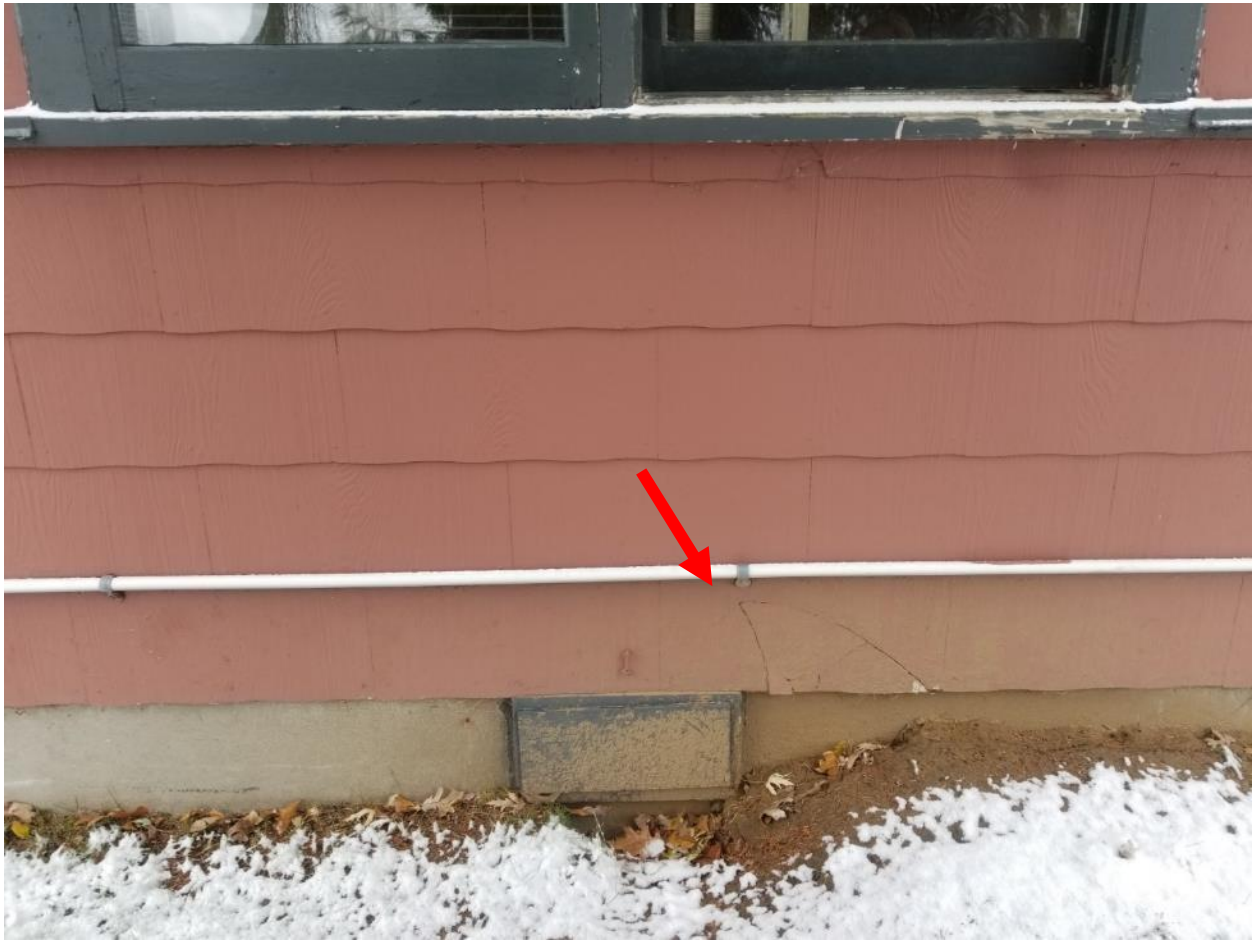
Photo 3. Exterior, south wall under second window from west, <1 square metre fair condition
Transite siding.

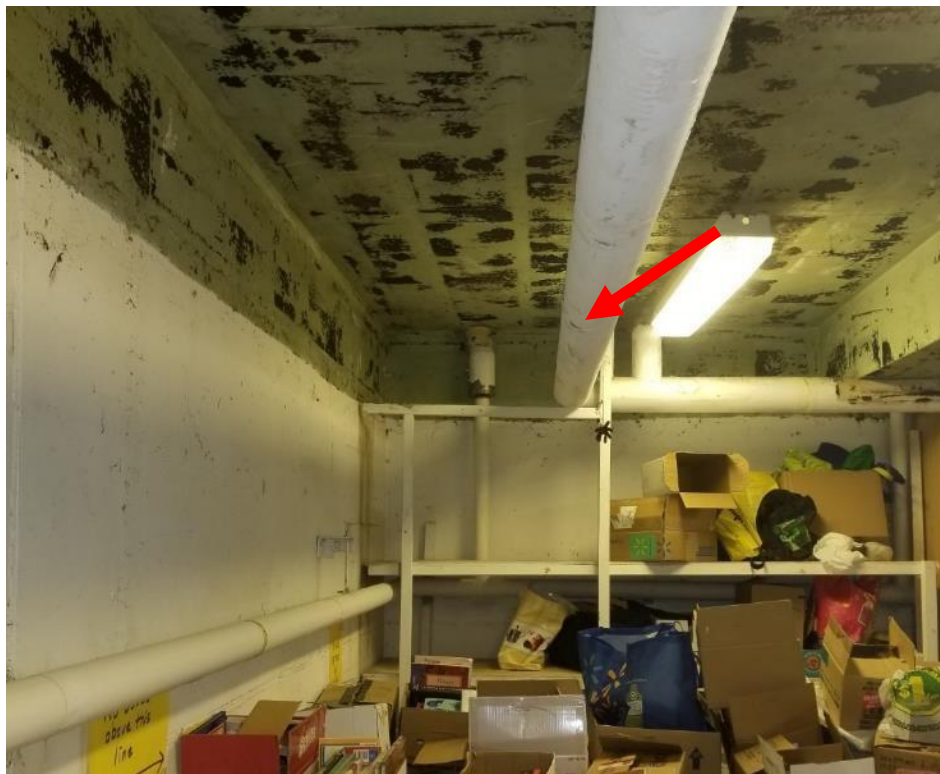
Photo 1. Basement, craft drying room, <1 linear metre fair condition Aircell on pipe running east to west in center of room.

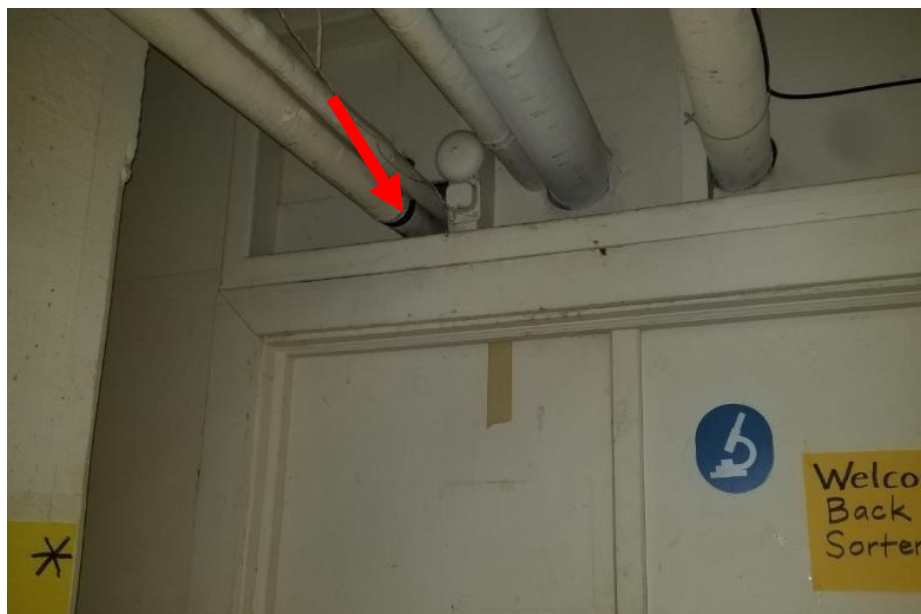
Photo 2. Basement, central, bottom of stairs next to door to B-1, <1 linear metre fair condition Aircell.

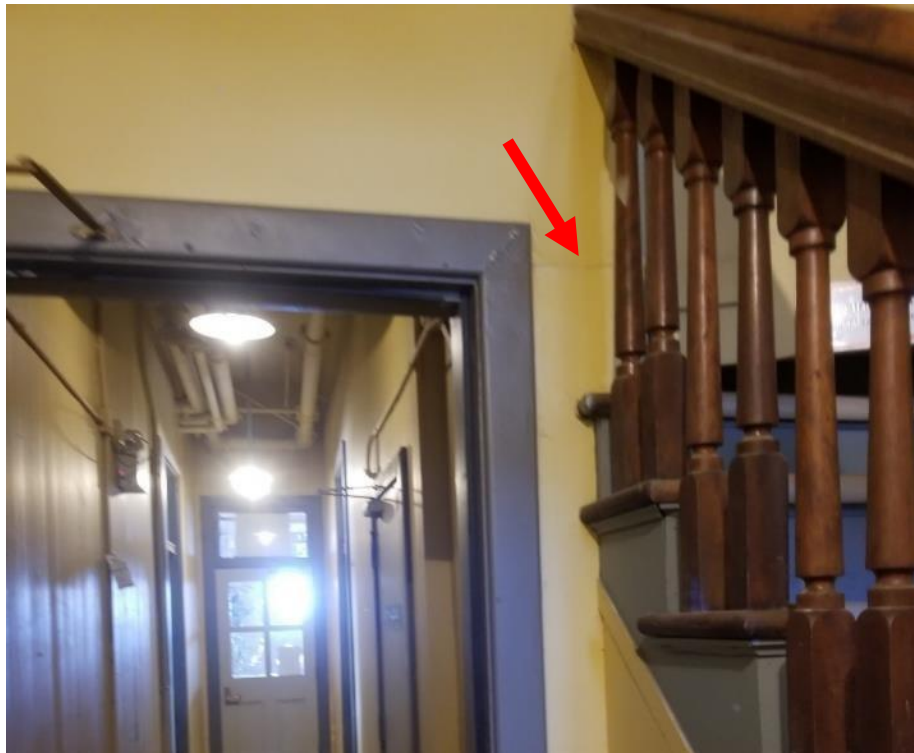
Photo 1. Ground floor, corridor/vestibule, <1 square metre fair condition drywall joint compound to the right of the door next to stairwell.

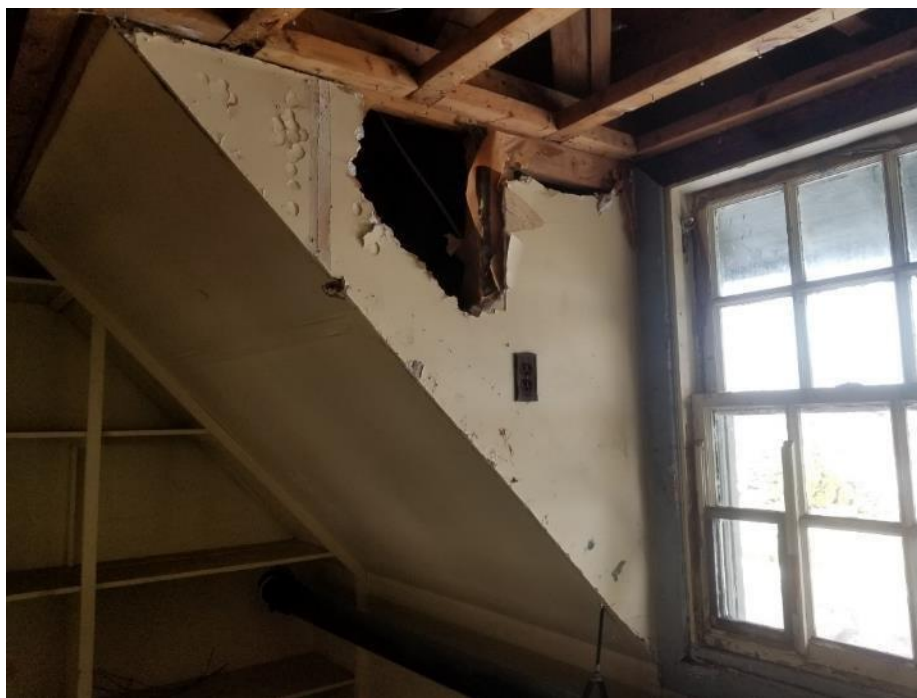
Photo 2. Third floor, storage room, 2 square metres poor condition drywall joint compound wall.

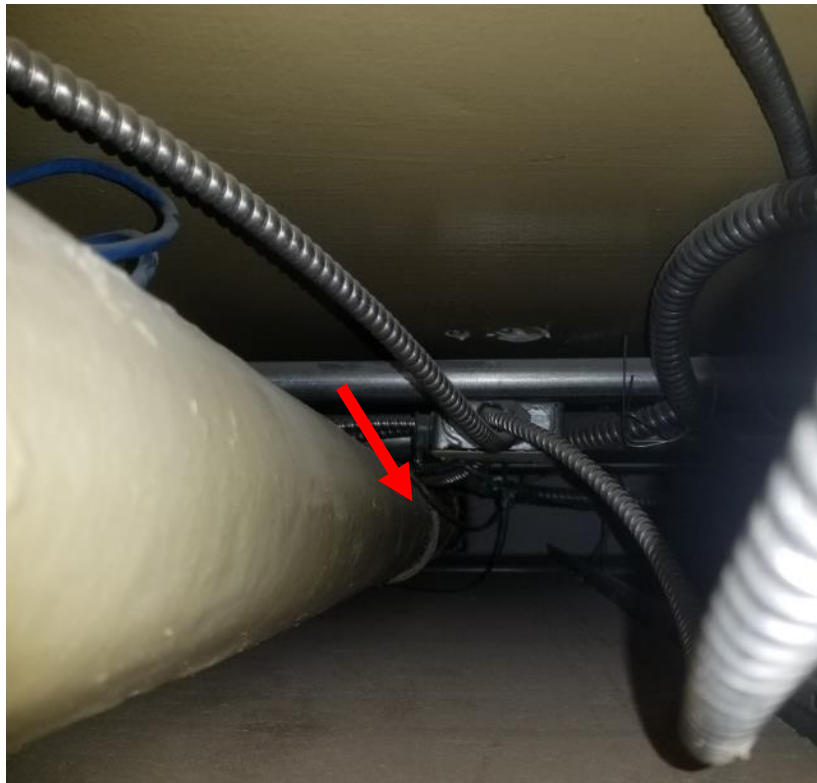
Photo 1. Basement, women's washroom, center of room, <1 linear metre poor condition thermal pipe insulation.

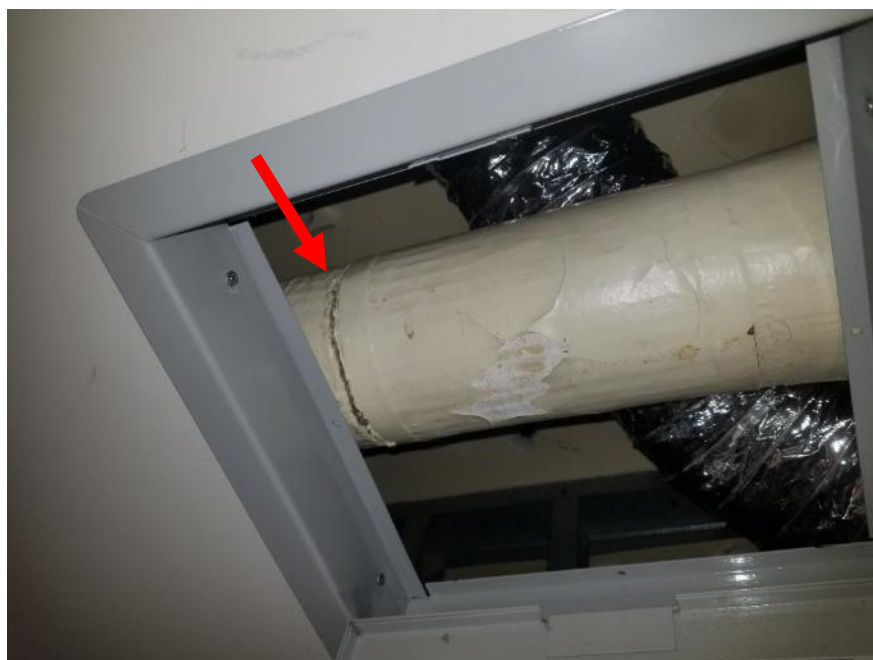
Photo 2. Basement, men's washroom, in ceiling hatch, <1 linear metre fair condition thermal pipe insulation.

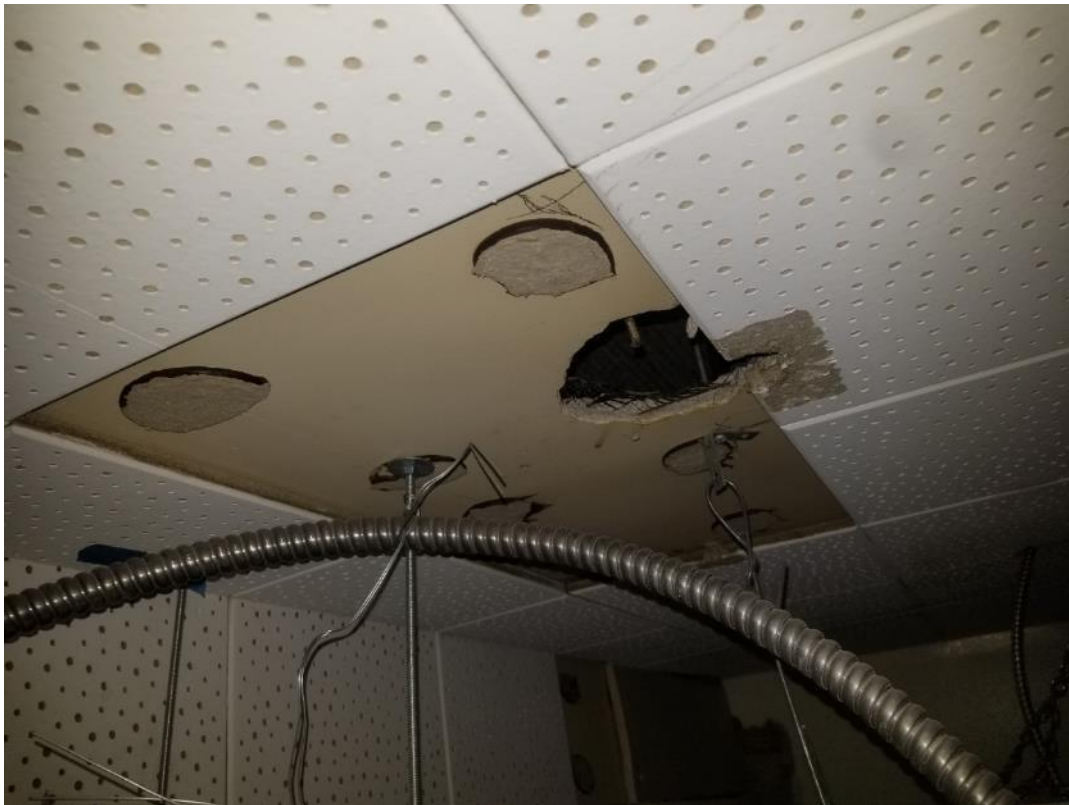
Photo 4. Second floor, room 201A, south side, <1 square metre (1 tile) in poor condition.

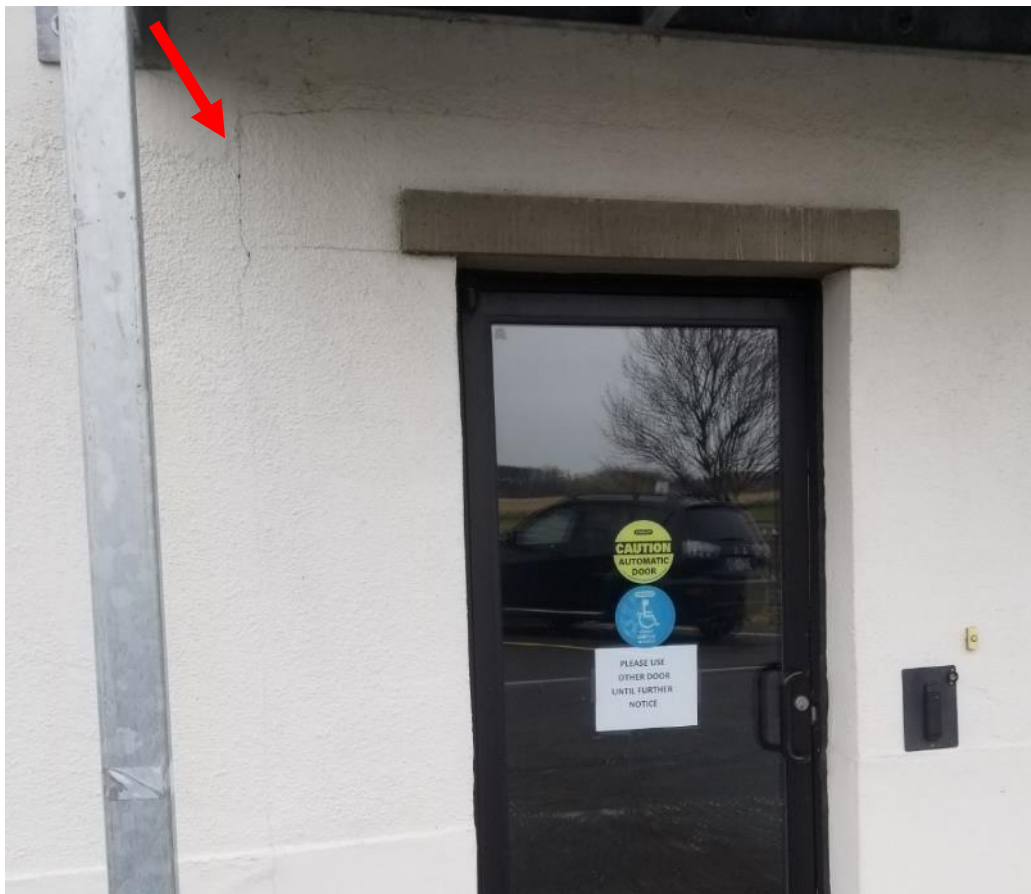
Photo 1. Exterior, west façade next to door, 1 metre fair condition texture coat on wall.

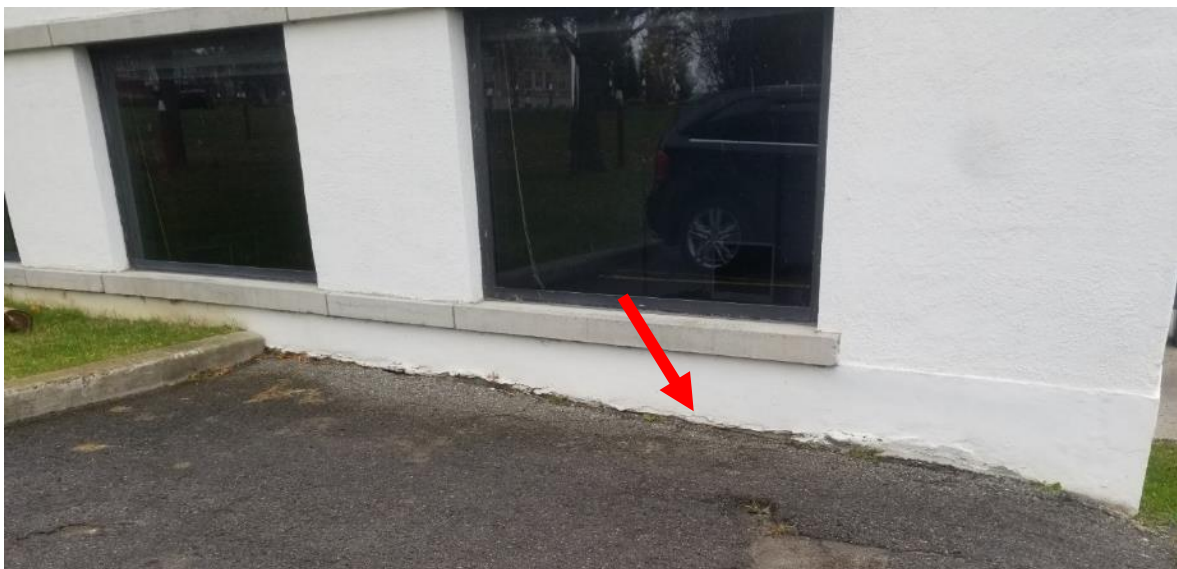
Photo 2. Exterior, north façade, 6 linear metres poor condition texture coat on wall.

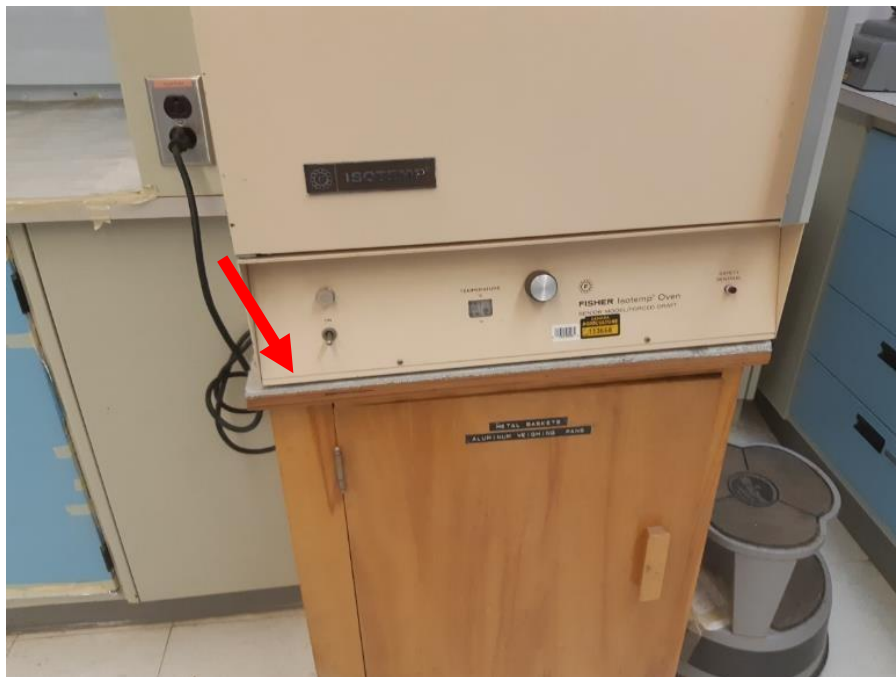
Photo 1. Ground floor, room 9 countertop, 2 linear metres fair condition transite.

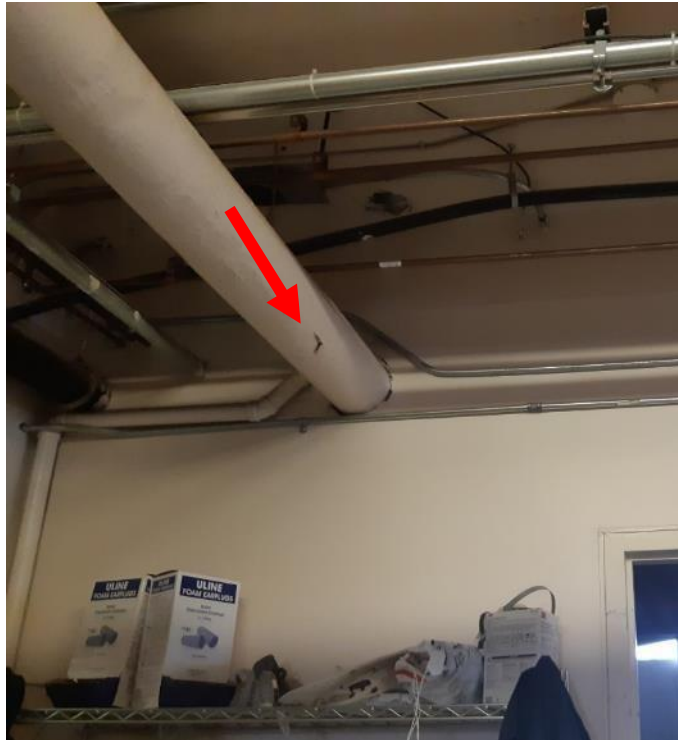
Photo 2. Basement, lab 12, on north wall to the west of room 14, <1 square metre fair condition Aircell.

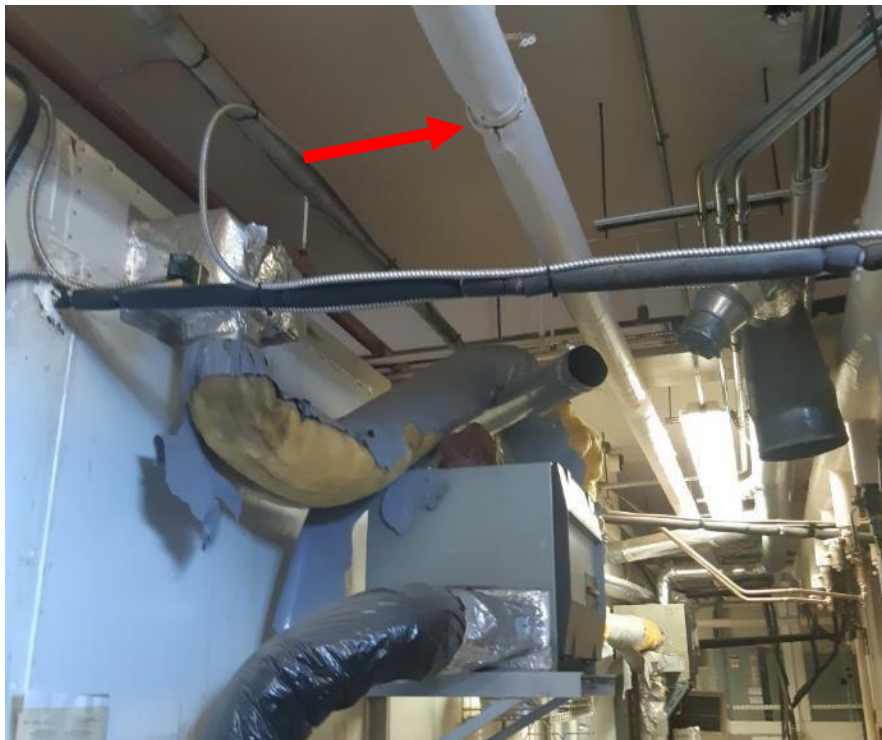
Photo 3. Basement, lab 15, along pipe above dehumidifier on north wall, <1 linear metre fair condition Aircell.

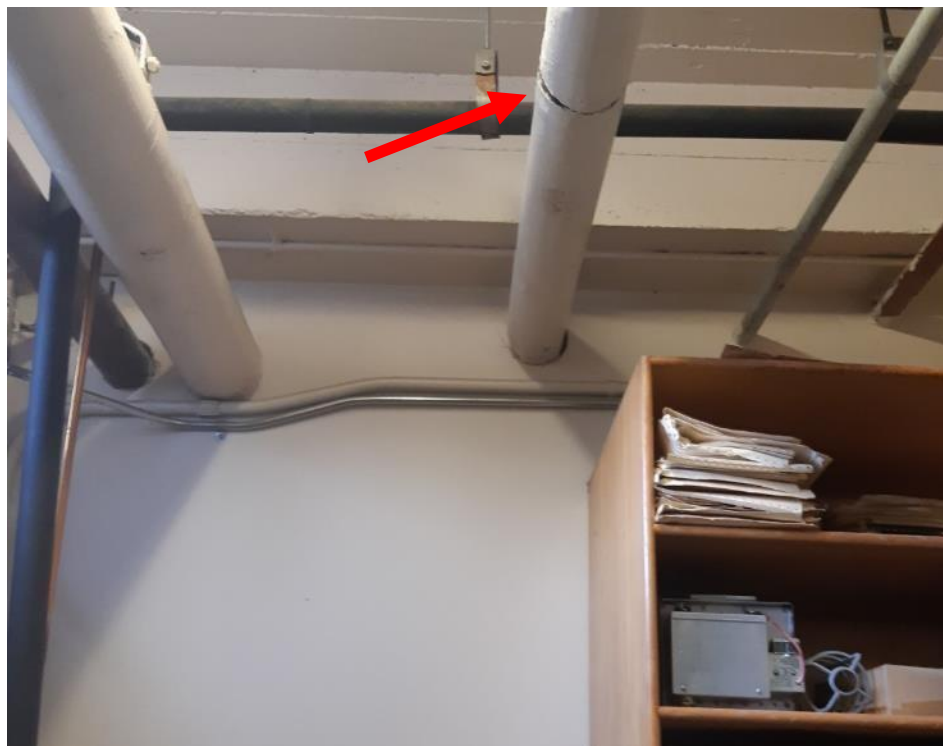
Photo 4. Basement, lab 15, along pipe above dehumidifier on north wall, <1 linear metre fair condition Aircell.

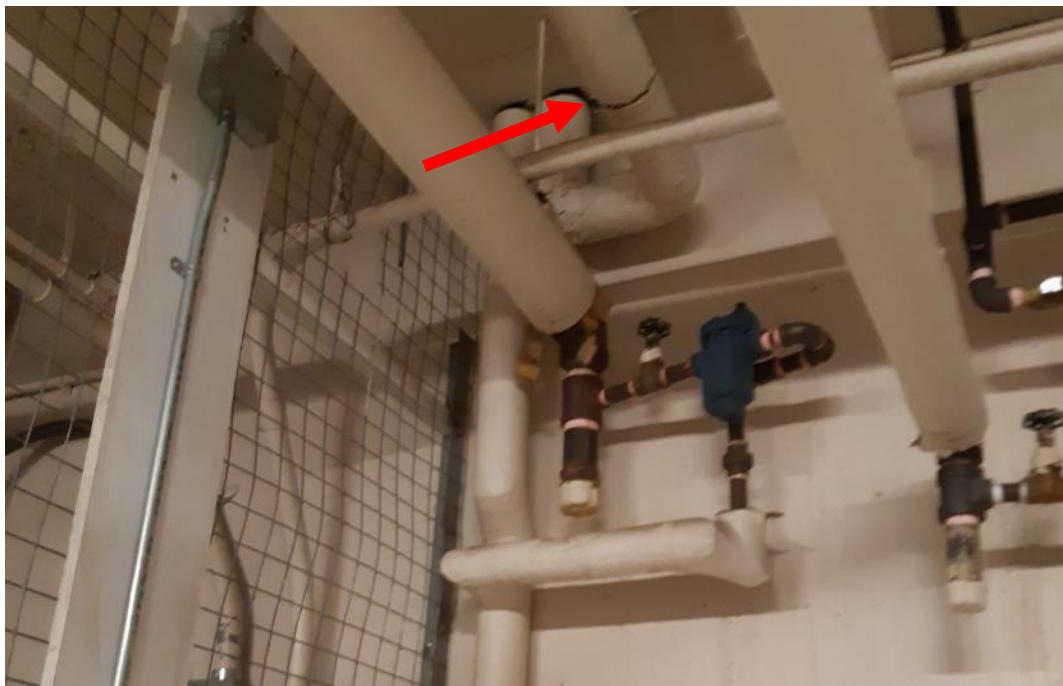
Photo 6. Basement, lab 15, north-west corner of room next to gated area, <1 linear metre fair condition Aircell.

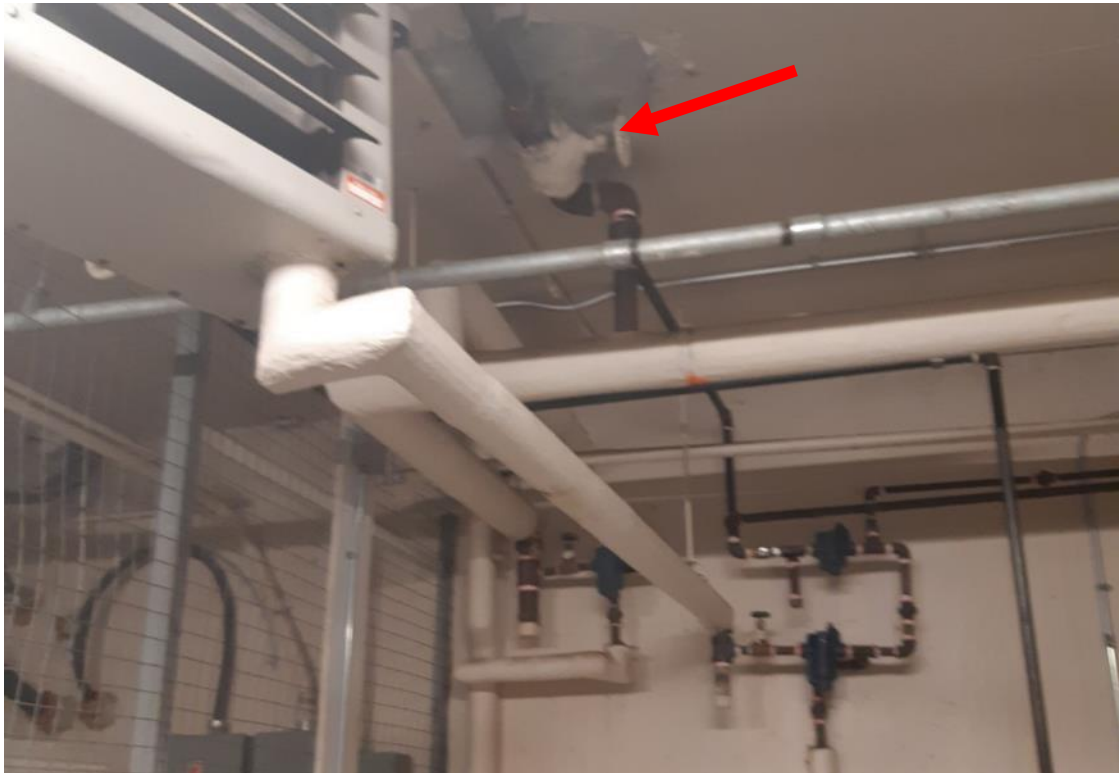
Photo 7. Basement, lab 15, north-west corner, 1 poor condition fitting.

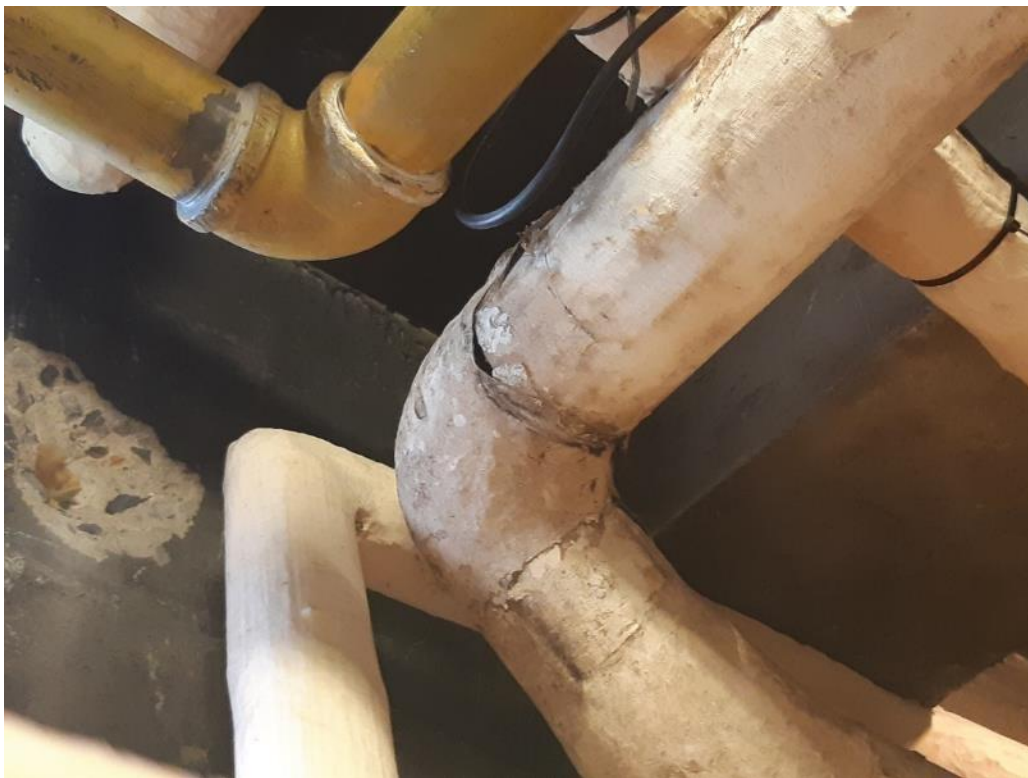
Photo 8. Basement, mechanical room, west wall, 1 fair condition fitting.

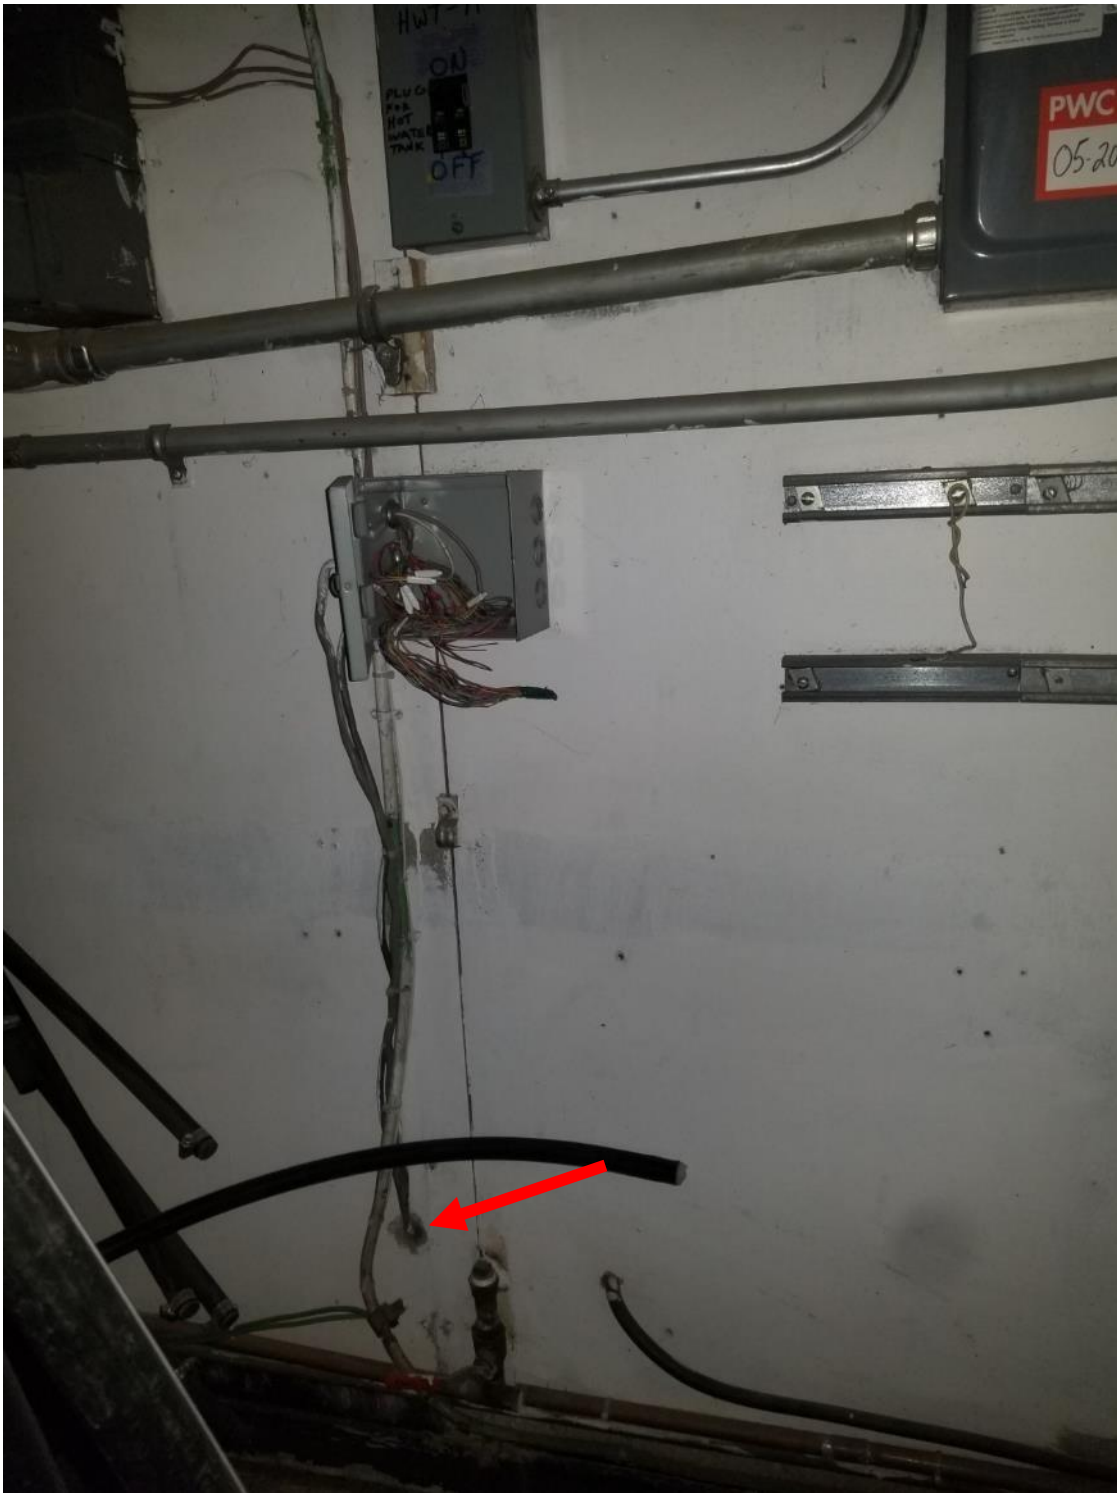
Photo 1. Main floor, storage room on north wall at pipe penetration under large ON/OFF switch, <1 square metre fair condition Transite on wall.

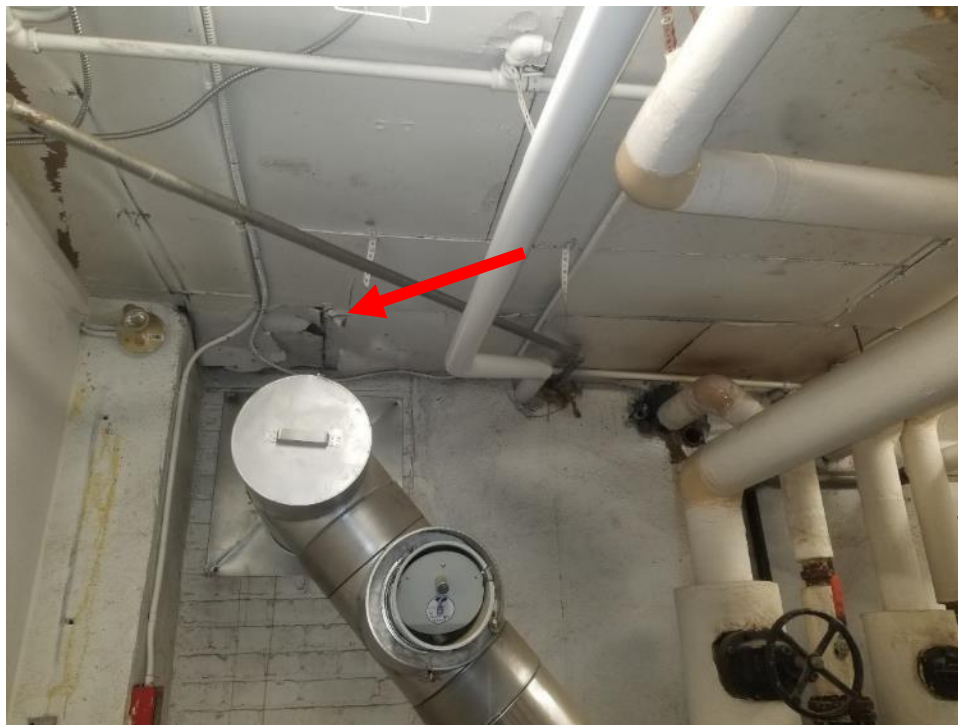
Photo 1. Basement, boiler room, west wall, 3 square metres poor condition Transite on ceiling.

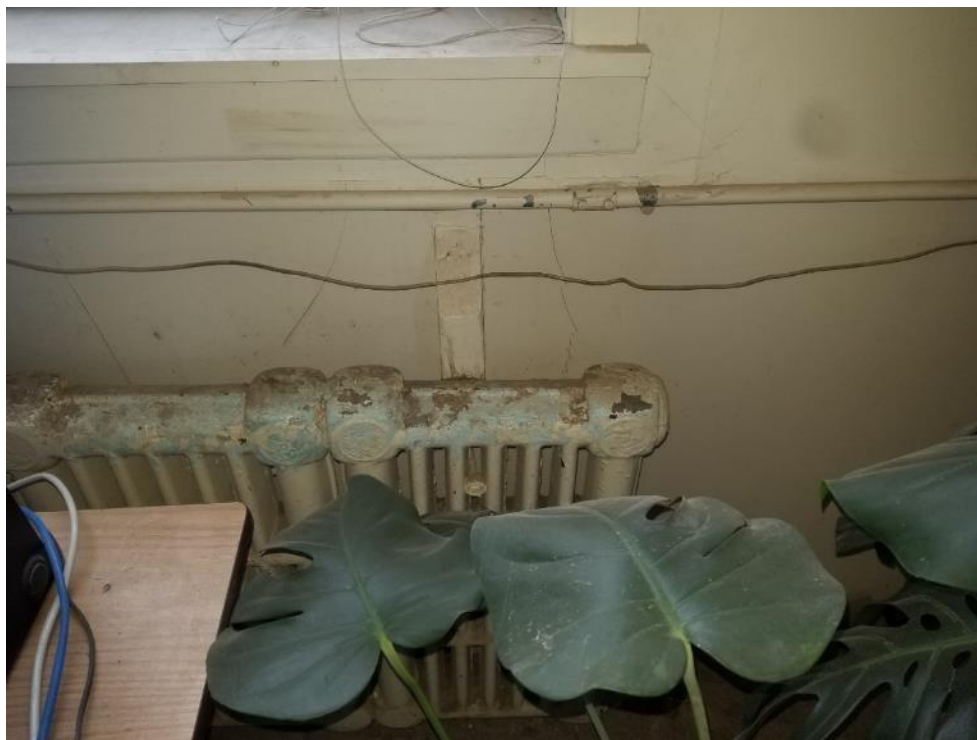
Photo 2. Ground floor, office 103, under north window, 1 square metre fair condition drywall joint compound wall.

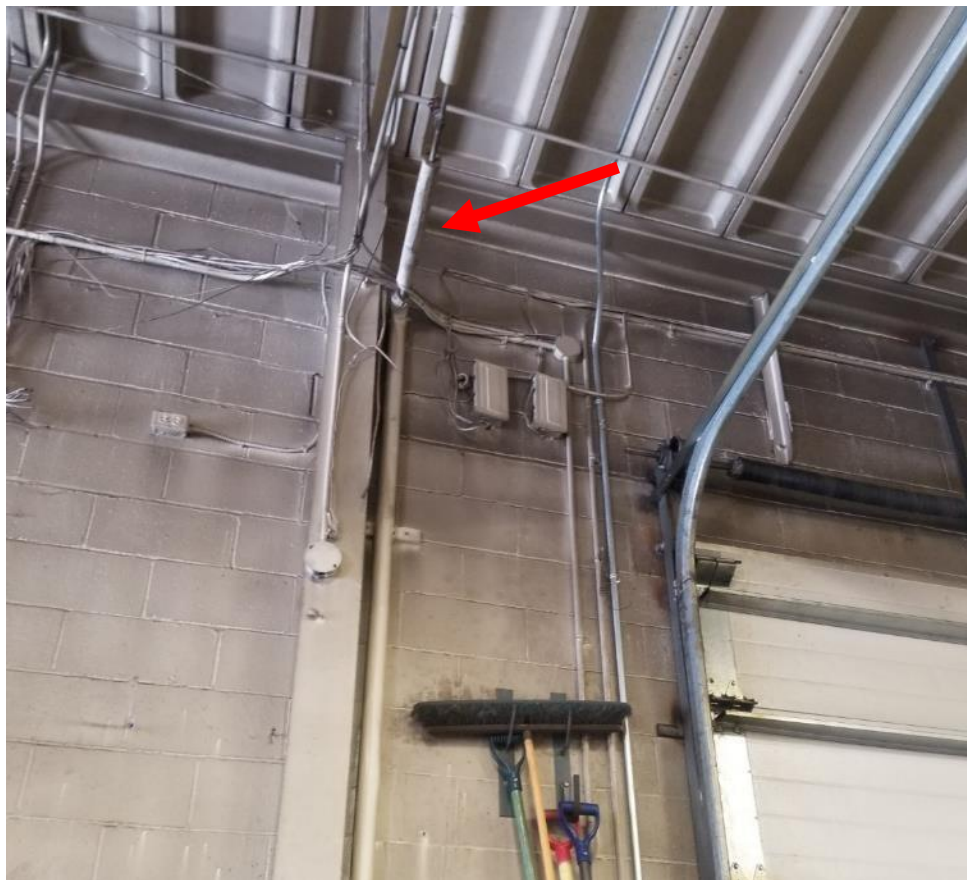
Photo 1. Ground floor, maintenance area, along west wall adjacent bay doors, 1 linear metre poor condition Aircell.
