ADDENDUM # 4

Solicitation Number: 19-1107

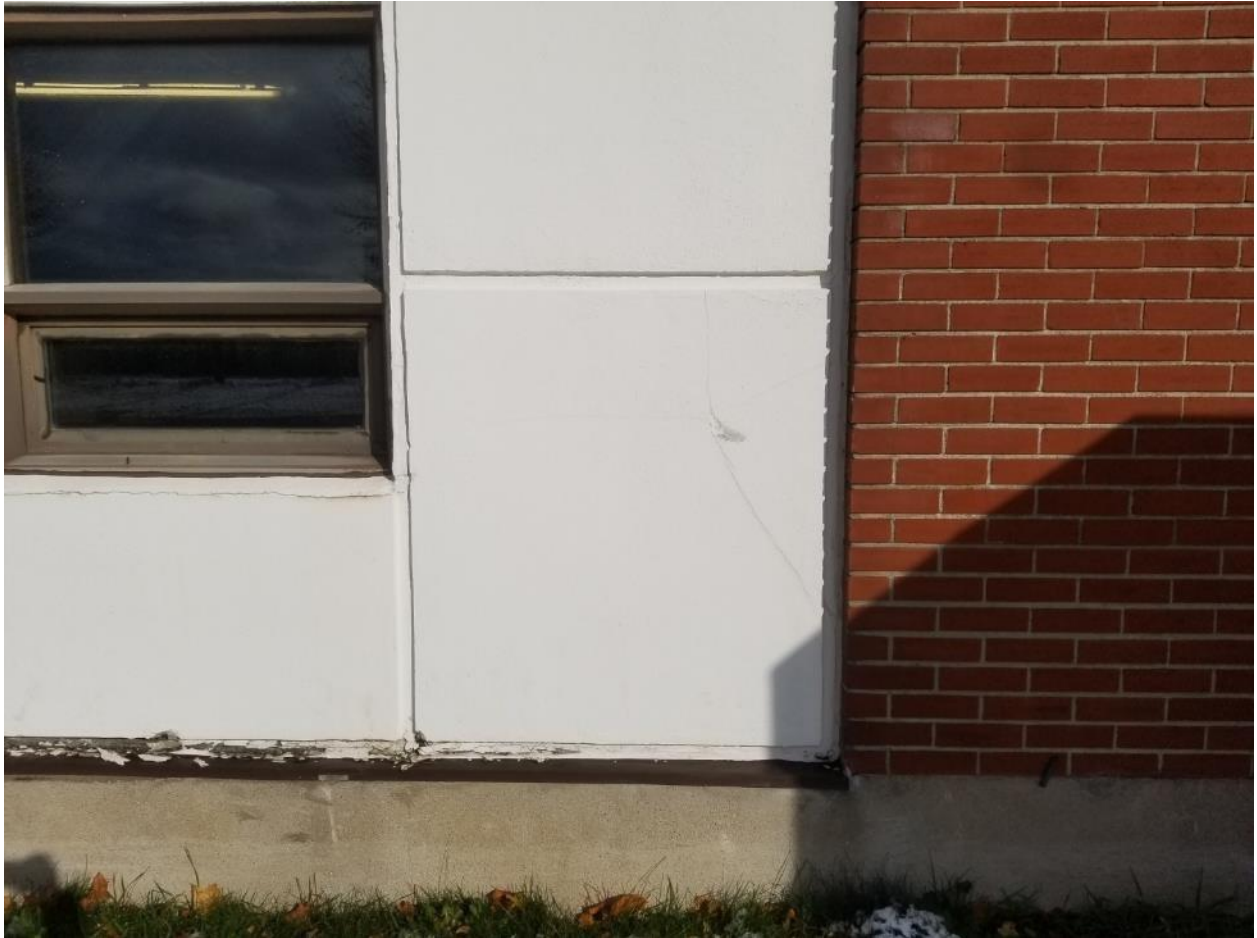
Photo 3. Exterior, south façade, east of first window, 1 square metre fair condition finish coat on wall.

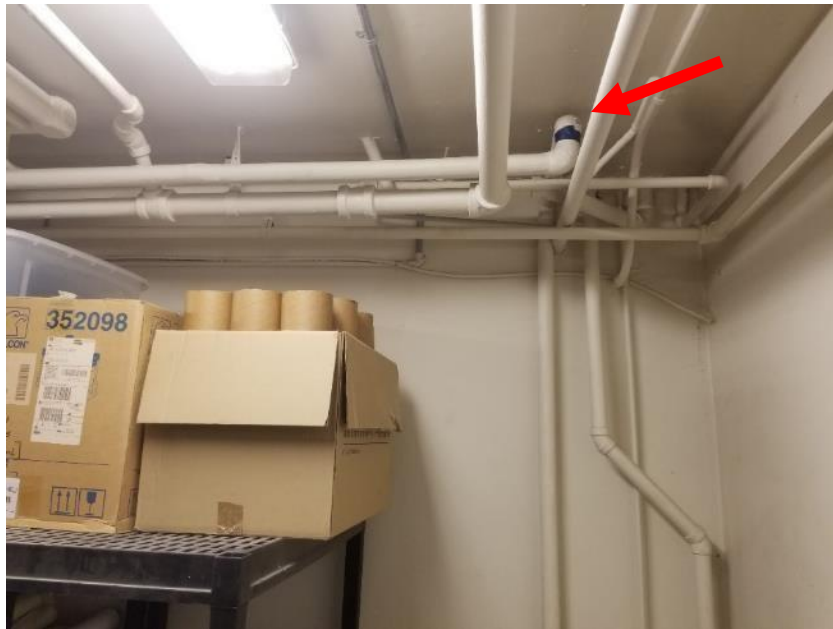
Photo 1. Basement, storage area, south-east corner, 1 poor condition fitting.

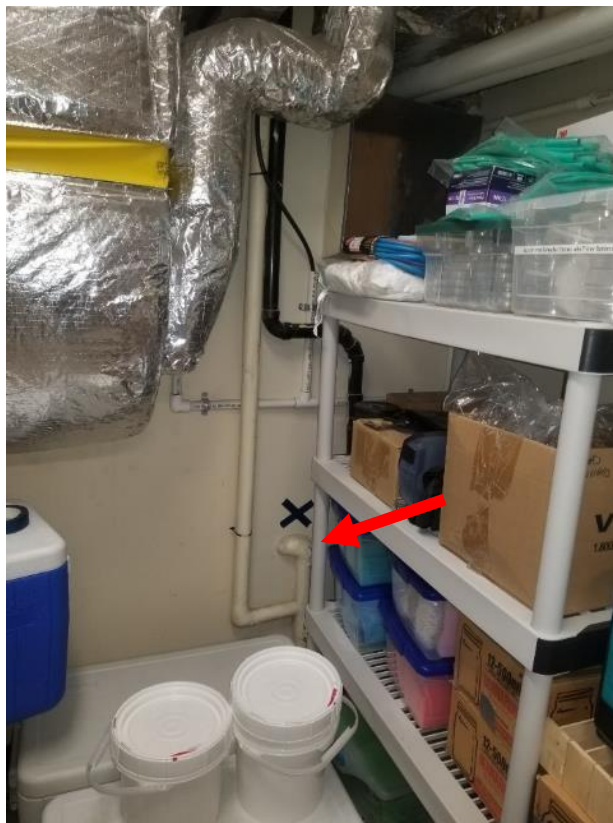
Photo 2. Ground floor, mechanical room, 1 poor condition fitting.

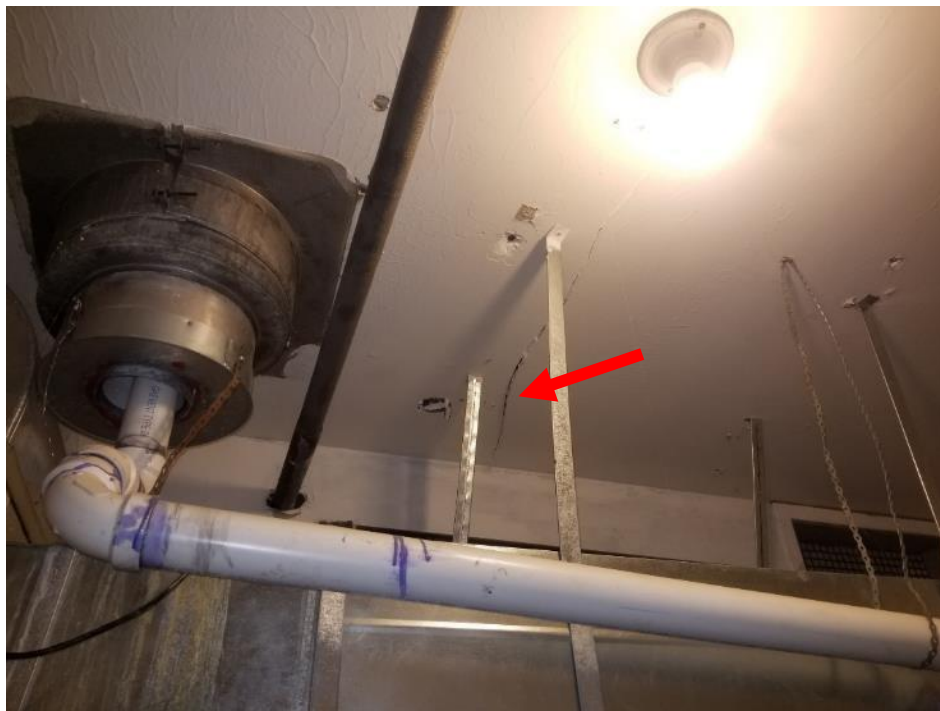
Photo 1. Ground floor, mechanical room ceiling, above duct, 1 square metre poor condition drywall joint compound.

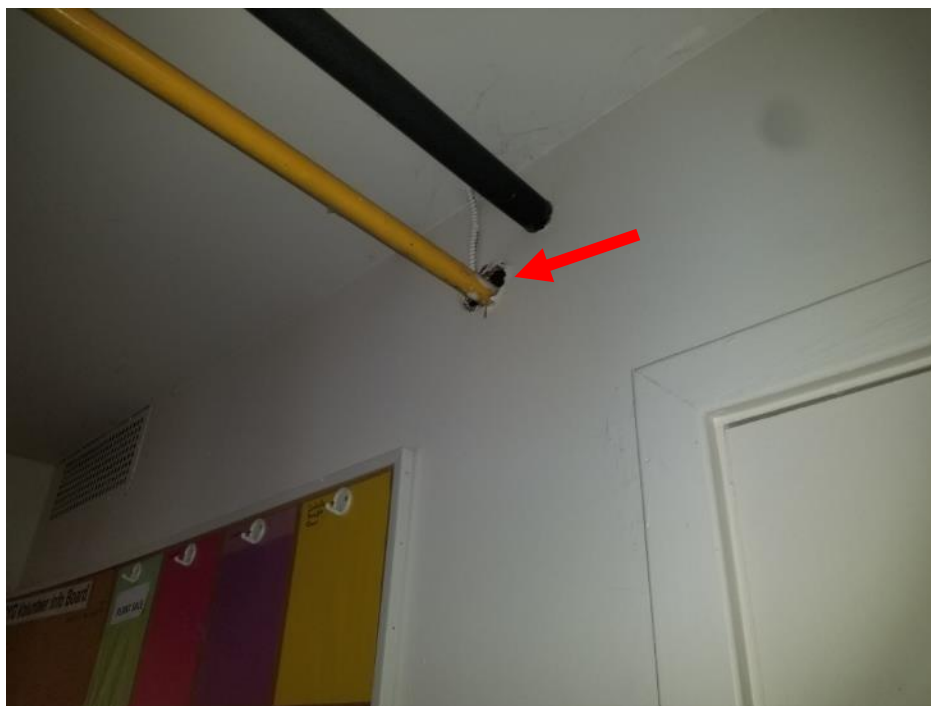
Photo 2. Ground floor, hall, east wall at yellow pipe penetration, <1 square metre poor condition drywall joint compound.

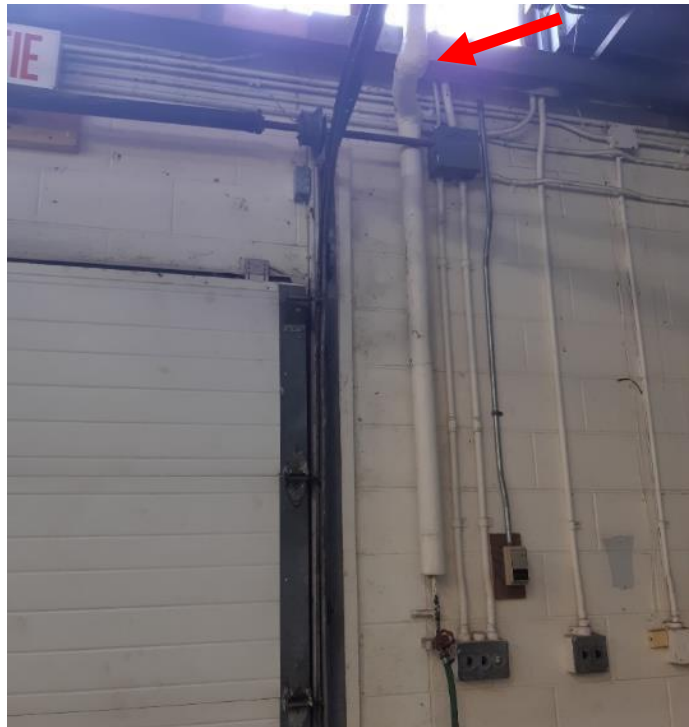
Photo 1. Ground floor, room 1, on east wall south of bay doors, 1 fair condition fitting.

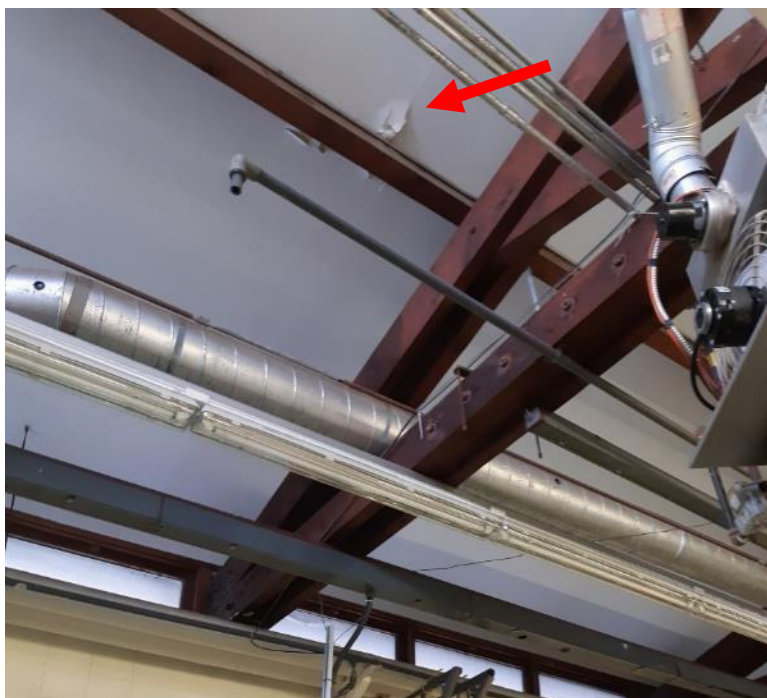
Photo 2. Ground floor, room 1, above growth unit #17, 1 square metre poor condition drywall joint compound.

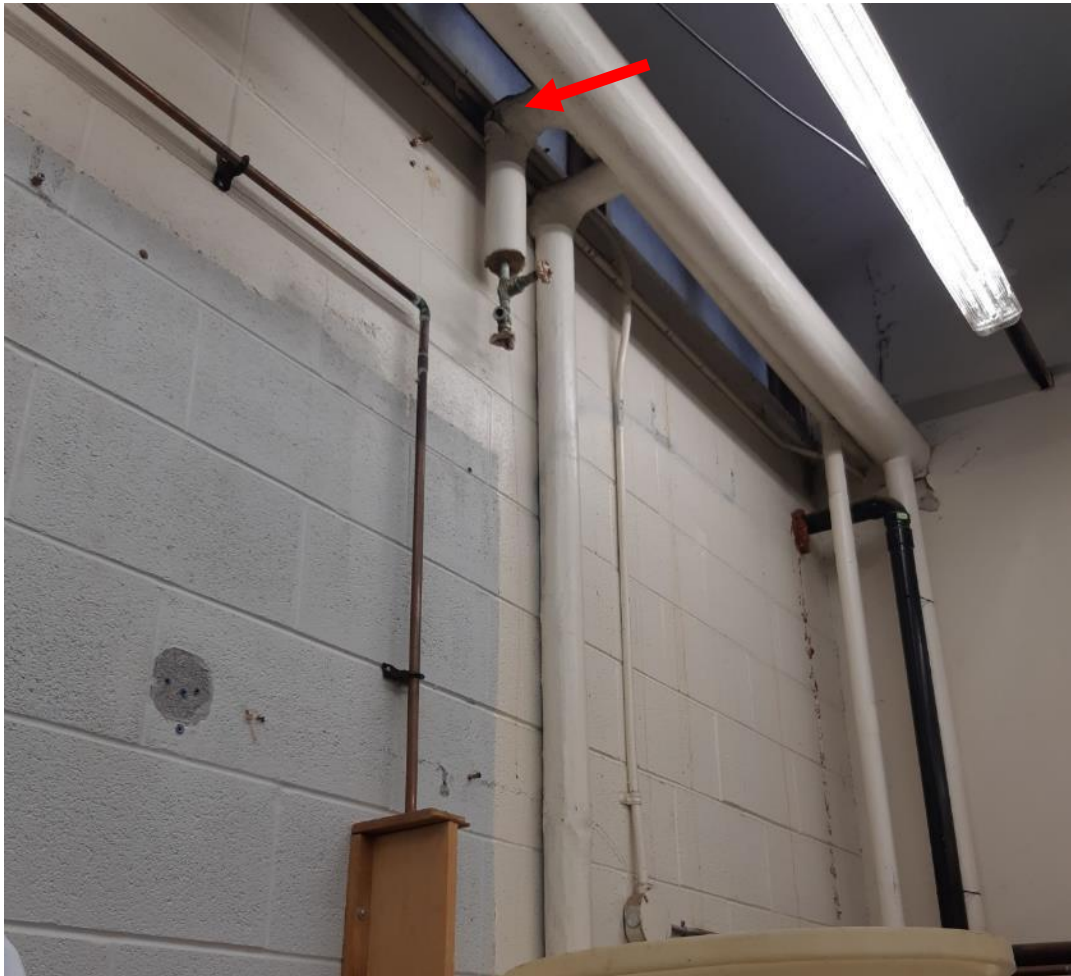
Photo 3. Ground floor, 2nd floor, south wall, 1 fair condition fitting.

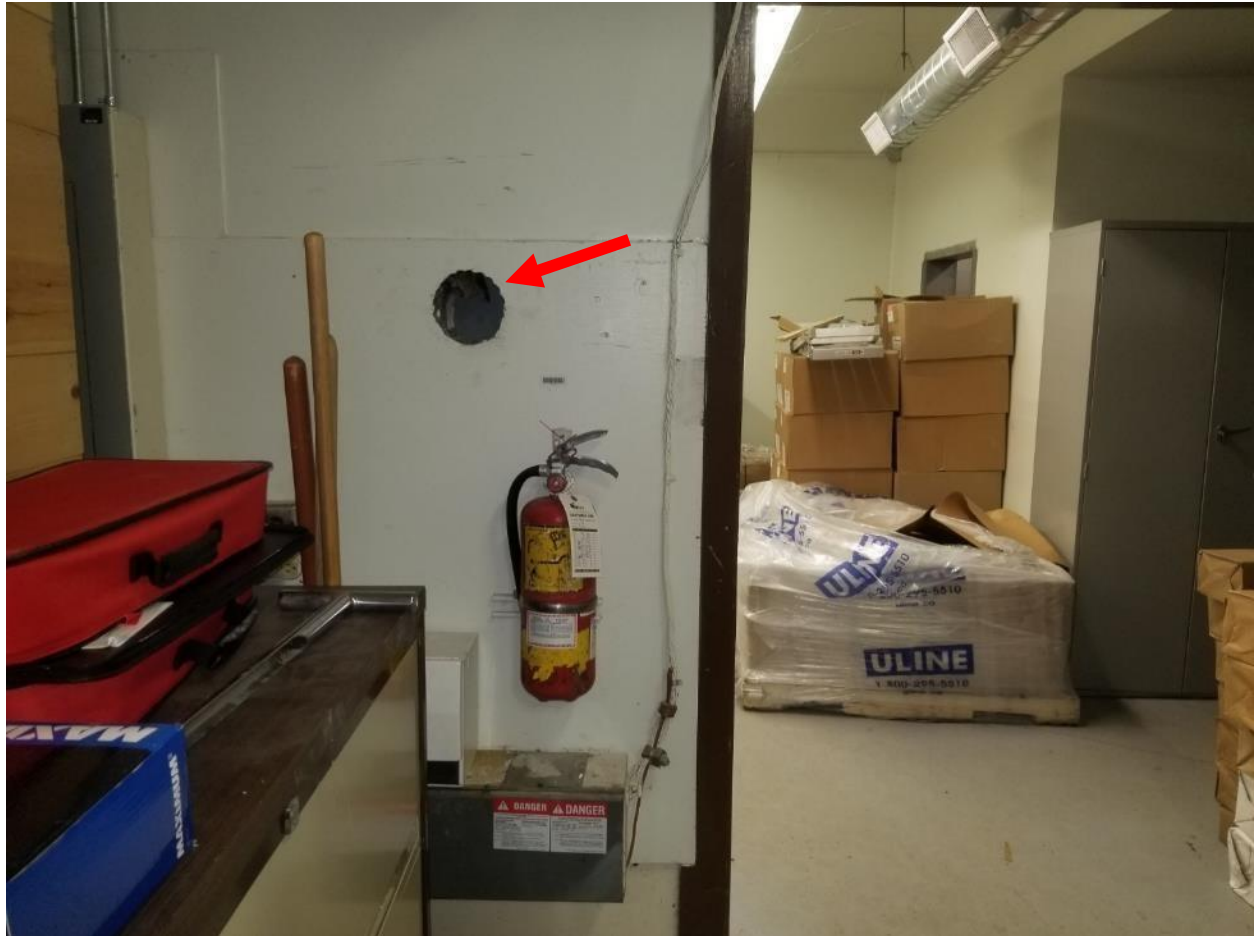
Photo 1. Ground floor, main room, north wall, <1 square metre fair condition Transite wall.

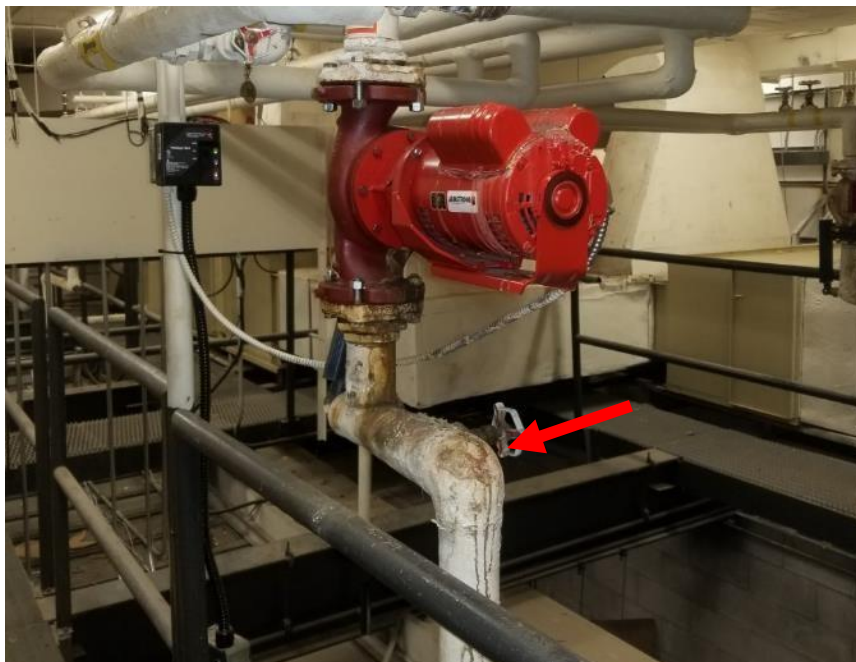
Photo 1. Mezzanine above boiler room, under red Armstrong machine, north-east side of room, 1 poor condition fitting.

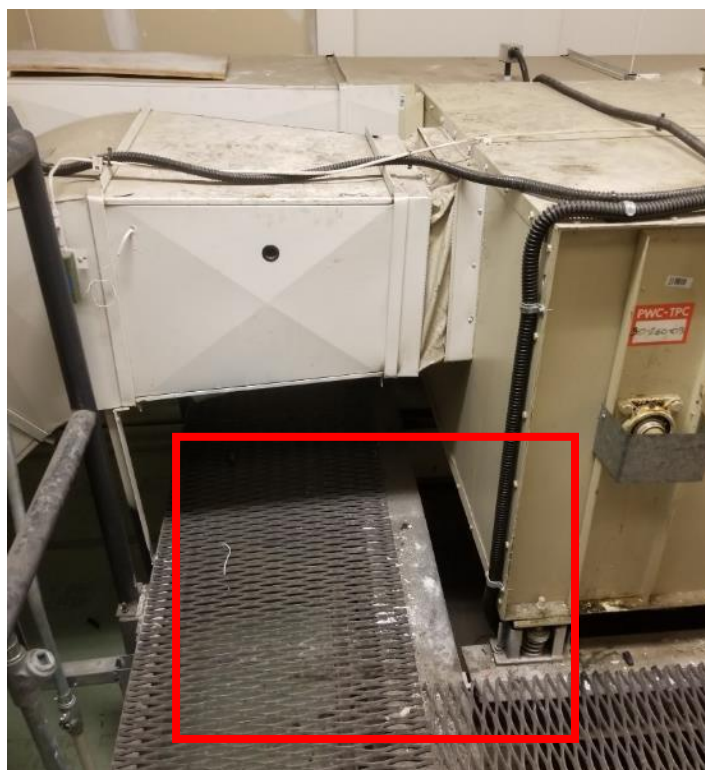
Photo 2. Mezzanine above boiler room, on catwalk, north-east corner, 1 square metre debris.

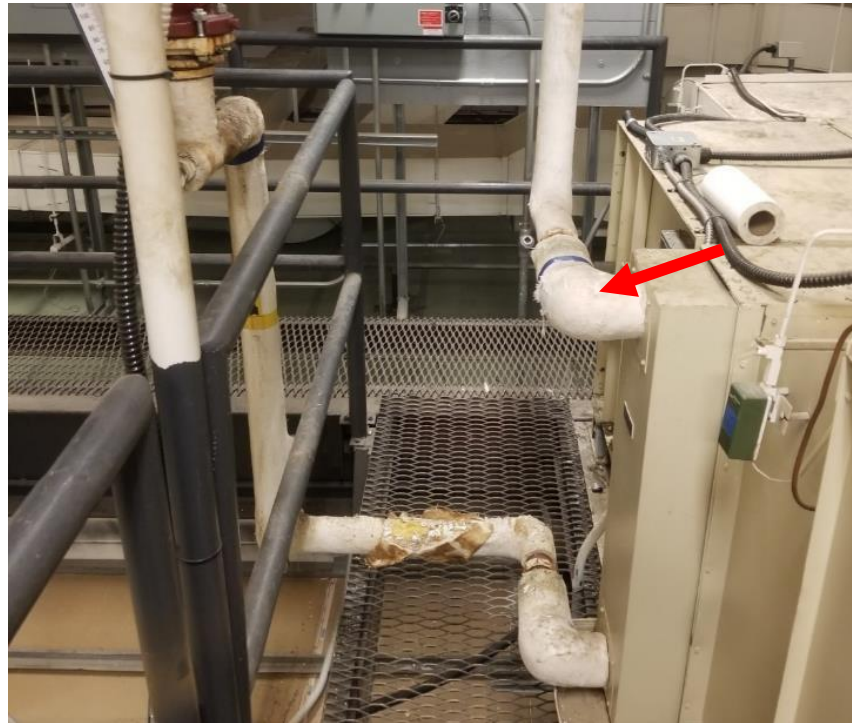
Photo 3. Mezzanine above boiler room, on AHU #3, north-east corner of room, 1 poor condition fitting.

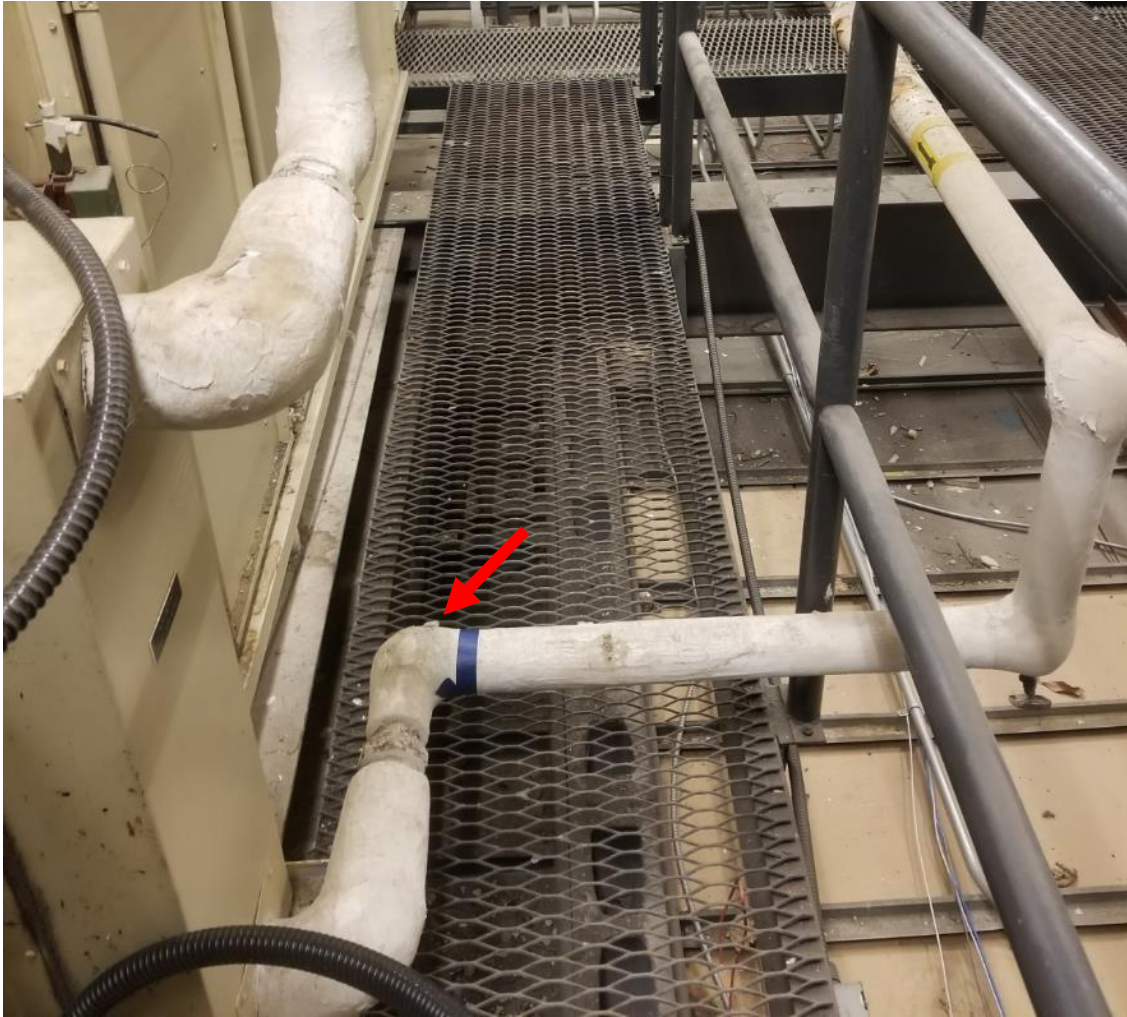
Photo 5. Mezzanine above boiler room, on catwalk, central-west, 1 fair condition fitting.
