## **ADDENDUM # 2**

*Solicitation Number: 19-1267*

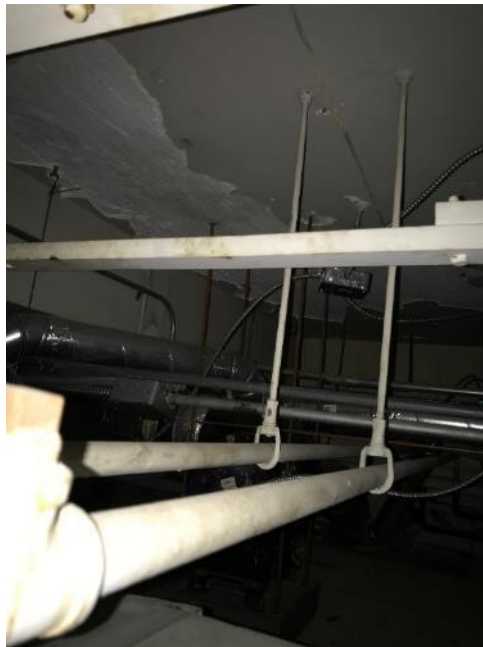
**Photo 1:** Room B-48, above ceiling tiles, Poor Condition Plaster and Debris

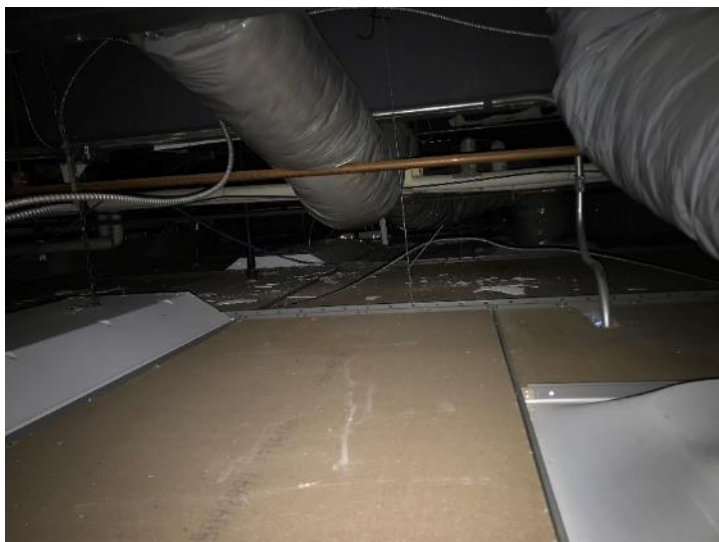
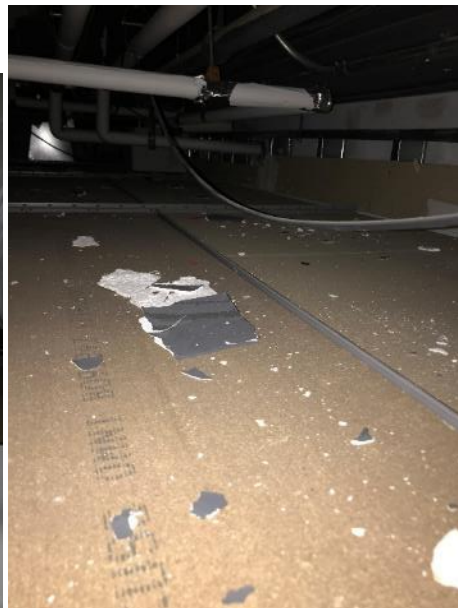
**Photos 2 & 3:** Rooms B577-B59, above ceiling tiles, Poor Condition Plaster and Debris

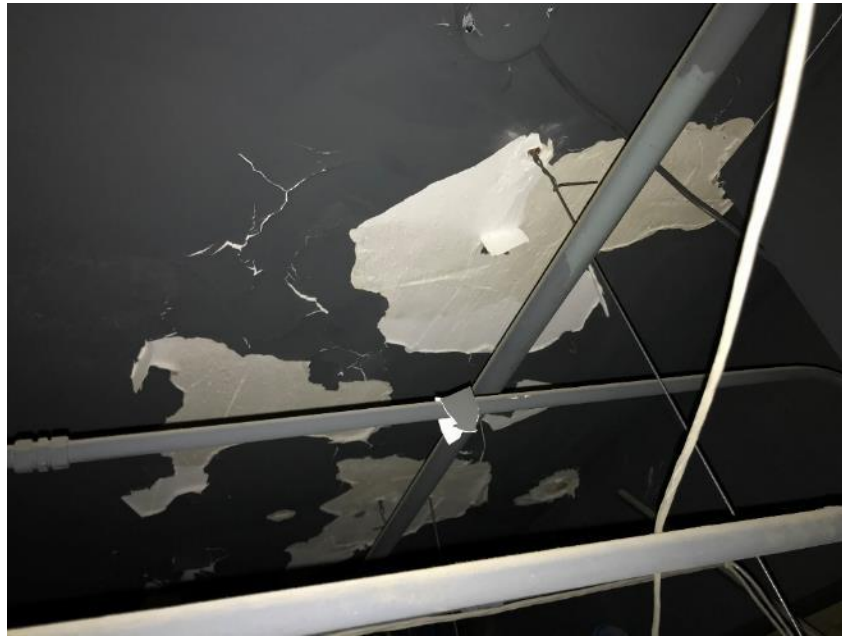
**Photo 4:** Room B58, Poor Condition Plaster above ceiling tiles

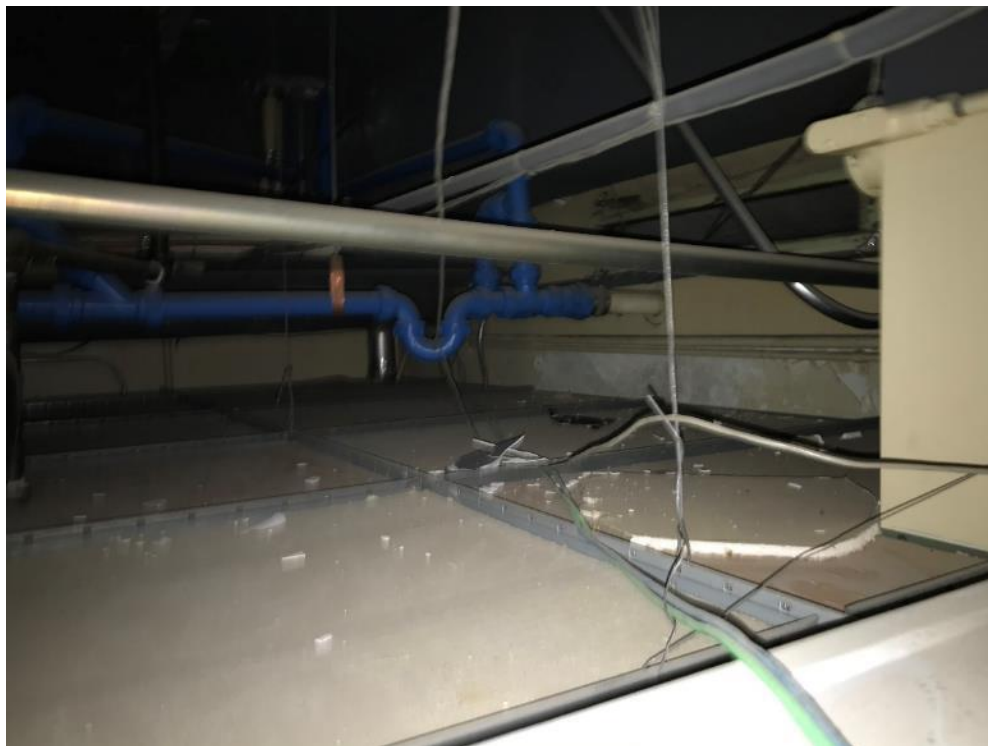
**Photo 5:** Room B58, Plaster Debris located on Ceiling tiles and lights

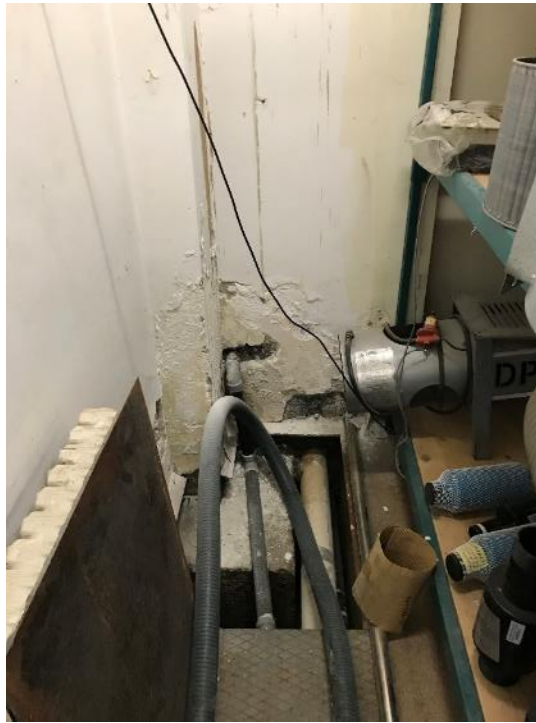
**Photo 6:** Room B61 Poor Condition Wall Plaster and Debris

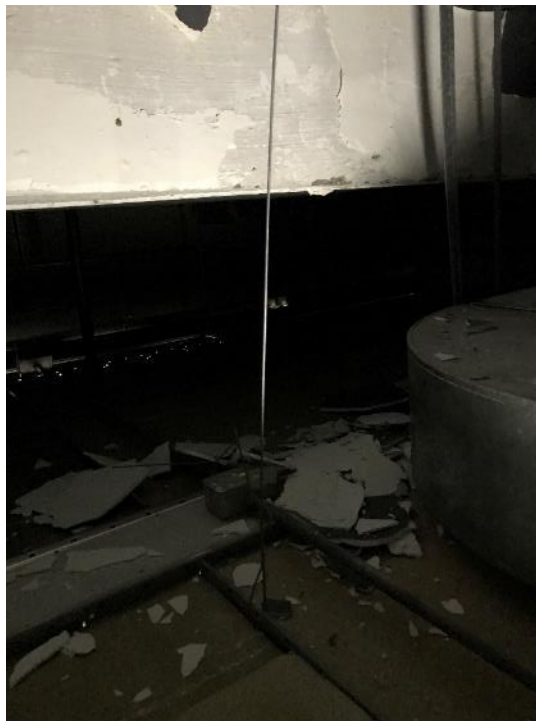
**Photo 7:** Room B71 and B71A Poor Condition Plaster and Debris located above and on Ceiling tiles

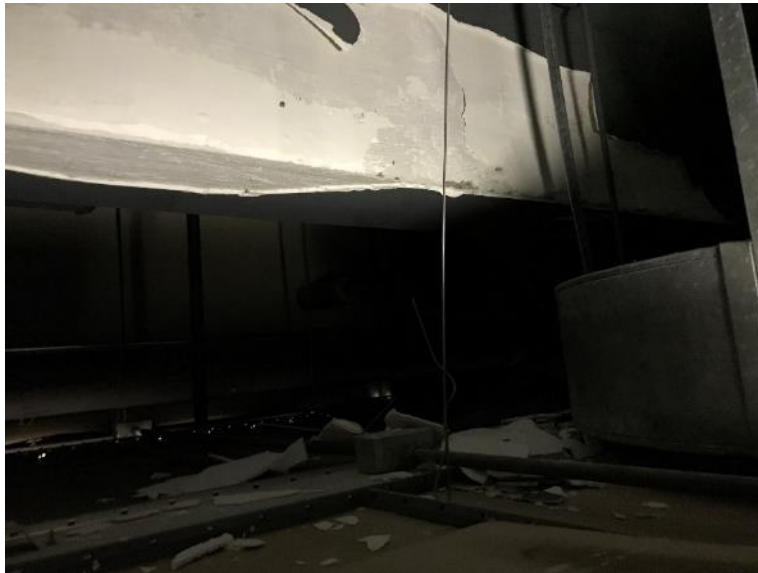
**Photo 8:** Room B71 and B71A Poor Condition Plaster and Debris located above and on Ceiling tiles

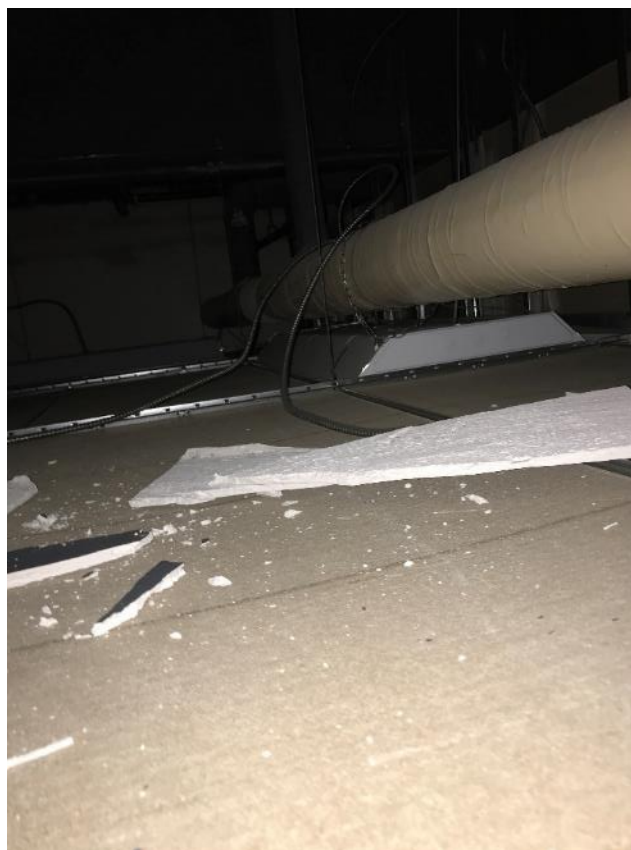
**Photo 9:** Room B84 Poor Condition Plaster and Debris located on Ceiling Tiles

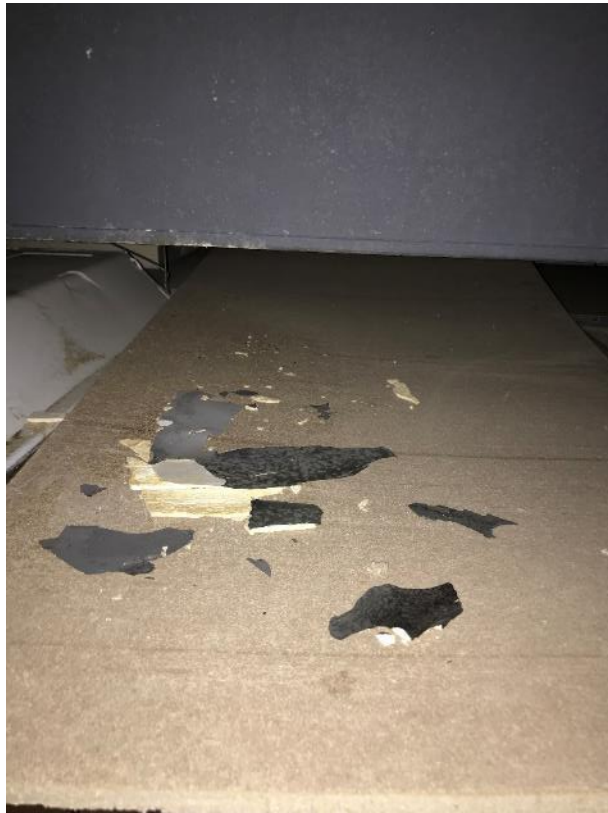
**Photo 10:** Room B85 Poor Condition Plaster and Debris located on Ceiling Tiles.

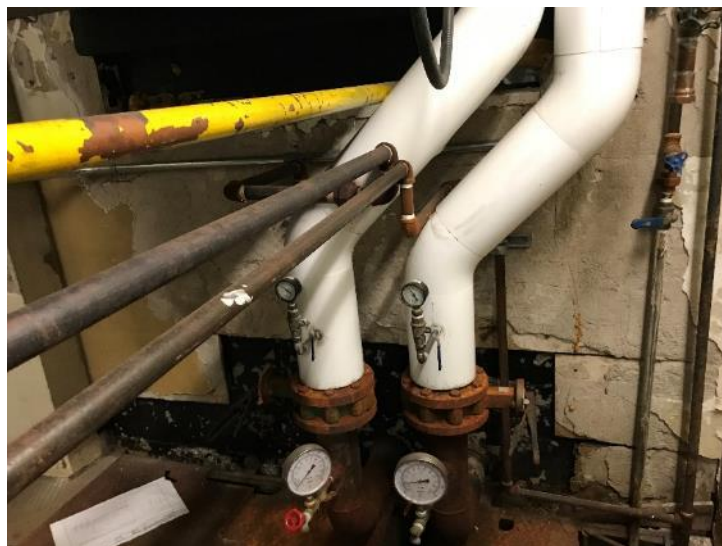
**Photo 11:** Room B86A Poor Condition Wall Plaster and Debris

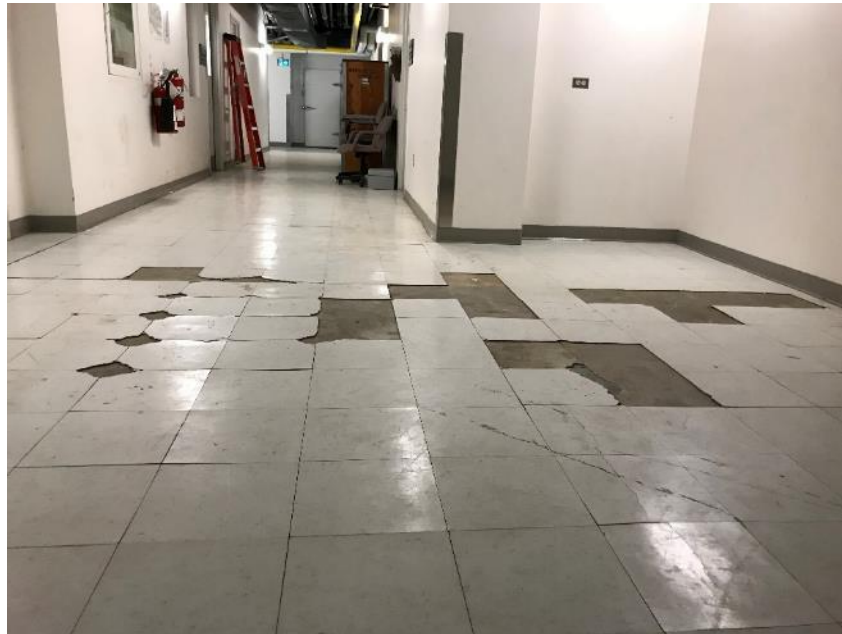
**Photo 12:** Corridor B85-B90 Poor Condition Vinyl Floor Tile

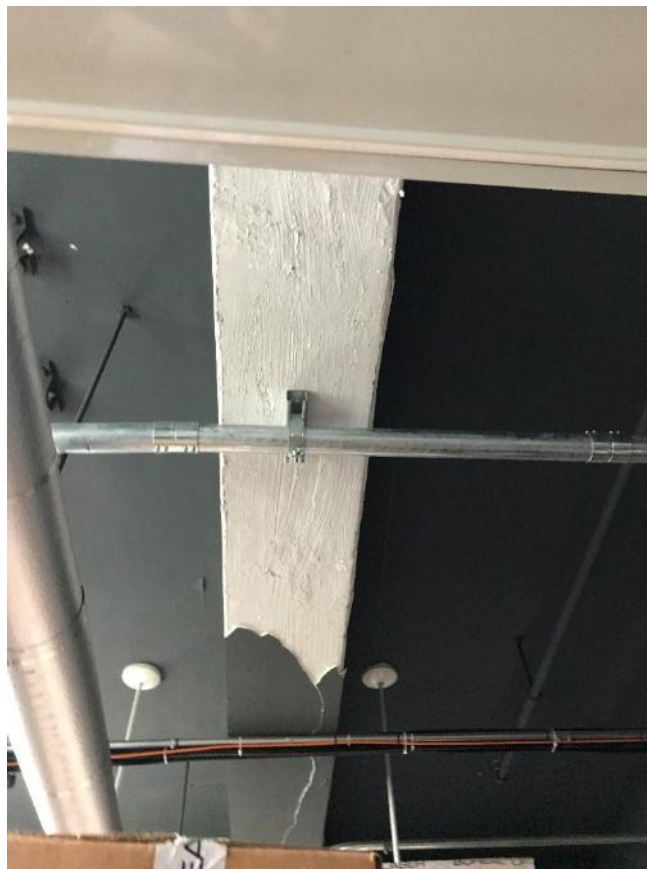
**Photo 13:** Room B87 Poor Condition Ceiling Plaster

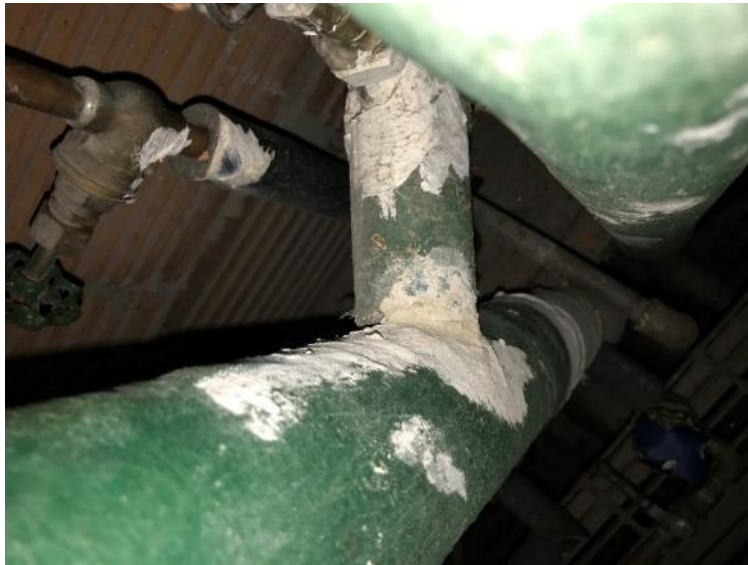
**Photo 14:** Pipe chase 1007-1009 Poor Condition Pipe Fitting and Aircell Pipe Insulation

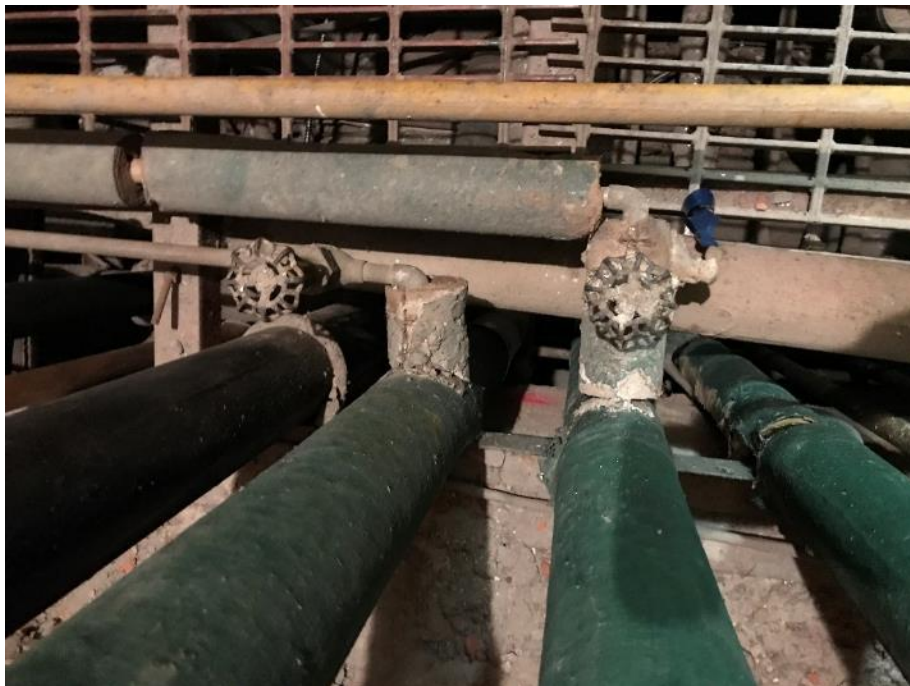
**Photo 15:** Pipe chase 1020-1022 Poor Condition Pipe Fittings and Debris

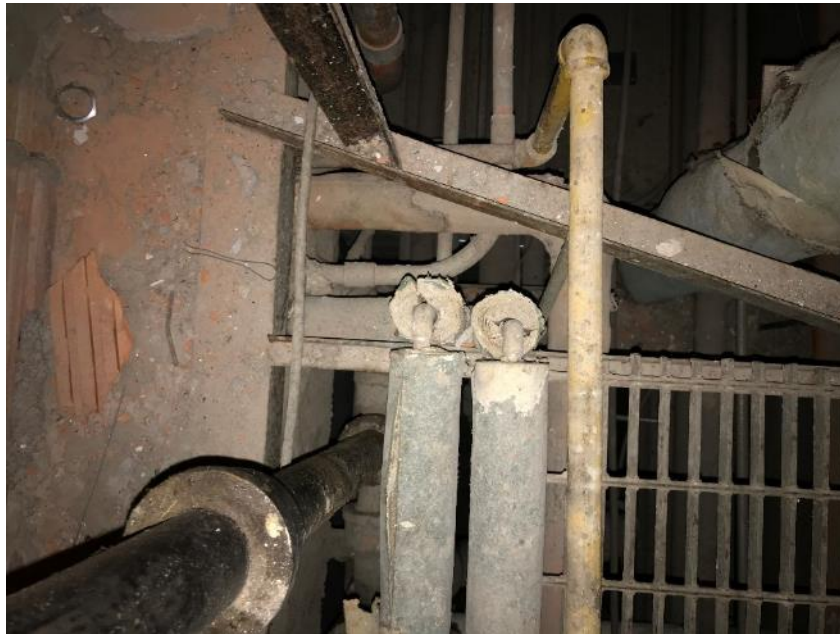
**Photo 16:** Pipe chase 1022-1024 Poor Condition Pipe Fittings

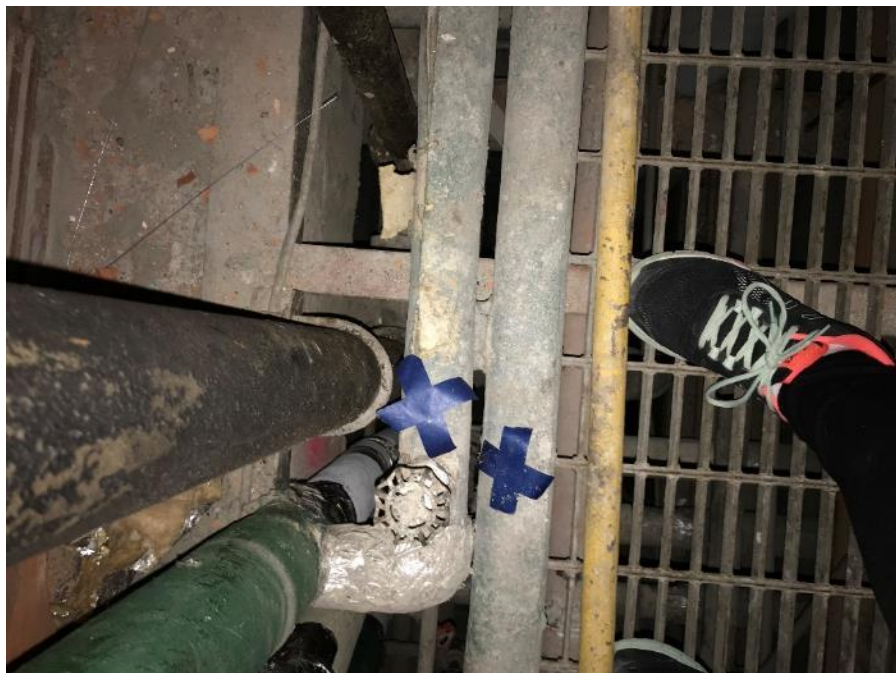
**Photo 17:** Pipe chase 1022-1024 Poor Condition Pipe Fittings and Aircell Pipe Insulation

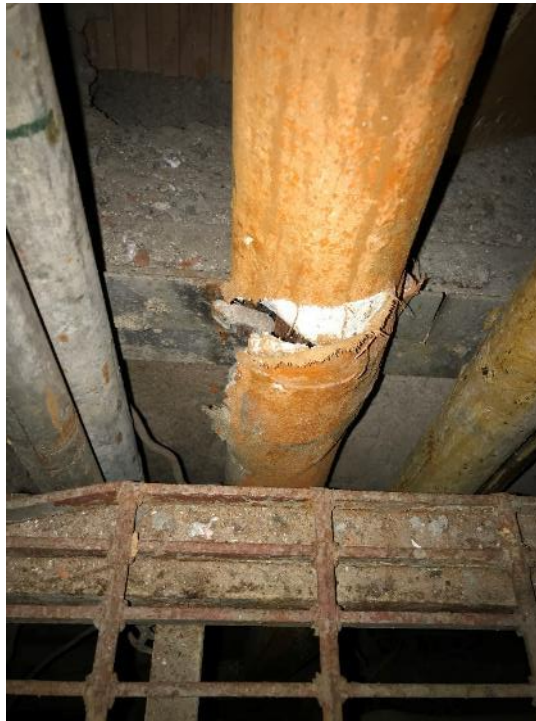
**Photo 18:** Pipe chase 1043-1045 Poor Condition Aircell Pipe Insulation

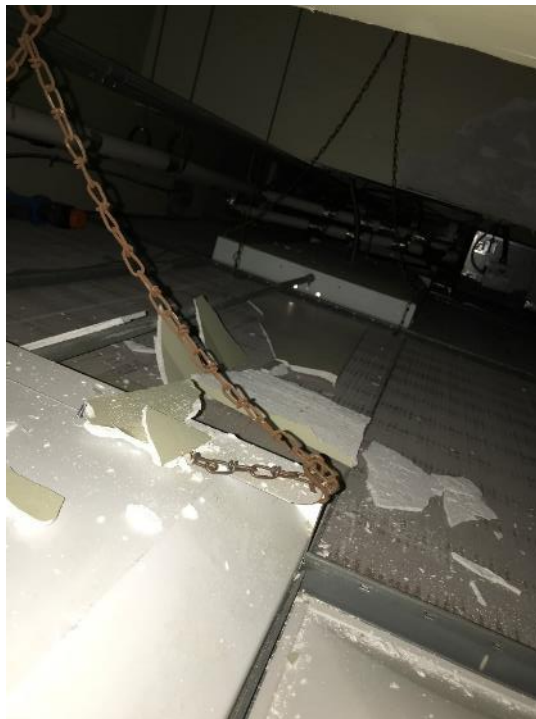
**Photo 19:** Room 1059, Poor Condition Ceiling Plaster and Plaster Debris located on Ceiling Tiles

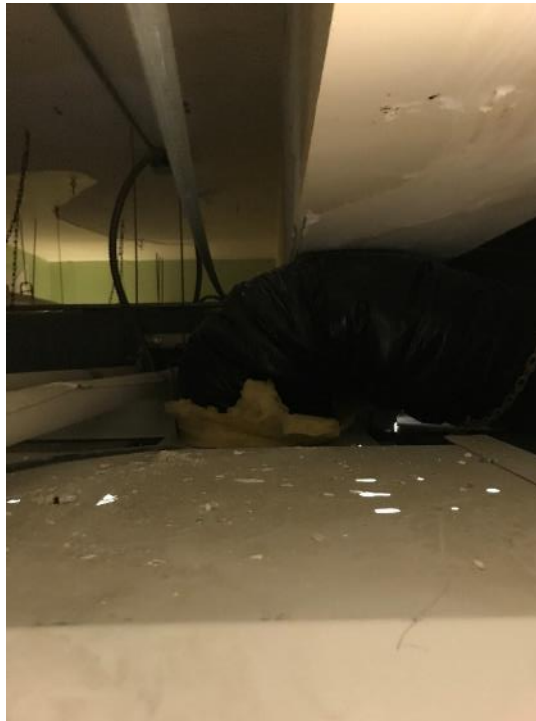
**Photo 20:** Room 1061A, Poor Condition Ceiling Plaster and Plaster Debris

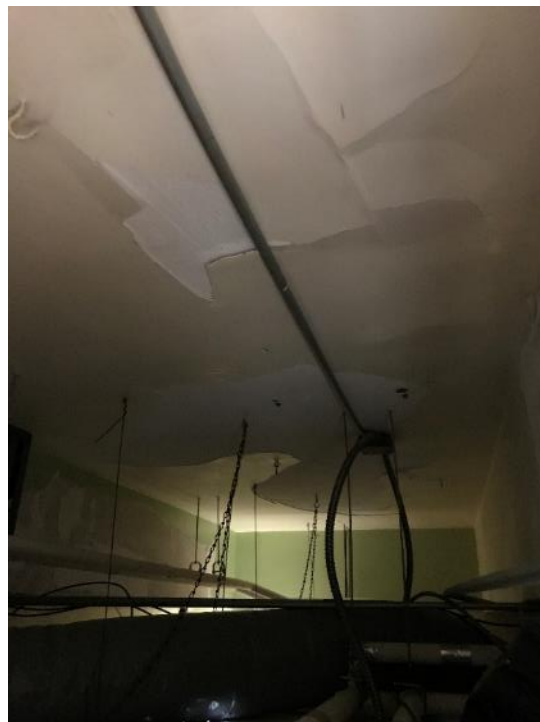
**Photo 21:** Room 1061A, Poor Condition Ceiling Plaster and Plaster Debris

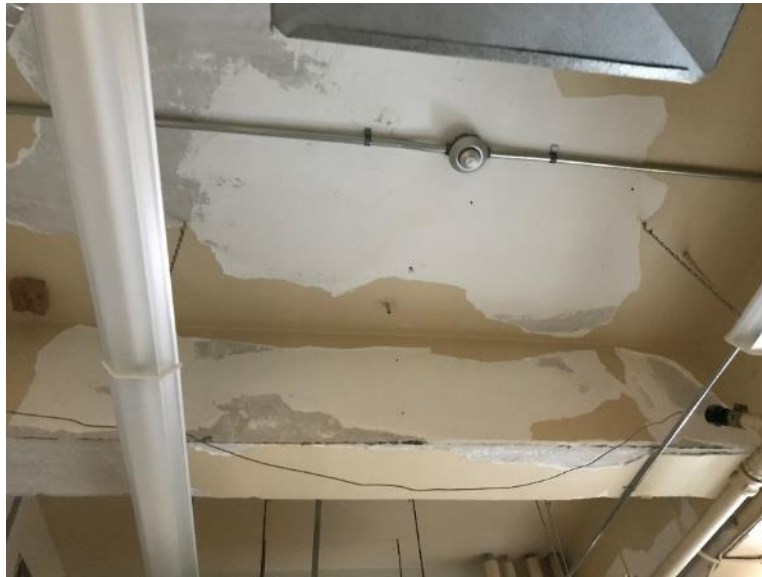
**Photo 22:** Room 1065A, Poor Condition Ceiling Plaster

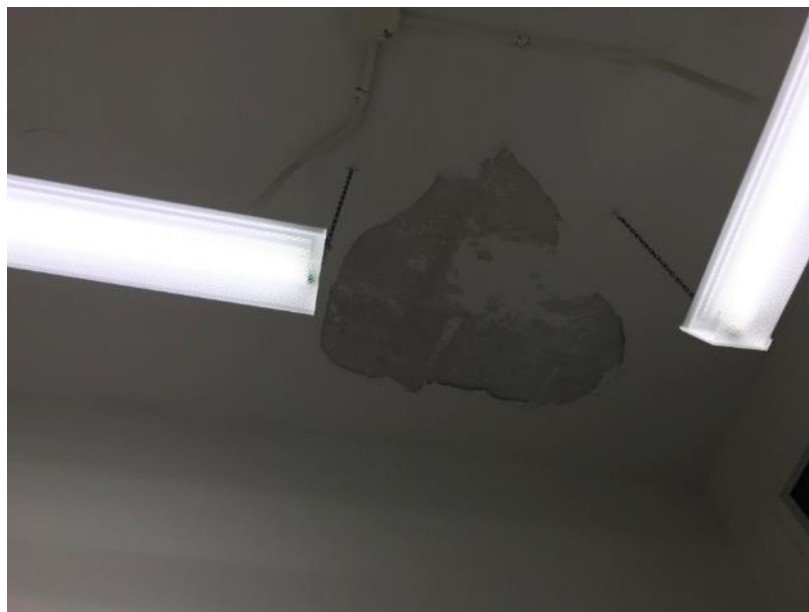
**Photo 23:** Room 1065B, Poor Condition Ceiling Plaster

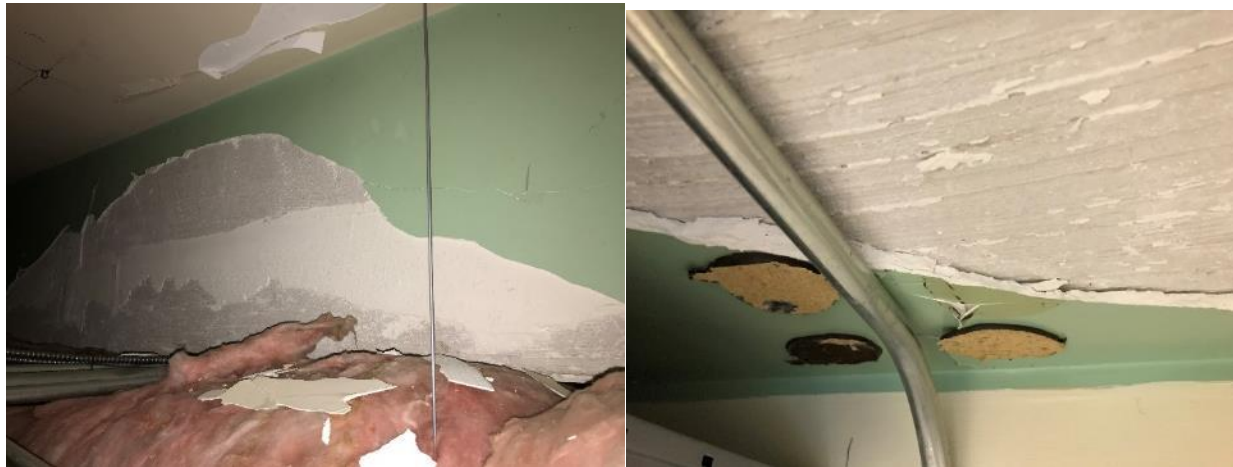
**Photos 24 & 25:** Room 1079, Poor Condition Ceiling Plaster and Plaster Debris

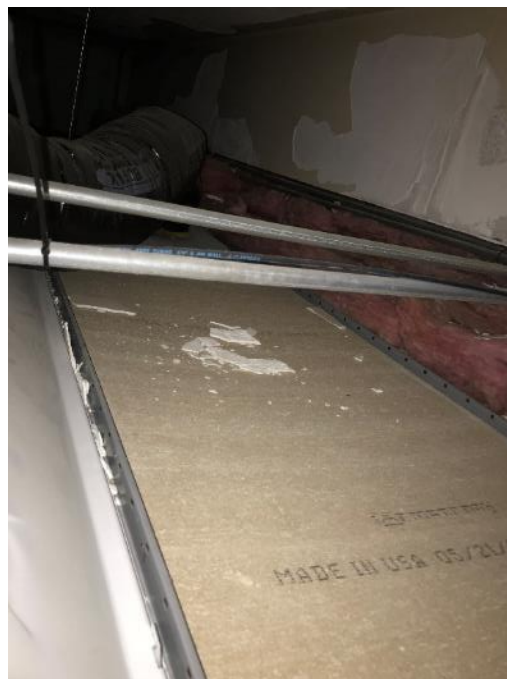
**Photo 26:** Room 1081, Poor Condition Ceiling Plaster and Plaster Debris Located on Ceiling Tiles

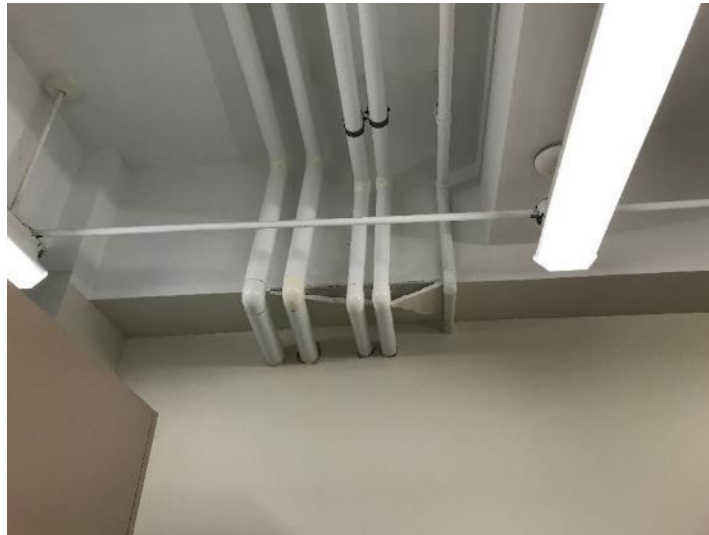
**Photo 27:** Room 1103, Poor Condition Ceiling Plaster and Plaster Debris

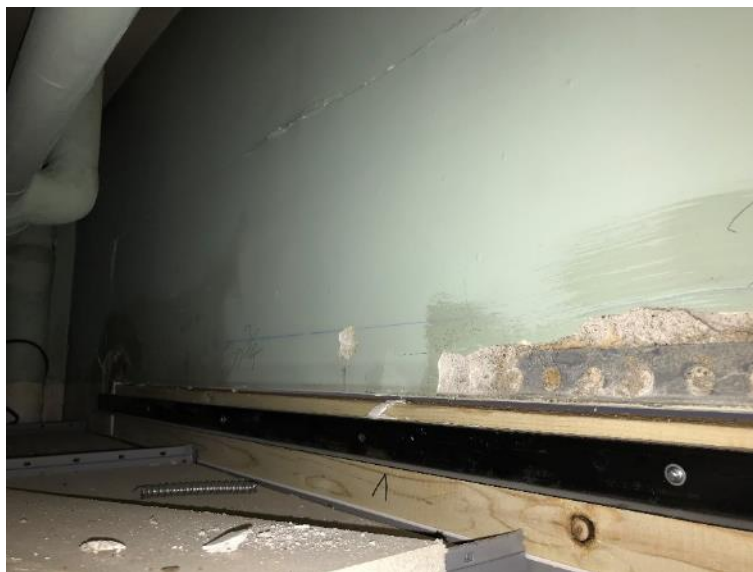
**Photo 28:** Room 1103A, Poor Condition Ceiling Plaster and Plaster Debris located on Ceiling Tiles

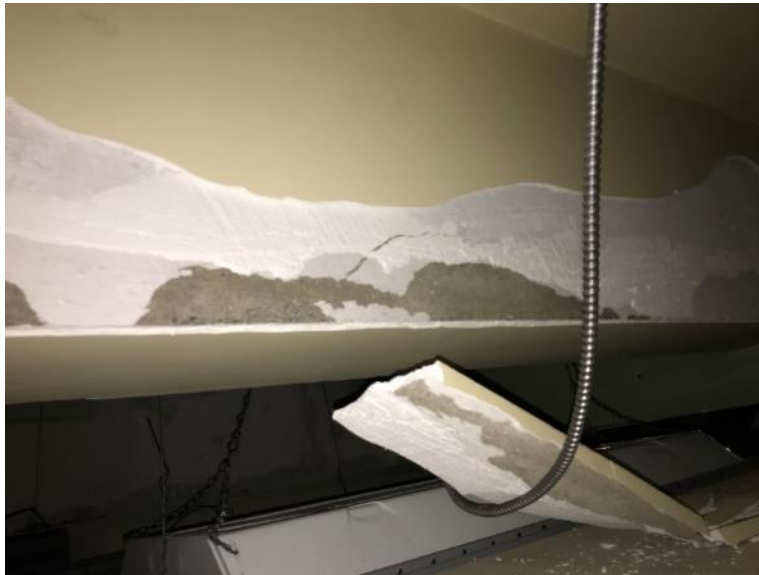
**Photo 29:** Room 1105, Poor Condition Ceiling Plaster and Plaster Debris located on Ceiling Tiles and Light fixtures.

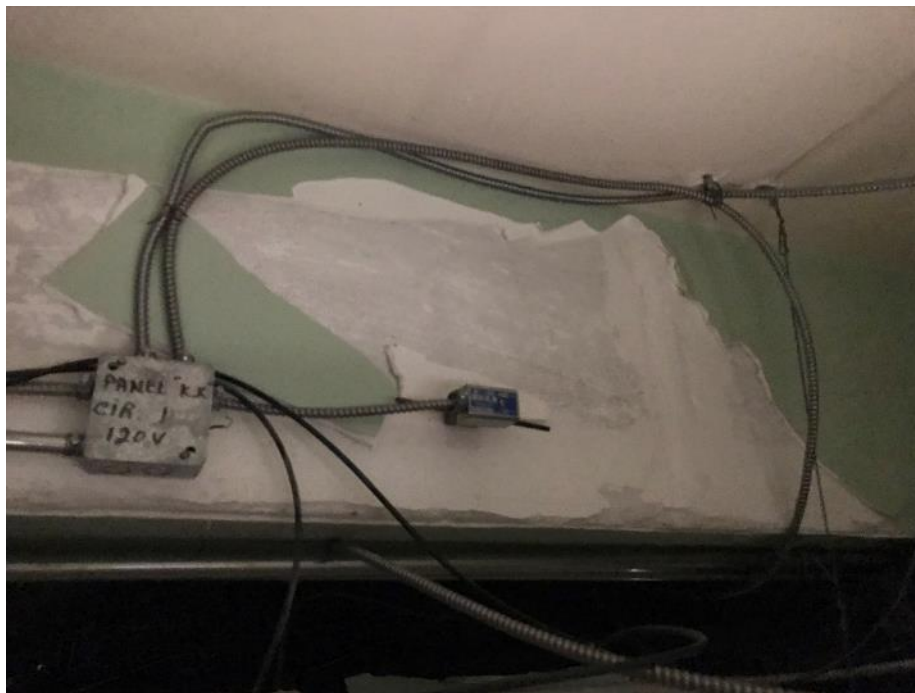
**Photo 30:** Room 1117, Poor Condition Ceiling Plaster located above Ceiling Tiles

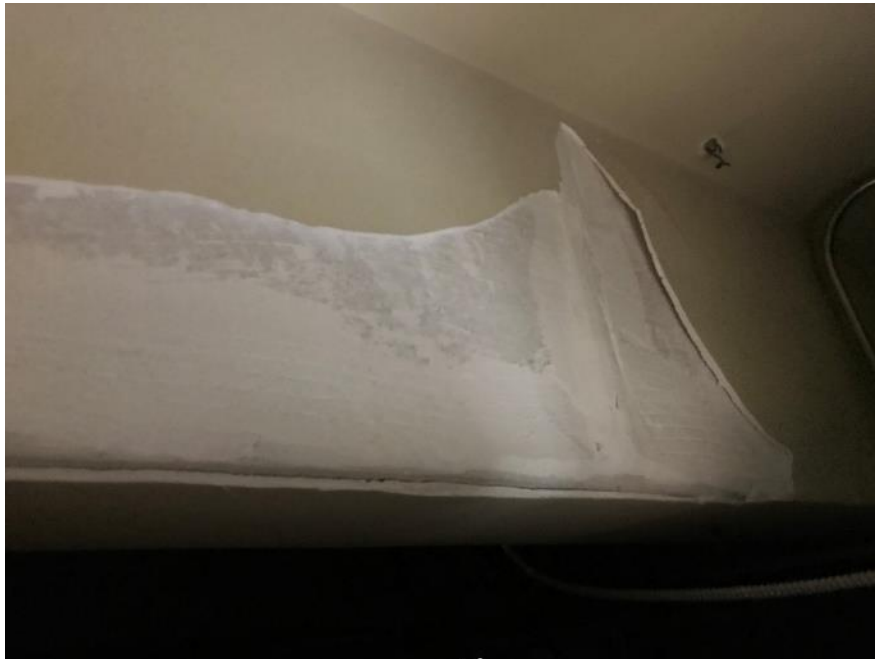
**Photo 31:** Room 1120, Poor Condition Ceiling Plaster located above Ceiling Plaster

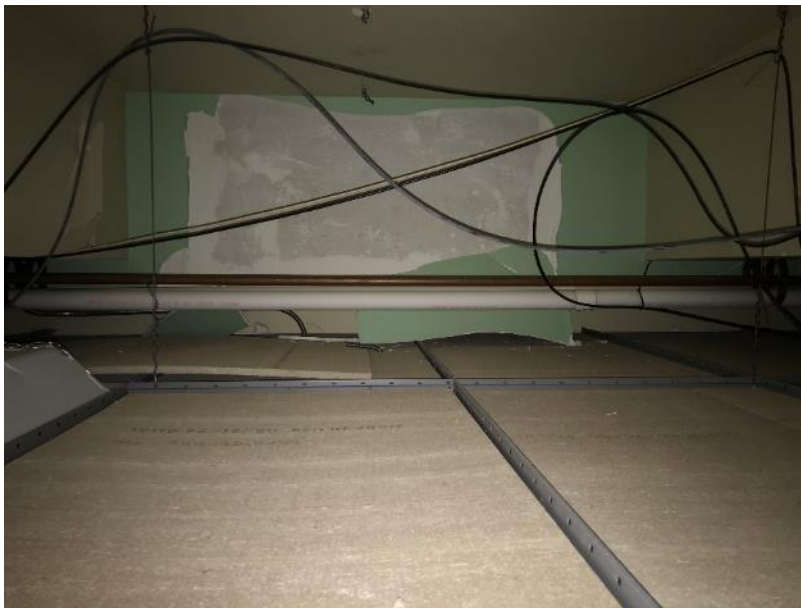
**Photo 32:** Room 1121A, Poor Condition Ceiling Plaster and Plaster Debris located on and above Ceiling Tiles

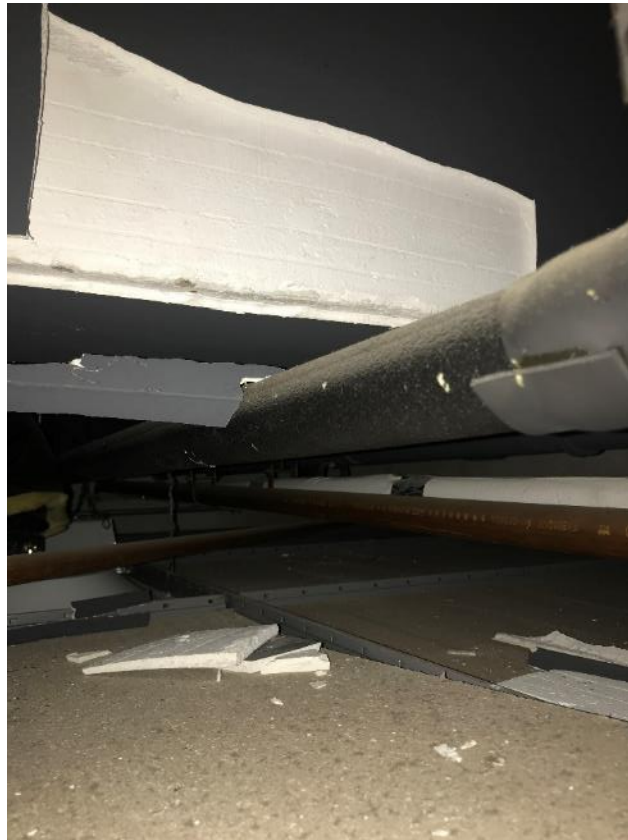
**Photo 33:** Room 1139, Poor Condition Ceiling Plaster and Plaster Debris located on and above Ceiling tiles/Light fixtures

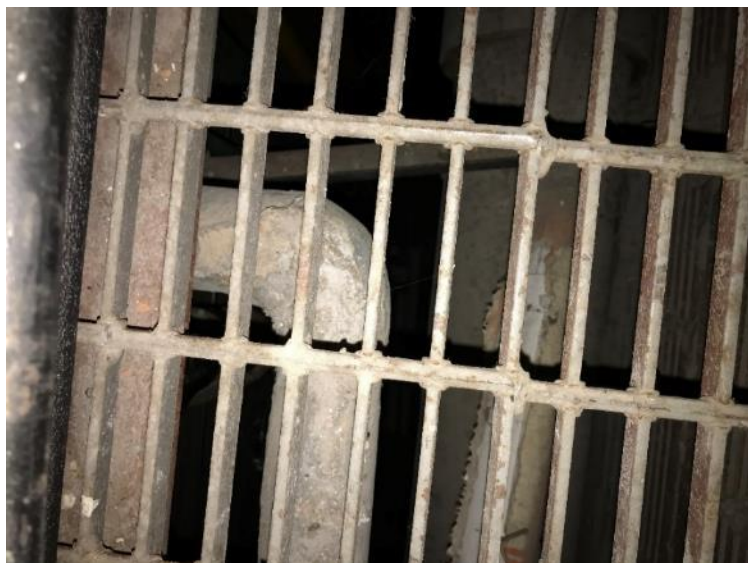
**Photo 34:** Pipe chase 2001-Stairwell, Poor Condition Pipe Fitting located below floor grate

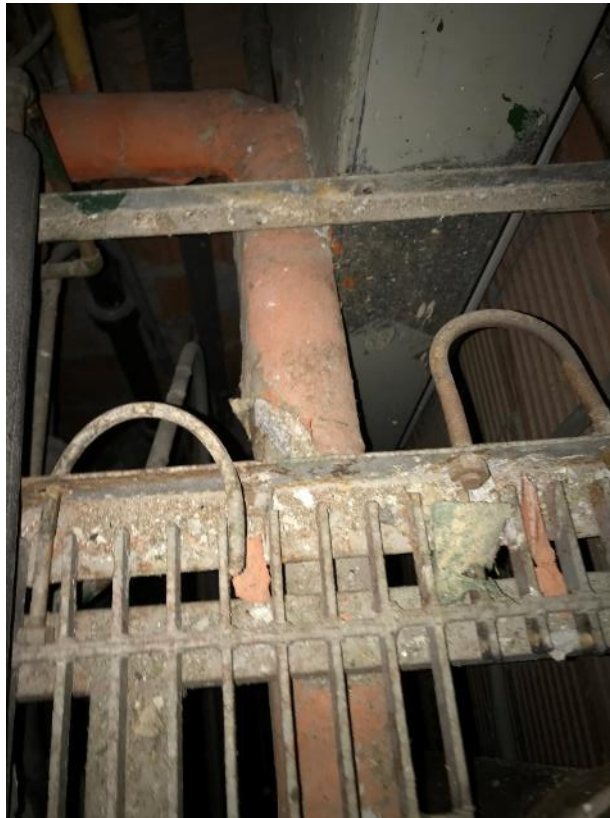
**Photo 35:** Pipe chase 2012-2014, Poor Condition Pipe Fitting and Aircell Pipe Insulation

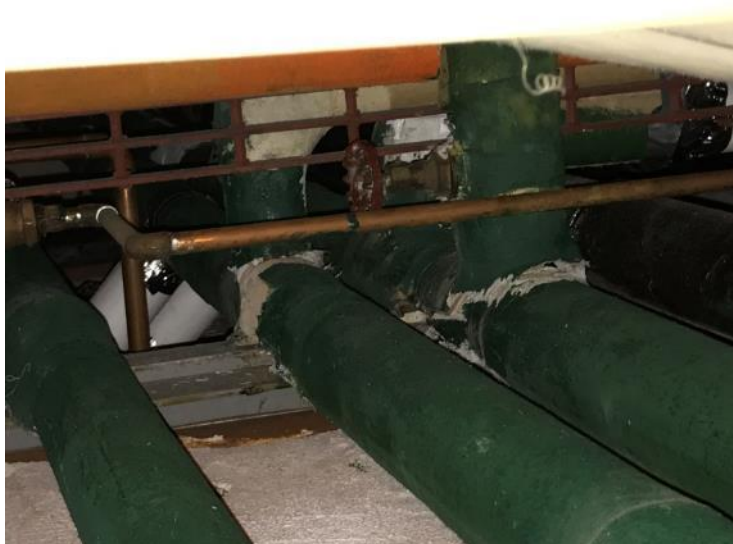
**Photo 36:** Pipe chase 2018-2020, Poor Condition Pipe Fittings

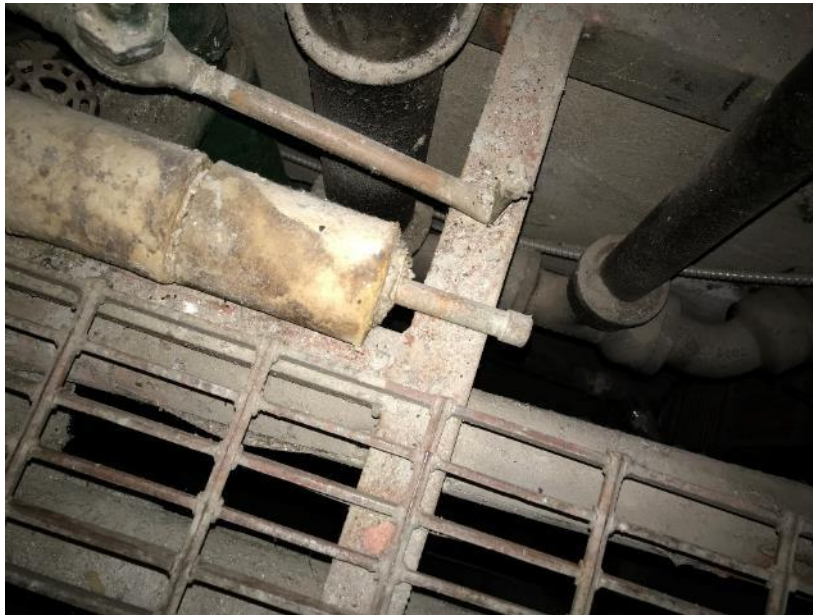
**Photo 37:** Pipe chase 2020-2022, Poor Condition Pipe Fitting located at floor grate

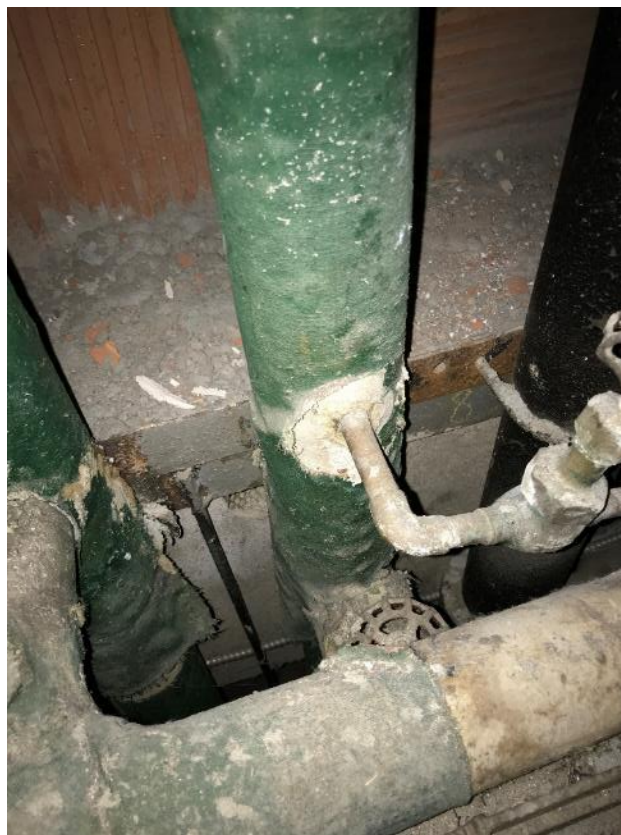
**Photo 38:** Pipe chase 2020-2022, Poor Condition Pipe Fittings and Aircell Pipe Insulation with Debris

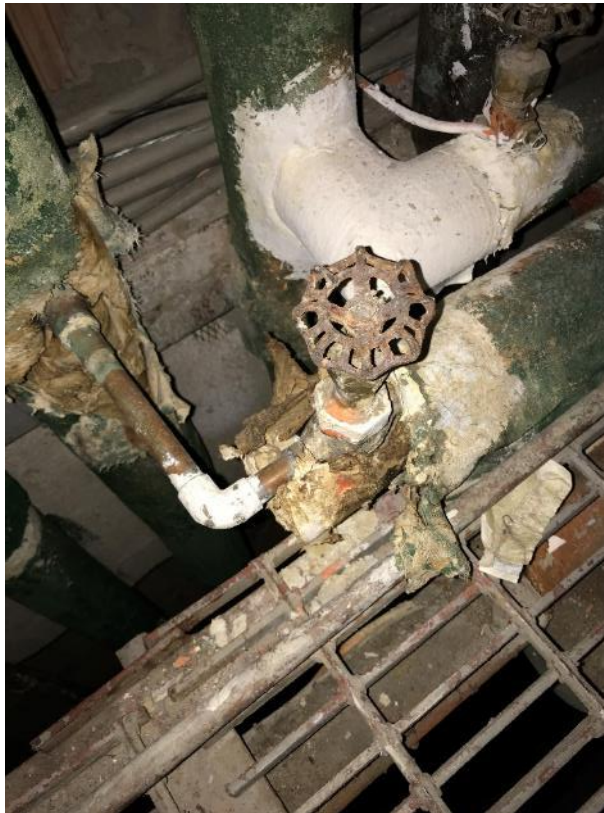
**Photo 39:** Pipe chase 2022-2024, Poor Condition Pipe Fittings and Aircell Pipe Insulation located at floor grate

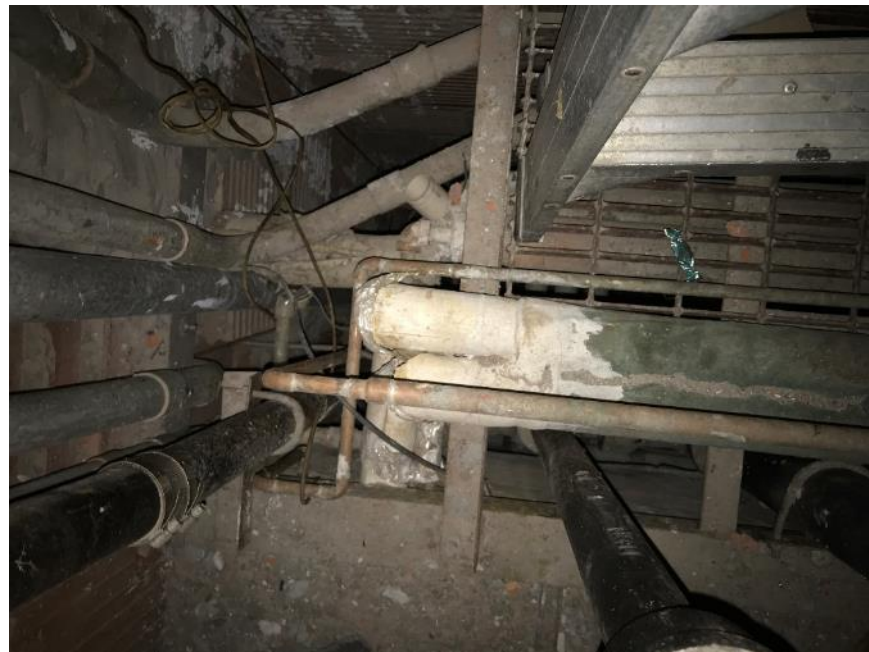
**Photo 40:** Pipe chase 2026-2028, Poor Condition Pipe Fitting and Aircell Pipe Insulation with Debris

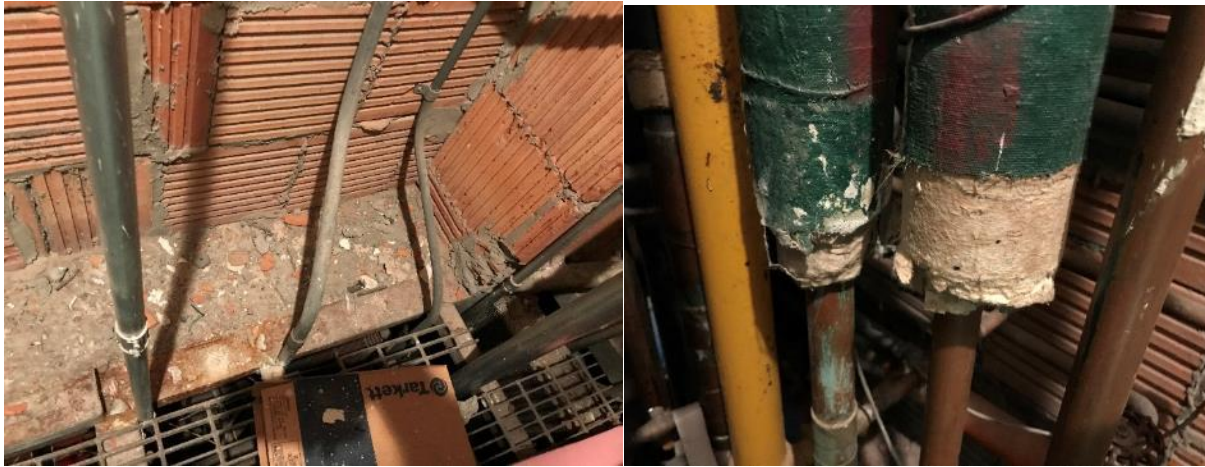
**Photo 41 & 42:** Pipe chase 2028-2030, Poor Condition Pipe Fittings with Poor Condition Aircell Pipe Insulation and Debris

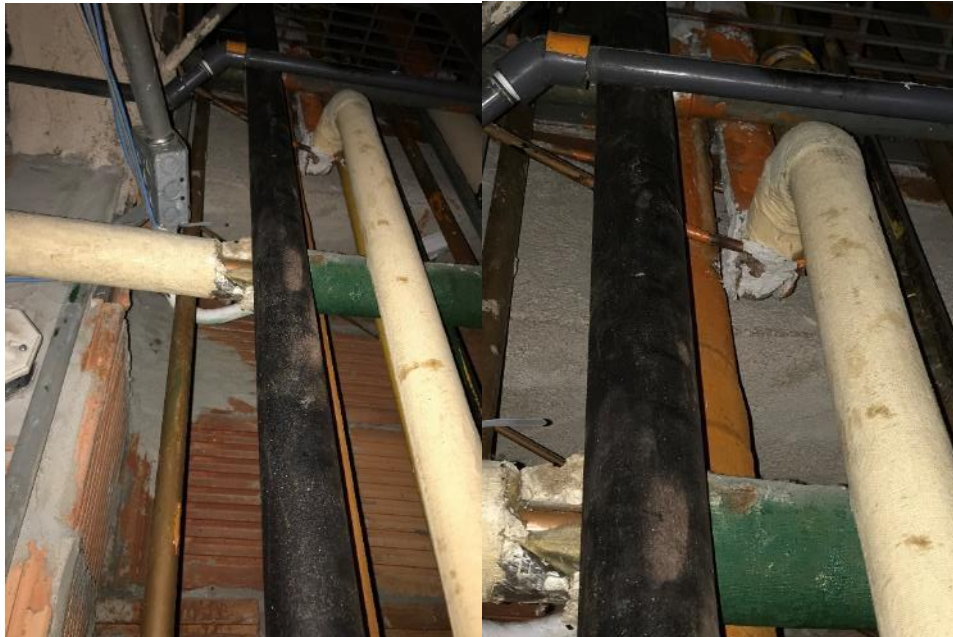
**Photo 43 & 44:** Pipe chase 2043-2045, Poor Condition Pipe Fittings and Aircell Pipe Insulation

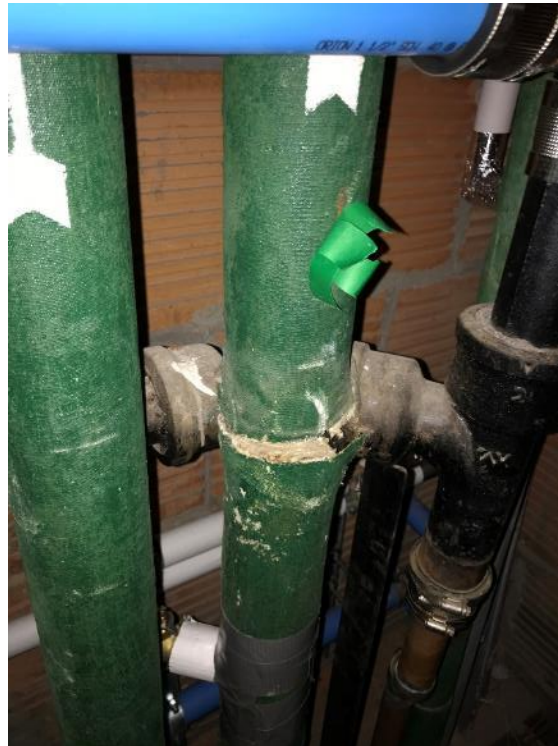
**Photo 45:** Pipe chase 2044-2046, Poor Condition Aircell Pipe Insulation

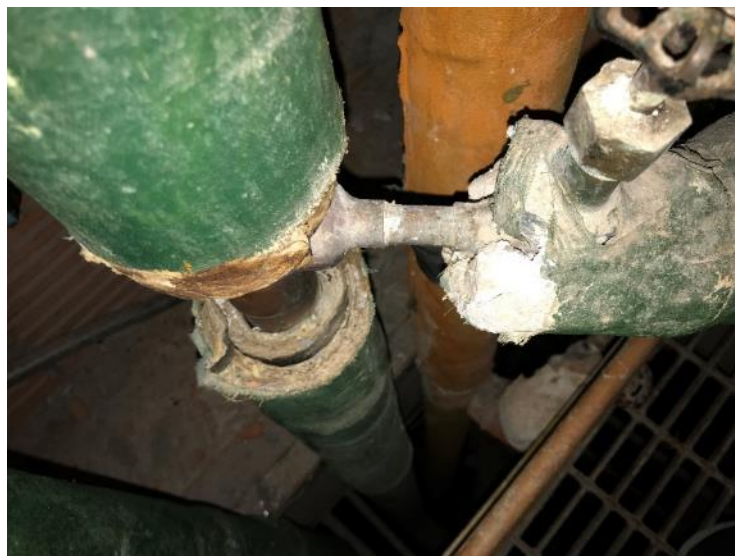
**Photo 46:** Pipe chase 2046-2048, Poor Condition Pipe Fittings and Aircell Pipe Insulation

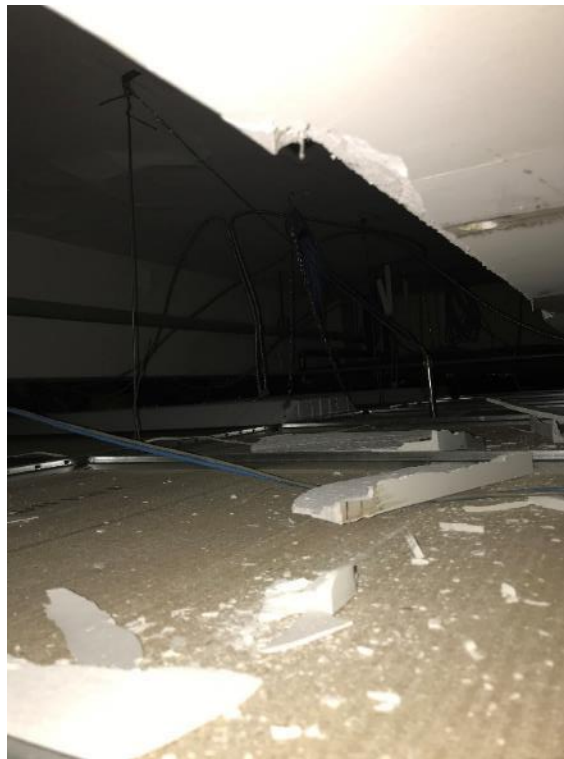
**Photo 47:** Room 2057, Poor Condition Ceiling Plaster and Plaster Debris located on and above Ceiling tiles

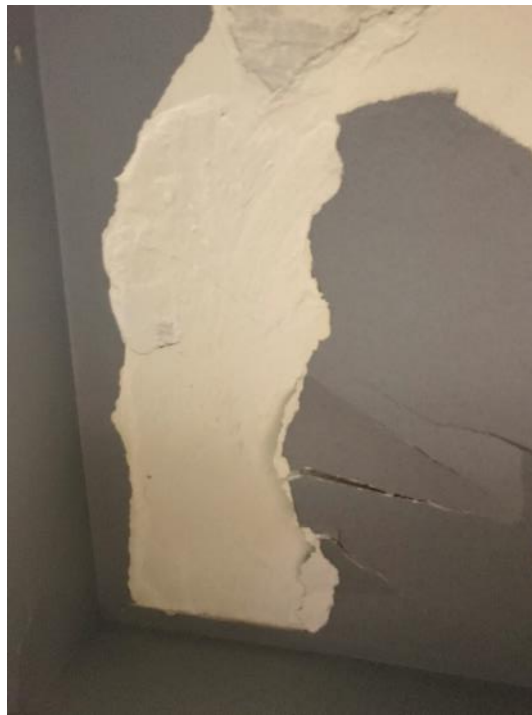
**Photo 48:** Room 2067, Poor Condition Ceiling Plaster and Plaster Debris located on and above Ceiling Tiles

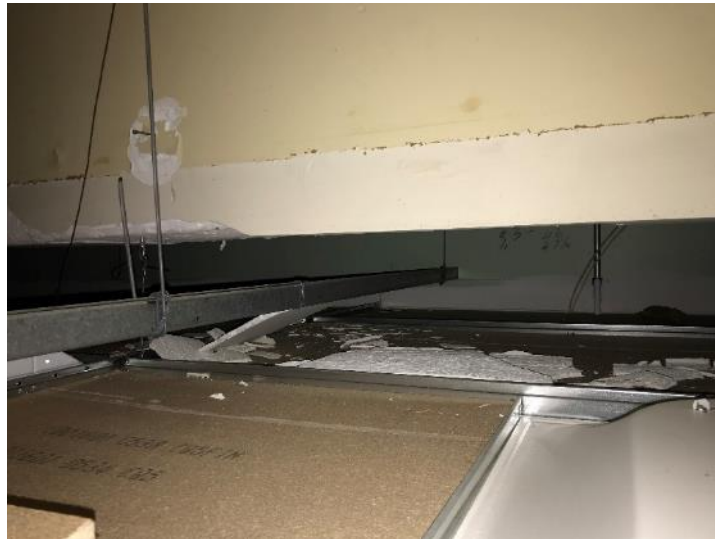
**Photo 50:** Room 2087, Poor Condition Ceiling Plaster and Plaster Debris located on and above the Ceiling Tiles

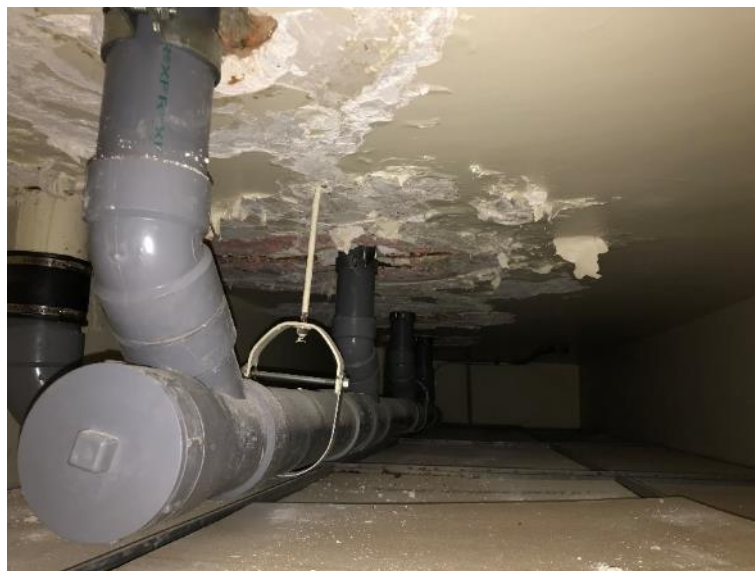
**Photo 51:** Room 2090, Poor Condition Ceiling Plaster and Plaster Debris located on and above the ceiling tiles.
