## **ADDENDUM # 2**

*Solicitation Number: 19-1267*

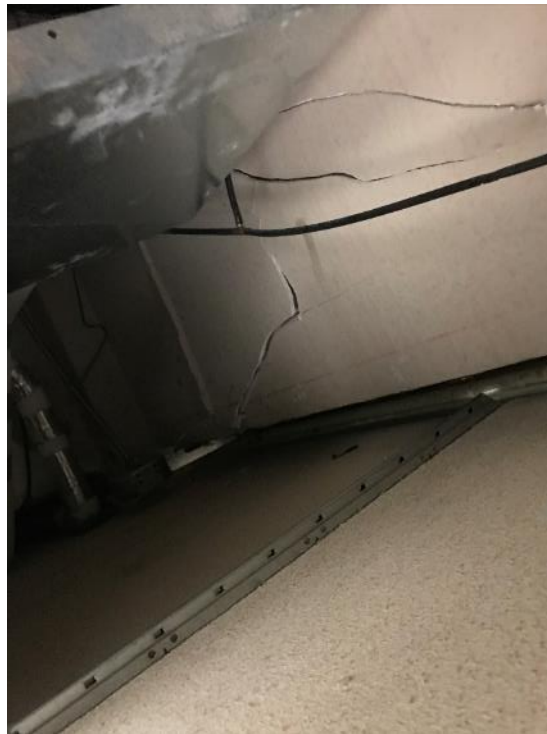
**Photo 52:** Room 2109, Poor Condition Wall and Ceiling Plaster located above ceiling tiles

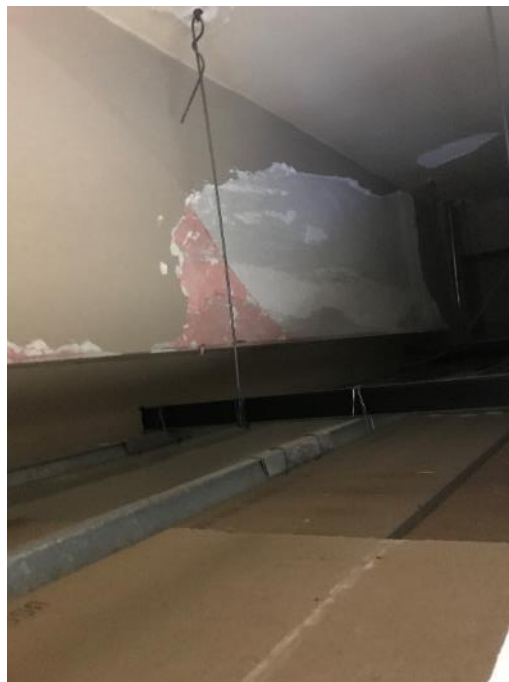
**Photo 53:** Room 2117, Poor Condition Ceiling Plaster and Plaster Debris located on and above ceiling tiles

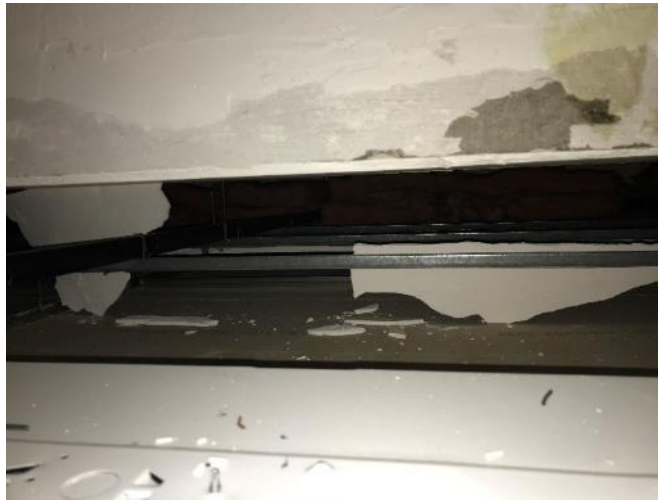
**Photo 54:** Room 2119, Poor Condition Ceiling Plaster and Plaster Debris located on and above ceiling tiles and light fixtures.

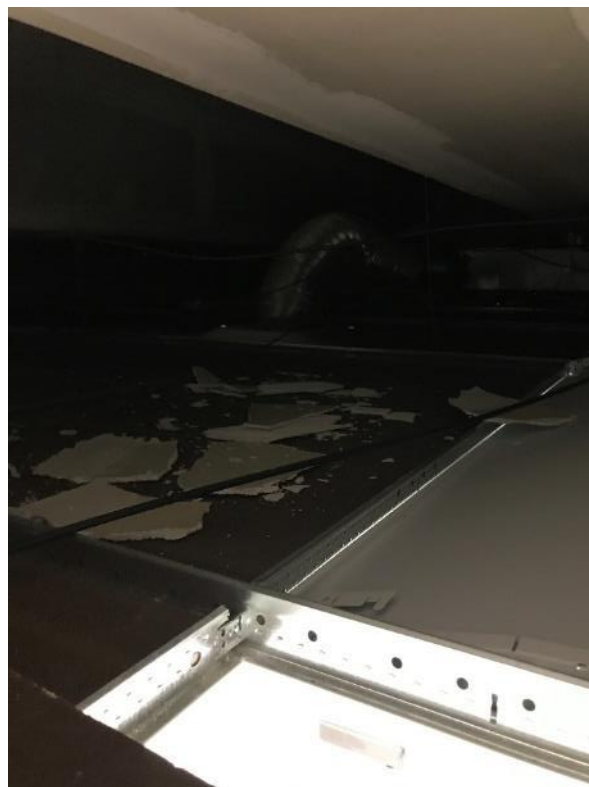
**Photo 55:** Room 2130, Poor Condition Ceiling Plaster and Plaster Debris located on and above ceiling tiles

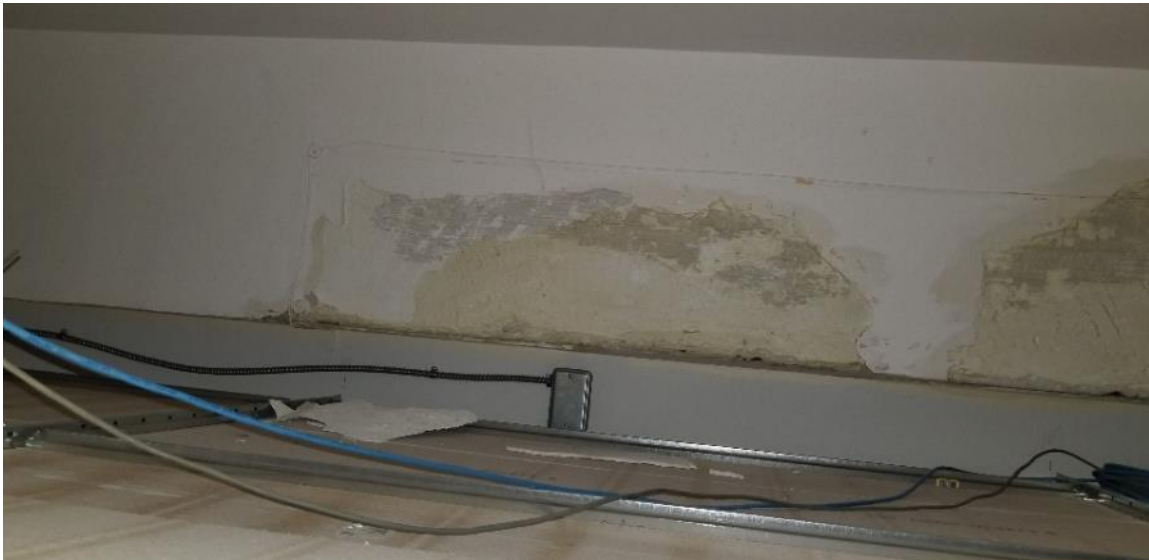
**Photo 56:** Room 3098, Poor Condition Ceiling Plaster and Plaster Debris located above ceiling tiles

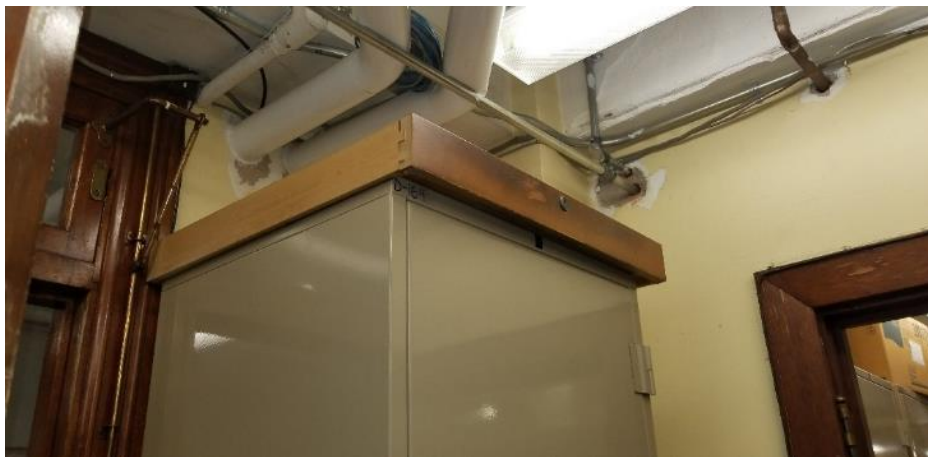
**Photo 57:** Common room of rooms 3109-3113, Poor Condition Poor Ceiling and Wall Plaster

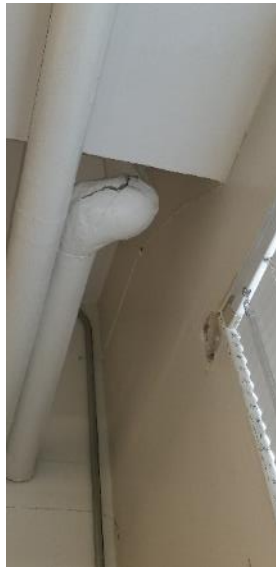
**Photo 58:** Room 3115-3117, Poor Condition Pipe Fitting and Ceiling Plaster

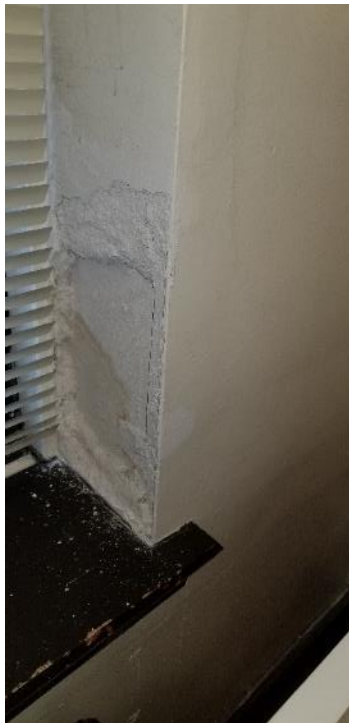
**Photo 59:** Room 3119, Poor Condition Wall Plaster and Debris located on Windowsill

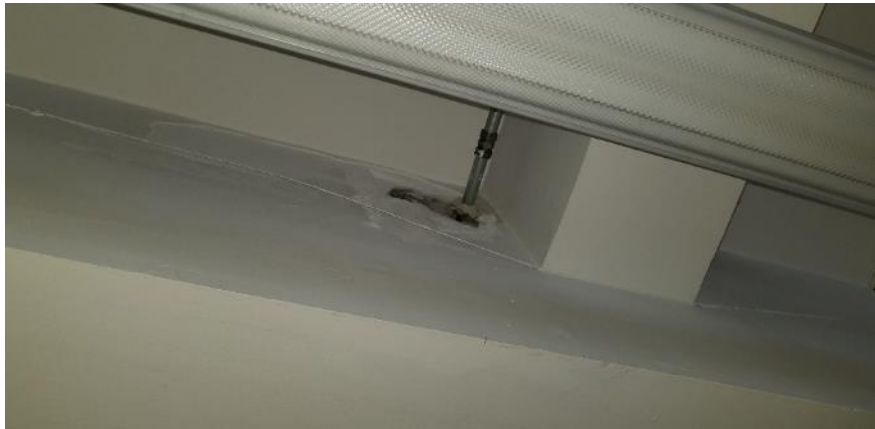
**Photo 60:** Room 3121-311A, Poor Condition Wall Plaster located on ceiling

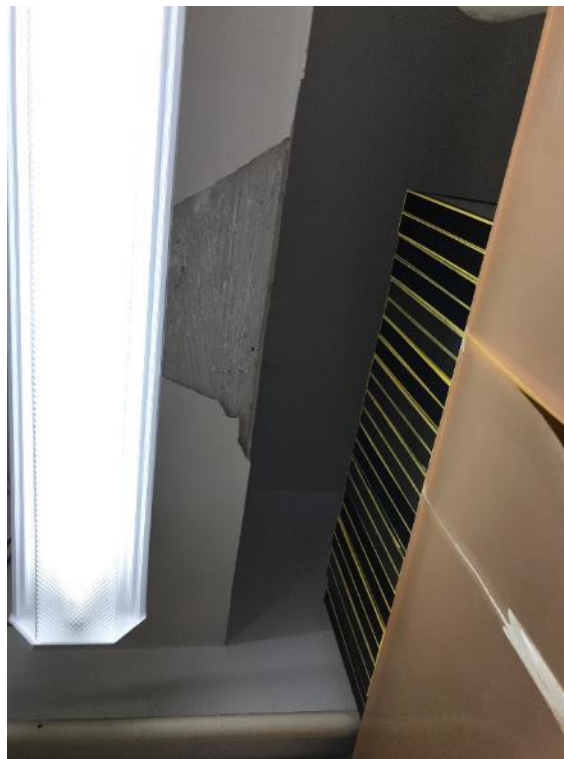
**Photo 61:** Room 3135, Poor Condition Ceiling Plaster on I-beam

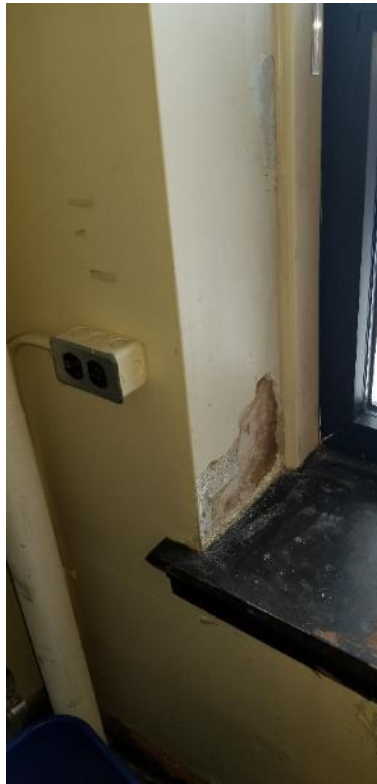
**Photo 62:** Room 3135B, Poor Condition Wall Plaster and Debris located on windowsill

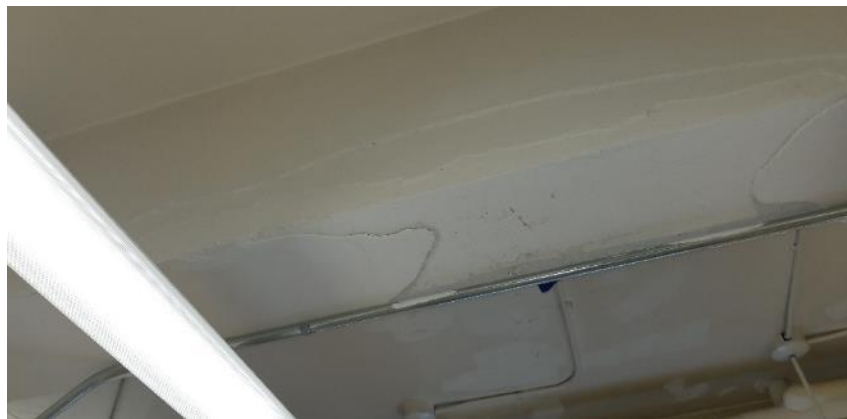
**Photo 63:** Room 3135E, Poor Condition Ceiling Plaster

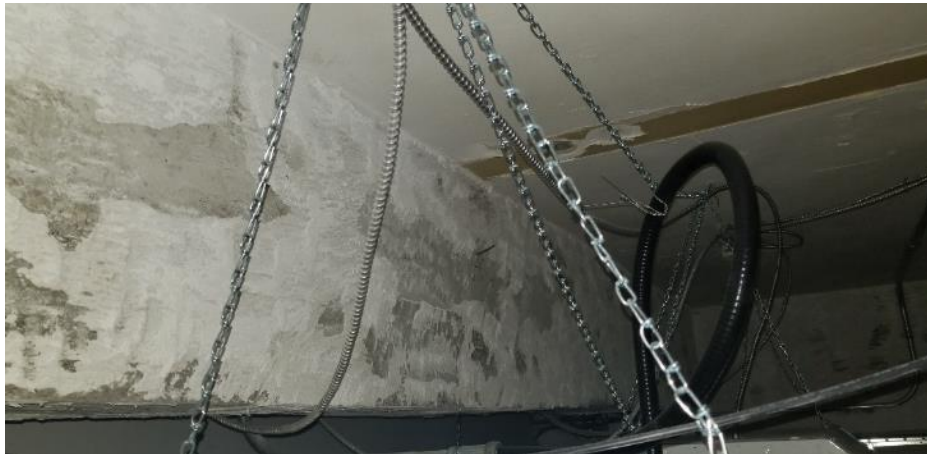
**Photo 64:** Room 3135G, Poor Condition Ceiling Plaster and Debris located above Ceiling Tiles

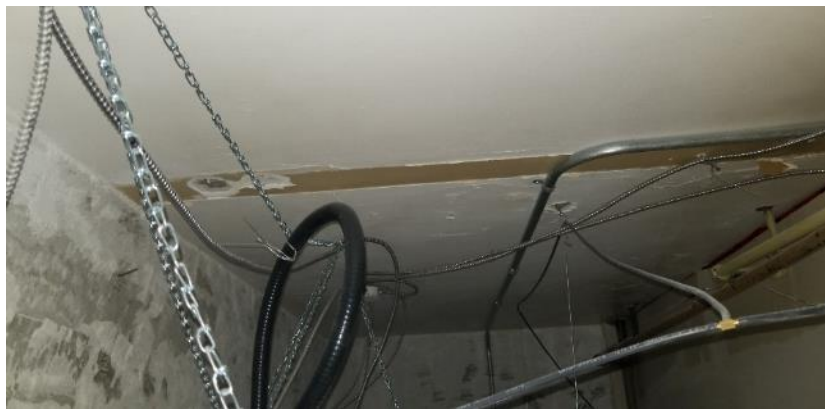
**Photo 65:** Room 3135H, Poor Condition Ceiling Plaster and Debris located above Ceiling Tiles

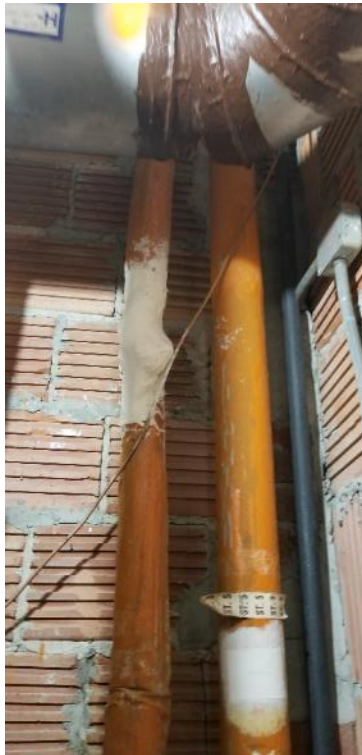
**Photo 66:** Pipe chase 4001-Stairwell, Poor Condition Aircell Pipe Insulation

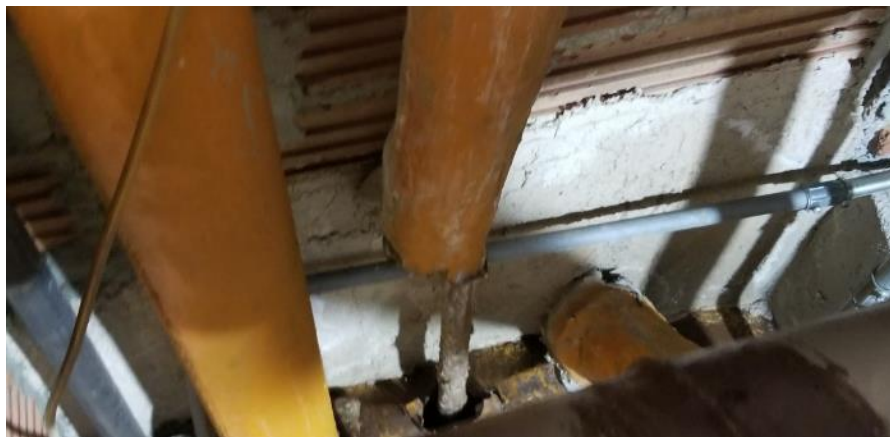
**Photo 67:** Pipe chase 4001-4003, Poor Condition Pipe Fittings and Aircell Pipe Insulation

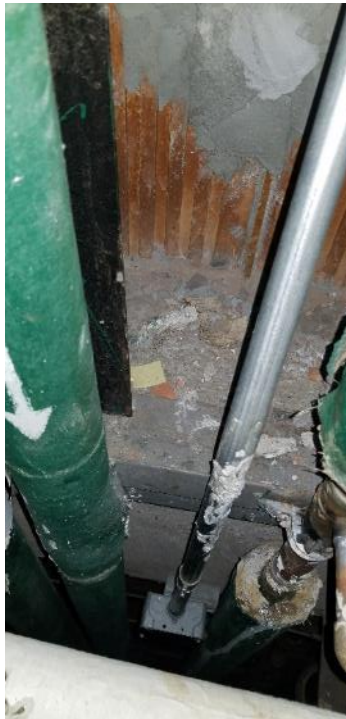
**Photo 68:** Pipe chase 4002-4004, Poor Condition Aircell Pipe Insulation and Debris

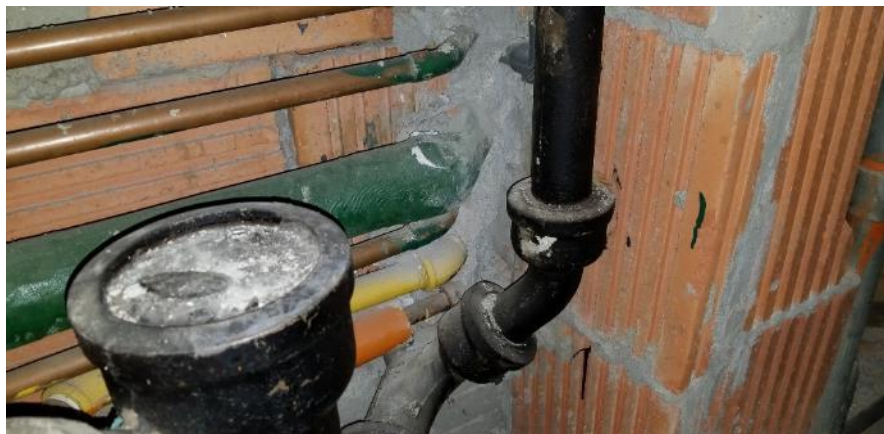
**Photo 69:** Pipe chase 4003-4005, Poor Condition Aircell Pipe Insulation and Debris

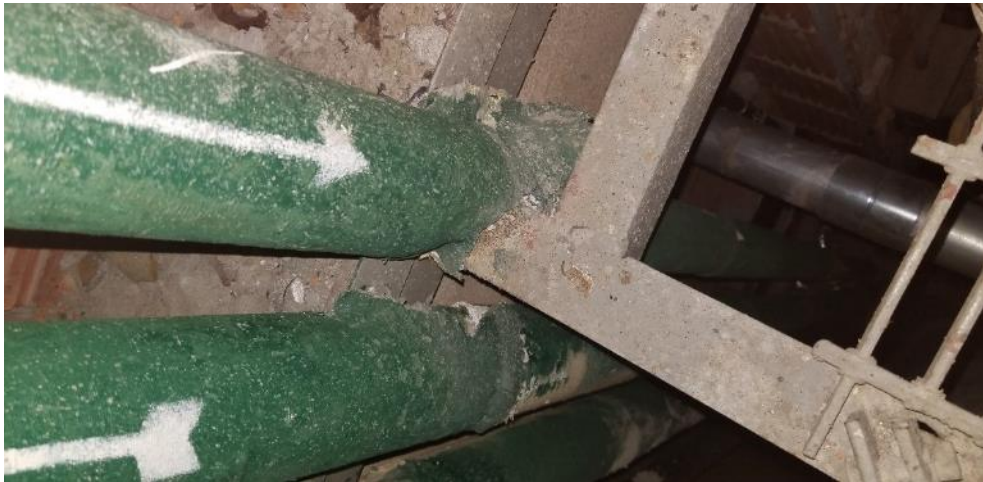
**Photo 70:** Pipe chase 4035-4037, Poor Condition Aircell Pipe Insulation and Debris located on floor grate

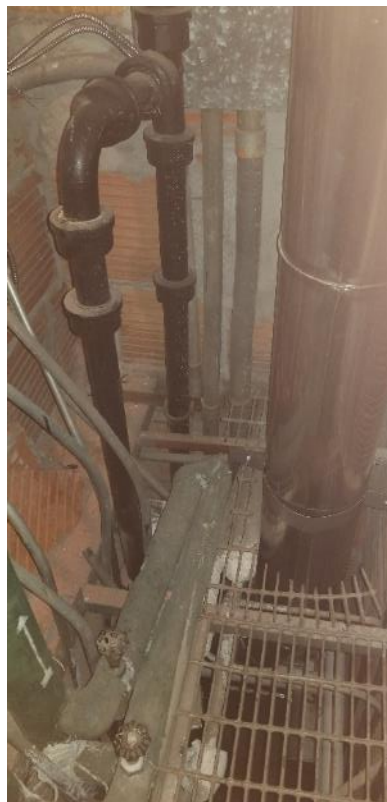
**Photo 71:** Pipe chase 4035-Elevator, Poor Condition Pipe Fittings and Aircell Pipe Insulation located below floor grate

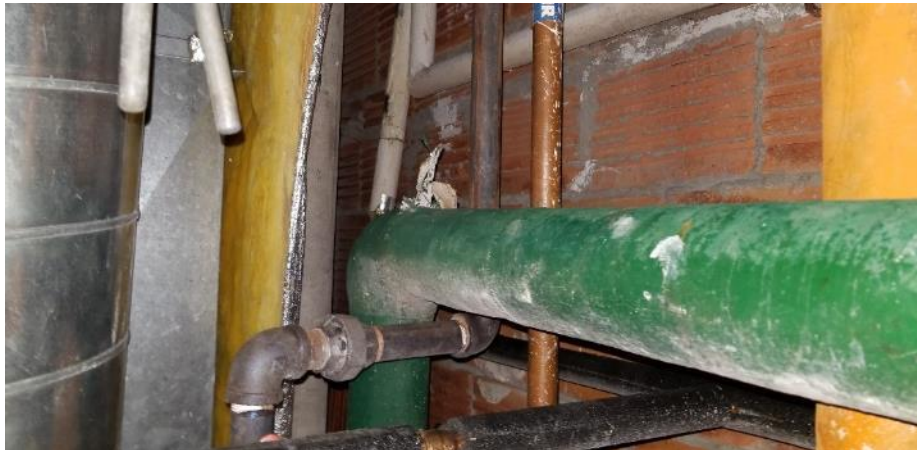
**Photo 72:** Pipe chase 4037-4039, Poor Condition Pipe Fitting

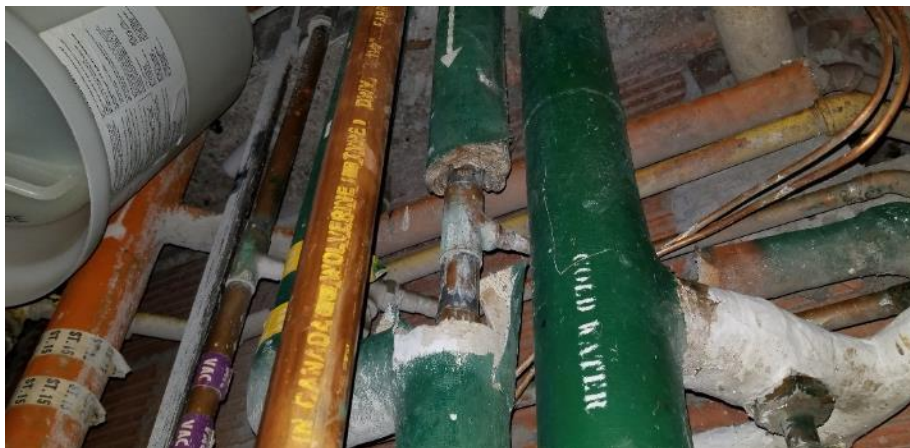
**Photo 73:** Pipe chase 4037-4039, Poor Condition Aircell Pipe Insulation and Pipe Fitting

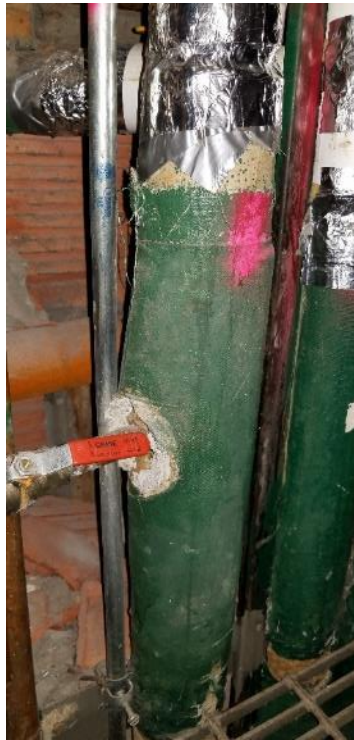
**Photo 74:** Pipe chase 4041-4043, Poor Condition Aircell Pipe Insulation

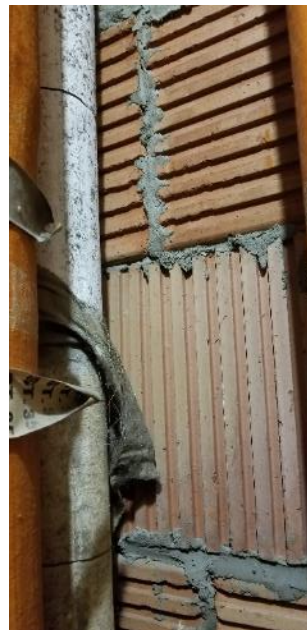
**Photo 75:** Pipe chase 4049-Stairwell, Poor Condition Aircell Pipe Insulation

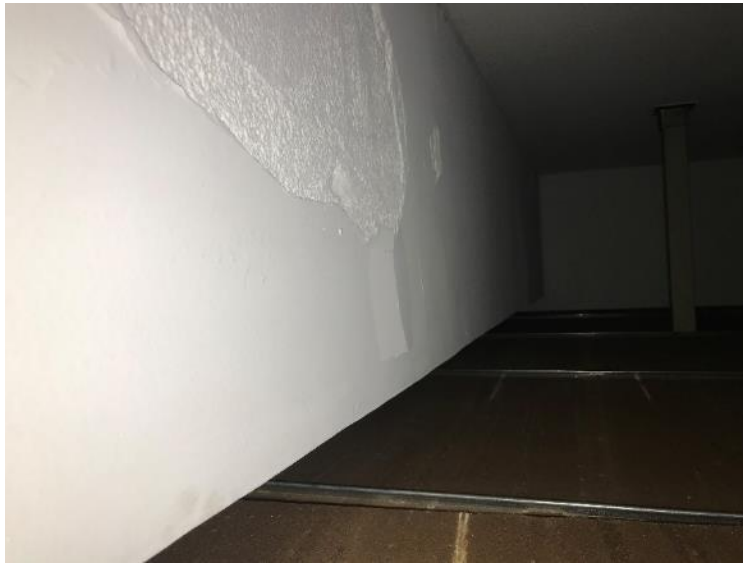
**Photo 76:** Room 4090, Poor Condition Ceiling Plaster and Debris located above and on ceiling tiles

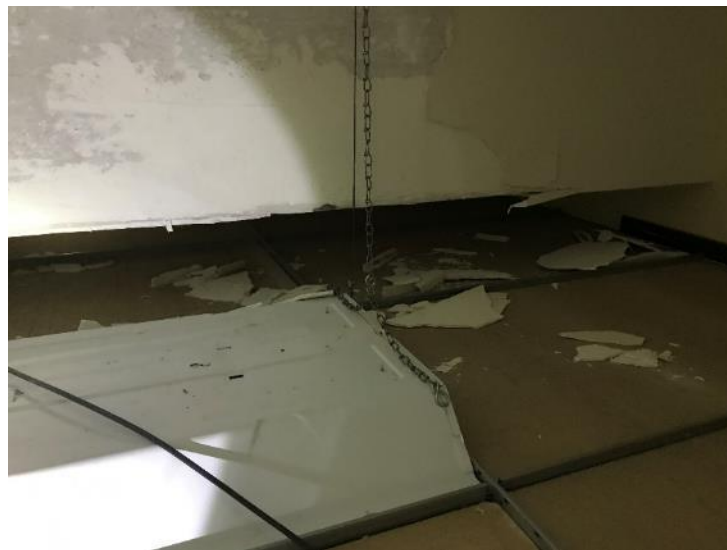
**Photo 77:** Room 4091, Poor Condition Ceiling Plaster and Plaster Debris located on and above ceiling tiles and on light fixtures

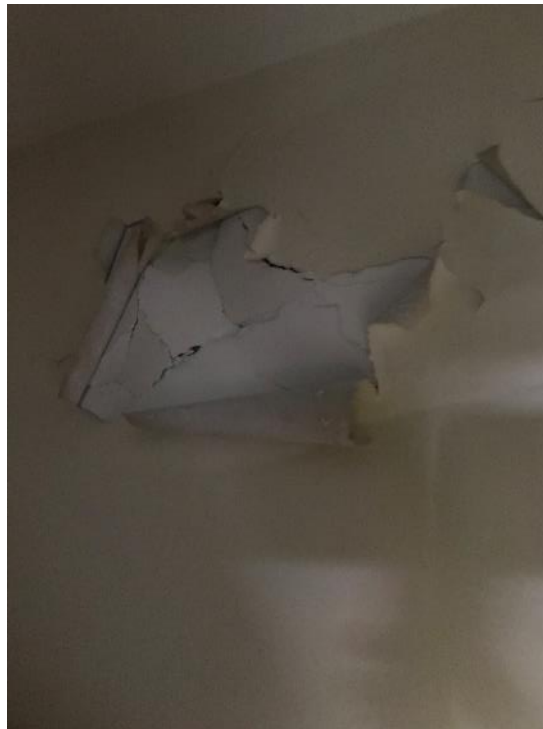
**Photo 78:** Room 4093, Poor Condition Ceiling Plaster located above ceiling tiles

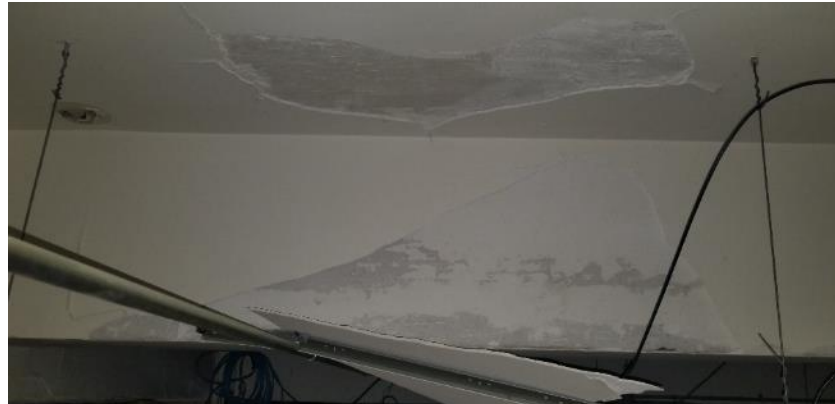
**Photo 79:** Room 4097, Poor Condition Ceiling Plaster and Ceiling Plaster Debris located above and on ceiling tiles

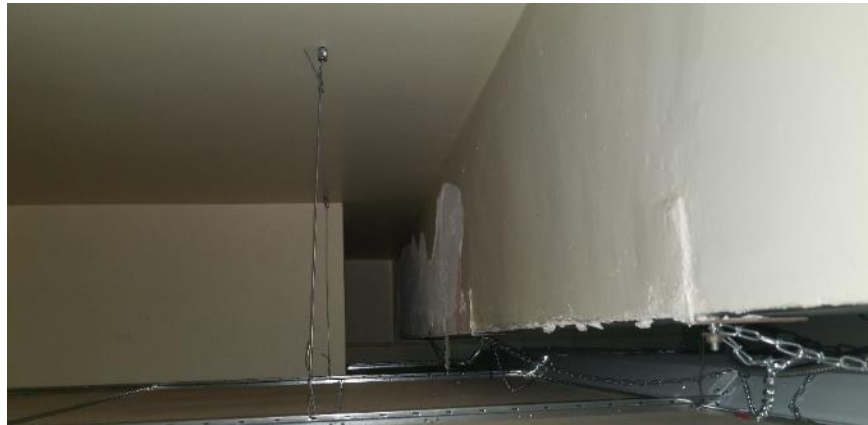
**Photo 80:** Room 4102, Poor Condition Ceiling Plaster and Plaster Debris located above Ceiling Tiles

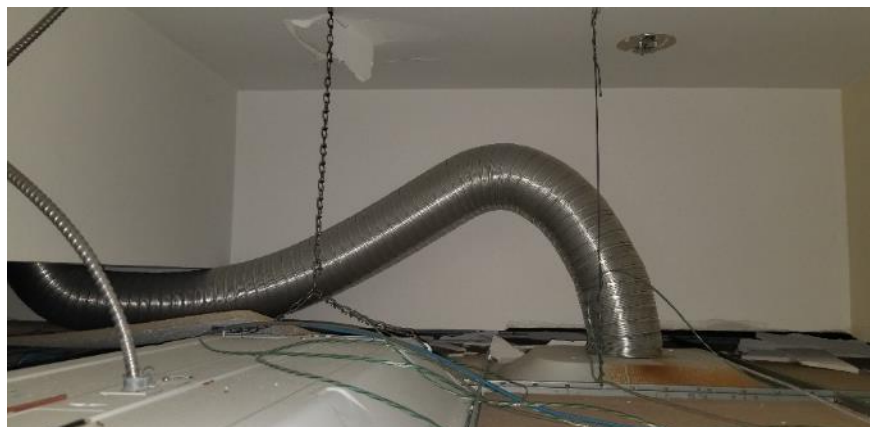
**Photo 81:** Room 4107, Poor Condition Ceiling Plaster and Plaster Debris located on and above ceiling tiles

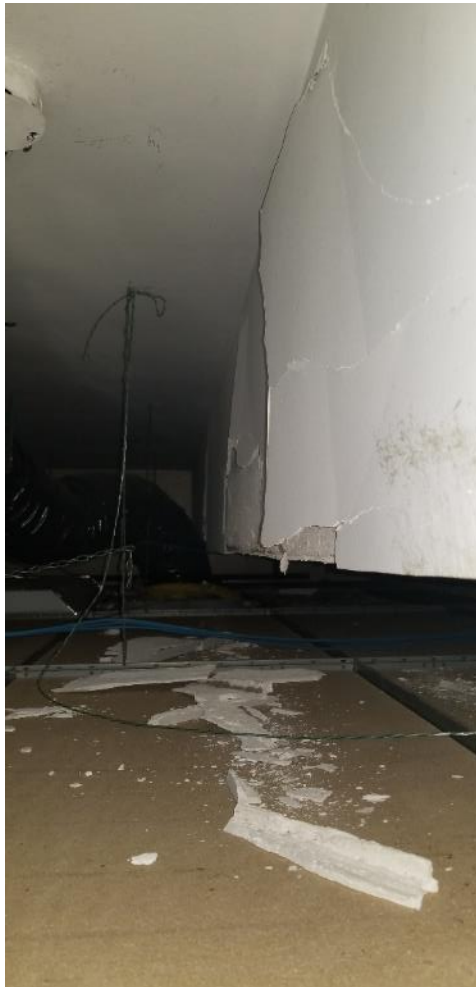
**Photo 82:** Room 4109, Poor Condition Ceiling Plaster and Plaster Debris located on and above ceiling tiles and light fixtures

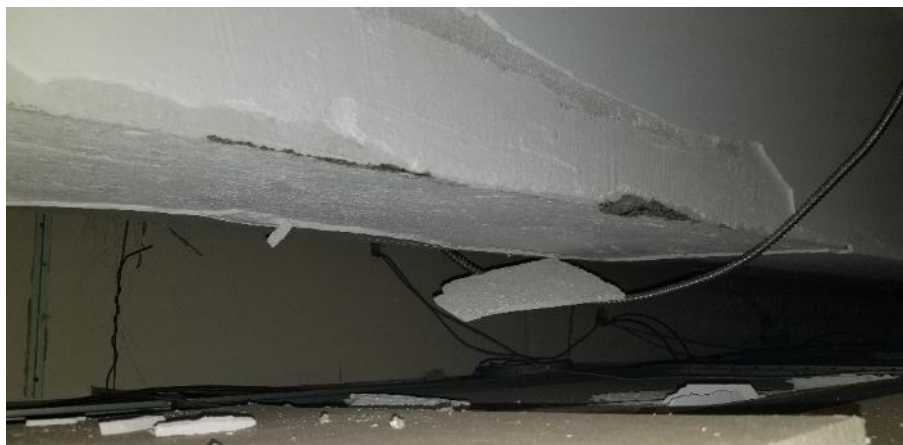
**Photo 83:** Room 4111, Poor Condition Ceiling Plaster and Plaster Debris located on and above ceiling tiles and light fixtures

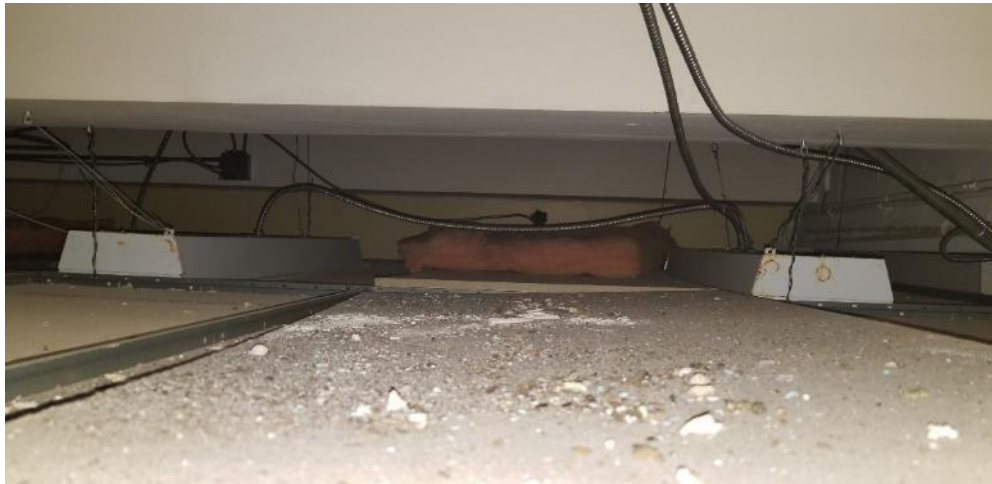
**Photo 84:** Room 4115, Poor Condition Ceiling Plaster and Plaster Debris located on and above ceiling tiles and light fixtures
