**DESIGNATED SUBSTANCE AND HAZARDOUS
MATERIAL EVALUATION**

Fort George Powder Magazine Building

Submitted To: Parks Canada

Issued: September 20, 2019

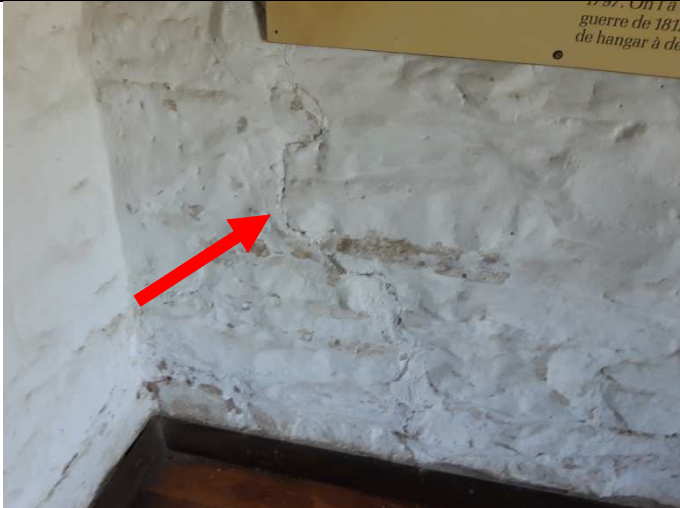
Asbestos was not detected in any of the samples collected/analyzed.

<p>Sample Identification 00090.008-M01, M02, M03</p>
	<p>Sample Code HM-01</p>
	<p>Sample Location of Material Interior Vestibule</p>
	<p>Sample Description Parging Cement</p>

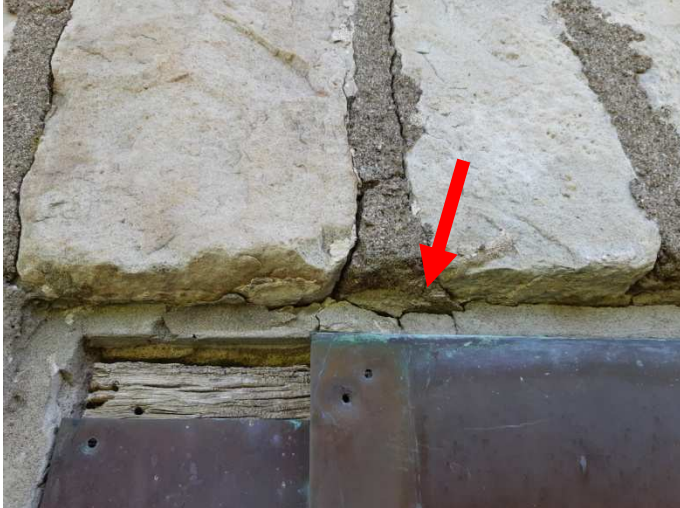
<p>Sample Identification 00090.008-M04, M05, M06</p>
	<p>Sample Code HM-02</p>
	<p>Sample Location of Material Exterior</p>
	<p>Sample Description Mortar (Smooth)</p>

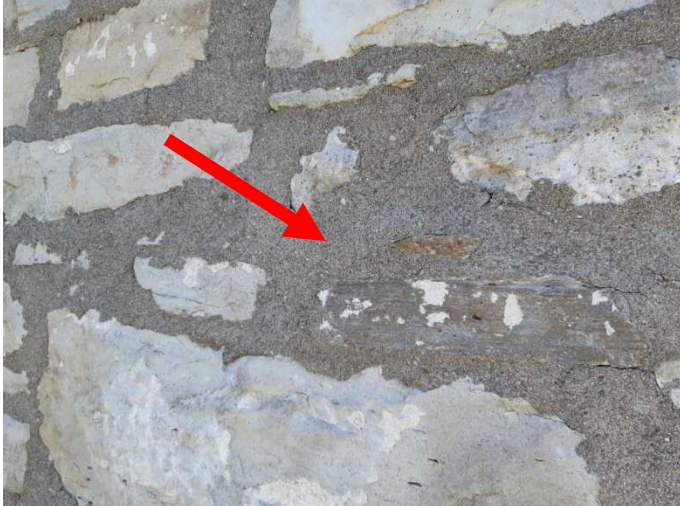
<p>Sample Identification 00090.008-M07, M08, M09</p>
	<p>Sample Code HM-03</p>
	<p>Sample Location of Material Exterior</p>
	<p>Sample Description Mortar (Textured)</p>
<p>Analytical Result: None Detected</p>

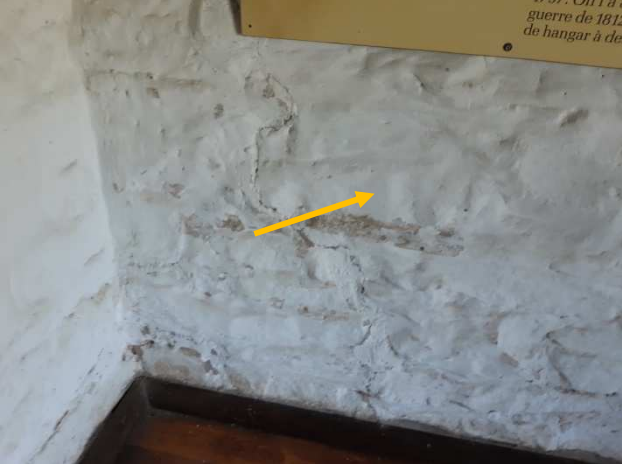
Sample Number	Paint Finish Description	Interpretation of Analytical Result		
		Arsenic	Lead	Mercury
00090.008-P01	White Paint (Stone)	<MDL	POSITIVE	POSITIVE

- Lead and mercury is present in the paint coating sampled at levels that do not warrant consideration for workers protection if materials are disturbed.
 - 00090.008-P01 – White Paint (on stone)
- Silica (assumed present in concrete materials)

Sample Identification White Paint (on Stone) 00090.008-P01
	Arsenic Content <50 µg/g
	Lead Content 5 µg/g
	Mercury Content 2 µg/g

4. Prior to disposal of substrates (designated for landfill) with arsenic, mercury and lead-containing coatings, the substrates should be tested in accordance with Ontario Regulation 347 for purposes of waste streaming.

- P01 - White - **Mercury TCLP**
