Service Report

Visit description **HCO Inspection**

Customer	DF Barnes	Vessel name	CCGS Henry Larsen
Order No	W.O.: 10678838	IMO number	8409329
Service Engineer/ Report by	Hrvoje Latkovic	Ship representative	Chief Engineer
Supervised by	M.H.	Place of service	CCG Terminal, St. John's NL CANADA
Date of visit	start 24/06/2019		
	end 24/06/2019

Equipment type	Serial no / drwg. no	Operating duty and climate	Tot. op. hrs / op. cycles
- HC - 2 sets, - identical - Main Deck, side-by-side - 2 panels - Flush type, W/T - wire operated	Unkown/ 21-69030	unknown	unknown

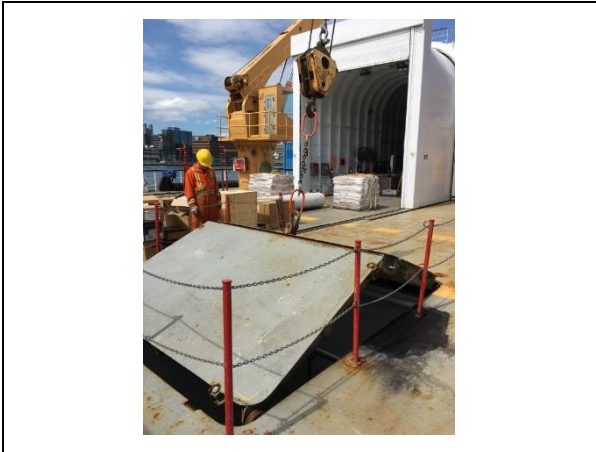
Figure 5: SB HC operation

- 1) Operation:** Good
- 2) Structure:**
 - a) Top plates: good
 - b) Side plates: good, except bottom portion rusty, needs to be sandblasted and painted
 - c) Double-skin plates: good

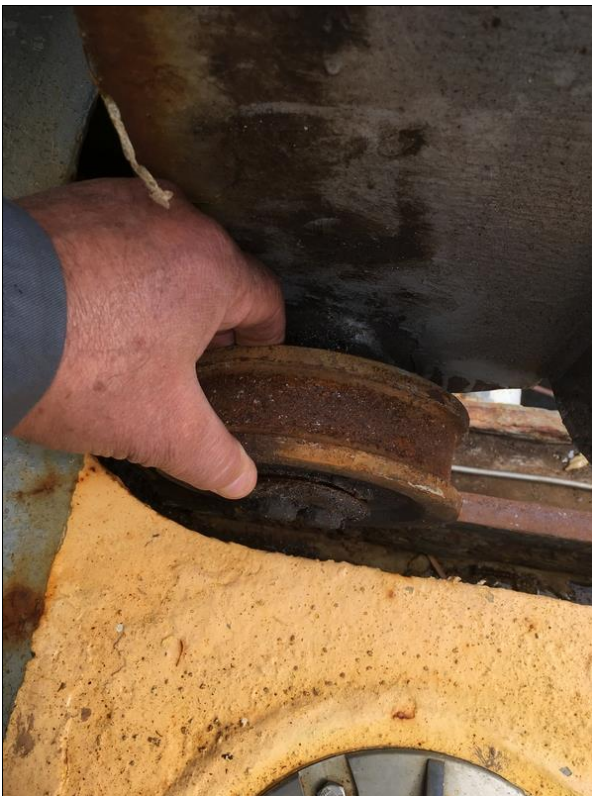
- 7) Preventer chains & attachments:** good
- 8) Flanged wheels:**
 - Wobbliness: no
 - Somewhat rusty
 - Keeper plates: good
 - Race: without detail measurements, seems slightly worn-out

Figure 9: Inspection of wheels, Typ.

- Ship representative is requesting new wheels

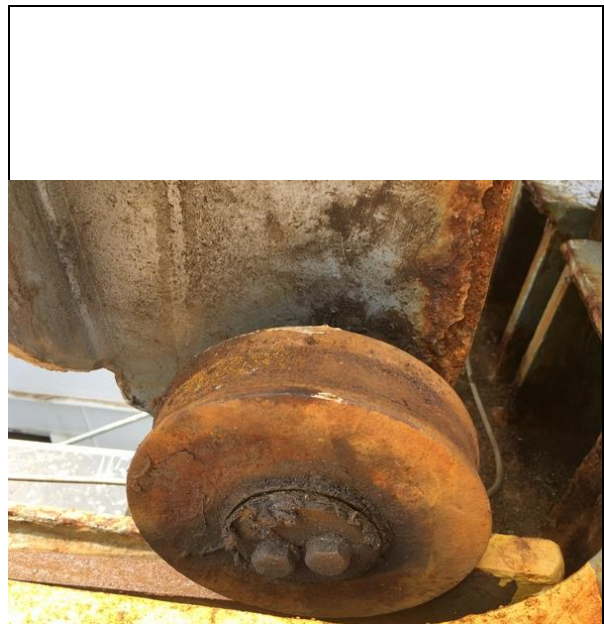
- Same comments as for Flanged wheels
- Races concavely worn-out, even to naked eye

Figure 10: Condition of plain wheel on PS HC. One can see large concave crown

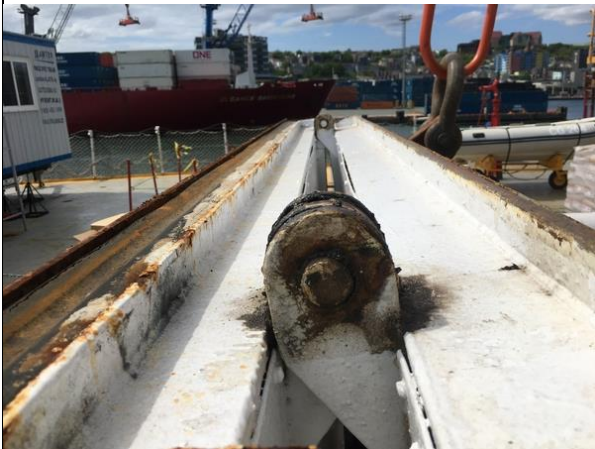
- 4) Intermediate panel hinges:**
 - Plates in good condition
 - Hinges greased
 - Must be dismantled in order to inspect the hinge-pins condition and hinge-pin holes condition, then compare with original design dimensions and TOL. and make decision if they are reusable or to be renewed.

Figure 11: Intermediate Hinges on SB HC

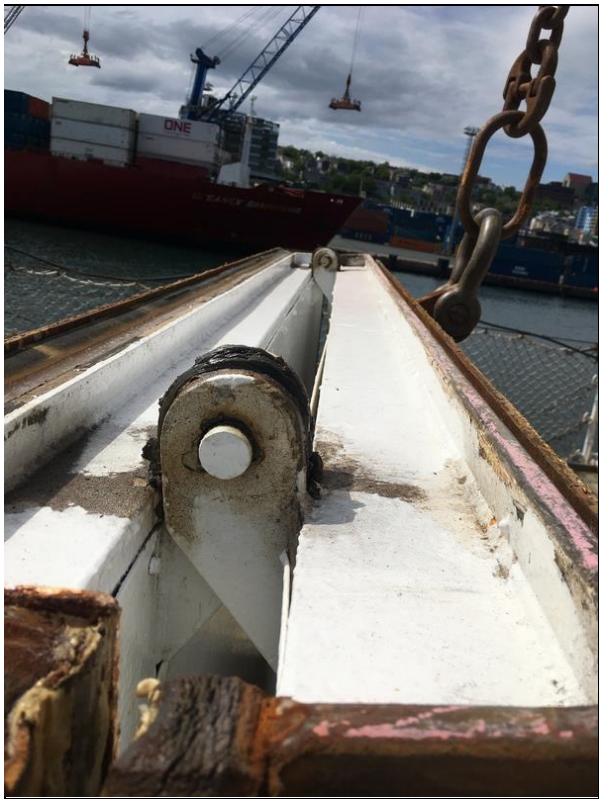
Figure 12: Intermediate Hinges on PS HC

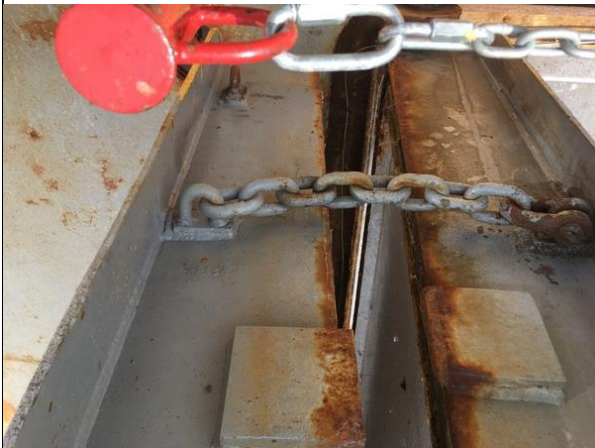
Figure 13: Preventer chain, typ.

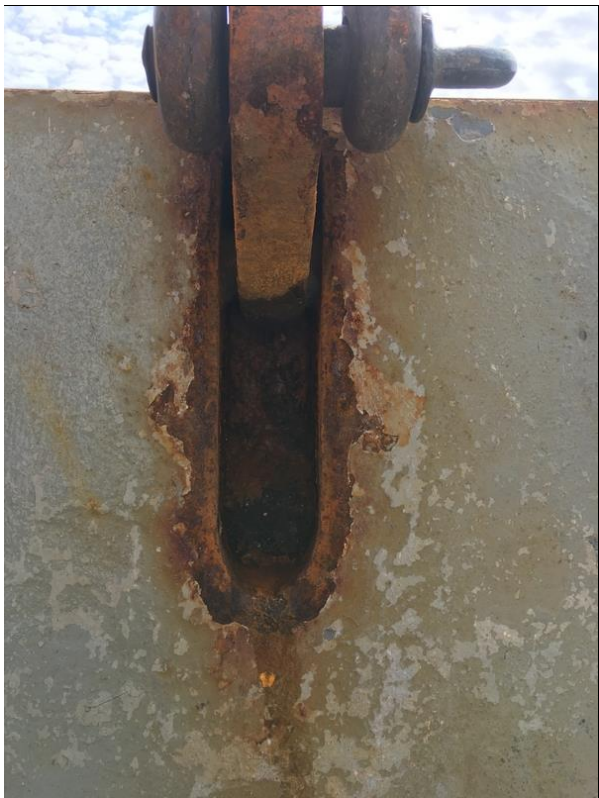
- 5) Lifting Lug & pocket:**
 - Good
 - Rusty, must be sandblasted and painted
- 6) Over-compression stoppers:**
 - Upper side good, bottom side & edge rusty, must be sandblasted and painted

Figure 14: Condition of lifting lug, typ.

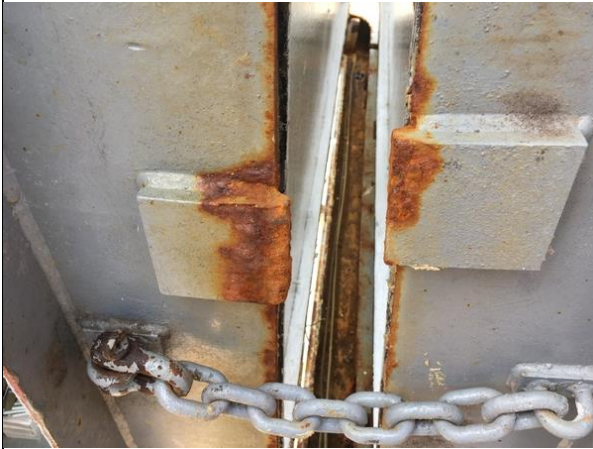
Figure 15: Condition of over-compression stoppers

- Relative Height from bottom of rubber retainer channel to stoppers bottom edge must be measured and compared with the requirement for achievement of nominal rubber compression. Any found deviation in height from originally designed, must be eliminated in order to maintain the required nominal rubber compression.

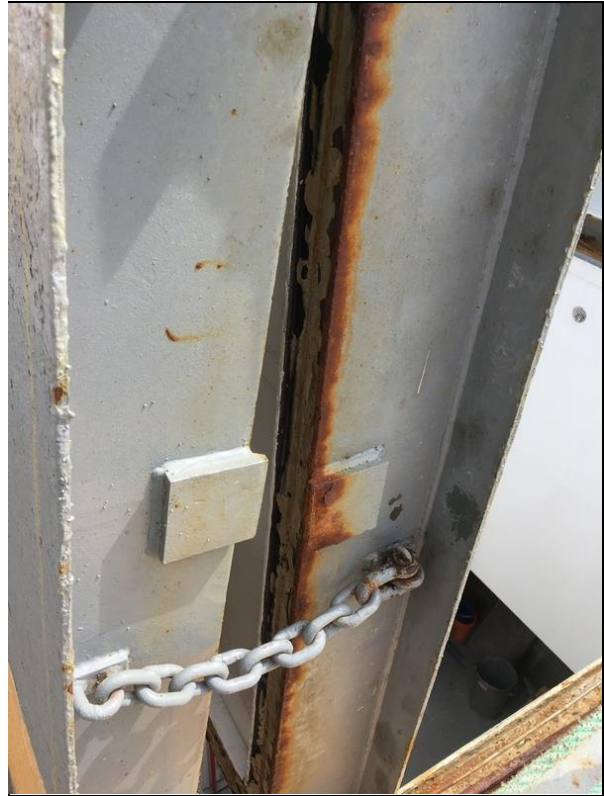
Figure 16: Condition of Side plates bottom edge

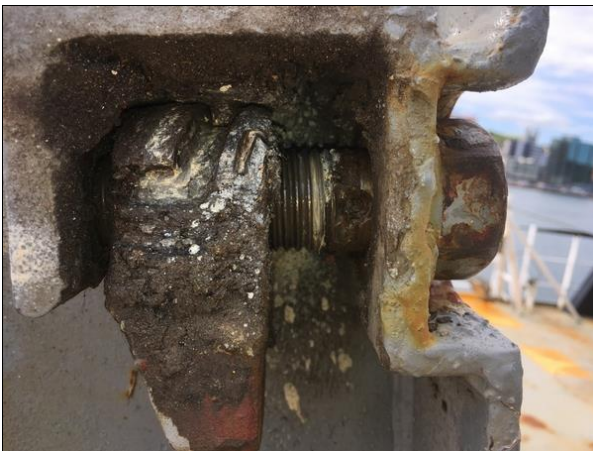
- Good
- A spring pin was found missing on PS HC – Fwrd Panel.
- All spring pins should be replaced.

Figure 17: Condition of flush deck cleats.
This one has a missing Spring Pin

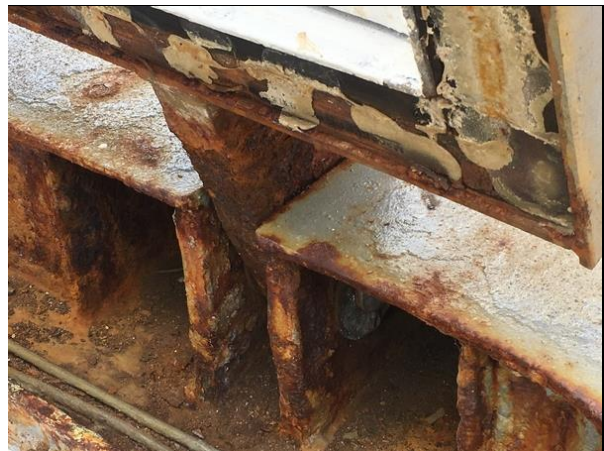
- d) Bottom structure: couldn't be inspected without removal of double-skin plates
- 3) Main hinges:**
 - Plates rusty, must be sandblasted and painted
 - Must be dismantled in order to inspect the hinge-pins condition and hinge-pin holes condition, then compare with original design dimensions and TOL. and make decision if they are reusable or to be renewed.

Figure 18: Condition of main hinges, typ.

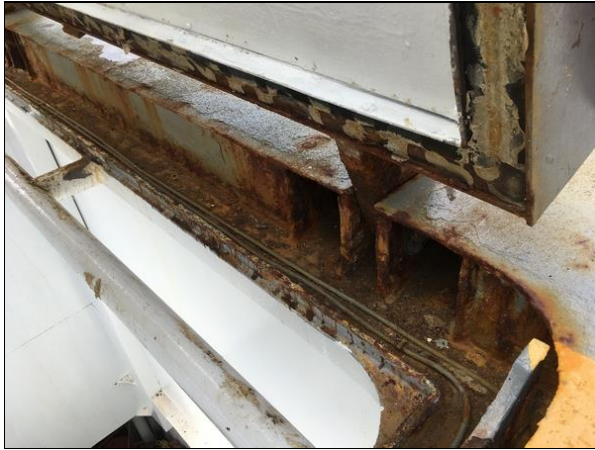
- No damages
- Must be renewed because rubber material lost its original elastic properties
- Seems lack of compression & W/T present, based on discovery of traces of neoprene glue on the entire HC parameter's exposed face of the rubber gasket, which is the result of gluing rubber shims on top of rubber gasket face, what didn't hold and rubber shims were falling-off. In any case, if rubber shims need to be used in order to compensate for lack of compression and W/T, the correct procedure is to install the rubber shims under the rubber gasket, not on its top face.

- Rusty
- To be sandblasted and painted

- Corrosion present, especially top face is critical since rough top face damages the rubber packing face and might not assure full W/T
- To be replaced with stainless steel compression bar, material: AISI 316-L. This suggestion & decision was in agreement with the Ship Representative.
- Top face of SS compression bar to be ½ round.

Figure 19: Condition of coaming, compression bar & Rubber Packing. One can see remaining of neoprene glue on top of rubber packing face.
