Building Condition Report - Winnipeg Tax Centre Site Winnipeg P600009A

66 Stapon
Winnipeg Tax Centre Site Winnipeg P600009A
P600009-101-60000321
Winnipeg
Construction Year: 1979
Gross Area (SM): 31,710
Date of Most Recent Assessment: 1/18/17

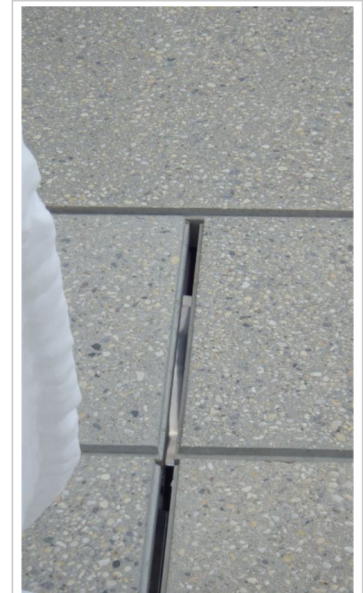
Precast Concrete Panels - Low-Rise
- Deformed metal closure strip at one of the vertical precast panel joints

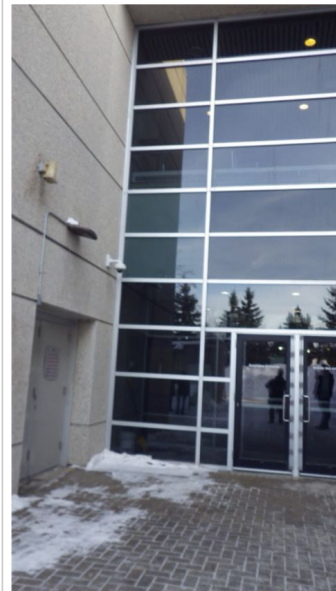
Curtain Wall System - Curtain wall on the west elevation.

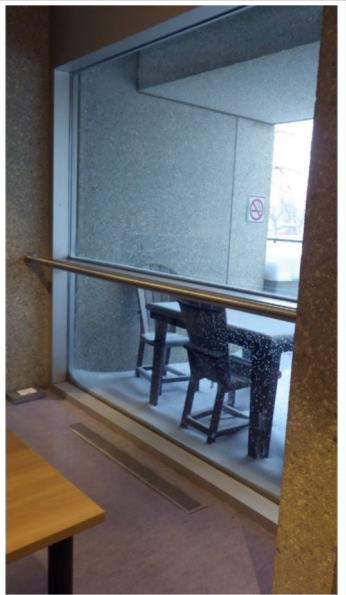
Aluminum Windows - Window in the lunchroom.

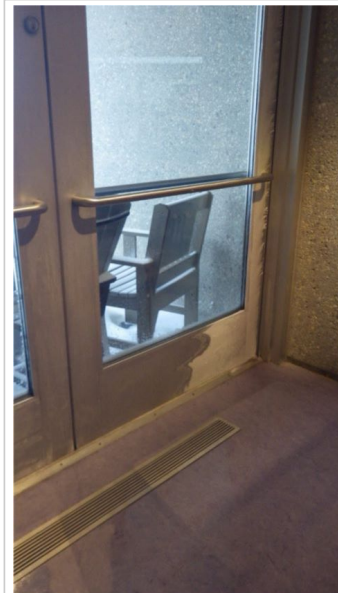
Glazed Doors - Frost build-up on one of the glazed aluminum doors in the lunchroom.

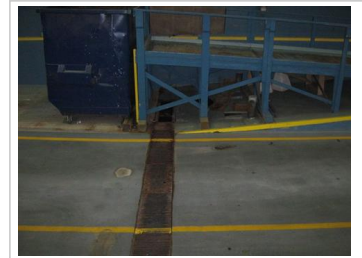
Oct.26-28 079 (Small).jpg - Note holes in the traffic bearing membrane.

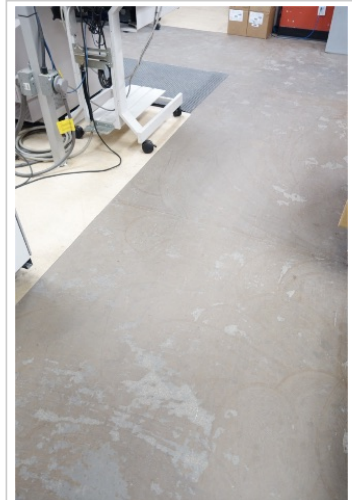
Sealed-Epoxy Concrete Floor - Mail Processing - Worn out sealed concrete flooring in mail processing area

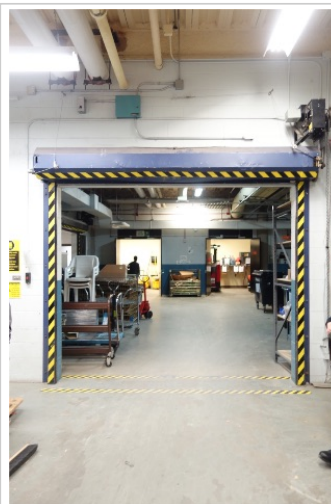
Painted Concrete Floor - Worn painted concrete floors in heavy traffic corridors.

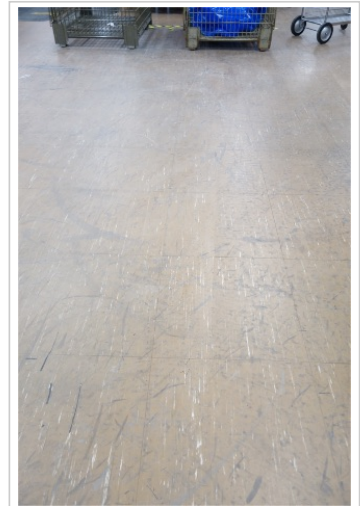
Vinyl Floor Tile - Scuffed vinyl floor tile on main floor west side of the building

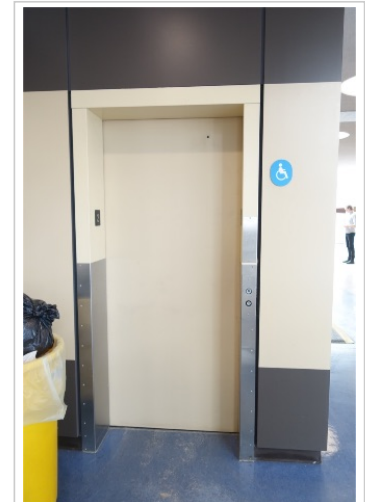
Upgrade both elevators - doors & cylinders - Passenger Elevator from second floor

We are recommending the three elevators be upgraded as identified in this report, which would extend their life cycle to 2044.

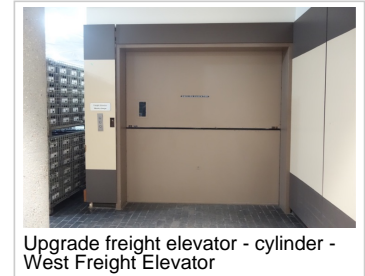
Upgrade freight elevator - cylinder - West Freight Elevator

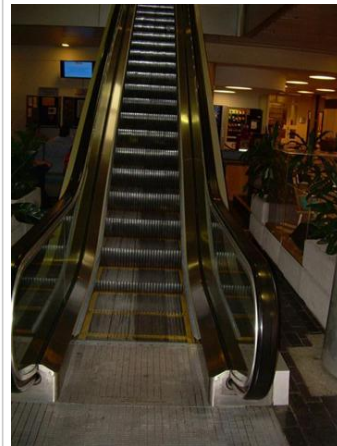
mech 098 (Small).jpg - One of the escalators near the front entrance to the building.

According to a conversation with the Building Manager on March 29, 2017, a capital project to replace the escalators has been proposed for 2019-2021.

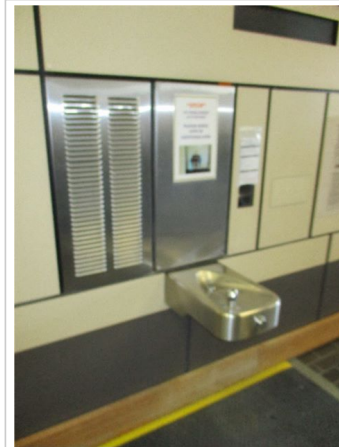
Replace: Water Coolers - Wall-Mounted Dual-Height (Each) - Water fountain to be replaced.

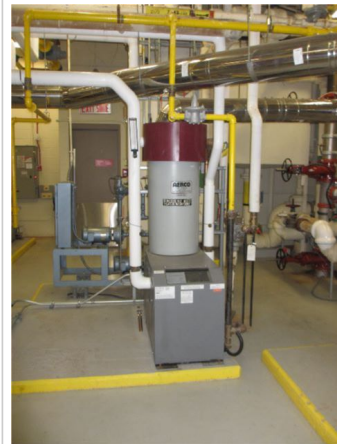
Replace 1 domestic hot water boilers - Existing domestic hot water boiler

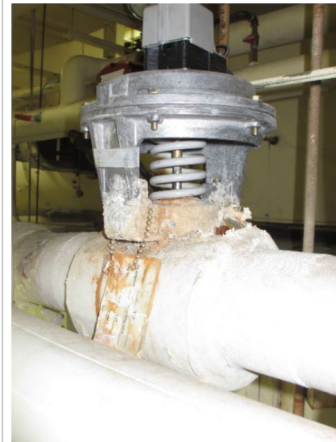
Renew pneumatic control valves - long term renewal - Leaking control valves.

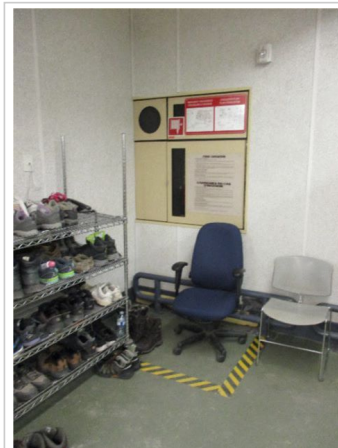
Provide Access to Hose Cabinet - Access to fire hose cabinets to be always clear

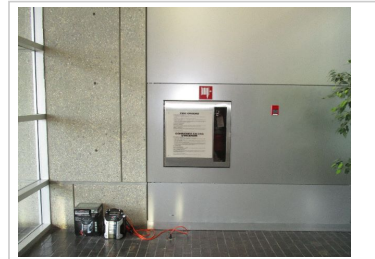
Replace Fire Hoses - Fire Hose Cabinet

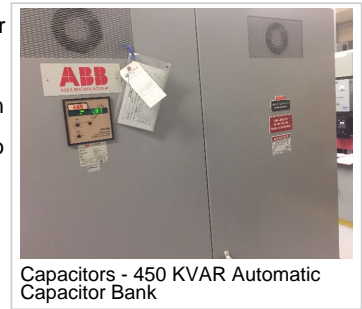
Capacitors - An Automatic Capacitor Bank has been lacking maintenance or record keeping, condition cannot be verified without proper testing.

Capacitors - 450 KVAR Automatic Capacitor Bank

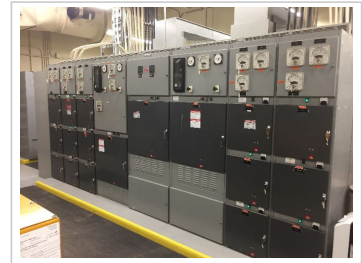
Secondary switch gear - The secondary switchgear appears to be in good condition except for the main breaker #2 was in the tripped position at time of review and was apparently due to an under voltage relay. The trip should be investigated and corrected.

Secondary Switchgear - Secondary Switchgear

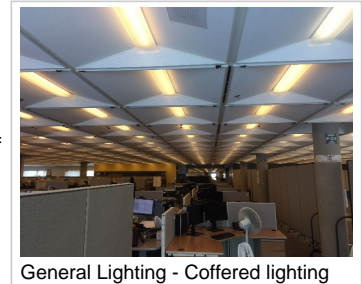
General lighting - Fluorescent fixtures are used almost exclusively. Fixtures in the coffered acoustical ceiling appear to be failing as netting has been installed to catch falling pieces. As lighting is replaced, LED should be considered.

General Lighting - Coffered lighting
