**Upper Kawartha DSR
Burleigh Falls Dam
2014 Geotechnical Site Investigation Report**
FINAL

**KGS Group 13-0006-012
December 2015**

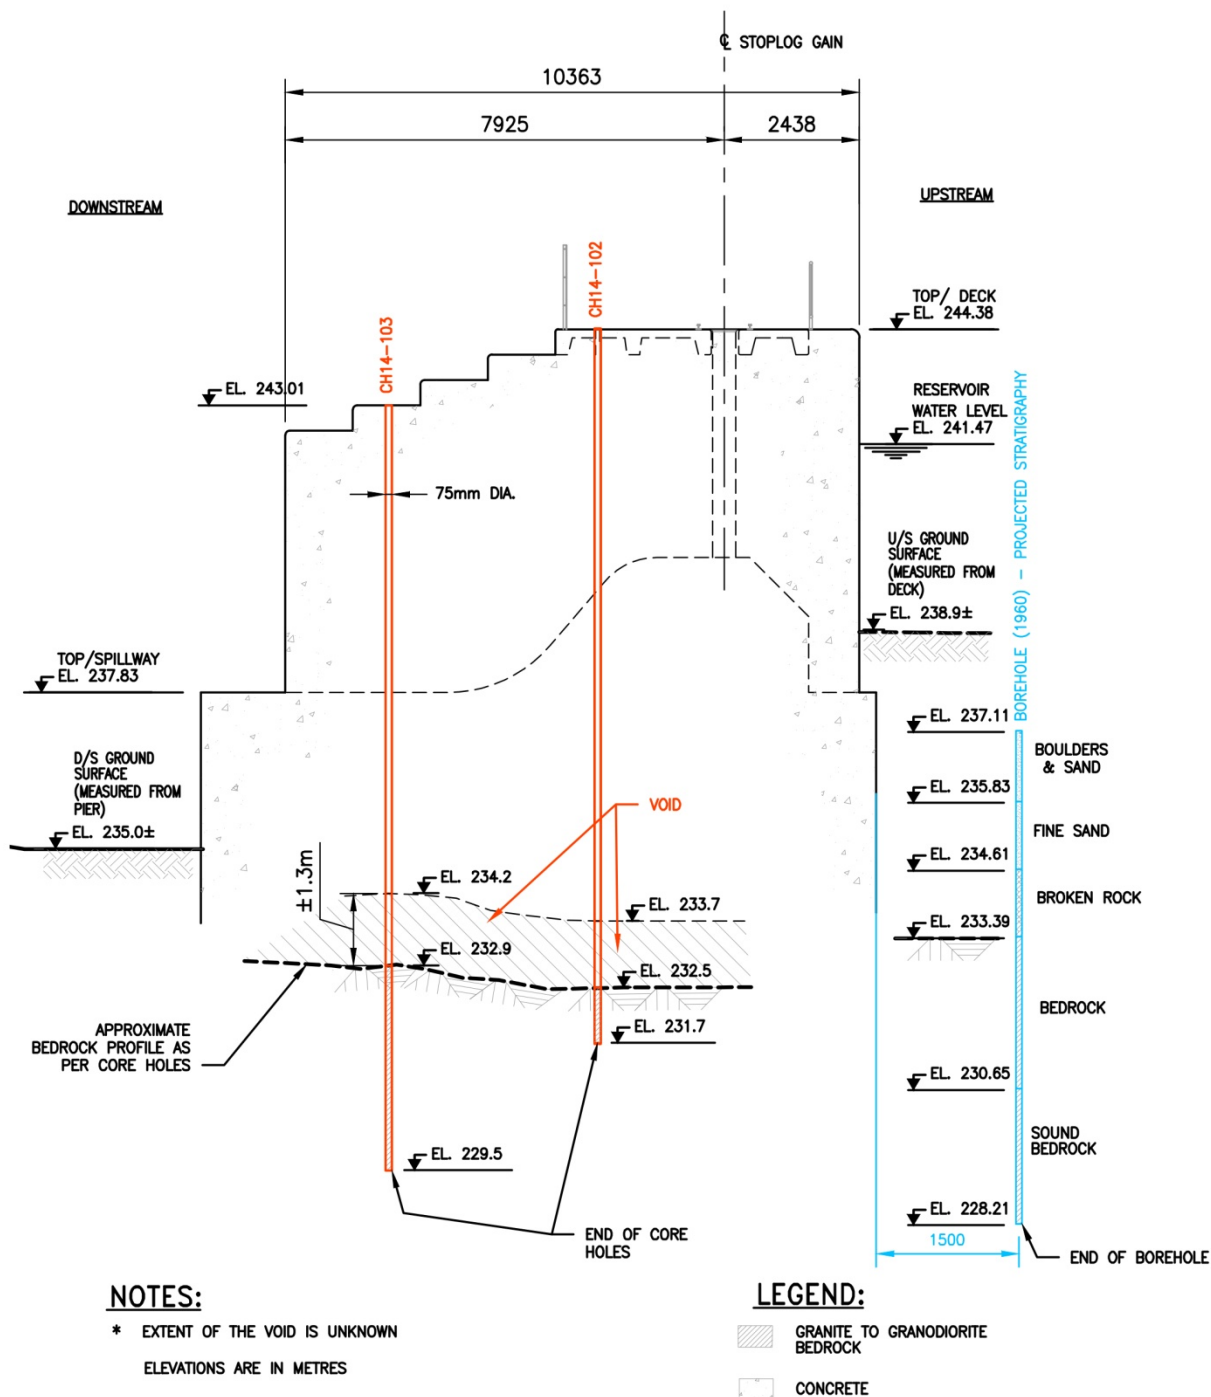
FIGURE 4.1-1
CROSS SECTION OF BURLEIGH FALLS DAM PIER #1

Numerous construction joints were noted throughout the structure during coring activities. Signs of possible seepage along a construction joint at 7.5 m depth was noted at CH14-102 and CH14-103, both located on Pier #1.

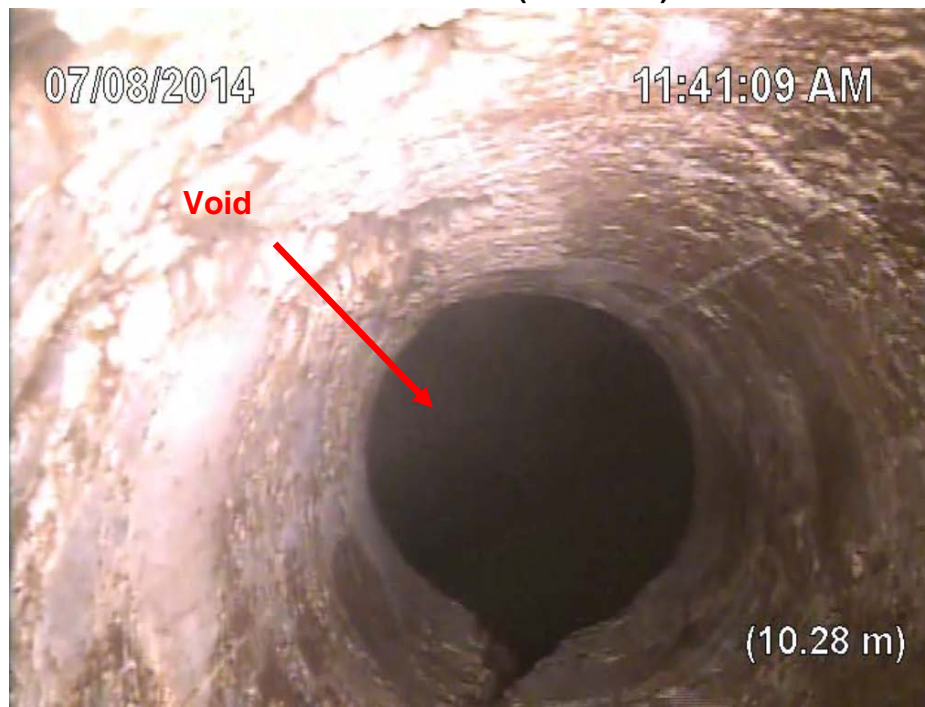
A downhole video survey was completed at CH14-102 and CH14-103 to investigate the nature of the void and potentially estimate its aerial extent. The survey was completed by Acu Flow Services of Peterborough, ON with continuous KGS Group supervision. The survey consisted of lowering a standard portable front view camera on a cable connected to a laptop computer for real time viewing and recording. Photographs (screen shots) showing the condition of the void and the concrete to bedrock interface are presented in Photos 4.1-1 to 4.1-6. The downhole video survey showed a significant void between the bottom of the concrete structure and the top of the bedrock (see Photos 4.1-2, 4.1-4 and 4.1-5). Granular sand, gravel, cobble sized material was noted on top of the bedrock surface (see Photo 4.1-4). Floating debris in the water column indicated that the flow of water was turbulent and appeared significant in volume. The aerial extent of the void could not be determined with the front view camera.

**PHOTO 4.1-1
VOID AT PIER #1 (CH14-102)**

It should be noted that PWGSC / PCA has informed KGS Group that any further investigation work of this void will be undertaken under a separate capital project.

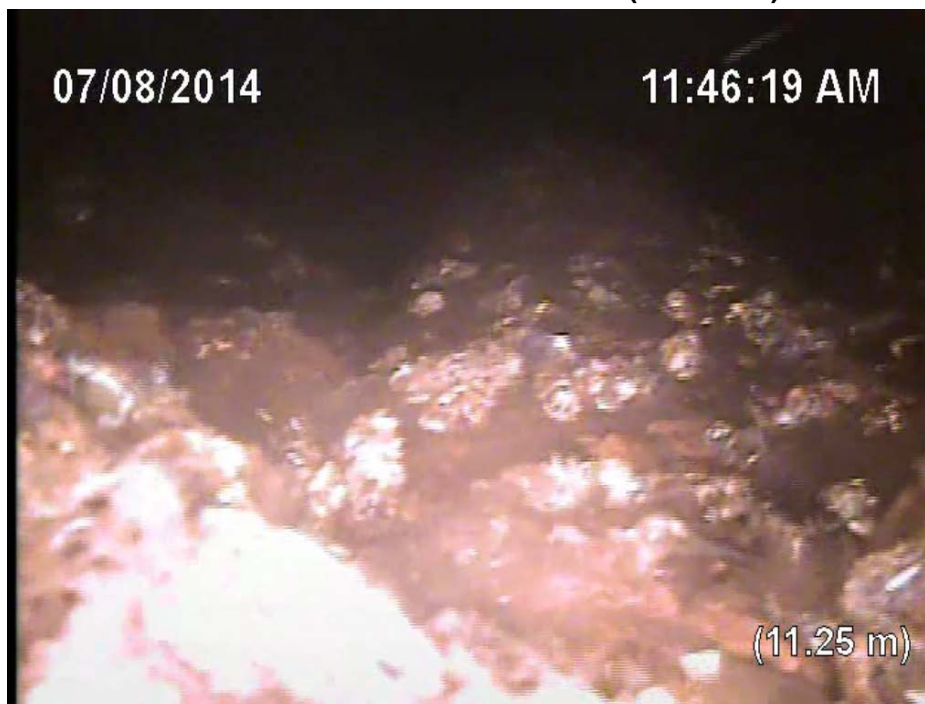
**PHOTO 4.1-2
CONDITION OF VOID AT PIER #1 (CH14-102)**

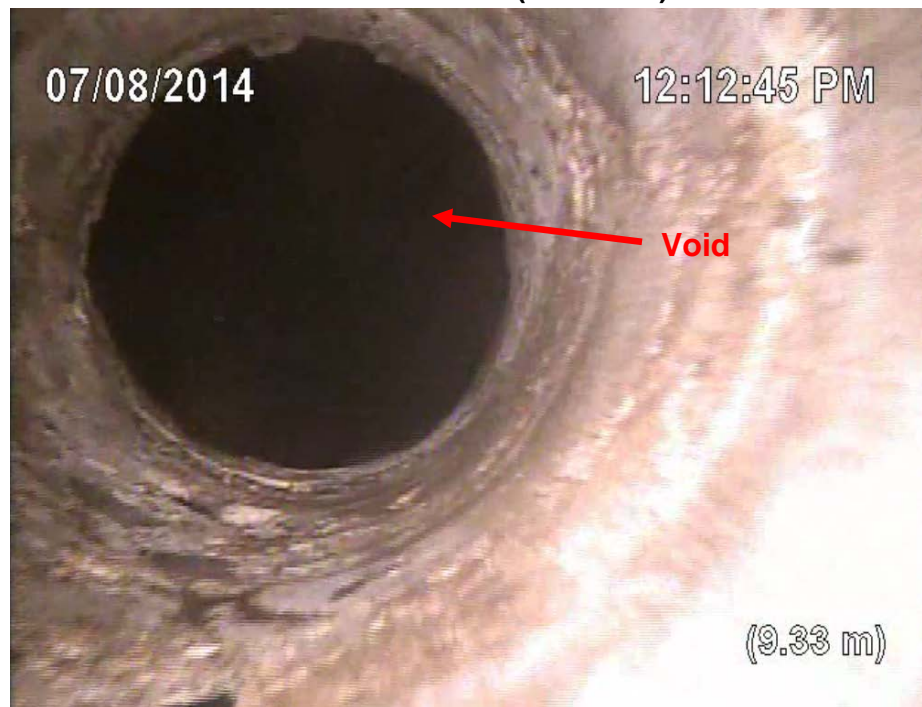
PHOTO 4.1-3
VOID AT PIER #1 (CH14-103)

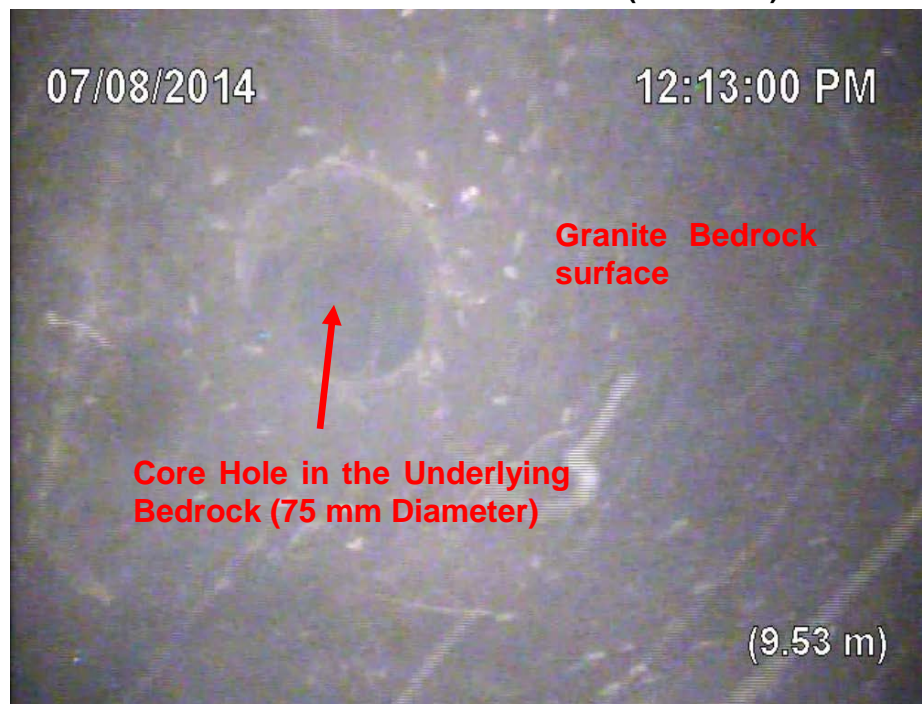
PHOTO 4.1-4
CONDITION OF VOID AT PIER #1 (CH14-103)

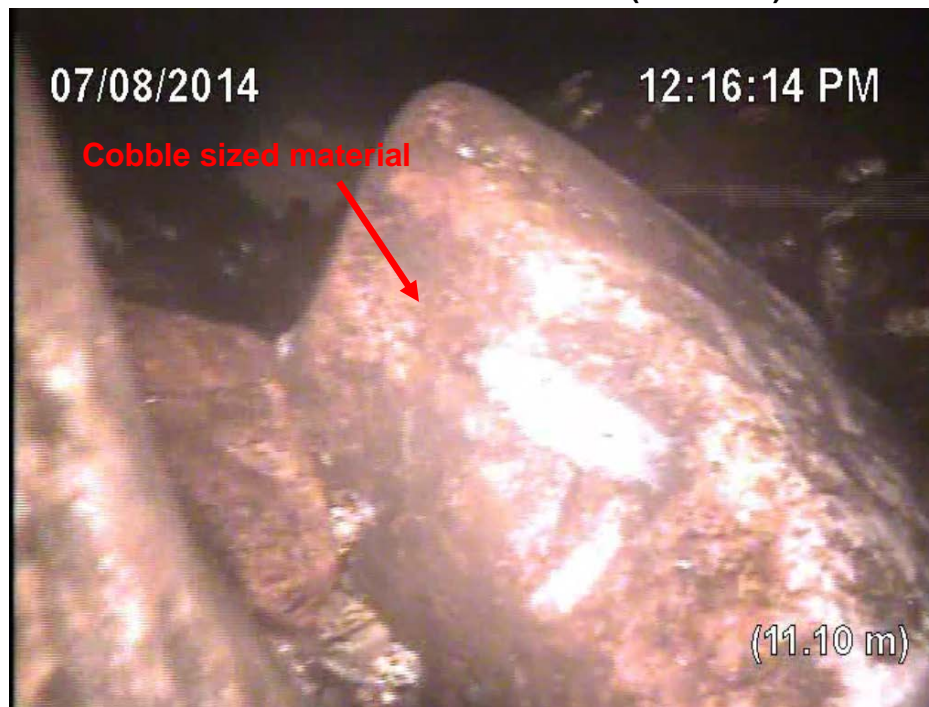
PHOTO 4.1-5
CONDITION OF VOID AT PIER #1 (CH14-103)

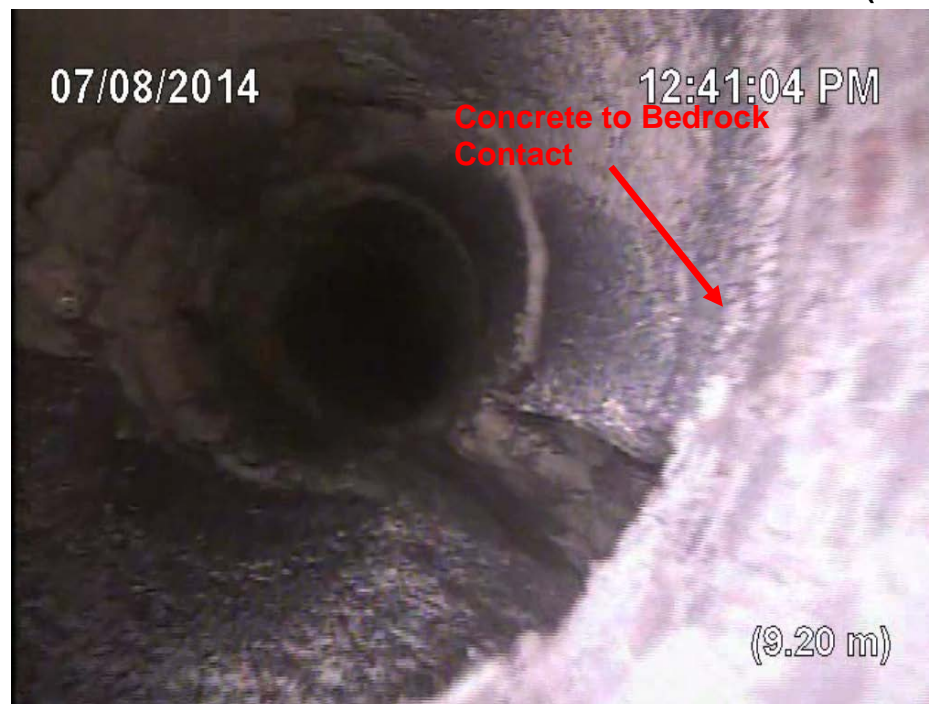
In addition to CH14-102 and CH14-103 the downhole survey was also completed at CH14-101 where the concrete to bedrock contact was observed to be good with no voids or separation (see Photo 4.1-6). It should be noted that the video has been recorded into DVD format and submitted to PWGSC.

PHOTO 4.1-6
CONCRETE TO BEDROCK CONTACT AT SOUTH ABUTMENT PIER (CH14-101)

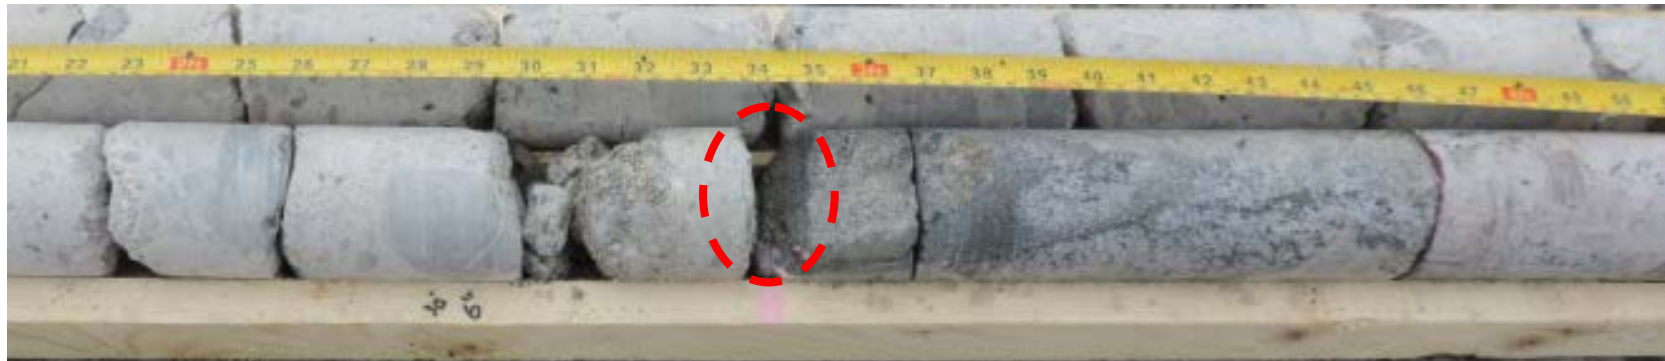
Spillway Concrete Structure
South (Right) Abutment Pier

-Unbonded bedrock to concrete interface. -A nail was observed at the bedrock - concrete interface. -Nearly horizontal bedrock to concrete interface, sloping at 85° to the core axis.

CH 14-101 Concrete-Bedrock interface
