**IQALUIT RECEIVER SITE – EQUIPMENT BUILDING  
MOULD AND BUILDING ENVELOPE ASSESSMENT &  
DESIGNATED SUBSTANCE SURVEY**

Iqaluit, Nunavut

**CONCENTRIC REFERENCE NUMBER:** 16-6912

**DATE:** SEPTEMBER 7, 2016

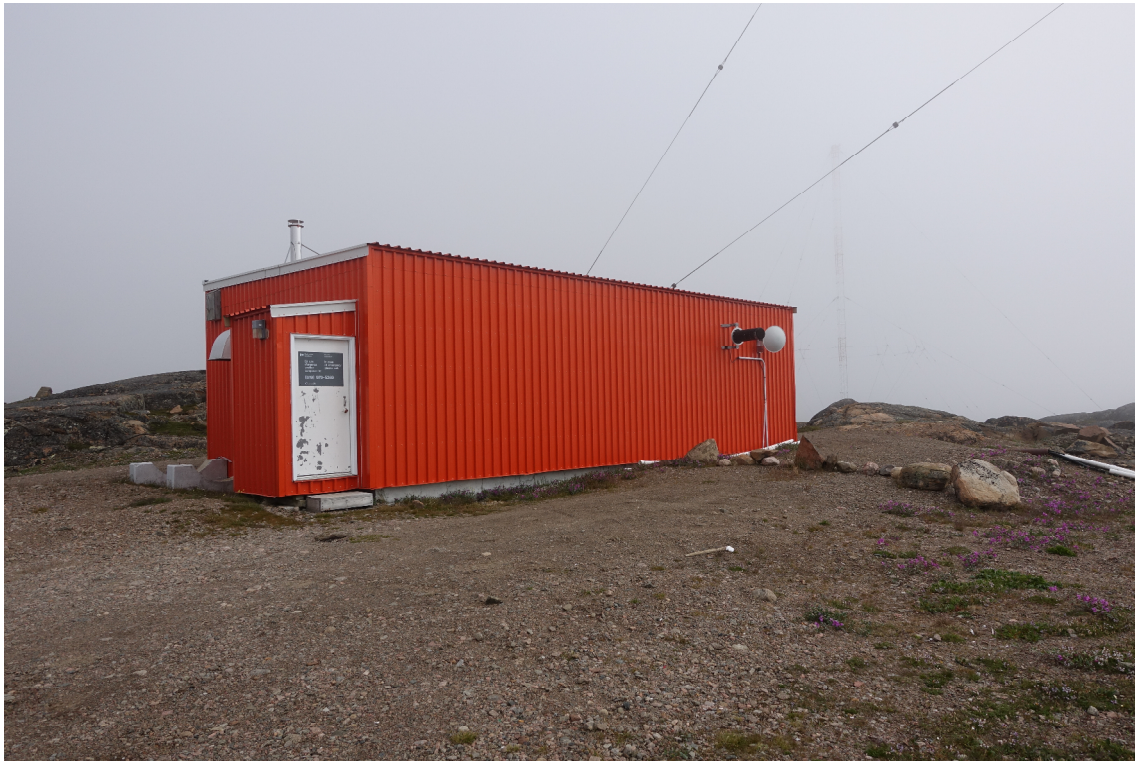
**Photograph 1.** View of CCG's equipment building at the Iqaluit receiver site.

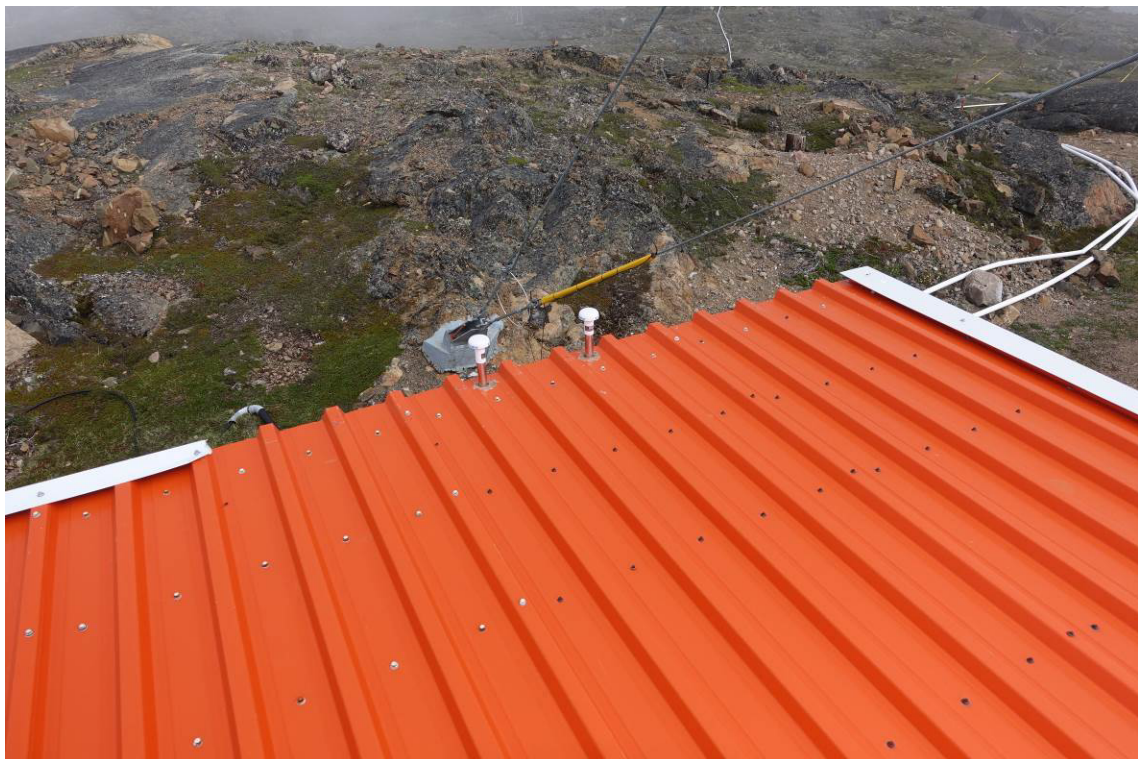
**Photograph 2.** View of the northeast corner of metal batten roof with flashing removed.

1. Seal flute openings with sealant (e.g. silicone or polyurethane).
2. Install metal flashing on the north (where previously removed) and south sides of the roof.
3. Repair any penetrations in metal cladding and ensure an adequate seal around exterior components (e.g. flue and air vents, pipes, cables and electrical, etc.).
4. Install more efficient (i.e. longer) vent covers that will prevent entry of wind-driven snow during the winter season

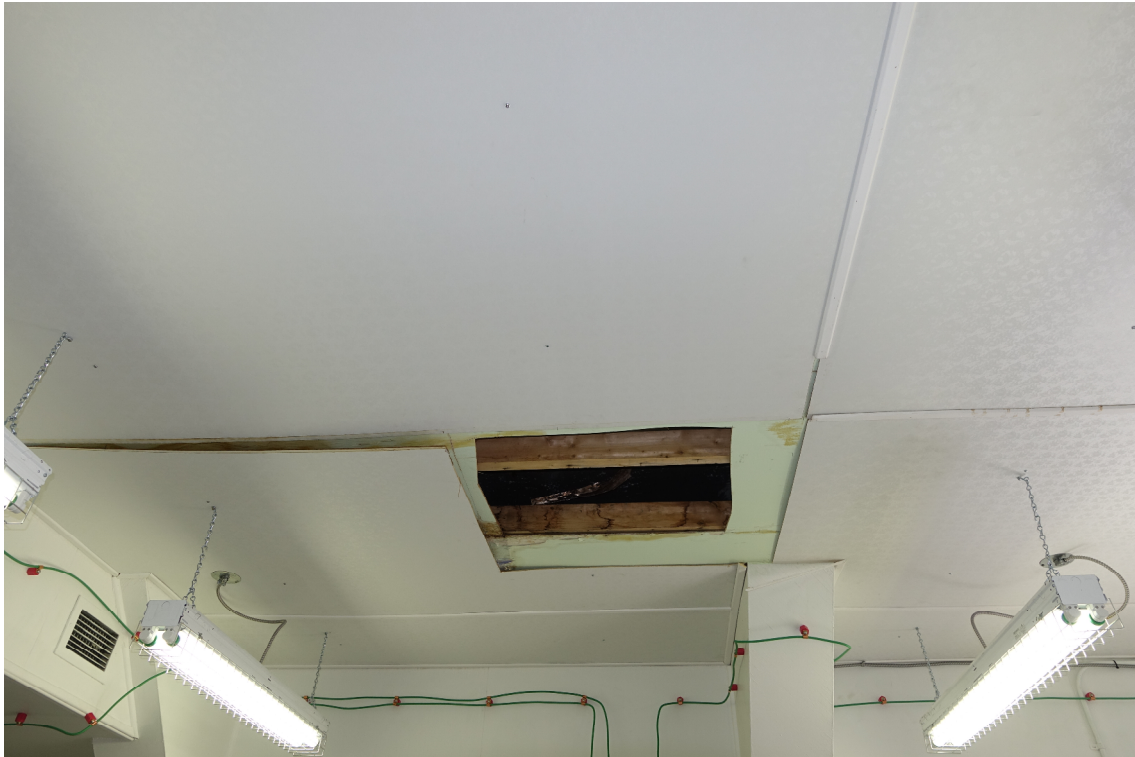
**Photograph 3.** View of test cut opening in the ceiling of the Radio room.

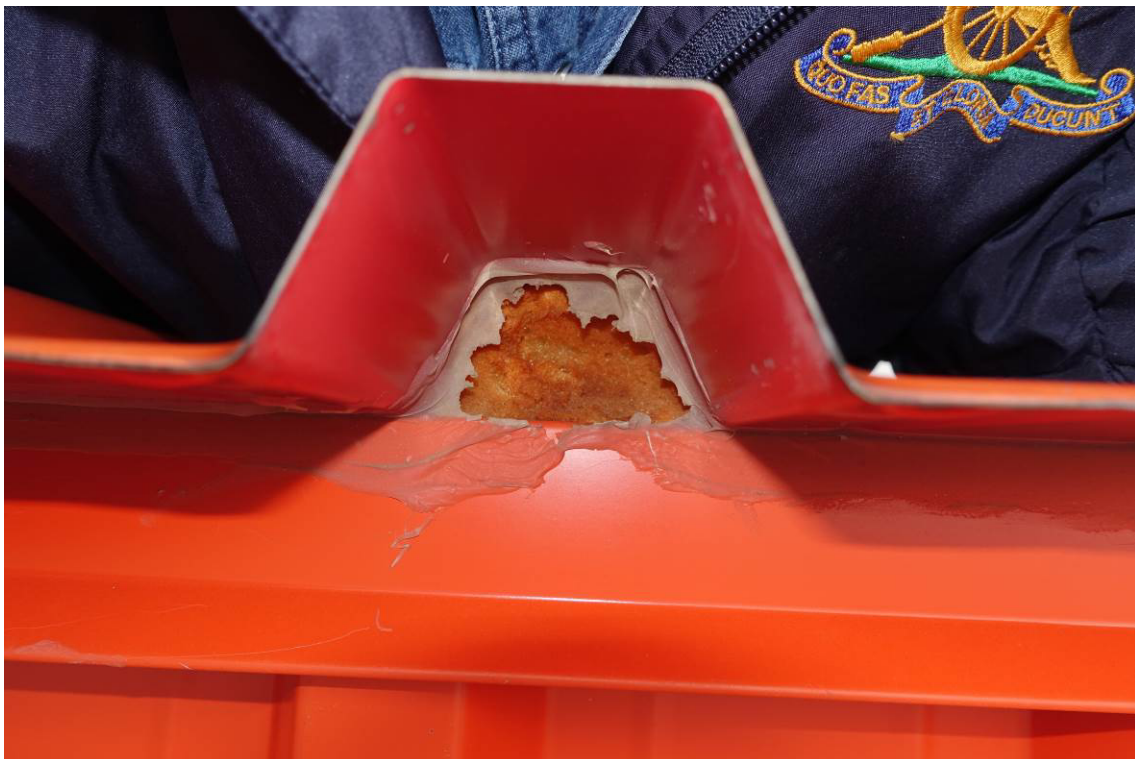
Various potential entryways for moisture into the ceiling assembly were observed. Most notably, insulation and sealant in the flute openings of the roofing system were deteriorated (see Photograph 4) and may be an entryway for moisture into the building. Various other penetrations or cavities in the building exterior were witnessed during the inspection, including the following:

**Photograph 4.** View of deteriorating sealant and insulation in flute opening of roof.

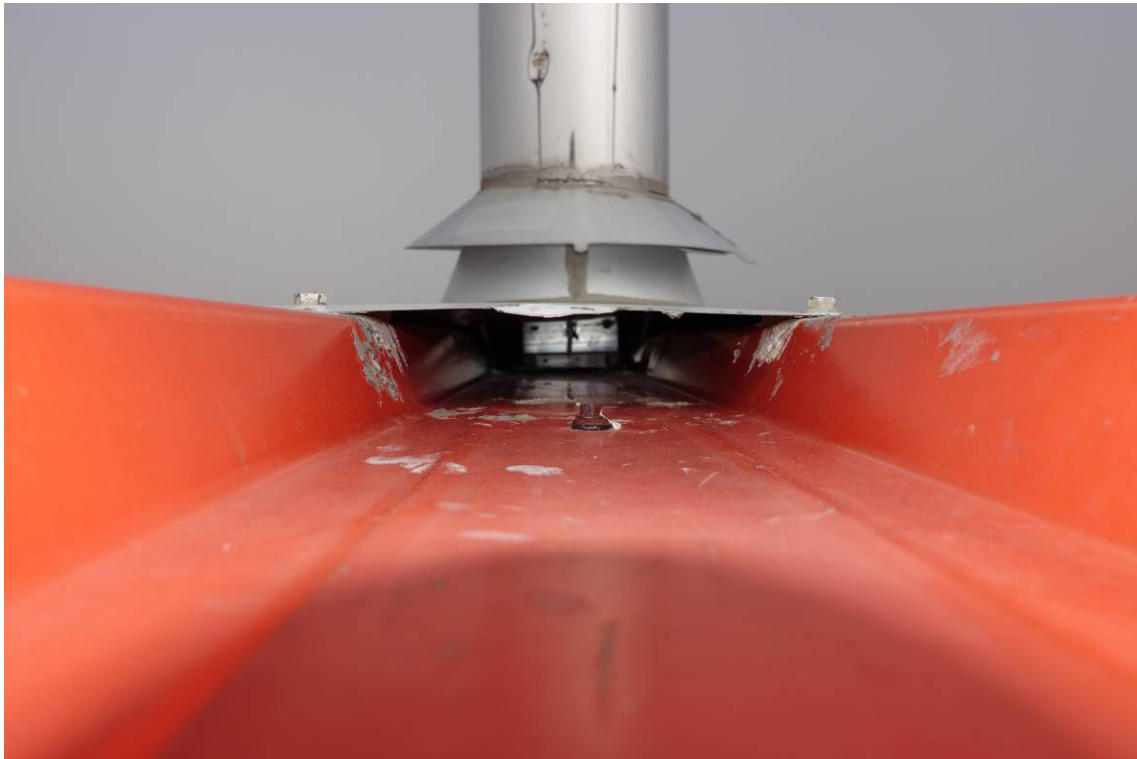
**Photograph 5.** View of the base of flue vent showing underlying cavity.

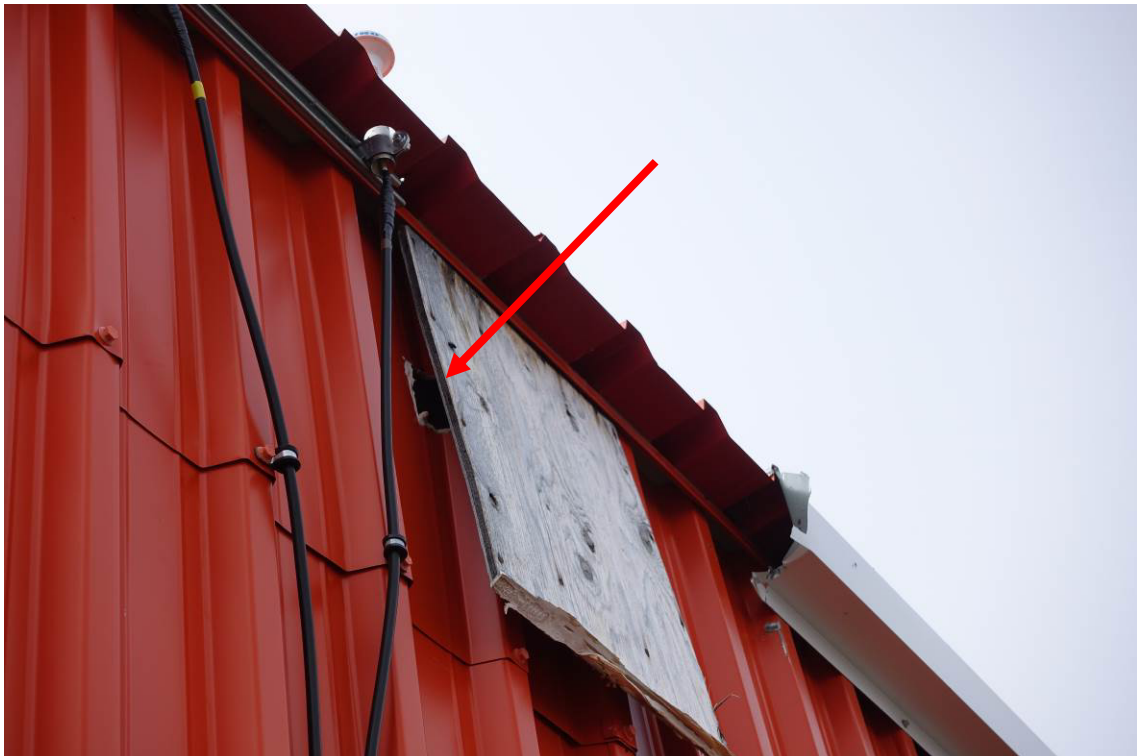
**Photograph 6.** View of ventilation opening in the metal cladding.

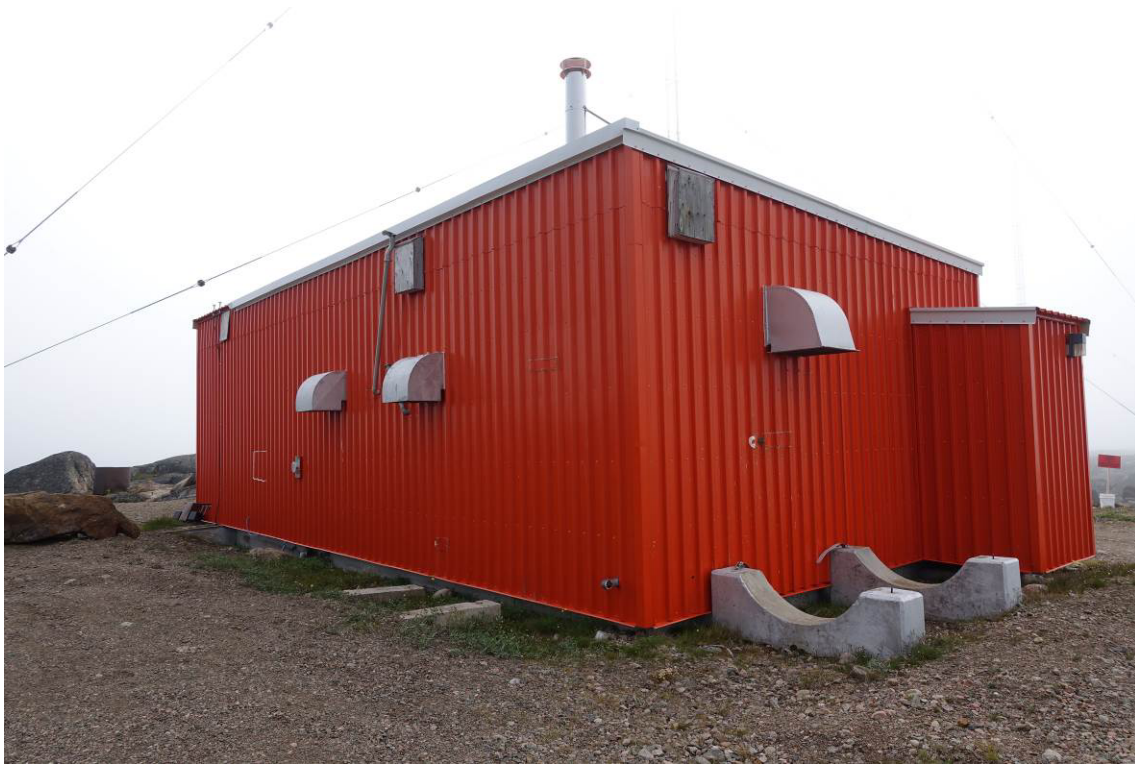
**Photograph 7.** Small vent hoods on the north and west sides of the building.

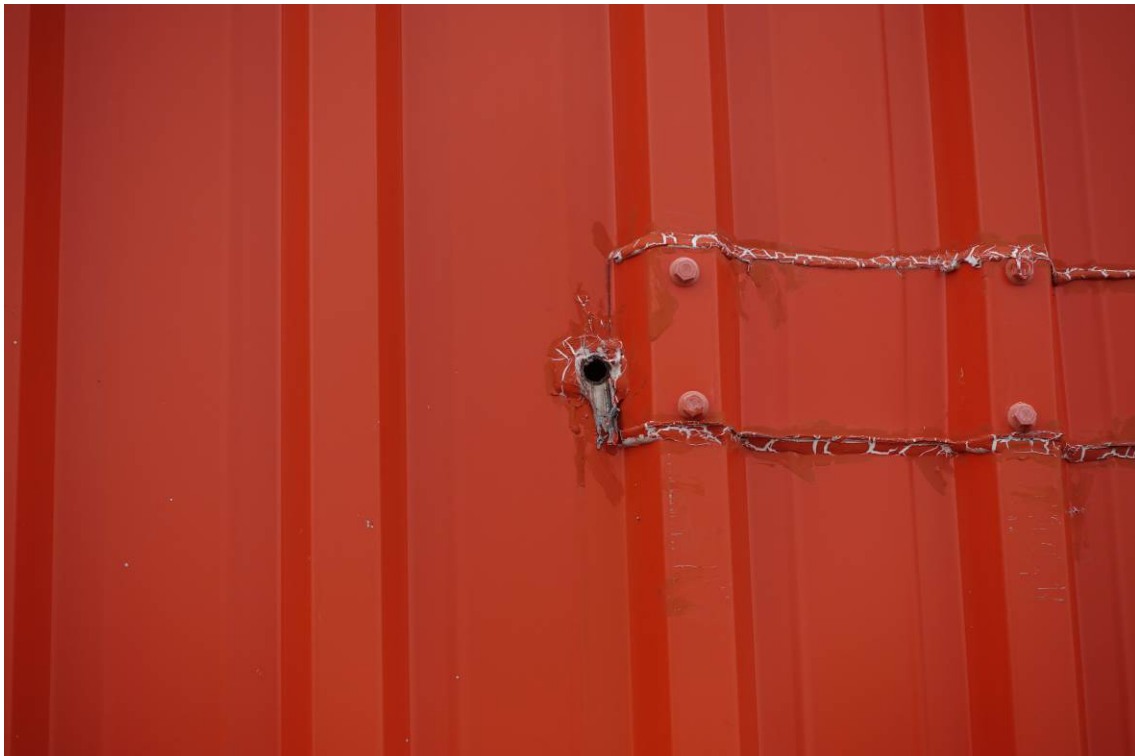
**Photograph 8.** Small penetration in the metal cladding of the building.

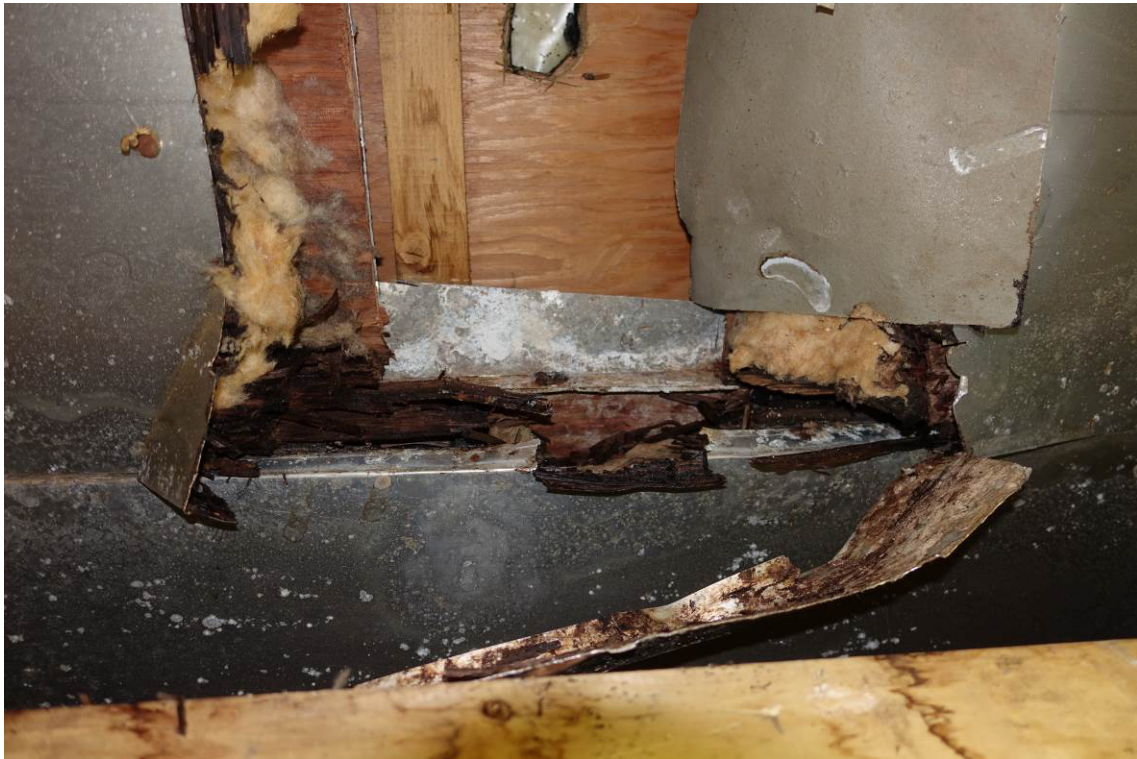
A visual inspection of the attic space above the radio room confirmed the presence of mould impacted and water-damaged (i.e. rotted) building materials (see Photograph 9). Specifically, the plywood appeared to be in an advanced stage of rot and the insulation was deteriorated. Due to accessibility issues, only the area immediately adjacent to the test opening in the radio room was inspected. Complete delineation of the attic space was not possible without creating additional destructive openings. However, due to the age of the building and severity of the water damage observed, it is presumed that the majority of the attic space above the wood joists and blocking are water damaged and/or contaminated with mould.

**Photograph 9.** View of rotted wood and mould-contamination in the attic space.

It is recommended that the all porous mould impacted or water damaged building materials within the attic space be removed. Non-porous materials (eg. wood, metal sheeting etc.) may need to be removed and replaced if it cannot be adequately cleaned or the mould has effected its soundness. Alternately encapsulation of this area may be an option if the area can be adequately sealed and ventilation within the building is not compromised.

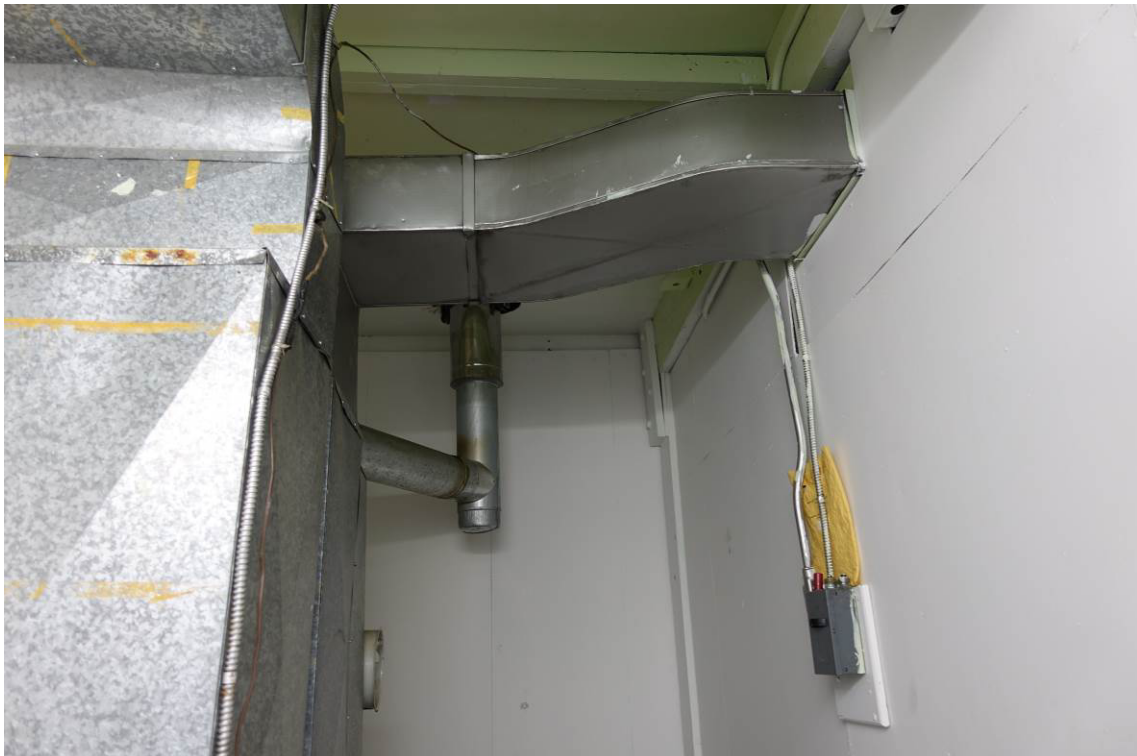
Analytical results confirmed the presence of asbestos in cement board on the south and east walls of the furnace room.

**Photograph 10.** Asbestos-containing cement board walls in the furnace room.

Cement board is considered a non-friable material and can therefore be removed by a qualified contractor using the low or moderate risk abatement procedures (depending on removal methods) specified in section 5.2 of the *Northwest Territories and Nunavut Codes of Practice for Asbestos Abatement*.

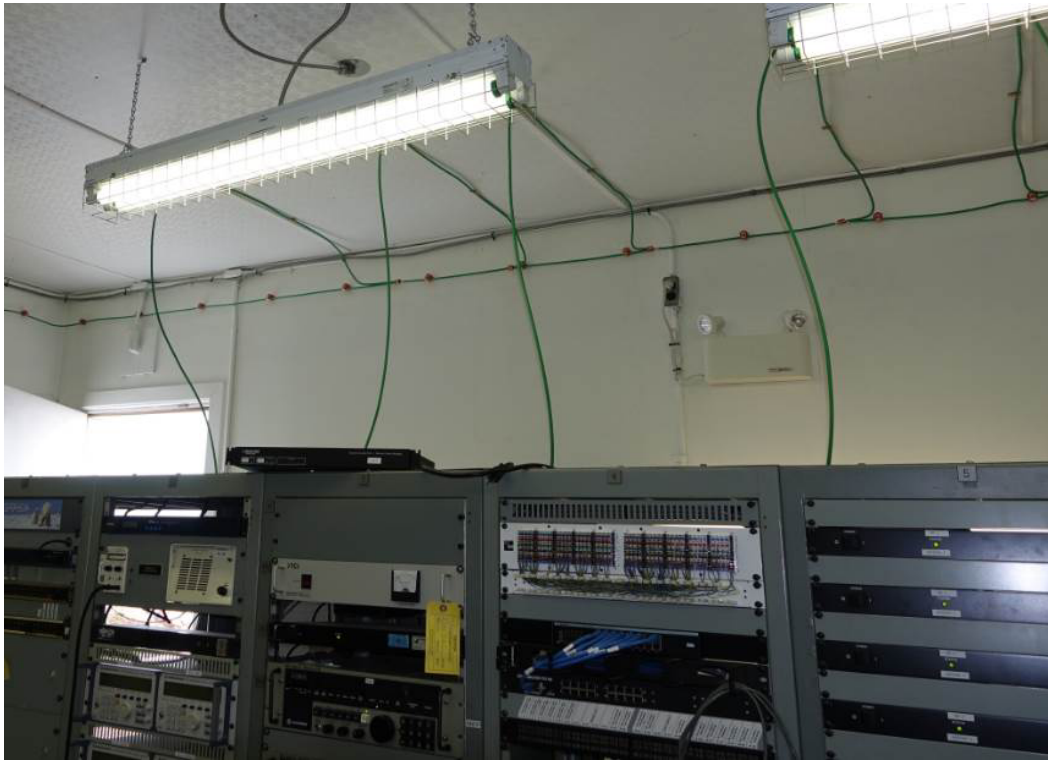
PCBs may be present in the ballasts of fluorescent lights (see Photograph 11). Concentric did not disassemble these light tubes to review ballast labels due to potential hazards to the surveyor.

**Photograph 11.** View of the generator room showing emergency lighting and fluorescent light tubes with potentially PCB containing ballasts.

It is recommended that fluorescent light ballast labels be checked to confirm the presence of PCB containing components prior to removal and disposal. If ballasts are not clearly labeled as "non-PCB", they must be considered PCB-containing. Alternatively, the Environment Canada Publication titled *Identification of Lamp Ballasts Containing PCBs* (1991) may be referenced to (potentially) determine if unlabeled ballasts contain PCBs.
