APPENDIX B4: DESIGNATED SUBSTANCE SURVEY

Project No: 19-1349
Regarding: Designated Substance and Hazardous Materials Survey
Marine Communication and Traffic Services Facility, Pointe Au Baril, Ontario

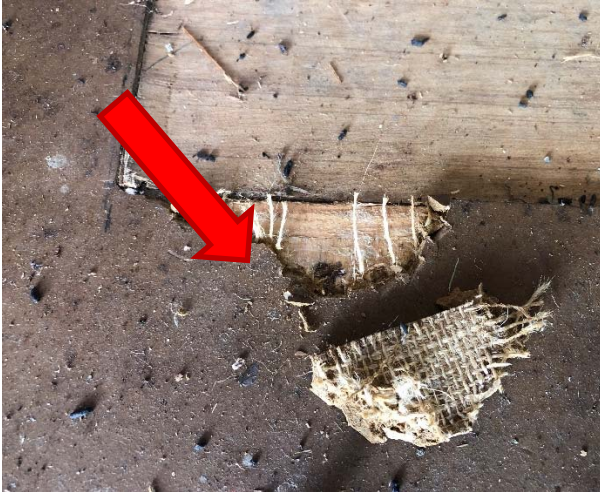
Brown sheet vinyl flooring with jute backing was found on the floor of the shed building. Based on inspection holes advanced in the floor and inspection of the access hatch, the shed floor consists of one layer of vinyl sheet flooring followed by plywood, insulation and a secondary layer of plywood. A total of three samples (S-004A-C) were collected of the sheet vinyl flooring and submitted for analysis. Brown sheet vinyl flooring and paper backing does not contain asbestos.

Brown sheet vinyl flooring with jute backing (S-004AC) does not contain asbestos.

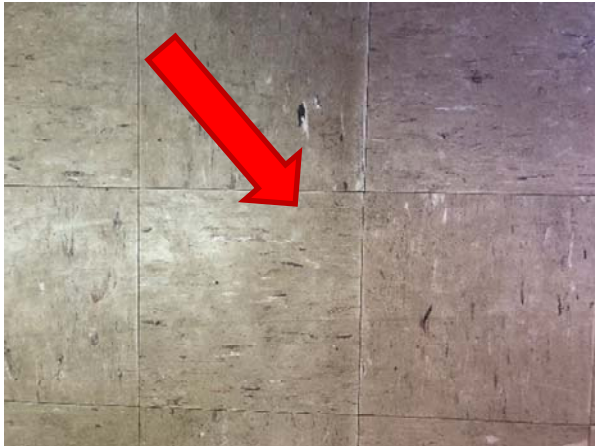
Beige with brown streaks 12" x 12" vinyl floor tiles were found in the trailer unit. Approximately 390 ft² of beige with brown streaks 12" x 12" vinyl floor tiles were found throughout the large trailer unit. A total of three samples were collected and submitted for analysis (S-005A-C). Beige with brown streaks 12" x 12" vinyl floor tiles contain chrysotile asbestos. The associated yellow mastic does not contain asbestos.

The beige with brown streak 12" x 12" vinyl floor tile (S-005A-C) and the pink 12" x 12" vinyl floor tile (S-007AC) both contain chrysotile asbestos, and as such, the removal of any flooring from the large trailer unit should be performed using methods stated in the recommendations section of the report.

Beige with brown streak 12" x 12" vinyl floor tile (S-005AC) contain chrysotile asbestos.

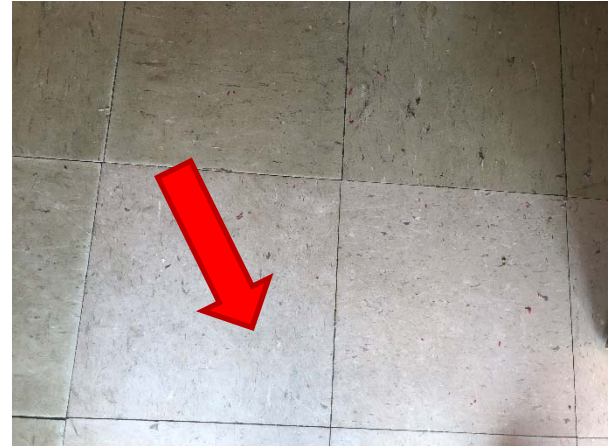
Pink 12" x 12" vinyl floor tiles were found at the north entrance to the trailer unit and consisted of approximately 10 ft² of tiles. A total of three samples were collected and submitted for analysis (S-007A-C). Pink 12" x 12" vinyl floor tiles contain chrysotile asbestos. The associated black mastic does not contain asbestos.

Pink 12" x 12" vinyl tile (S-007AC) contain chrysotile asbestos.

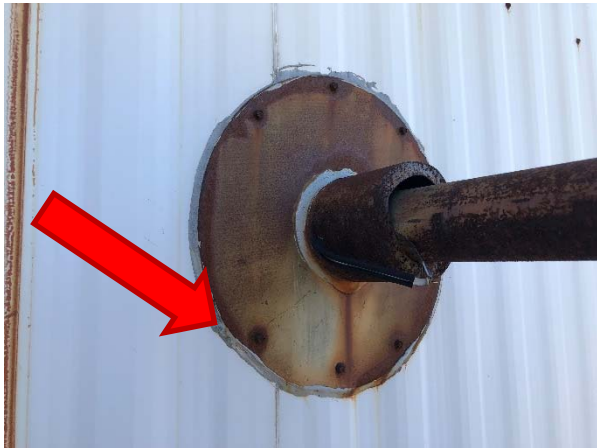
Grey caulking was observed around the exterior ducts and pipes of the shed building. A total of three samples of the grey caulking from the around the ducts and pipes were collected and submitted for analysis (S-001A-C). Grey caulking does not contain asbestos.

Grey caulking around pipes on the exterior of the shed building (S-001A-C) does not contain asbestos.

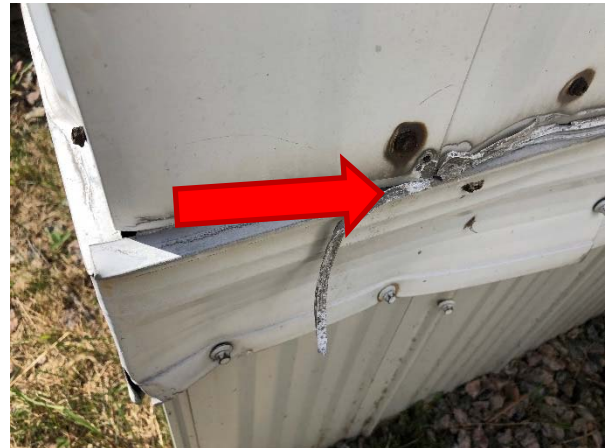
Clear caulking was observed around the base of the exterior steel panels of the shed building. The caulking was observed to be pliable and suspected to be silicone caulking which is known to not contain asbestos. Samples of the clear caulking were not collected.

Silicone caulking around the base of steel exterior panels on the shed building. Known to not contain asbestos.

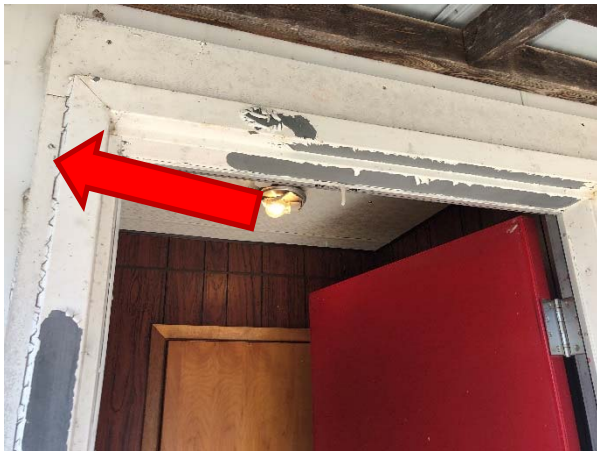
White caulking was observed around the exterior doors of the trailer unit building. A total of three samples of the white caulking were collected and submitted for analysis (S-002A-C). White caulking does not contain asbestos.

White caulking around doors on the exterior of the trailer unit building (S-002A-C) does not contain asbestos.

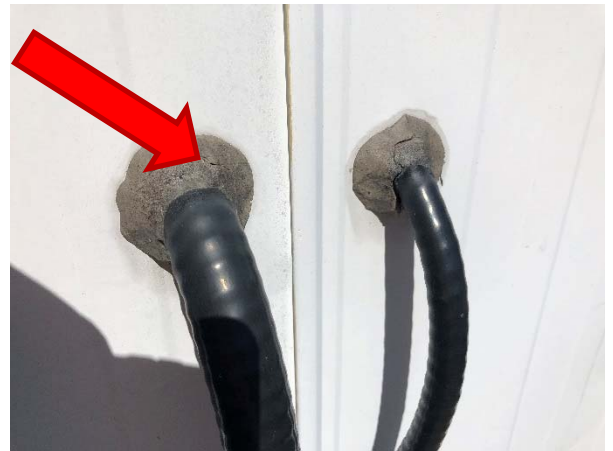
Grey caulking was observed around the exterior wiring of the trailer unit building. A total of three samples of grey caulking were collected and submitted for analysis (S-003A-C). Grey caulking does not contain asbestos.

Grey caulking around wiring on the exterior of the trailer unit building (S-003A-C) does not contain asbestos.

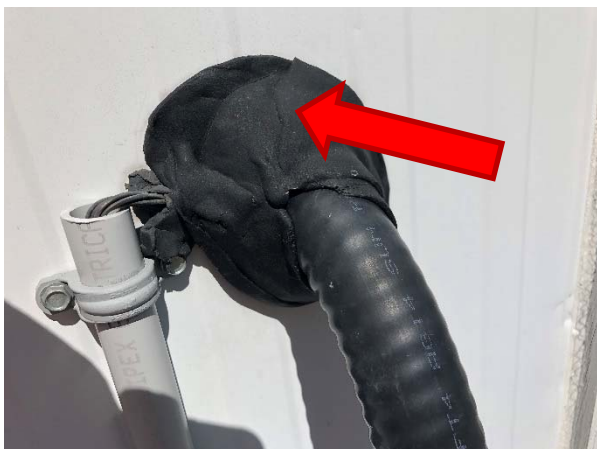
Black putty was observed around the exterior wiring of the trailer unit building. A total of three samples of black putty were collected and submitted for analysis (S-008A-C). Black putty does not contain asbestos.

Black putty around wiring on the exterior of the trailer unit building (S-008A-C) does not contain asbestos.

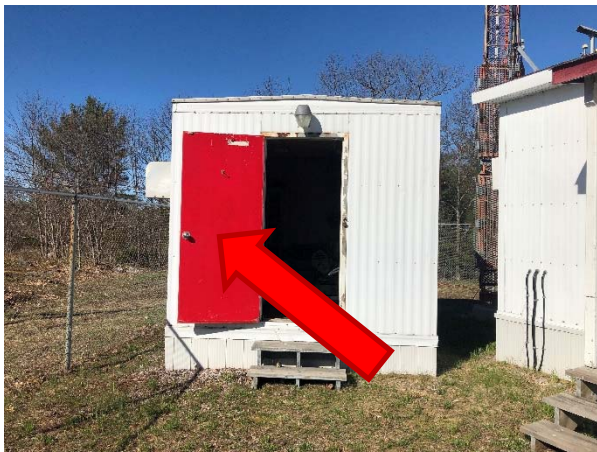
- Red paint (LP-01) on the exterior doors contains lead-containing paint (2.37%) and was found in poor condition with peeling and flaking.
- White paint (LP-02) on exterior door trim contains 0.32% lead and was found in poor condition with peeling and flaking.

Paint on most surfaces was in good to fair condition with some localized areas of peeling. The red paint (LP-01) on the exterior doors and the white paint (LP-02) on exterior trim was found to be peeling and flaking in many areas.

Red paint on the exterior doors (LP-01) contains 2.37% lead.

All substrates that are schedule to undergo demolition by cutting, grinding, burning or any other aggressive method that are coated with lead-containing paint should be properly abated prior to demolition by qualified workers trained in the abatement of lead and should generally follow guidelines such as the Ontario Ministry of Labour Guideline "Lead on Construction Projects" or the Environmental Abatement Council of Ontario (EACO) "Lead Guideline for Construction, Renovation, Maintenance or Repair", dated October 2014.

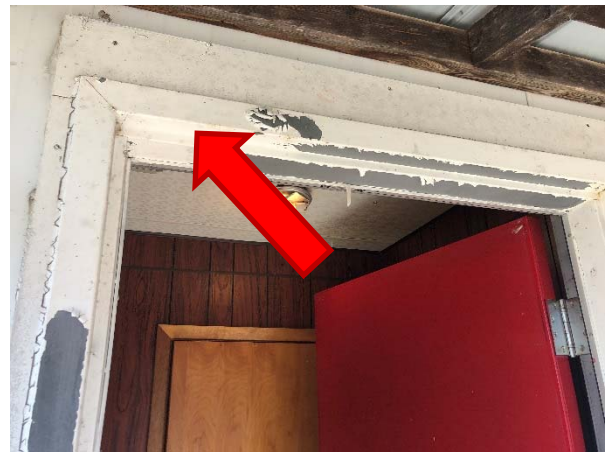
White paint on door trim on the exterior doors (LP-02) contains lead.

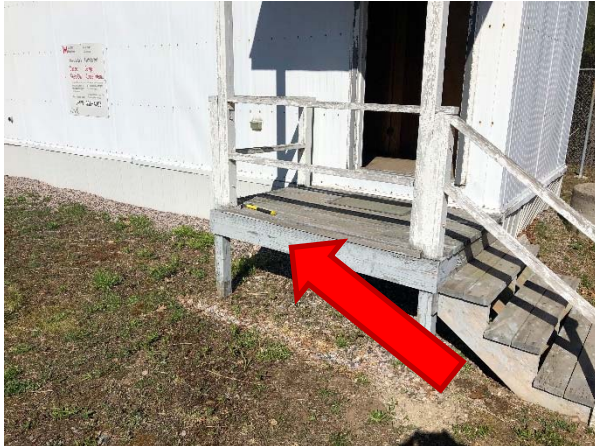
- Grey paint (LP-03) on decking contains very low levels of lead 0.0015% and was found in moderate condition with minimal peeling or flaking.
- Brown paint (LP-04) on wood skirting behind the metal skirting of the trailer unit contains 0.14% lead and was found in moderate condition with minimal peeling or flaking.

Grey paint on the exterior decking (LP-03) contains very low levels of lead (0.0015%).

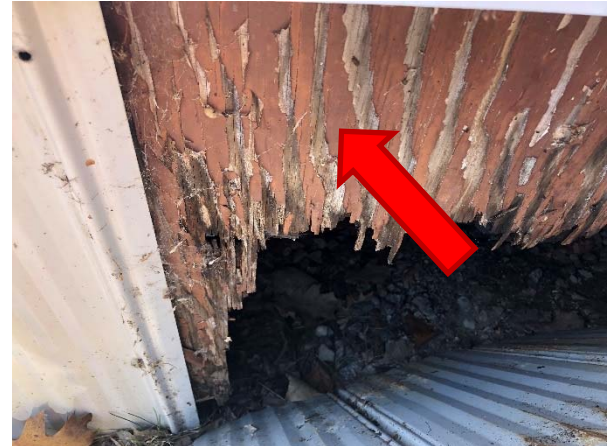
Brown paint on exterior trailer skirting beneath steel cladding (LP-04) contains 0.14% lead.

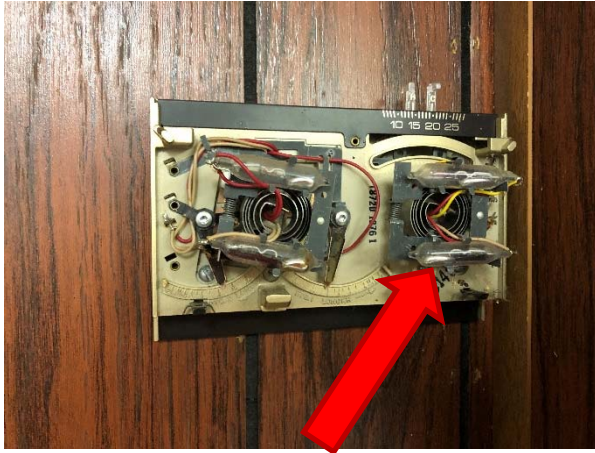
- Compact fluorescent lights and fluorescent light tubes contain mercury vapour and are present throughout the Site in small quantities.
- One thermostat was found in the trailer that contains mercury switches. All thermostats should be dismantled and inspected for mercury switches prior to disposal.

Thermostat present in the trailer unit contains mercury.

consisting of elemental, inorganic or organic mercury that exceed the Leachate Quality Criteria of 0.1 ppm, as established by Regulation 347 (as amended) TCLP, cannot be disposed of at a solid non-hazardous waste site. The waste removal contractor should be responsible for finding a source for the disposal of materials containing mercury. Mercury is also listed in the “*Transportation of Dangerous Goods Act*”; therefore, specific requirements apply for the transportation of materials containing mercury.

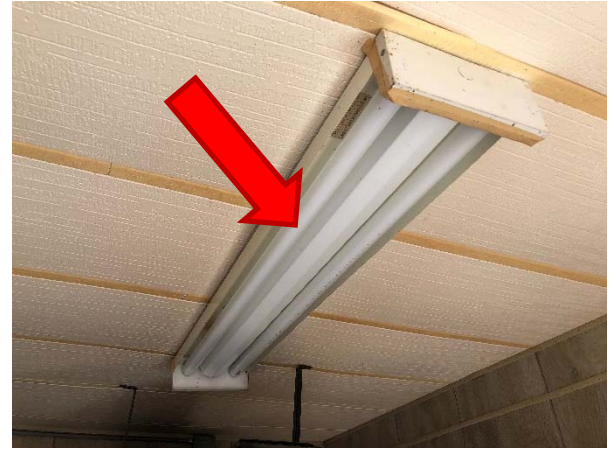
At the time of our visit, limited quantities of compact fluorescent lamps and fluorescent light tubes were observed to be in use throughout the Site. Compact fluorescent light bulbs and fluorescent light tubes contain mercury vapour. Fluorescent lamps should be removed intact and properly disposed of. One thermostat was observed during our assessment. TULLOCH determined that the thermostat did contain mercury switches. All thermostats found during demolition should be removed and inspected for the presence of mercury switches prior to disposal.

Fluorescent light tubes present throughout the Site contain mercury gas.

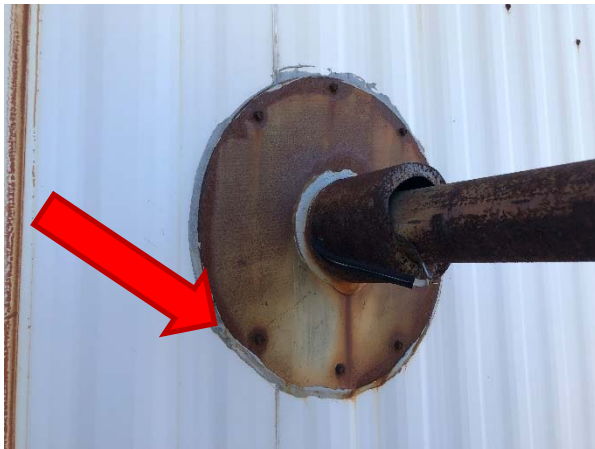
Grey caulking was observed around the exterior ducts and pipes of the shed building. One sample of grey caulking was collected and submitted for analysis (PCB-01). Grey caulking does not contain PCBs.

Grey caulking around pipes on the exterior of the shed building (PCB-01) does not contain PCBs.

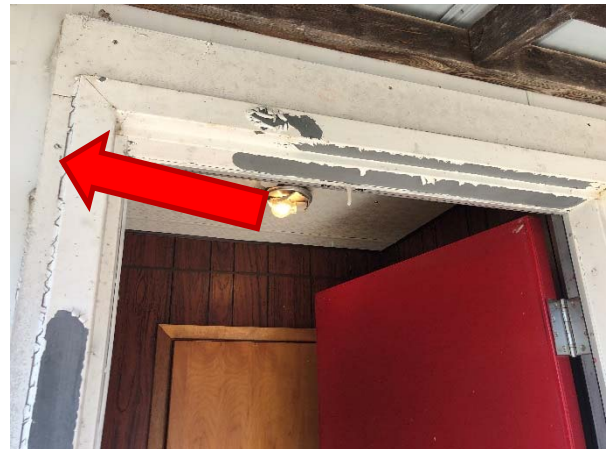
White caulking was observed around the exterior doors of the trailer unit building. One sample of the white caulking was collected and submitted for analysis (PCB-02). White caulking does not contain PCBs.

White caulking around doors on the exterior of the trailer unit building (PCB-02) does not contain PCBs.

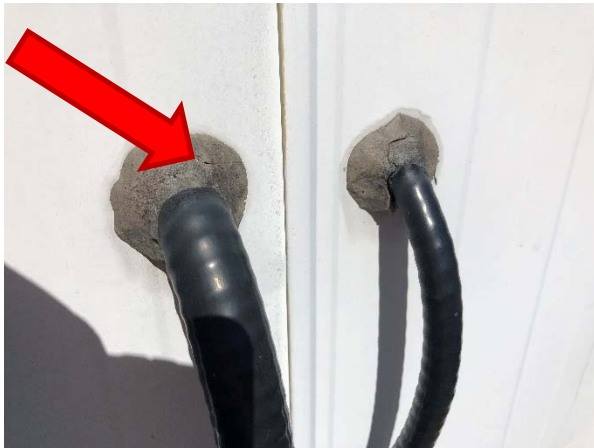
Grey caulking was observed around the exterior wiring of the trailer unit building. One sample was collected and submitted for analysis (PCB-03). Grey caulking does not contain PCBs.

Grey caulking around wiring on the exterior of the trailer unit building (PCB-03) does not contain PCBs.

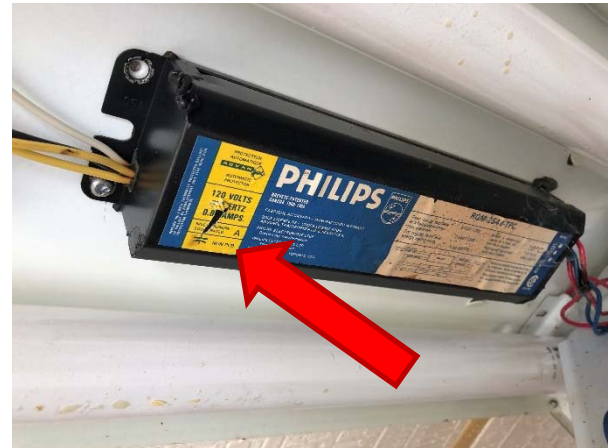
- PCBs may be present in ballasts found in older T12 fluorescent light fixtures present throughout the Site. One ballast was inspected and was found to be non-PCB, however, all T12 fixtures should be de-energized and inspected for the presence of PCB containing ballasts prior to disposal.

Ballast observed in the shed building stated it did not contain PCBs.

Compact fluorescent light fixtures and fluorescent light fixtures were observed at the Site. Compact fluorescent light fixtures do not contain ballasts that contain PCBs. Some older T12 fluorescent light fixtures may contain light ballasts that contain PCBs, one ballast was observed in the shed building and found to not contain PCBs, however, it should not be assumed that all ballasts are non-PCB. All T12 fluorescent light fixtures scheduled for removal should be de-energized, dismantled and inspected for PCB containing ballasts.

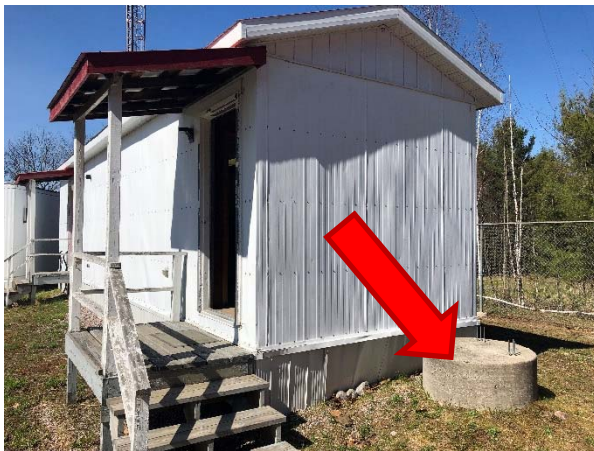
Concrete materials and gravel, which have the potential of containing silica, were used in concrete materials used for foundations.

Concrete contains silica and is found throughout the survey area.

Samples of building materials were not relinquished for silica analysis. Cast in place concrete slabs, foundations, masonry and granular fill are likely to contain silica, since silicon dioxide is the basic component of sand, sandstone, slate, flint, quartz and granite rock. The Waste Diversion Act, O. Reg. 102/94, specifies that materials containing silica or that have the potential of containing silica should not be disposed of at a landfill. Exposure to fine dust containing airborne silica becomes a health issue when inhaled. Engineering control, such as wetting materials during demolition/construction activities should be used in order to limit the accumulation of dust. O. Reg. 490/09 and the Ministry of Labour document “*Guideline – Silica on Construction Projects*” (September 2004), should be referred to when demolishing materials that may contain silica.

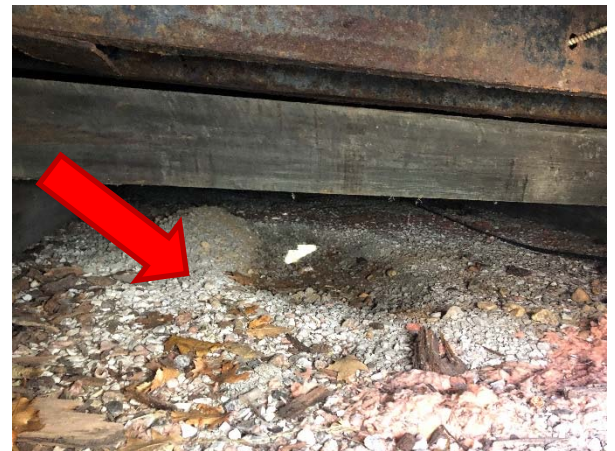
Gravel used for timber foundation contains silica.
