Foreshore File No.: 9047-R-01.1

Re: Concrete Float Inspection

Small Craft Harbours,
Concrete Float Inspection,
Steveston, British Columbia

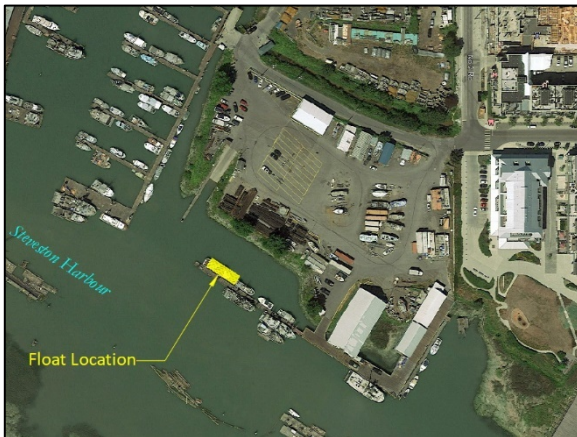
Image 1. Concrete float location in Steveston Harbour at Foot of No. 2 Road.

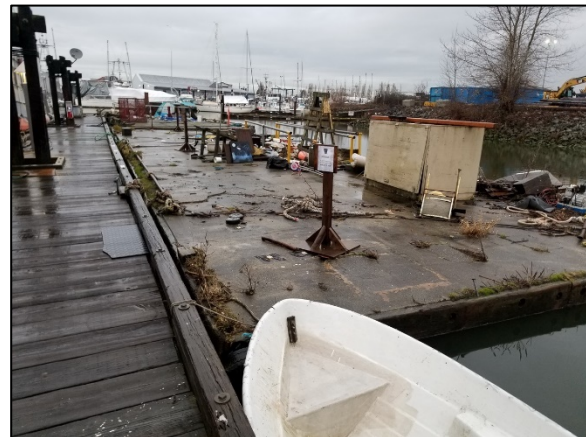
Image 2. Concrete float surface partially covered with anthropogenic debris.

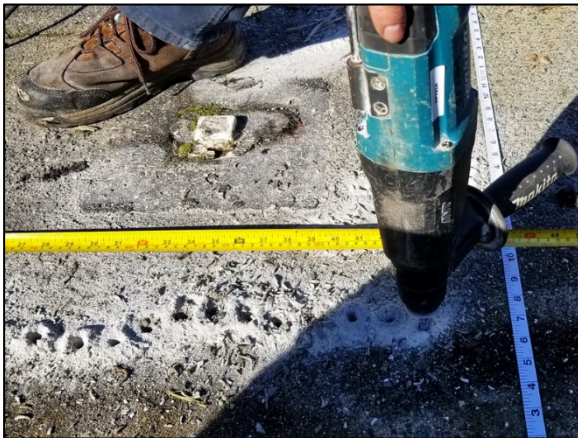
Image 3. Test holes drilled to determine location of bulkhead walls below the concrete deck.

Test holes identified there are internal bulkheads that run lengthwise down the float with an estimated thickness of 2" to 2½". While no other bulkheads were found during the inspection, pony walls and/or other structures may exist internally within the structure.

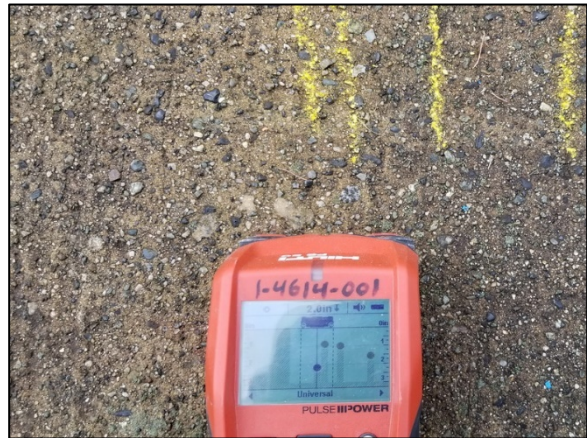
Image 4. Pulsed radar showing the presence of reinforcing steel within the concrete deck.

Pulsed radar measurements identified the presence of reinforcing steel within the concrete deck. Due to limited access no pulsed radar measurements were made of the float hull.

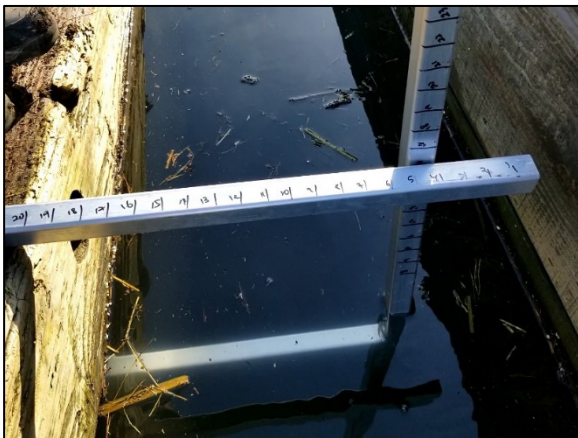
Image 5. Remote measuring device provides a measure of the elevation and horizontal distance of float hull relative to the edge of the concrete deck.

Remote sensing with a rod below the water surface showed all four sides of the float are sloped (see Sections A and B on Drawing 9047-D-01.1). In addition to being sloped, the starboard and port sides have horizontal linear irregularities resulting in “stepped” hull surfaces (see Section B on Drawing 9047-D-01.1).

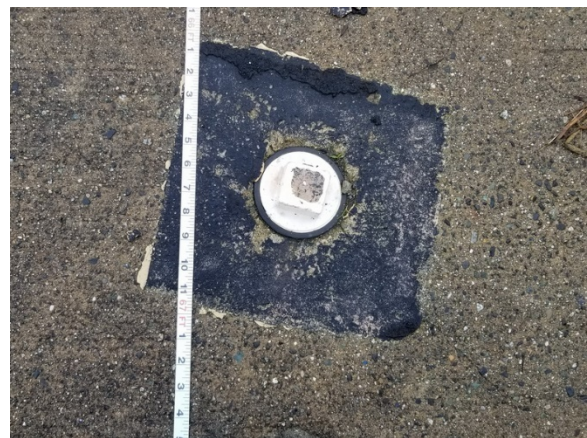
Image 6. Deck bung with removable plastic cap and internal sleeve set into concrete deck.

All test holes and sampled deck bungs indicate the chambers between the bulkheads contain Styrofoam. Dip stick tests show the Styrofoam fills the chamber from the underside of the concrete deck down to the bottom of the bilge. The lower regions of the Styrofoam are wet. As there are cracks and openings in the surface and the float is filled with Styrofoam, the water present in the chambers could be the result of rainfall or river water.

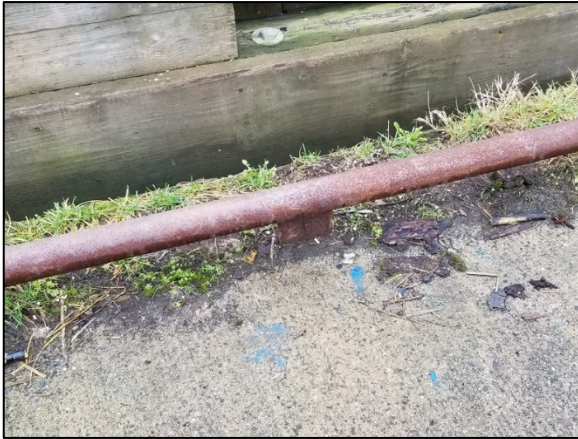
The float is 75' in length with a width of 24' and a typical thickness of 46". Three of the four corners of the float have rectangular notches. The freeboard of the float ranged from 10½" to 11½". A 36' long section of steel pipe bull rail is still present along the starboard side of the float as well as a number of the steel bull rail deck plates (see Image 7).

Image 7. Steel pipe bull rail welded to steel deck plates set into concrete deck.

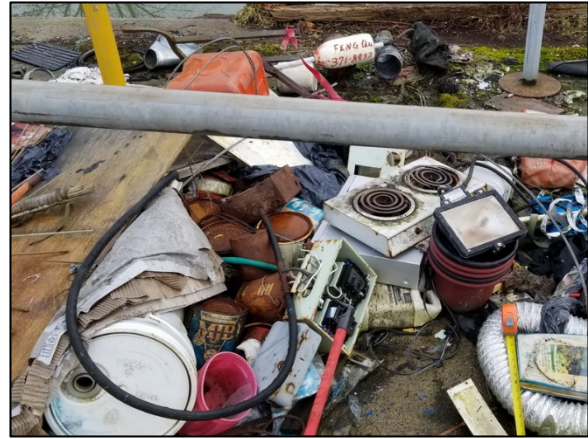
Anthropogenic debris is scattered in piles about the surface of the float including a small shed, cook tops, buckets, hoses, vent pipe, wooden and metal stands, ropes, paint cans and cables (see Image 8).

Image 8. Typical debris found on the float.

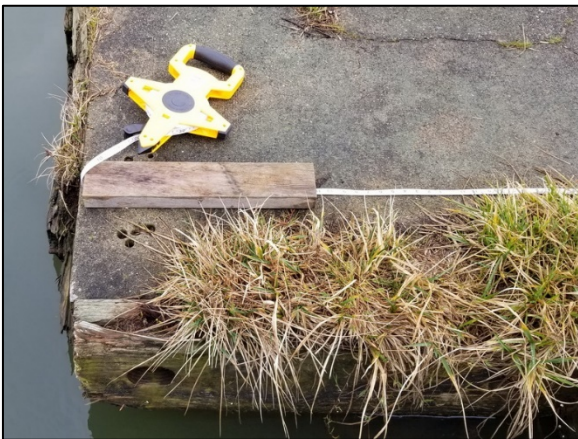
Portions of the timber fascia system remain in place but have sustained significant fungal and/or mechanical damage (see Image 9). Cracking, typically <math>< 1/8''</math> in width, was observed at locations on the surface of the deck (see Image 10).

Image 9. Heavy fungal damage in fascia.

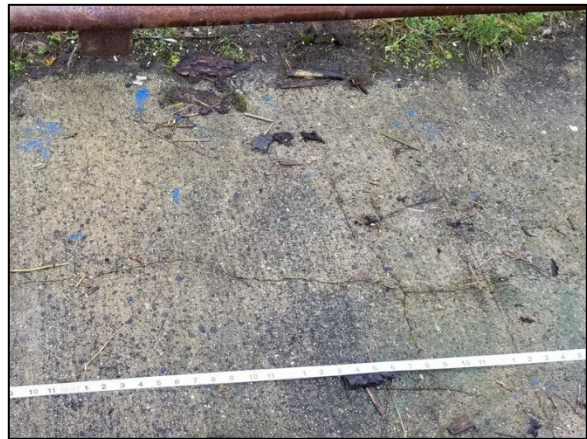
Image 10. Typical cracking observed on the surface of the concrete deck.

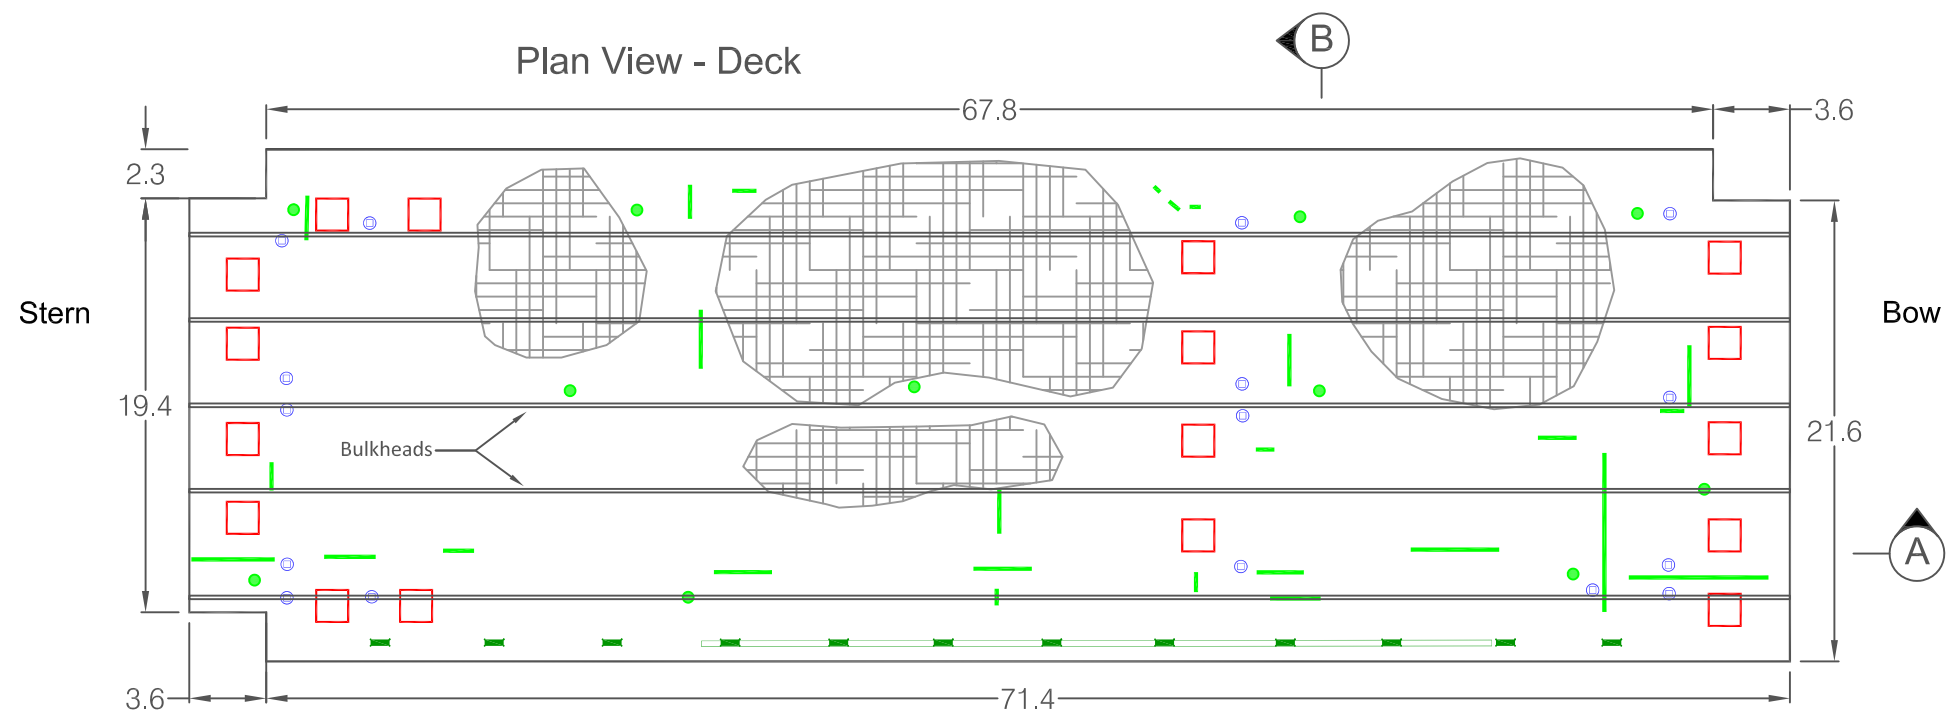
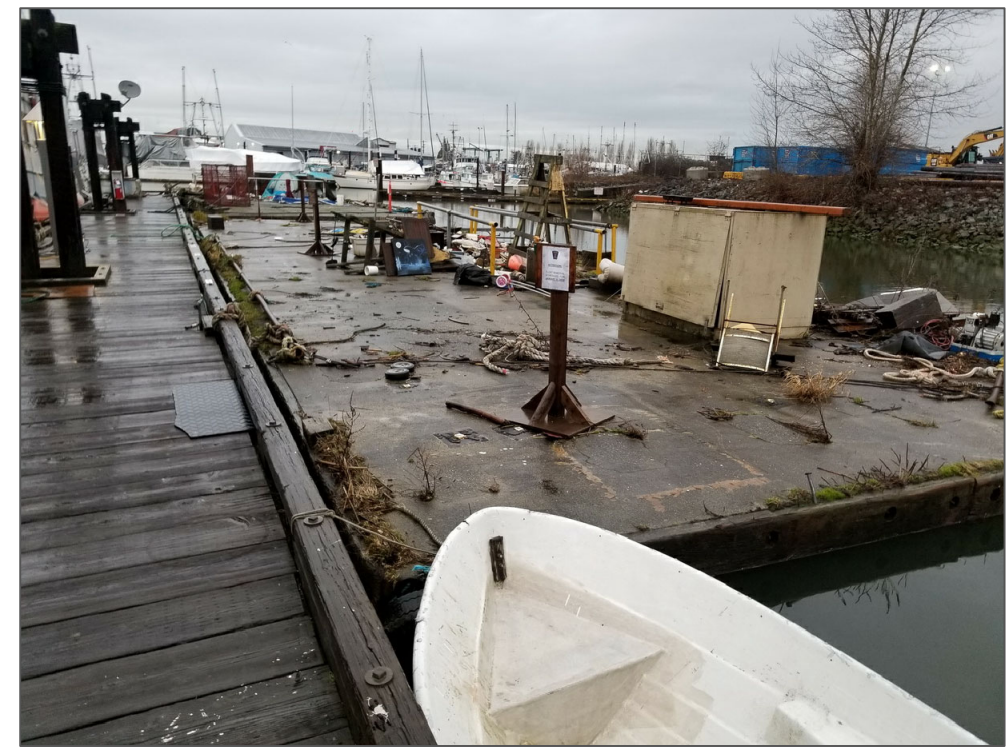
Photo 1. Looking from the bow towards the stern of the concrete float. Note debris collected on float.

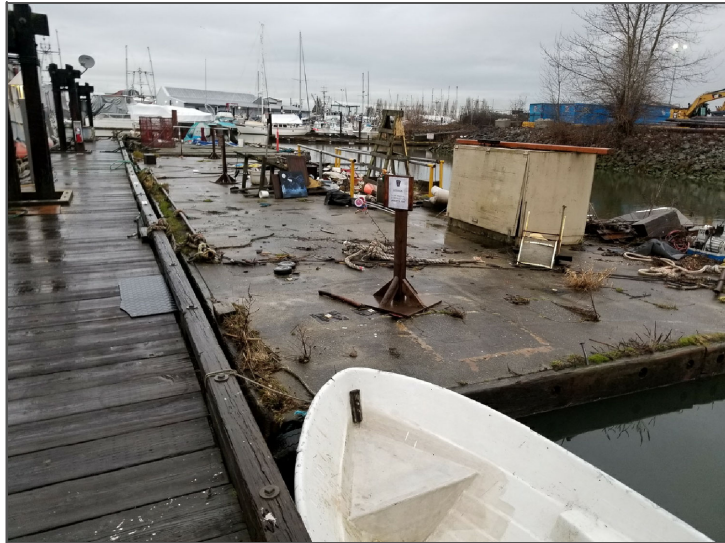
Photo 1. Looking from the bow towards the stern of the concrete float. Note debris collected on float.

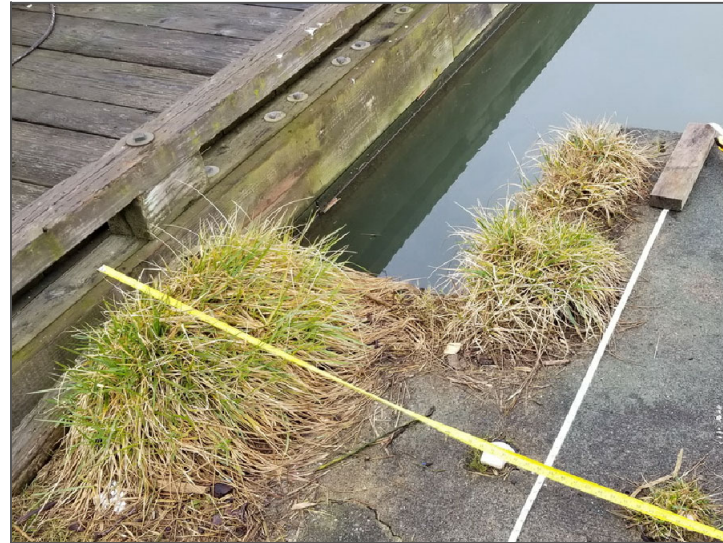
Photo 2. Stern starboard corner. Note notch in corner of float.

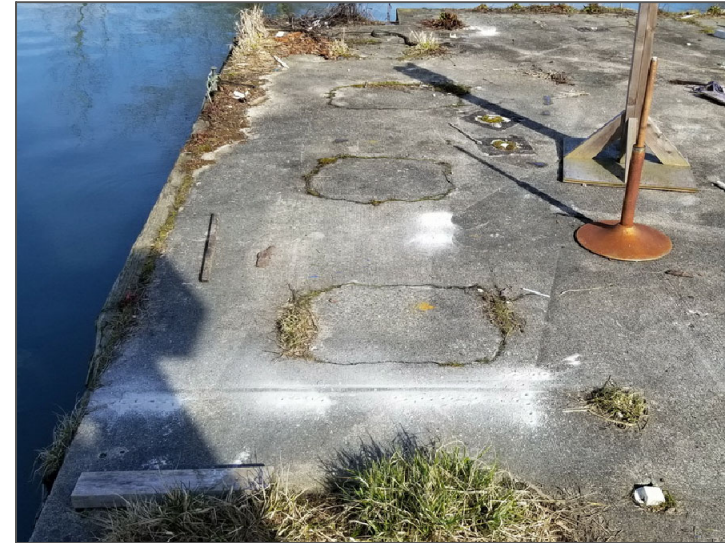
Photo 3. Looking towards stern port corner. Note rectangular patches in upper deck surface.

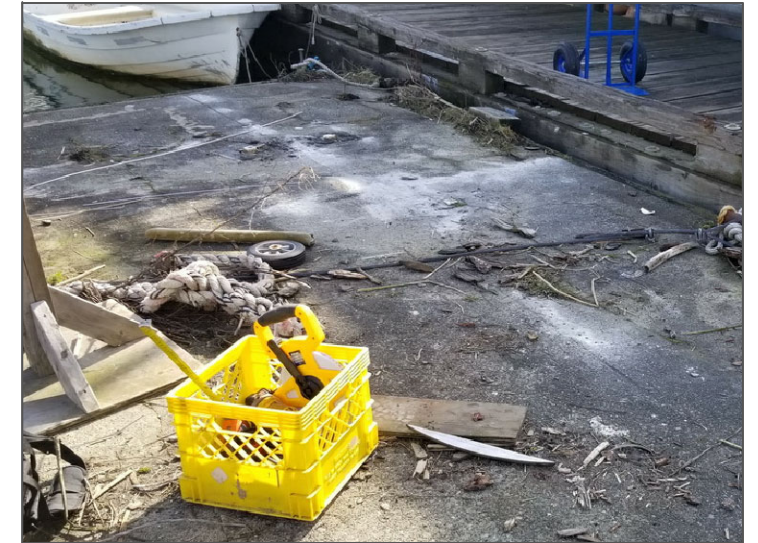
Photo 4. Looking towards the bow starboard. Note no notch in corner. Also note test holes to assess presence/absence and location of internal bulkheads.

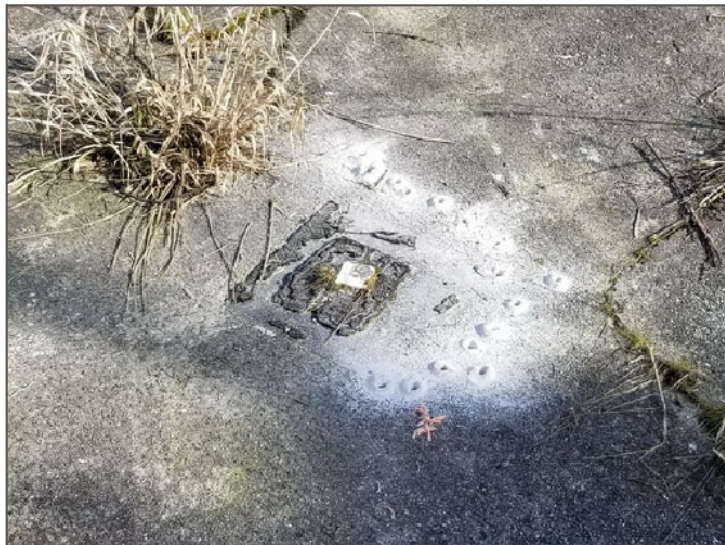
Photo 5. Typical plastic bung fitting located in upper deck surface

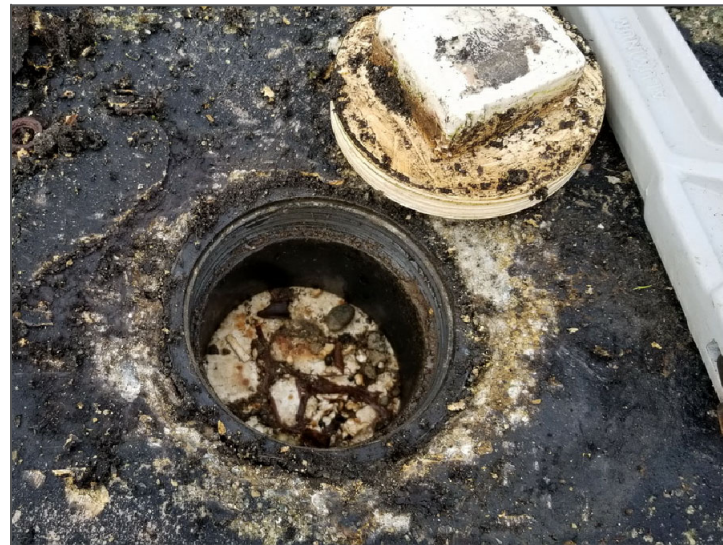
Photo 6. Plastic bung opened to reveal internal Styrofoam used to fill the internal hull of the float.

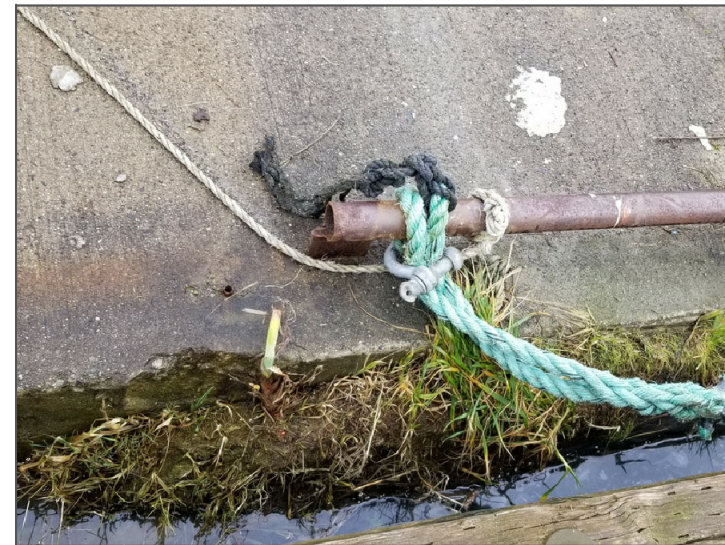
Photo 7. Broken steel pipe bull rail. Note bull rail welded to steel flat bar stand-offs protruding from concrete deck.

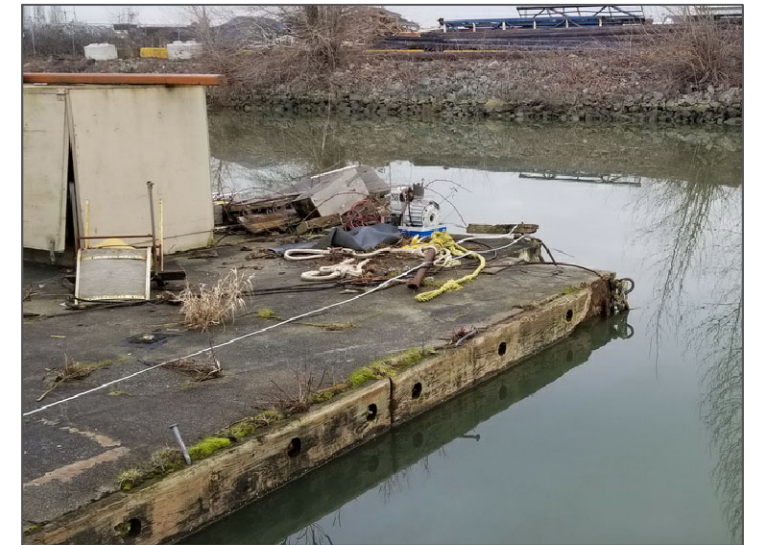
Photo 8. Looking at bow port corner along bow fascia. Note debris collected on float.
