Foreshore File No.: 9047-R-01.1

Re: Concrete Float Inspection

Please find below the results of Foreshore's inspection of the Department of Fisheries and Oceans Small Craft Harbours' concrete float located in Steveston Harbour, British Columbia (see Images 1 and 2). The purpose of the inspection was to determine the general condition of the float.

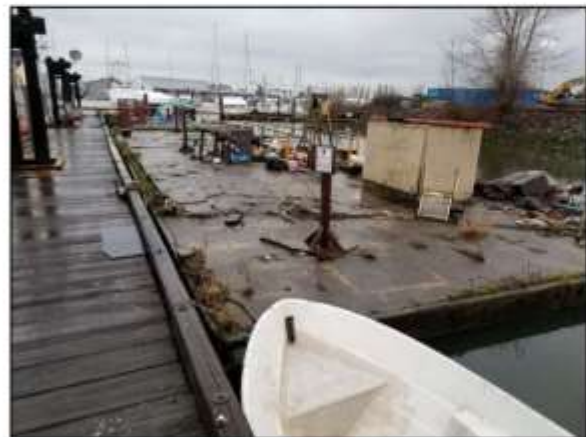
Image 2. Concrete float surface partially covered with anthropogenic debris.

Anthropogenic debris is scattered in piles about the surface of the float including a small shed, cook tops, buckets, hoses, vent pipe, wooden and metal stands, ropes, paint cans and cables (see Image 8).

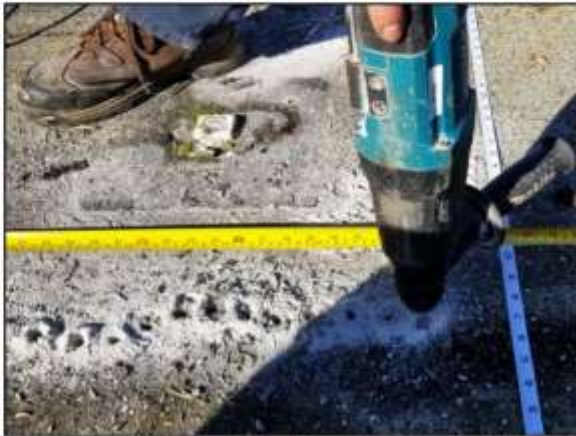
Image 3. Test holes drilled to determine location of bulkhead walls below the concrete deck.

Test holes identified there are internal bulkheads that run lengthwise down the float with an estimated thickness of 2" to 2½". While no other bulkheads were found during the inspection, pony walls and/or other structures may exist internally within the structure.

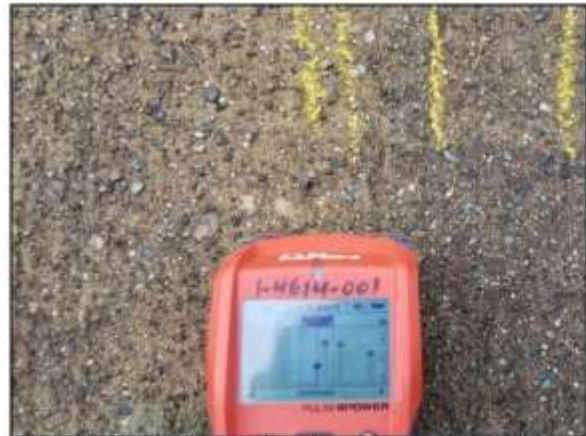
Image 4. Pulsed radar showing the presence of reinforcing steel within the concrete deck.

Pulsed radar measurements identified the presence of reinforcing steel within the concrete deck. Due to limited access no pulsed radar measurements were made of the float hull.

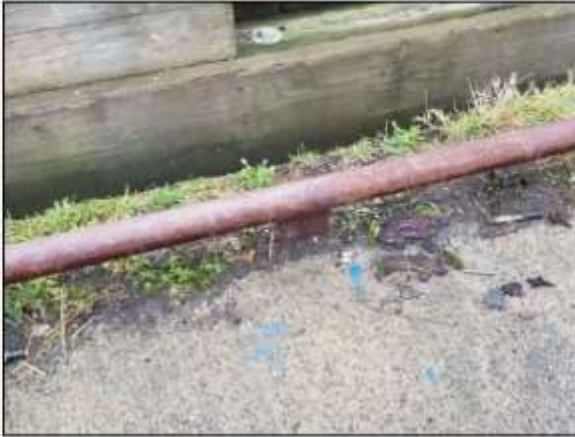
The float is 75' in length with a width of 24' and a typical thickness of 46". Three of the four corners of the float have rectangular notches. The freeboard of the float ranged from 10½" to 11½". A 36' long section of steel pipe bull rail is still present along the starboard side of the float as well as a number of the steel bull rail deck plates (see Image 7).

Image 7. Steel pipe bull rail welded to steel deck plates set into concrete deck.

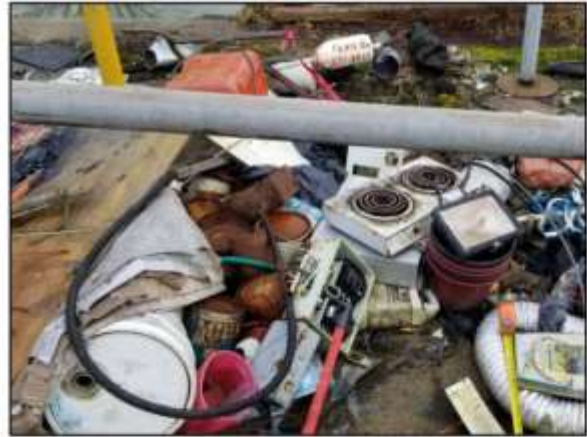
Image 8. Typical debris found on the float.

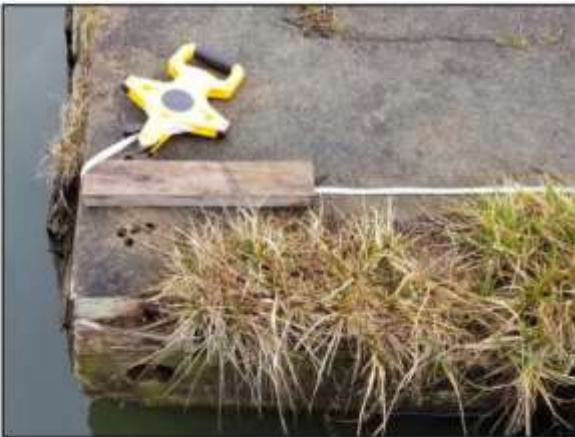
Portions of the timber fascia system remain in place but have sustained significant fungal and/or mechanical damage (see Image 9). Cracking, typically <math>< 1/8''</math> in width, was observed at locations on the surface of the deck (see Image 10).

Image 9. Heavy fungal damage in fascia.

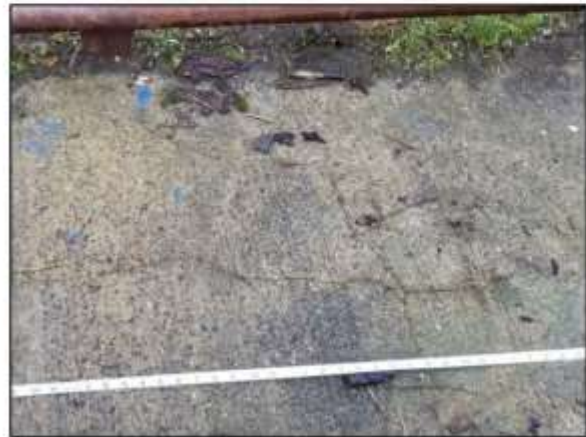
Image 10. Typical cracking observed on the surface of the concrete deck.

The overall condition of the float is poor with cracking present over the entire deck surface. All attachments to the float including fascia and bull rails are heavily damaged by fungi, corrosion or mechanical impact. The presence of water internally indicates there are leaks in the concrete deck or hull.
